**Doc CMIT--2006-206**

**HOUSE FIRE SPREAD, AN INVESTIGATION –  
GULGONG NSW**

**Report to  
Bushfire CRC**

**CSIRO - Manufacturing and Infrastructure Technology  
Fire Science and Technology Laboratory**

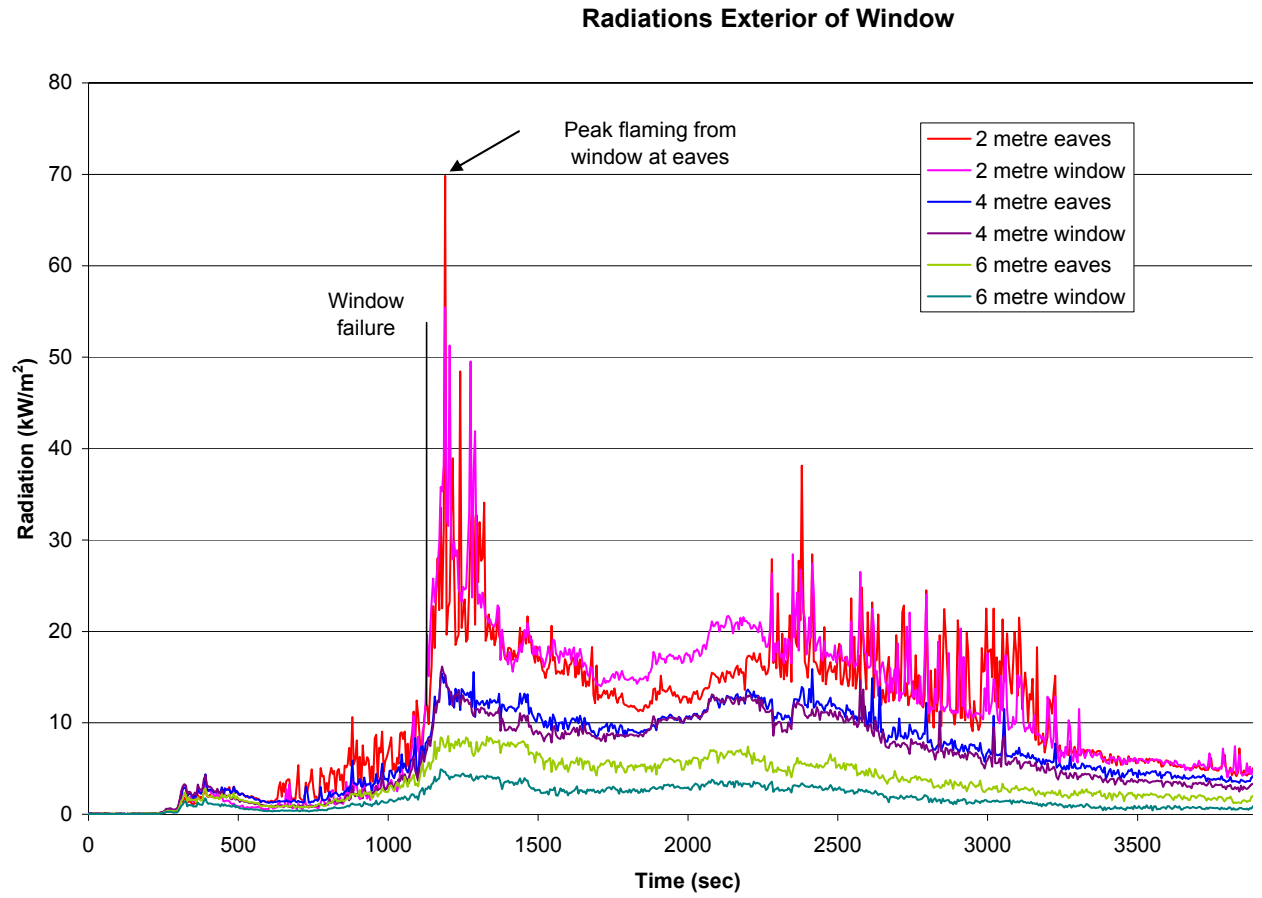
Figure 13. Radiation v. time during experimentation.

Immediate spikes in data occurred after window failure. Peak radiation and temperature occurred 80 sec later as the fire within the room intensified with the ingress of fresh air. Peak radiation 2 metres from the window centre was  $55 \text{ kW/m}^2$  with a temperature of  $223^\circ\text{C}$ . At this time peak radiation at eaves was  $70 \text{ kW/m}^2$  with a temperature of  $400^\circ\text{C}$ .

Radiation and temperature reduces after this peak as available fuel lessens. The rise in radiation and temperature after approximately 2200 sec occurs when the walls have burnt sufficiently to expose the internal house structure.

Radiation measured during the experiment, see Figure 13, shows sustained periods of radiation in excess of  $25 \text{ kW/m}^2$ . The radiation measurement at 2 metres from the window exceeded  $25 \text{ kW/m}^2$  for a duration of 145 seconds..

If another house with external timber features, timber fence or other combustible material was placed at 2 metres from the window, ignition of that material would most likely occur in the presence of a pilot flame. Peak radiation was  $55 \text{ kW/m}^2$  at this position with temperatures exceeding  $300^\circ\text{C}$ .

At eaves height the peak radiation was almost  $70 \text{ kW/m}^2$  which would pose potential threat to tall structures within 2 metres e.g. water tanks and power or phone lines.

Radiation levels at 4 and 6 metres from the window peaked at  $16 \text{ kW/m}^2$  for short periods and without sustained exposure and pilot flames present it is unlikely that if a fence was present at these distances that it would ignite and flaming would occur.

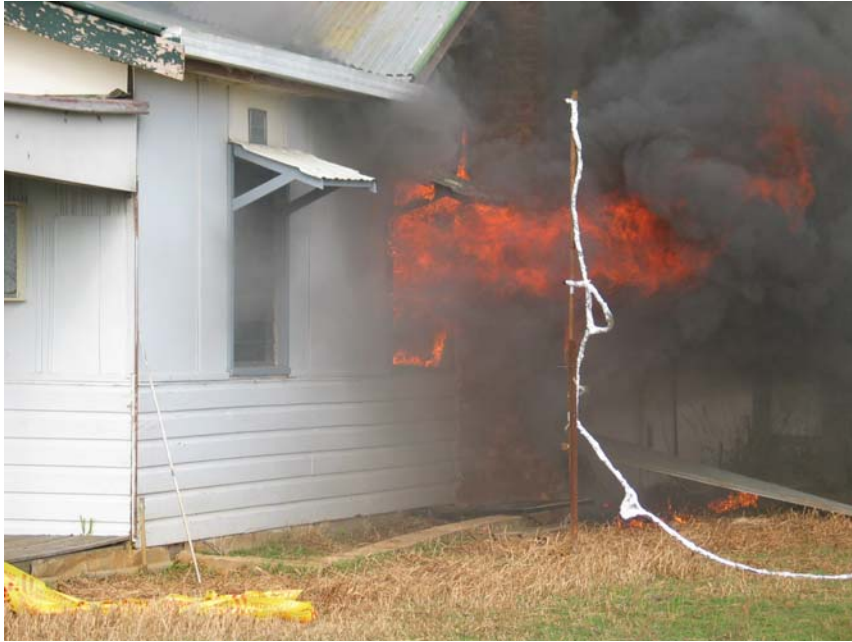
*Figure B3. Depth of flames through lounge room window. These flames are much larger than that for bedroom 1, given the room is of a greater volume and has more fuel. This photo is indicative of the extent flames can protrude from a building in this case approximately 4 metres.*

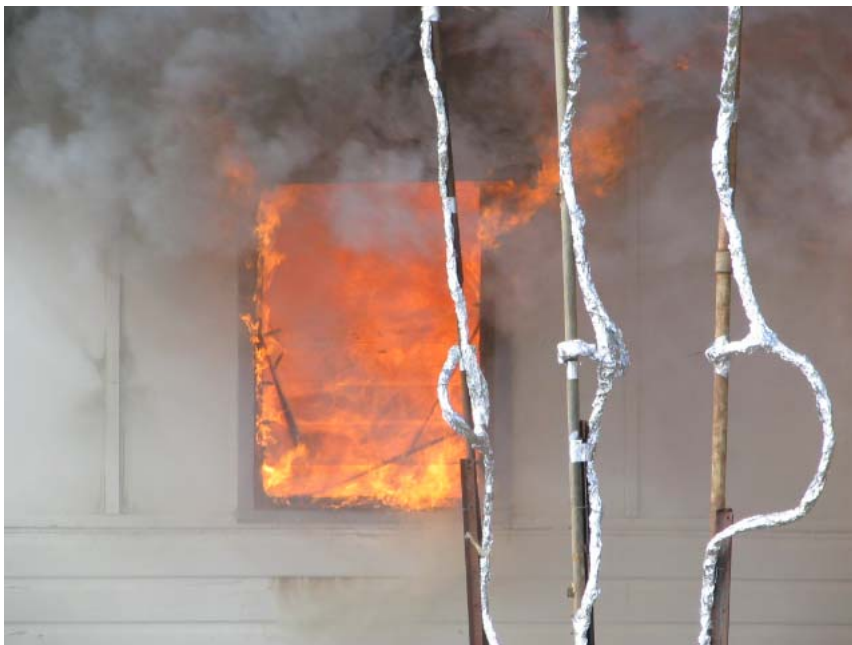
*Figure B4. Flames beginning to emerge from bedroom 1 window, most louvres still in place.*

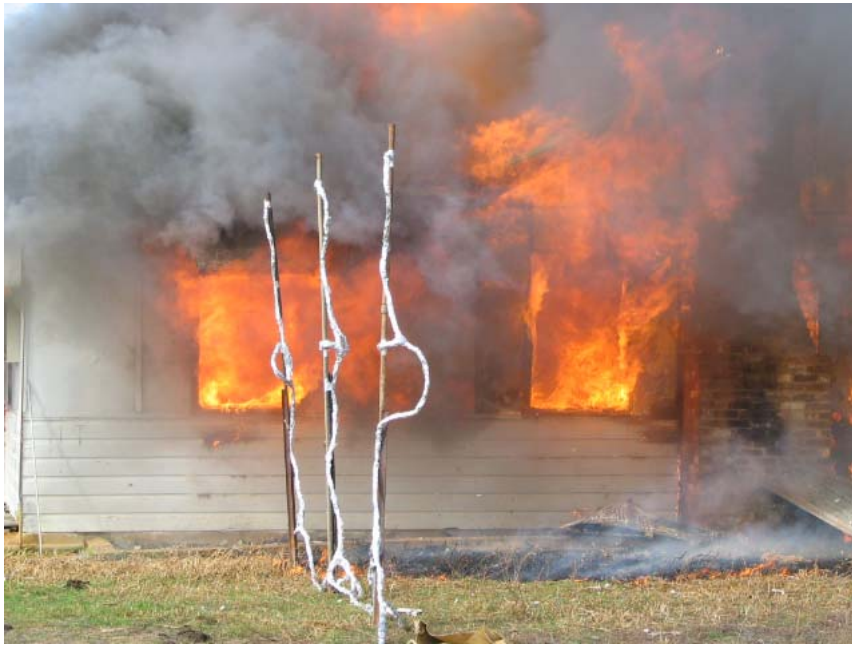
*Figure B5. Fire well established in Bedroom 1*

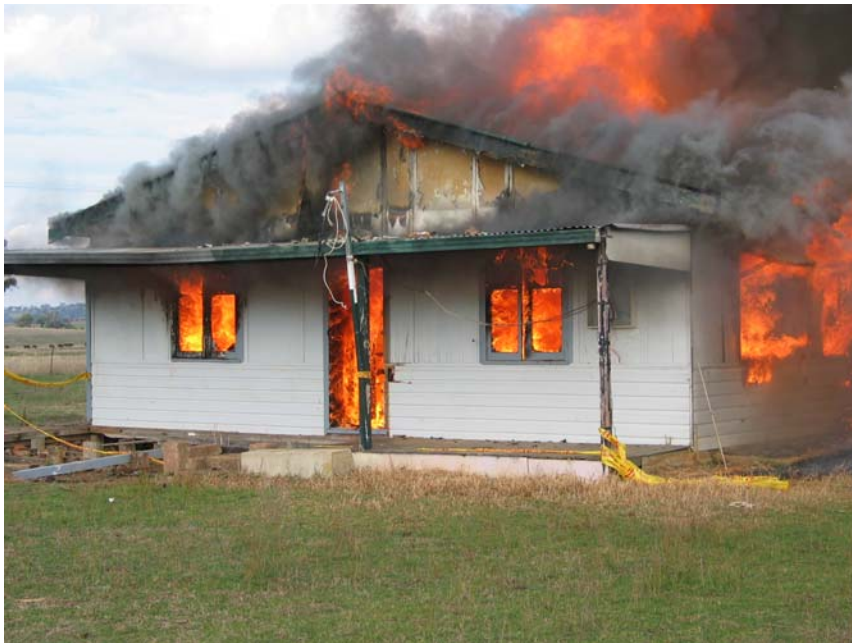
*Figure B6. House totally involved*

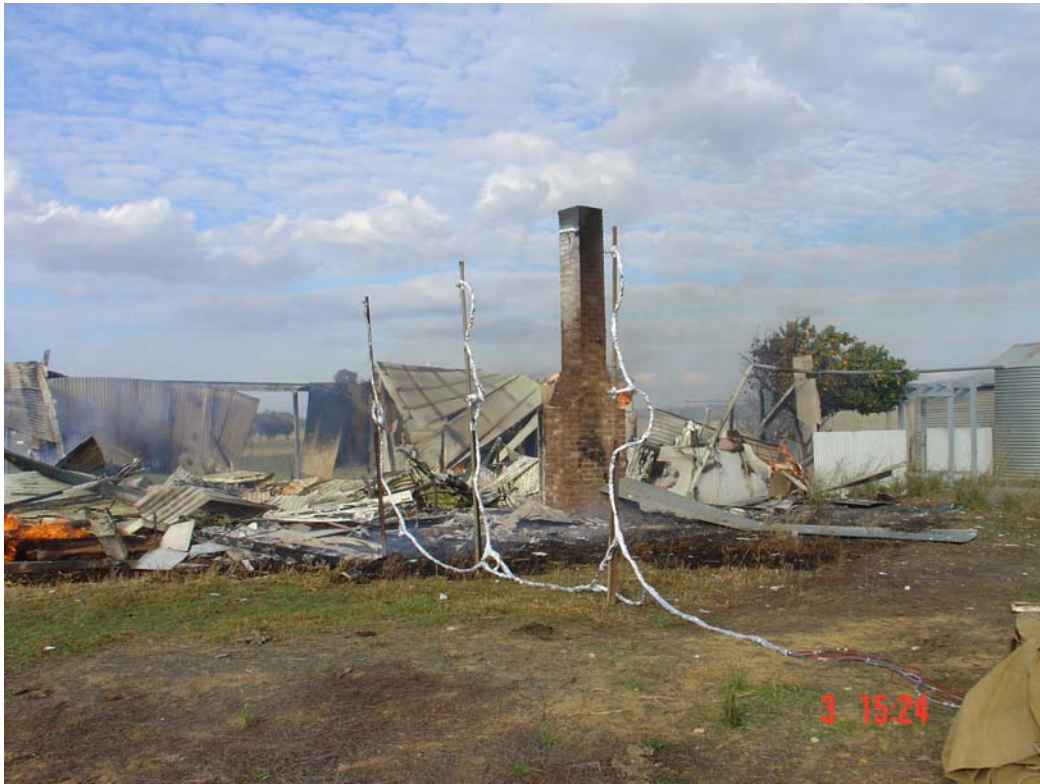
*Figure B7. Aftermath of the fire*
