DCEMP - CONSTRUCTION HERITAGE MANAGEMENT PLAN (CHMP)

LOCAL HERITAGE PLACES
(BRIDGEWATER RAILWAY STATION, PARKVIEW, & FAIRFIELD)

BRIDGEWATER BRIDGE PROJECT NO: 2024

DOC NO: 2024-MCD-0000-PLA-PRJ-00063

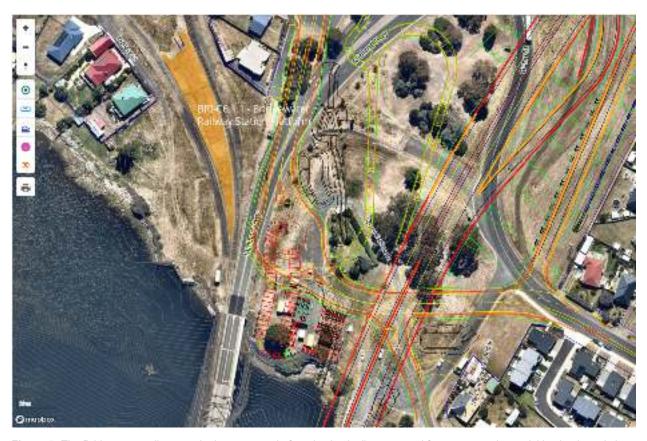
Figure 5: The Bridgewater railway station's concrete platform is physically separated from construction activities by the existing midland highway embankment and the railway tracks separate the platform from access, 'Exclusion Zone' fencing or equivalent will be determined in consultation with TasRail. Source: MCD Civillo accessed 02-Nov-2022.

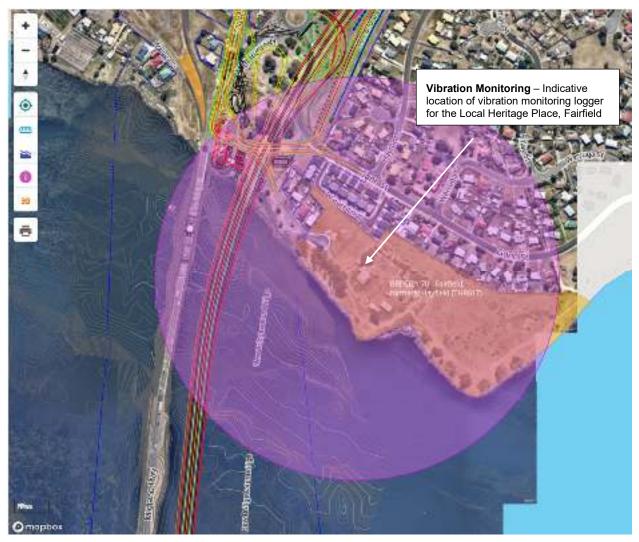
Figure 8: Indicative 280m Vibration Management Zone (pink circles) for protection of BRI-C6.1.70 Fairfield, formerly Hayfield (THR617) during impact piling. Where works are required within these distances, the mitigation measures listed in Section 8 of the CNVMP will be applied where reasonable and feasible, including installation of a continuous vibration monitoring logger. Source: Map from Civillo 02-Nov-2022.

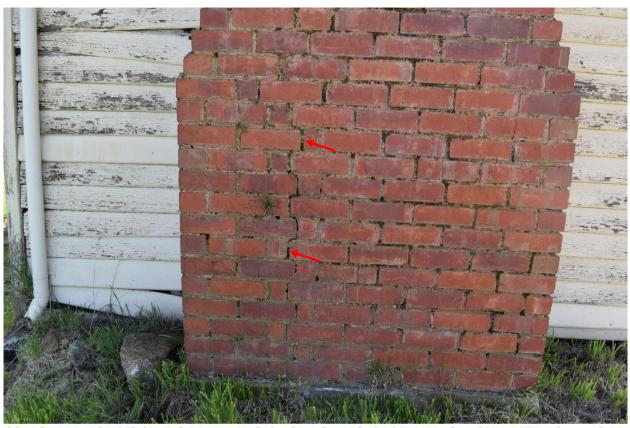
(ORIGINAL HOUSE) SIDE OF BUILDING 2- CRACKING OBSERVED ON CHIMNEY-10mm GAP APPROXIMATES

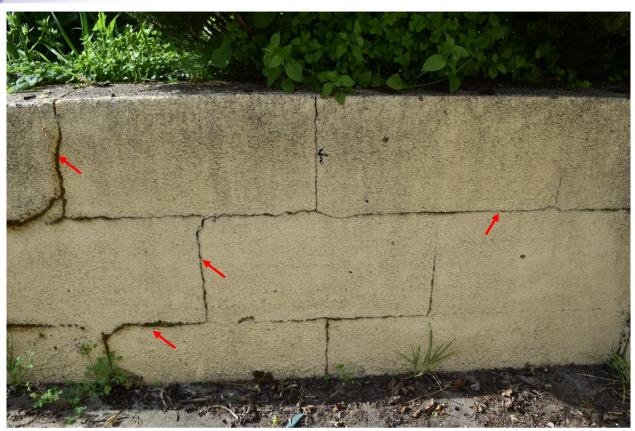
CRACKING IN RETAINING WALL- 1mm GAP APPROXIMATES

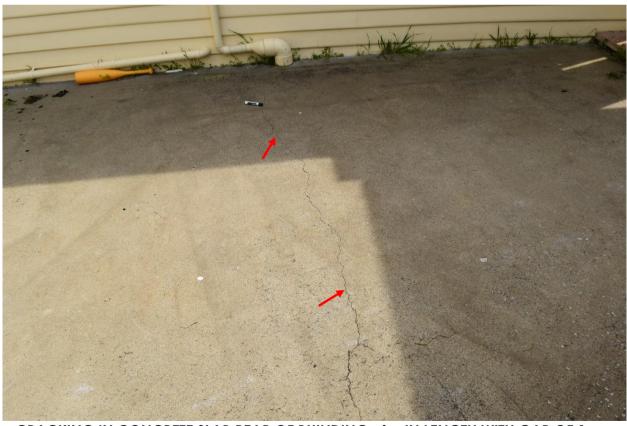
CRACKING IN CONCRETE SLAB REAR OF BUILIDING- 4m IN LENGTH WITH GAP OF 1mm APPROXIMATES

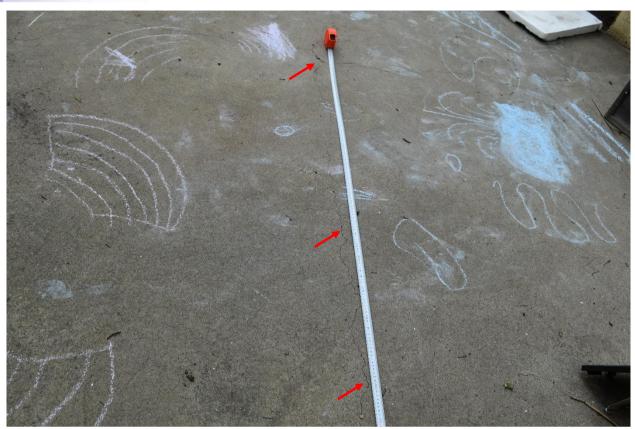
CRACKING IN CONCRETE SLAB REAR OF BUILIDING- 2.64m IN LENGTH WITH GAP OF 1mm

APPROXIMATES

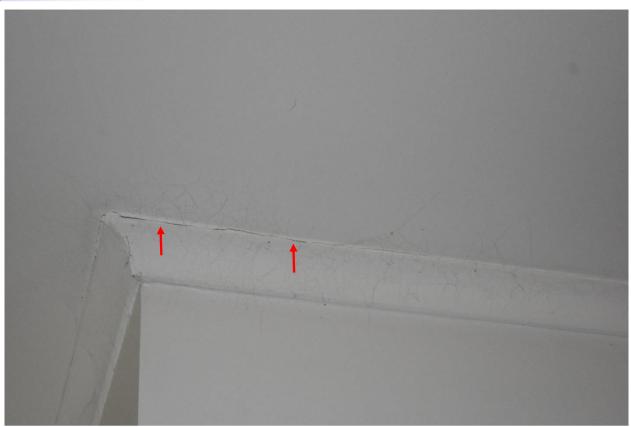
CRACKING IN LIVING ROOM CEILING

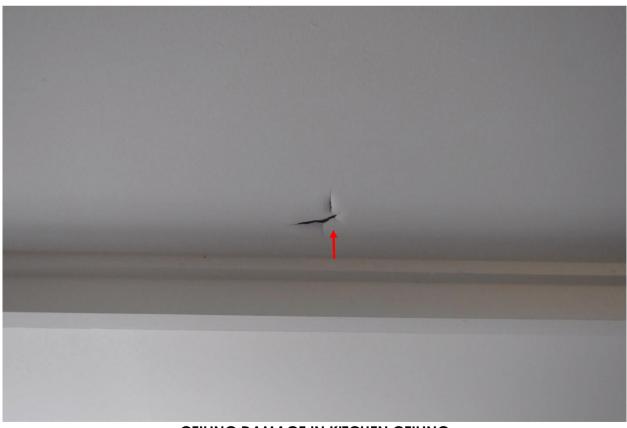
CEILING DAMAGE IN KITCHEN CEILING

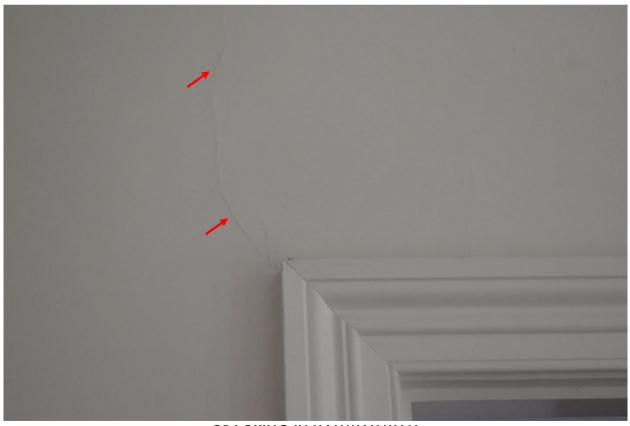
CRACKING IN HALLWAY WALL

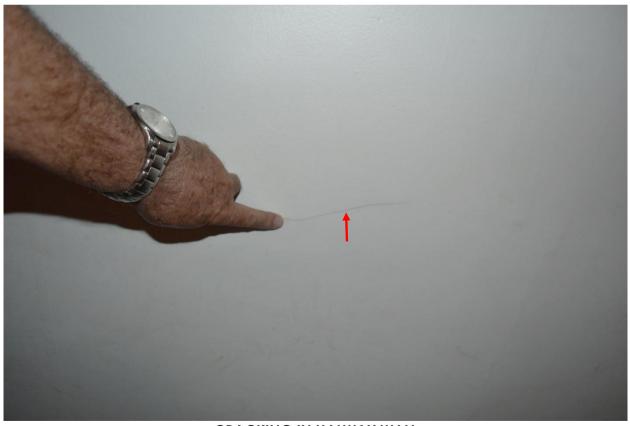
CRACKING IN HALWAY WALL

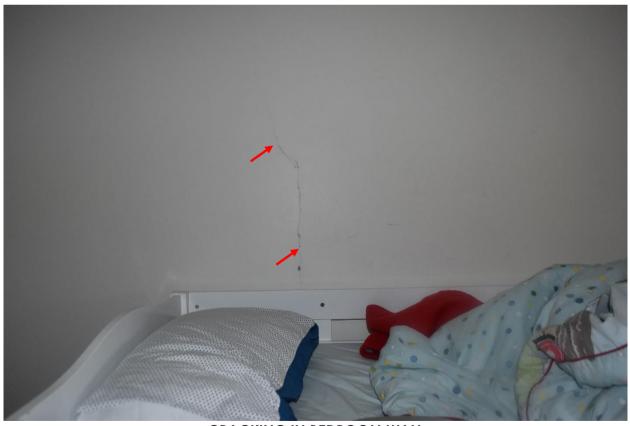
CRACKING IN BEDROOM WALL

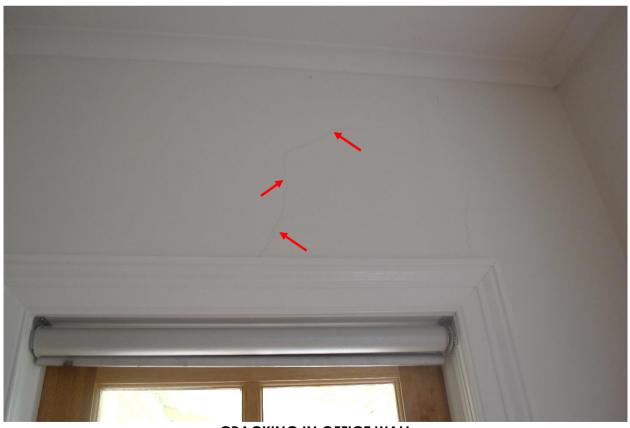
CRACKING IN OFFICE WALL

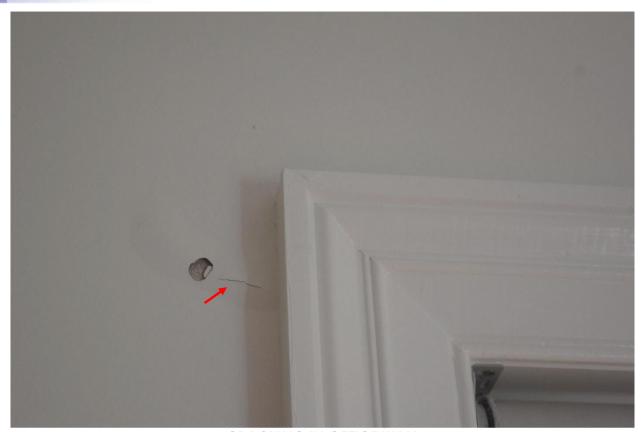
CRACKING IN OFFICE WALL
