## 450 ROKEBY ROAD HOWRAH REPRESENTATION TO DRAFT CLARENCE LOCAL PROVISIONS SCHEDULE

Geotechnical assessment:-450 Rokeby Road HOWRAH

Weldon GeoTech 2003/12431aa

Quarry, 450 Rokeby Road Rehabilitation Management Plan

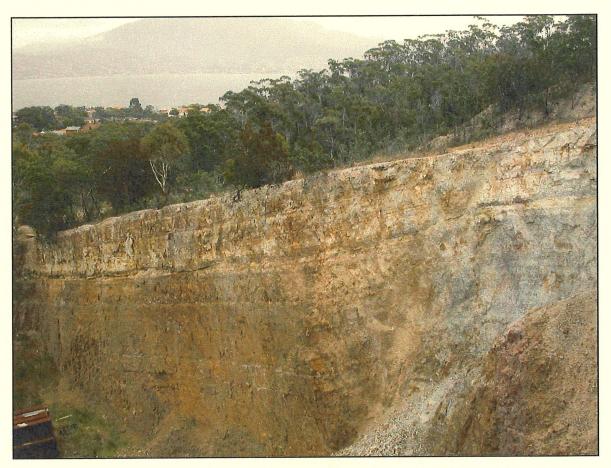
Plate 1 Prominent subvertical defect forms western quarry face.

The quarry face exposes a prominent bedding plane dipping to the southwest at about 14, that is, the defect dips out into the face of the quarry. The defect runs roughly parallel to the ground surface at about 2m below it. Although the defect may have a clay lining in places, the surface is undulating on a broad scale but planar to curved on a smaller scale. The surface roughness varies from smooth to rough. We assess that the angle of friction is unlikely to fall below the slope angle and we asses that it is unlikely to rare that the hillside will fail on this defect surface. Where the defect daylights in the quarry face around the northern boundaries of the quarry face there is no resistance to sliding and we assess the qualitative measures of consequences to property in the fall-out zone below the quarry face to be major to catastrophic and the level of risk to property is assessed as moderate to low. Moderate risks are tolerable provided a treatment plan is implemented to reduce risks. Low risks are usually accepted.

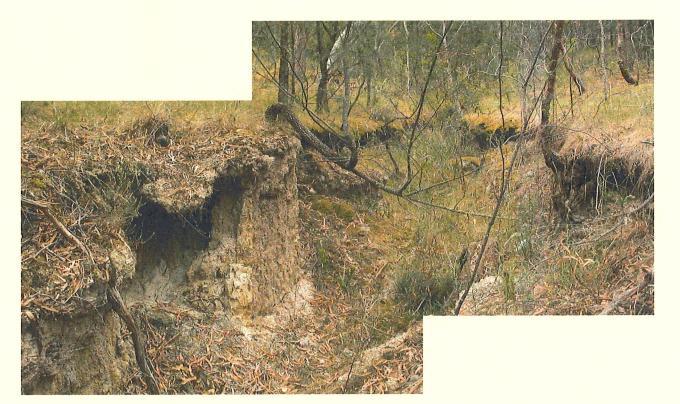
Proposed lots 1 and 2 are largely bushland with a small creek occupying a natural gully on the western side of the proposed lots. There are two dams on the creek, one on each proposed lot. The creek bed leading to the upper dam on lot 2 is deeply eroded and has been subject to tunnel and gully erosion (Plate 2). Piping and

Plate 2 Tunnel erosion in creek bed leading to dams on each of lots 2 and 1.

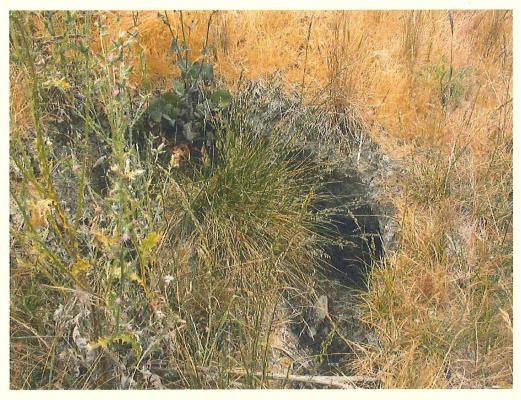
tunnel erosion has also occurred in the upstream face of each dam (Plates 3 and 4). The failures are near the base of the dam embankment. Outlets for the tunnels were not observed. We assess that the naturally occurring materials are not suitable for dam embankments and because of their susceptibility to tunnel erosion, should be stripped from any proposed dam site and the dam embankment constructed with imported materials. Considerable remedial work will be required if the dams are to be restored to effective water storages.

Plate 4 Tunnel erosion in upstream face of dam on proposed lot1.

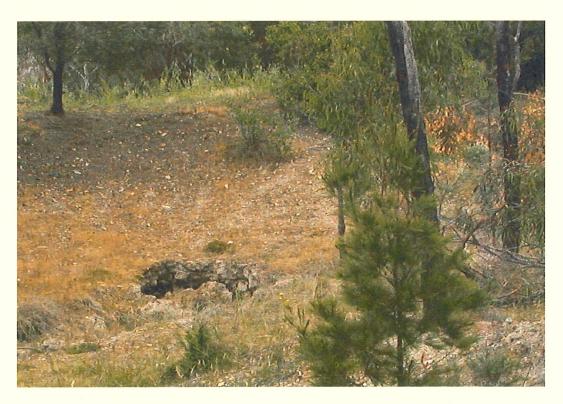
Plate 3 Tunnel erosion in upstream face of dam on proposed lot 2

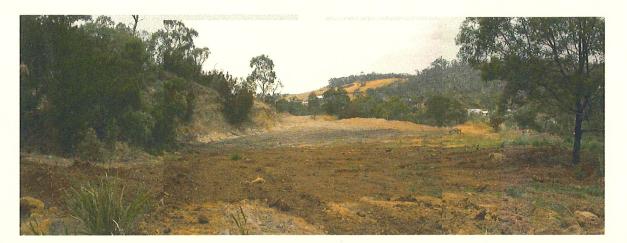
Also on each of proposed lots 1 and 2 slope grooming has been undertaken (probably) using spall and stripped overburden from the quarry site (Plates 5 and 6 respectively). The relatively flat areas created on each of these proposed lots by slope grooming are considered to be viable dwelling sites away from any quarry face and potential landslide hazard.

Plate 6 Flat area created on proposed lot 2 by slope grooming

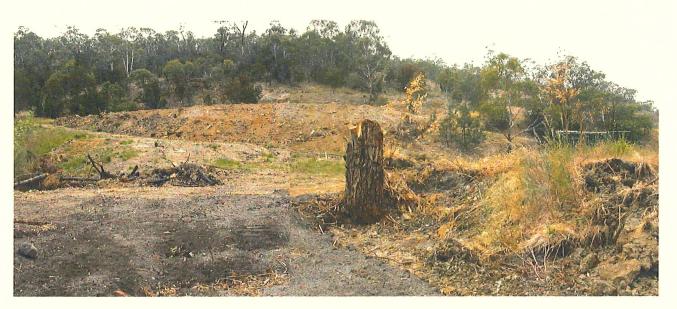
Plate 5 Fill embankment on proposed lot 2 (background) and slope grooming on proposed lot 1

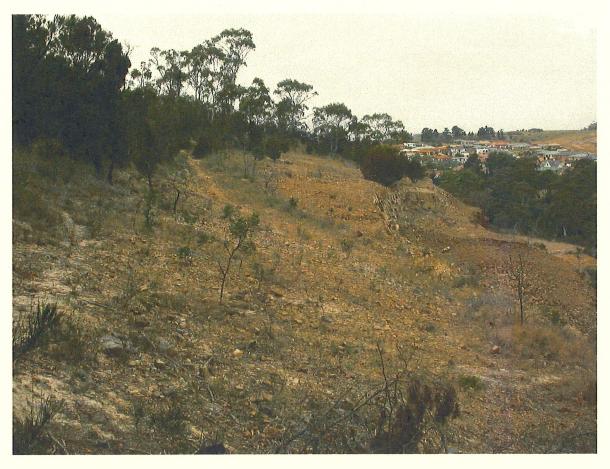
Plate 8 Overburden stripped from land between quarry face and property boundary

We recommend that top soil be imported to rehabilitate the areas denuded of vegetation above the face of the quarry (proposed lots 3 and 4), and to rehabilitate the upper bench on proposed lot 3. Plants local to the area should be used to revegetate the slope above the quarry face and the upper bench.

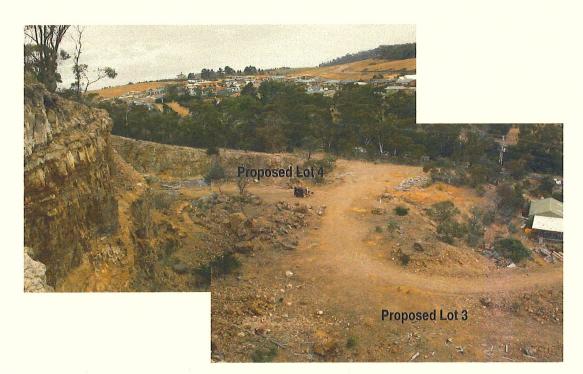
The floor area of the quarry in proposed lot 3 is extensive and a large flat area has been leased to DIERT for storage of demountable bridge sections (Plate 8). The flat areas on proposed lot 4 are less extensive

Plate 7 Floor of quarry proposed lot 4, and part of proposed lot 3

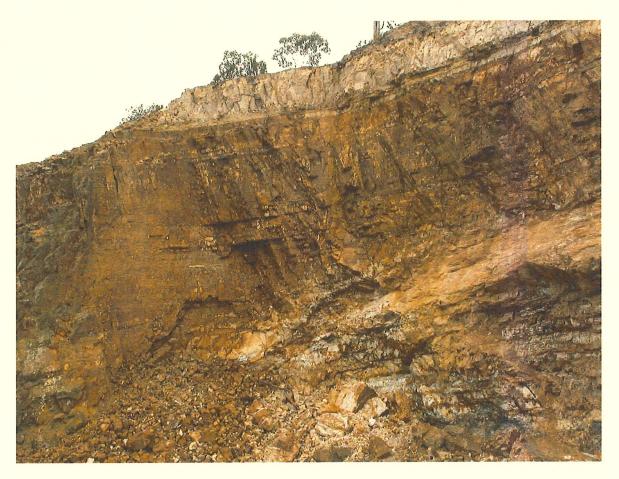
Other defects dip out of the quarry face at steeper angles (Plate 9). These present a hazard of planar rock slides involving the material above the defects. The angle of dip on these defects is estimated to be near the friction angle and the likelihood of failure occurring on them defect is assessed as almost certain. The consequence to structures within the fall-out zone is major to catastrophic. The level of risk is therefore assessed as very high. Very high risks require detailed investigation, planning and implementation of treatment options essential to reduce the risk to acceptable levels.

Plate 9 Defects dipping out into the quarry allow present a hazard of planar rock failures

We assess that an acceptable treatment is to restrict access to the potential fall-out zone and the set-back requirement is discussed later in this report.

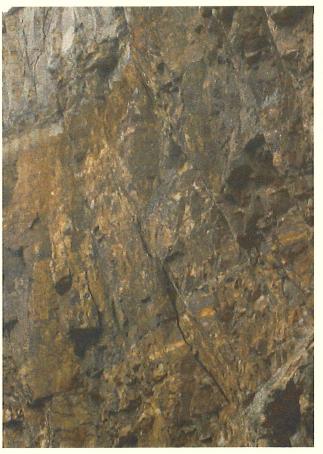
will eventually topple (Plate 11). The volume of the column affects the consequences to property. We assess with the relatively close spacing of defects in the quarry that the consequences to property in the fall out zone will be minor to medium and that the level of risk is high. High level of risk requires planning and implementation of treatment options to reduce the risk to acceptable levels.

## Plate 11 Separation along a defect has resulted in a column of rock that is almost certain to topple into the floor of the quarry.

Another potential mode of failure is planar failure on the defect at the base of the column. Other rock fragments are overhangs without support beneath and are almost certain to fail and fall under the influence of gravity.

We assess that an acceptable treatment is to restrict access to the potential fall-out zone and the set-back requirement is discussed later in this report.

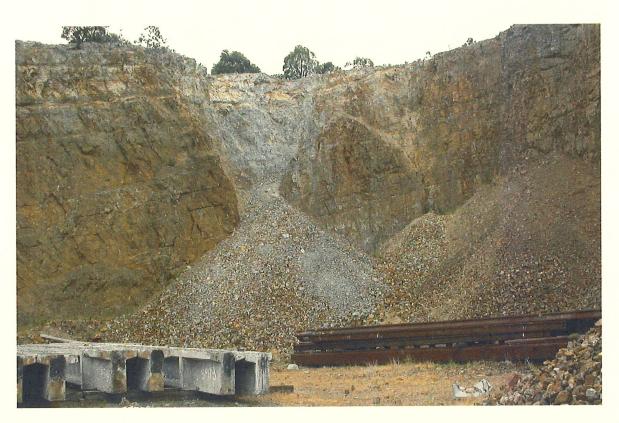
Under some conditions, continuous sloping defects may intersect with the line of intersection sloping toward the quarry face. Where the line of intersection between the defects also intersects the face of the quarry there is the potential of a wedge failure. This appears to be the underlying mechanism that has resulted in the formation of a cone of debris in the northwestern corner of the quarry (Plate 12). Other failure modes are also represented in this area. The concentration of surface run-off from the upper bench of the quarry towards the failed area is considered to be a contributing factor to the failures.

Plate 12 Debris cones in the northwestern corner of the quarry floor

We assess it possible for the failures in the northwestern corner of the quarry to enlarge. Due to the relatively shattered nature of the rock mass in this area, the consequence to property in the fall out zone is assessed to be medium. The level of risk is moderate and moderate risk is usually tolerable provided treatment is implemented to maintain or reduce the risks.

We assess that an acceptable treatment is to restrict access to the potential fall-out zone and the set-back requirement is discussed later in this report. We also recommend the treatment plan include control of the surface run-off from the upper bench of the quarry in this area.

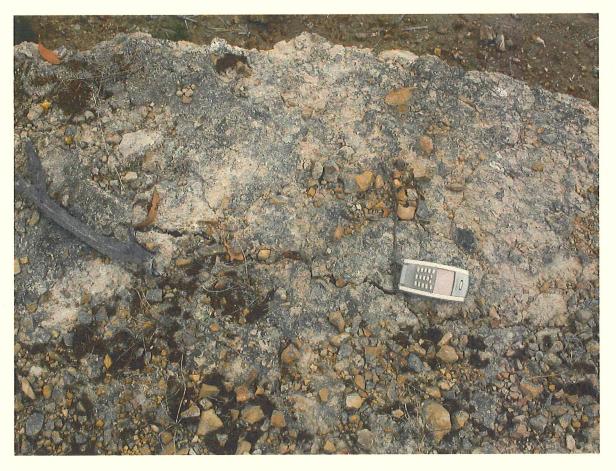
quarry. We have observed areas of overhang and in places tension cracks are opening up near the edge of the quarry (Plate 13). We recommend that the perimeter of the quarry face be fenced with a high, non-scaleable chain mesh fence and that warning / danger notices be posted. The fence should be placed behind areas of overhang.

Plate 13 Tension crack in an overhanging area near the edge of the upper bench of the quarry

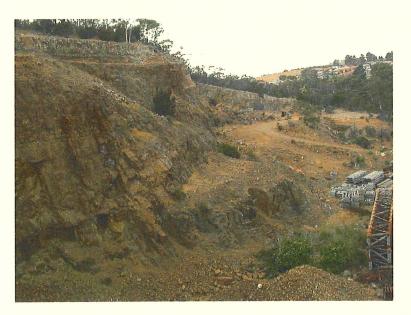
For rock falls, bouncing and rolling rocks we assess the set-back for the height of the quarry and the overall quarry face slope to be 9.2m in plan from the toe of the quarry face to the centreline of the crest of a 2m wide earth embankment constructed 1.8m high above the floor of the quarry with batter slopes of 1:1 (Horizontal : Vertical). The area between the embankment and the toe of the quarry acts as a ditch to constrain rock falls etc. and should be cleared of fallen debris at the time the embankment is constructed. In places the quarry face may be comprised in several segments, separated by a flatter slope segment (refer plate 14). Some judgement will therefore be necessary in defining the toe of the quarry face. We recommend that a suitably qualified and experienced engineering geologist, mining engineer or geotechnical engineer be engaged to define the toe of the quarry and thus the position of the earth embankment.

Plate 14 In places the quarry face is a composite of slope segments and quarry face
