From: Mark & Helen <mossvalealpacas2@bigpond.com>
Sent: Saturday, 29 April 2023 7:17 PM
To: McCrossen, Samuel
Cc: TPC Enquiry
Subject: FW: Whale Point Titles

Huon Heritage Review Stage 1 - Review of Existing Items not included on SHR

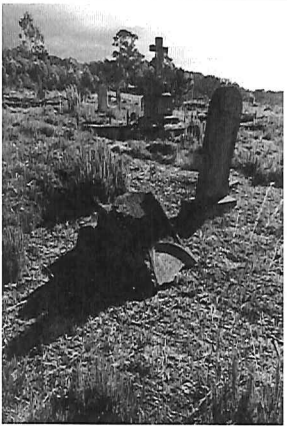
<p>once existed.</p> <p>It can be imagined that the knoll was cleared and was visible in the early years of use and that more recently it has become overgrown.</p> <p>The cemetery is still active and the earliest observe graves were 1860, however the gravestones are very deteriorated and many are missing. There has been extensive vandalism and neglect.</p> <p>The cemetery cannot be seen from the public roadways.</p> <p>It is a significant part of the area, even though outside the edge of the village and should be heritage listed.</p>	<p>D Cemeteries are a well-recognised class of places that as a group have high heritage significance. This is a small but good example of the class of place.</p> <p>E Funereal art demonstrates high levels of artistic achievement and even though the cemetery is overall modest, there are some fine examples of headstones.</p> <p>F Cemeteries have strong meaning to the community as they are reminders of those who have died, of the history of the locality and of human frailty.</p> <p>G Cemeteries have many special associations to those who are interred. These will vary from cemetery to cemetery, it is not known of particularly significant burials in this location, however, the meaning for the local community satisfies this criterion.</p>

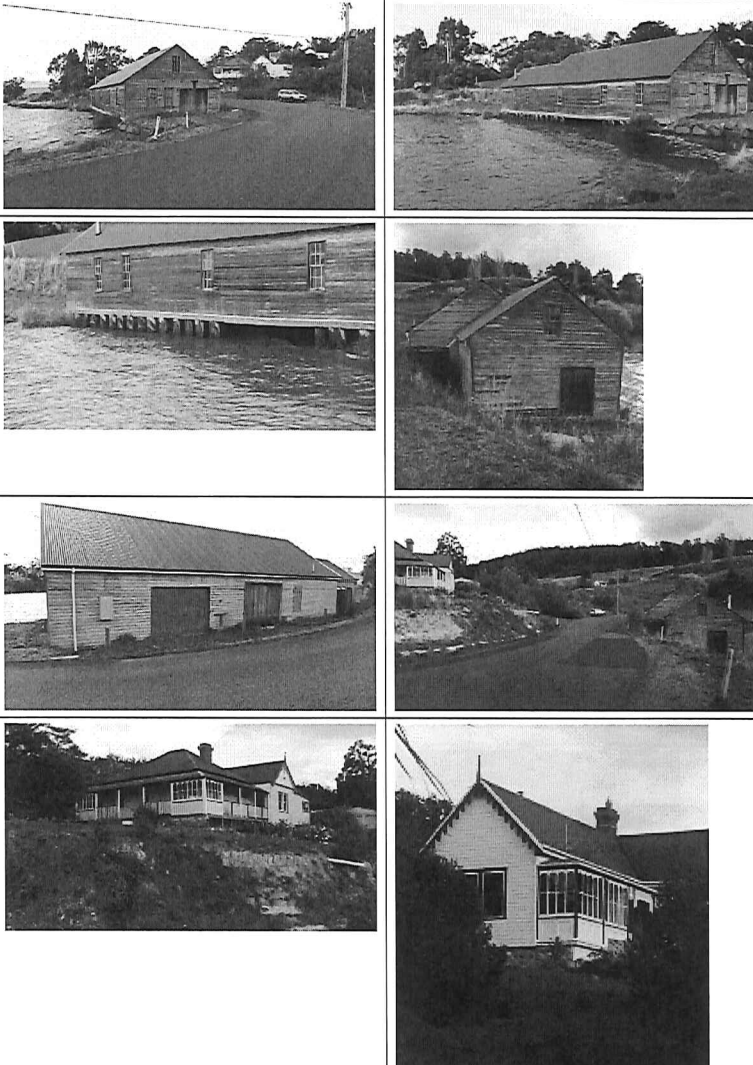
4	Settlement Brooks Bay	A	<p>The listing for this is vague as it does not nominate which buildings in the small valley are meant to be included in the listing. There is a fine apple shed located on the waters edge, partially on filled and reclaimed land. It has a new roof, is in good condition and has had new drainage and tanks recently added. A house c1890-1900 (no 330) is directly behind it of heritage value. It is fine example of the c1900 period farm house in a prominent setting with fine detailing that indicates a house of some value in contrast to many more modest dwellings in the region.</p> <p>Directly behind this is another fine house of the same vintage (no 336) that also has heritage value. It is also a well detailed house c1890-1900</p> <p>Opposite and to the south of the shed is a mid twentieth century house that is not of individual heritage value, it would have been added to the area probably after the cessation of river transport.</p> <p>There are several other houses around the valley set further back from the road, one is of modest heritage value.</p> <p>The 1983 photos show other sheds that no longer remain on the opposite side of the road.</p> <p>As a group the whole valley reads as a landscape unit with the various buildings. If precinct listing is undertaken this valley should be listed as a landscape element, if this occurs the shed should be individually listed and the remaining elements identified in the precinct.</p> <p>If this does not occur, separately the shed and two adjoining houses should be individually heritage listed.</p> <p>Interestingly on several visits to the location there were a number of people stopped photographing the shed and bay suggesting it has a level of esteem in the broader community.</p>	<p>Apple Shed</p> <p>A Apple and fruit sheds are a core historic element of the Huon Valley that demonstrate patterns of development, farming and the key industry of the region for over 150 years of settlement.</p> <p>B Although once prolific in number and while a number remain, mostly in ruined form, this building type is endangered and maintained examples are rare. This is an excellent and rare example of a shed that is located directly on the water. This form of shed is found at larger centres but rarely in remote locations.</p> <p>C The shed has some ability to reveal information about its construction but this is limited.</p> <p>D The shed is an excellent example of the broader class of places of apple and fruit sheds within the Huon Valley.</p> <p>E The building construction demonstrates modest achievement in technical matters.</p> <p>F Fruit and apple sheds are identified by the community as part of their farming heritage and have some community esteem. The buildings have high tourist value as important historic element within the landscape, this is seen in the number of people who stop and photograph these structures.</p> <p>G There are no known particular associations with this structure.</p> <p>Houses</p> <p>A The houses are good examples of their type and form, that is rural well built farm housing from the core period of development of the region. They demonstrate different design and stylistic approaches in a tight knit grouping.</p> <p>B The houses are not rare or threatened, however the grouping with the waterfront shed is rare.</p> <p>C The houses have limited ability to reveal information that is not already known.</p> <p>D The houses are good examples of settlement in a remote and largely intact setting that is closely related to fruit growing and transport of crops by sea and road. This is a reasonably rare grouping of</p>

<p>The image grid contains eight photographs. The top row shows two long, low wooden sheds with gabled roofs. The second row shows a shed on stilts over water and a smaller, more rustic shed. The third row shows a long wooden shed with a large door and a house on a hillside. The bottom row shows two houses with prominent porches and gabled roofs, one of which is a two-story house with a large bay window.</p>

<p>elements.</p> <p>E The buildings construction demonstrates modest achievement in technical matters.</p> <p>F The shed is held in some community esteem as it is often photographed and visited for its rather iconic value and superb setting.</p> <p>G There are no known particular associations with these structures however research may reveal associations.</p>

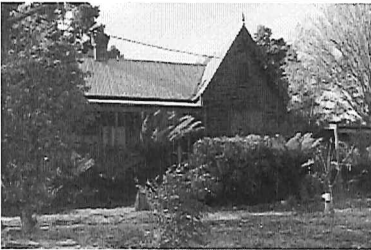
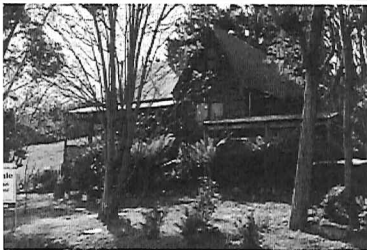
9	House c1890 5093 Huon Highway Riley Creek	B	<p>The house exists with some alteration and numerous additions around it. The building is typical of many farm houses in the region that are not heritage listed. In the overall pattern of farm buildings it is a reasonably well represented type and there are more interesting and significant buildings that are not listed. Some of the changes to the building and setting detract from its</p>	<p>A All buildings demonstrate this criterion to some extent, this building along with all farm buildings demonstrates a pattern of settlement, however, this element is not distinctive or a particularly fine example of its type.</p> <p>B The building is not endangered or part of an endangered group of places.</p> <p>C The building does not contribute particular or new knowledge about Tasmania or a</p>

<p>significance.</p> <p>On balance it is not recommended for heritage listing unless there is some historical reason for listing.</p>	<p>class of places.</p> <p>D The building is not an important representative example of a class of places.</p> <p>E The building does not demonstrate particular technical or other values beyond a wide range of similar buildings.</p> <p>F The building does not have particular community esteem even though it is an attractive building.</p> <p>G There are no known associations that set the place apart.</p>

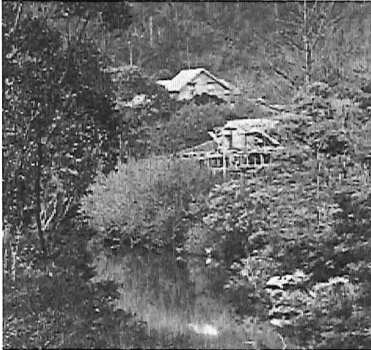
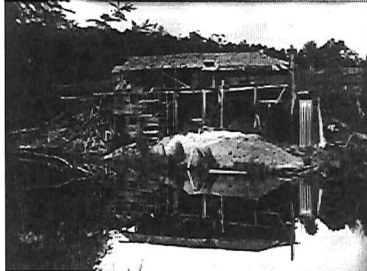
10	Honeywood 68 O'Halloran's Rd Geeveston	C	<p>The site was first developed in the 1840s by JB Walter who used convict labour to dig a channel from upstream to power a mill that appears to have first been a flour mill. The channel remains in remnant elements (outside the property) and was largely removed through bushcare works some 40 years ago. Richard Hill purchased the mill in 1849 with 100 acres and converted it to a sawmill, it appears to be the first sawmill in the Huon area.</p> <p>It is probable that Hill built the first house which was a hipped roof building with attic rooms and dormer windows. It is reported 12 people lived there. The two storey addition to one side also appears quite early and is in early photos. These photos show the hipped roof form with a separate two level addition.</p> <p>The Hills maintained the property until the middle of the 20th century and at some point the government acquired it using it for staff accommodation, it sold around 2000 with the current owners acquiring it in 2011.</p> <p>Substantial changes were made after 2000 with the site being excavated and levelled.</p> <p>The house (other buildings apart from one shed are not of interest or significance) has had major changes to much of its fabric over time: hipped roof removed and new gabled roof added with lower pitch; attic rooms removed (possible through fire); internal walls removed; nearly all external windows and joinery replaced c 1930-40; external linings removed and reinstalled in different locations; verandahs added, side addition linking to early twentieth century shed added; external boarding replaced; new internal fitout. The two storey addition retains a reasonable level of fabric internally.</p>	<p>A The site is very important in demonstrating the commencement of the timber industry in the Huon with a few remnant elements from that period. The documentary evidence available is compelling and the site remains evocative of this use.</p> <p>The house demonstrates early settlement, despite its changes and allows an understanding of the pattern of development in the early phase of settlement of the Huon.</p> <p>B The house is not endangered and has been repaired.</p> <p>The shed is not endangered as it is in use.</p> <p>The remnant convict water channels are endangered but are not on the subject property but on adjacent land.</p> <p>C The site makes some contribution to an understanding of a class of places in the development of the timber industry in the Huon.</p> <p>D The building is a modest example of its type as a result of the level of change that has occurred to the structure.</p> <p>E The building continues to demonstrate some, albeit limited now, technical values in the use of local materials.</p> <p>F It appears the building has a level of community esteem and is well recognised for the former mill use.</p> <p>G The place has strong associations with the local Hill family who were prominent in business, orchards, milling, commerce, and community activities.</p> <p>The site has important associations with the development of the timber industry and convict construction.</p>

<p>Despite changes the house retains some significance and has a recognisable form when compared to early photos.</p> <p>The mill site has been completely removed, however an adjacent shed shows limited evidence of an early use and was probably the mill office building that is apparent in the photos. It is in very deteriorated condition.</p> <p>While the place is significant, it is far from intact and is not recoverable to an earlier form, even with research.</p>			
11	Former Savings Bank of Tasmania 13 Church Street Geeveston	A	<p>No longer a bank but now a restaurant and real estate agency, it retains its form and detail, partially painted which is unfortunate.</p> <p>The building dates from the 1950's and is built in a restrained manner with a parapeted form. It is well-designed to express solidity and the conservative nature of the bank function.</p> <p>The main façade features a central doorway with pilasters to each side and a restrained porch. The parapeted form is dominant set above a painted string course. The facades are symmetrical.</p> <p>An eating deck is now located to one side of the street corner however this does not detract from the form of the building.</p> <p>It is importantly located on a central corner of the town centre opposite the former town hall and is key visual element within the main street. The change of use has not diminished its form or importance in the township.</p> <p>An important element in the town centre streetscape amidst other heritage buildings.</p> <p>The building even without further research should be heritage listed.</p>	<p>A The building demonstrates the importance of townships within the largely rural setting of the Huon Valley and the quality of the building, even though built in the 1950's shows the importance of banks and institutions to small communities. The building is an excellent example of its type.</p> <p>B The building is not endangered or part of an endangered group of places.</p> <p>C The building does not contribute particular or new knowledge about Tasmania or a class of places.</p> <p>D The building is a good, if reasonably modest example of a class of places, being rural bank and institutional buildings. Along with the former town hall it is important within the setting of Geeveston.</p> <p>E The building does not demonstrate particular technical or other values beyond a wide range of similar buildings.</p> <p>F The building will have some community esteem as part of the heritage centre of Geeveston and for its contribution to the overall quality of the townscape.</p> <p>G There are no known associations that set the place apart.</p>

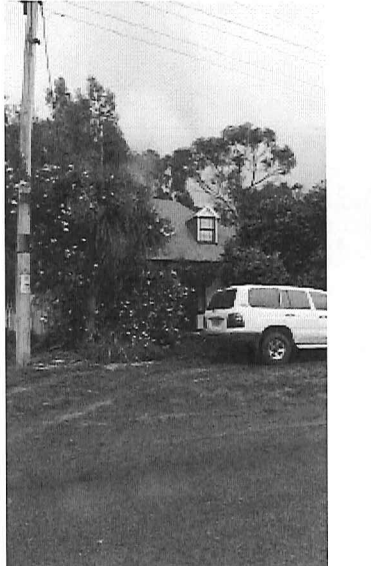
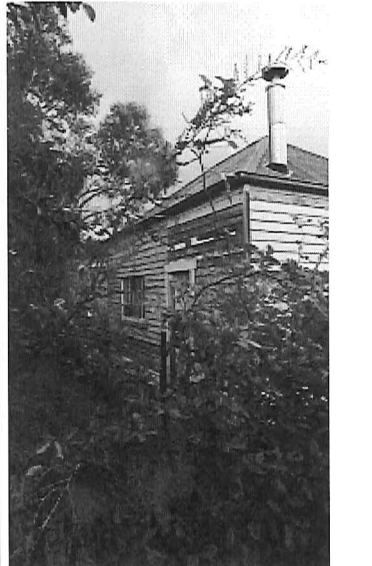
12	House and Cottage Four Foot Road Geeveston	A	<p>Two dwellings on the same title.</p> <p>The main house from c 1880 has attic rooms, steep pitched roof and is reasonably intact. As visible from the street it is a four-room structure on the ground floor with a rear skillion. It is a typical house from the late Victorian period of more interest due to its relationship to the cottage adjacent and its ability to demonstrate phases of development in the area.</p> <p>The cottage, which is much earlier in date, possibly 1850s, is occupied with interesting recent additions. Sufficient of the early building remains for it to be considered for heritage listing as one of the early buildings of the area.</p> <p>It would seem that the cottage is the first building on the site and that as fortunes improved, a larger and more commodious house was built adjacent. This was a reasonably common action that can be seen elsewhere in the Huon area.</p> <p>The building retains early windows and cladding and the original form of the simple probably single room structure.</p>	<p>House</p> <p>A The house demonstrates the change from early simple cottages to more substantial housing that, even though there are stylistic differences became the quintessential house form in the Huon from this time through to the second world war. It is a good example of the early form of the timber farmhouse in the region and is importantly linked to its antecedent structure.</p> <p>B The building is not endangered or part of an endangered group of places.</p> <p>C The building does not contribute particular or new knowledge about Tasmania or a class of places but does illustrate this period of construction well.</p> <p>D The building is a good, if reasonably modest example of a class of residential farm houses that typify the Huon Valley area.</p> <p>E The building does not demonstrate particular technical or other values beyond a wide range of similar buildings.</p> <p>F The building does not have particular community esteem even though it is an attractive building.</p> <p>G There are no known associations that set the place apart, however further research may reveal associations that are important to the district.</p> <p>Cottage</p> <p>A The house demonstrates the change from early simple cottages to more substantial housing. It is an excellent is slightly altered example of this class of early settlement housing.</p> <p>B The building type is endangered and very few remain in use.</p> <p>C The cottage has the ability to reveal early construction detail and information that is rapidly disappearing within the Huon Valley area.</p> <p>D The building is a very good example of the first stage of settlement of the region.</p>

<p>E The building demonstrates early construction methods and use of materials.</p> <p>F The building does not have particular community esteem.</p> <p>G There are no known associations that set the place apart, however further research may reveal associations that are important to the district.</p>		
13	Former Roman Catholic Church 5 Bronwell St Geeveston	A	<p>The building is extant but has been converted to residential use. The form of the building can still be seen however the description of Victorian Gothic Revival is not accurate. It is a simple rustic timber church building with minimal decoration and adornment (externally) that is typical of modest church construction across the state.</p> <p>It is located in a residential streetscape set back from the Huon Highway and has similar scale to the residential buildings.</p> <p>The building although changed in use has some ability to demonstrate its historic use and makes a contribution to the townscape.</p>	<p>A The building does have some ability, despite its change of use, to demonstrate a pattern of development where church buildings of various scales were built in rural areas. This is perhaps the most modest church in the township reflected in its siting on a single residential lot and out of the main town centre.</p> <p>B It does not demonstrate rare or endangered aspects of Tasmania's history, as even though there is a large change in the ownership of church buildings taking place across the State, the building can still be understood as a former church within the townscape.</p> <p>C The building has limited ability to reveal new information or contribute to an enhanced understanding of Tasmania's history.</p> <p>D The building does represent a broader class of places, that is modest church buildings, even though it is no longer in use.</p> <p>E The building does not demonstrate a particular technical achievement.</p> <p>F The building does not have special meaning to the community as it has ceased church use and was sold.</p> <p>G There are no known associations of importance and it is likely that these ceased, if they existed when the building was sold.</p>
