## APPENDIX K2: STORMWATER RFI RESPONSE LETTER

**RE: COUNTRY CLUB ESTATE**

**DRAFT AMENDMENT 4/2020 - REQUEST FOR FURTHER INFORMATION**

**CIVIL ENGINEERING ITEMS**

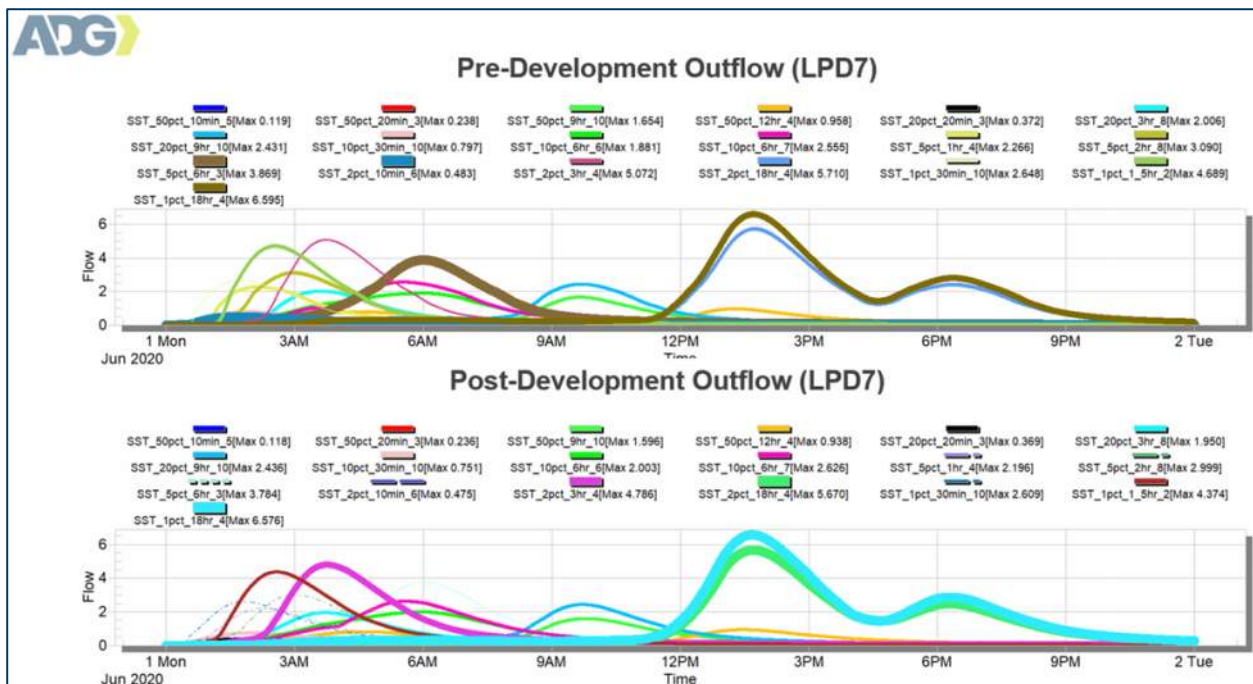
Figure 1 - Predicted Future Flow Rates - LPD 7

2 (e) (i) Part 3	If not, this needs to be discussed and justified, or alternatively, the climate scenario is shown and associated mitigation described.	<p>The stormwater model has been re-run with rainfall intensities increased by 39.84% in order to represent predicted climate change impacts as listed in the Climate Futures for Tasmania. The overall site stormwater mitigation philosophy is unchanged, however, if the development is to mitigate the future flow rates to the pre-development case flows at year 2100, some additional detention would be required in the eastern basin due to the greater volume of water. The design of the outlets from the west lake is unchanged from the previous model. It should be noted that the increase in rainfall was found to result in a smaller increase in site discharge than that predicted in the flood model advice provided by Council's Hydrologist (6.6m<sup>3</sup>/s vs 10.4m<sup>3</sup>/s at LPD 7). We have not assessed the capacity of Councils drainage network for predicted increases in flow rates.</p> <p>The below results show the predicted future flows across/under Country Club Avenue (LPD7 in our report) and coincide with a max water level in the east lake of 170.89m AHD, which will require filling around the existing dam outlet (already necessary without rainfall intensity increase) and some additional localised filling to a depth of approx. 300mm over a length of 30-35m centered approximately at: 41°28'56.8"S 147°06'54.9"E. This filling would be required to provide a shallow bund and prevent the existing lake overflowing through this area in the event of very intense rainfall. There is a modelled increase of about 90mm to the water level in east lake between the pre and post development cases.</p>

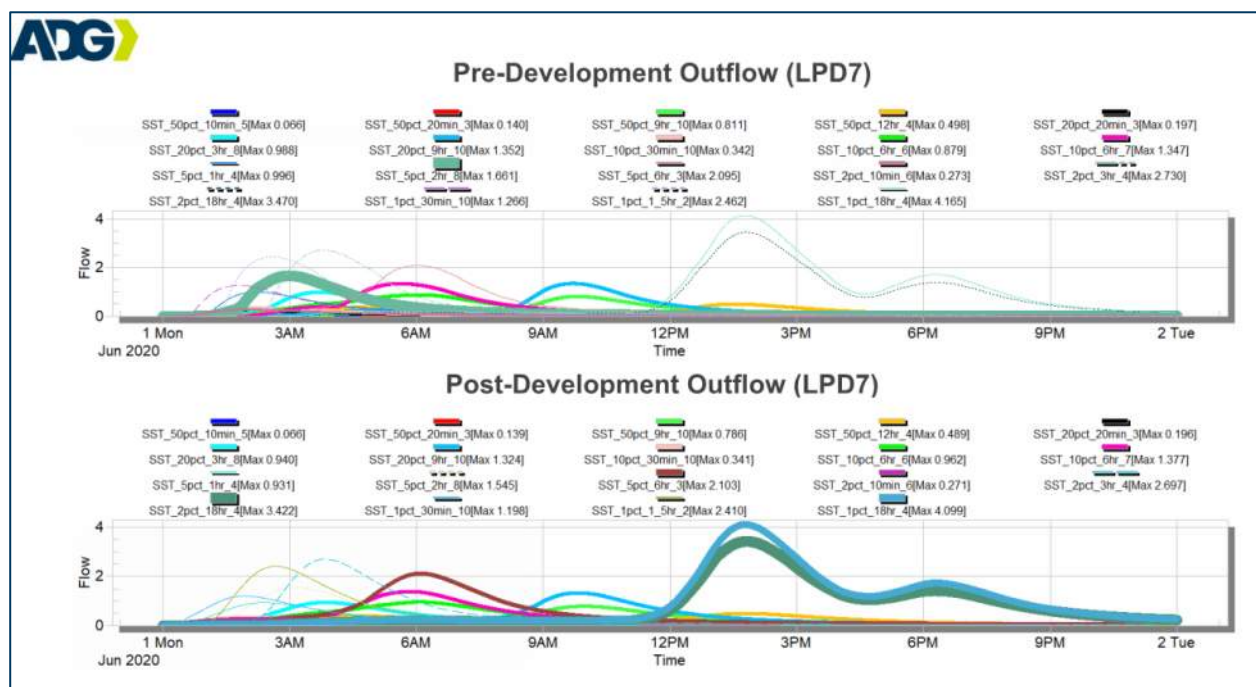
Figure 2 - Current Day Flow Rates - LPD 7

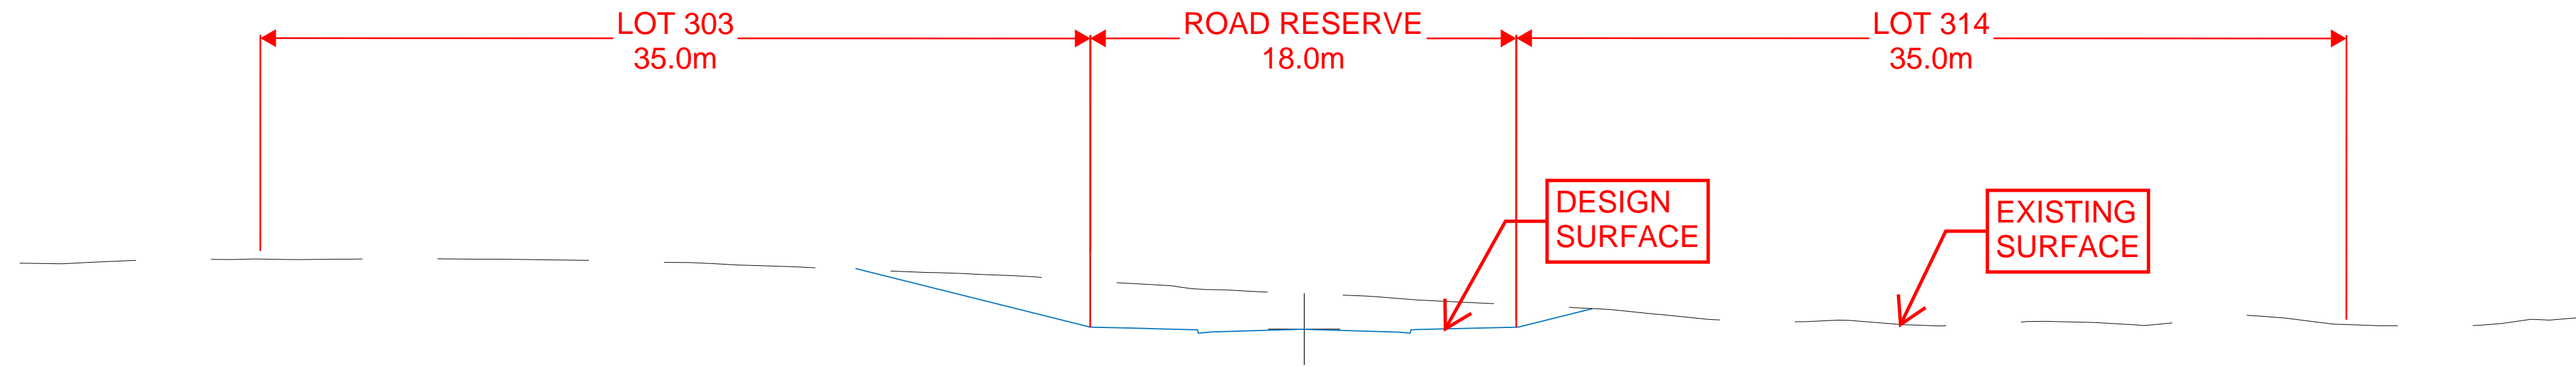
**SECTION C-C**  
1:200

2 (e) (ii)	<p>Subdivision Design: Post construction sections are required through:</p> <ul style="list-style-type: none"> <li>• Lots 303, 314 and road;</li> <li>• Lots 274, 293 and road;</li> <li>• Lot 116 and road.</li> </ul>	Please refer to the attached ADG Cross Sections.

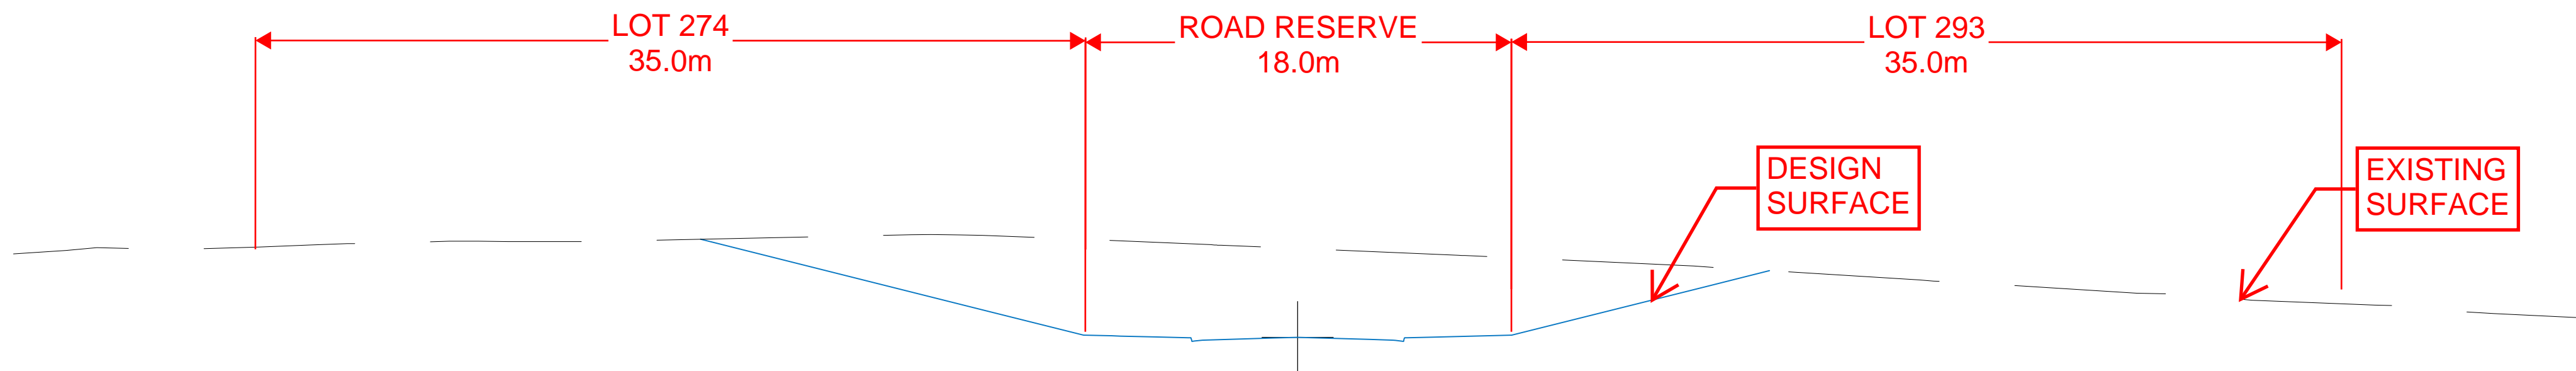
**SECTION B-B**  
1:200

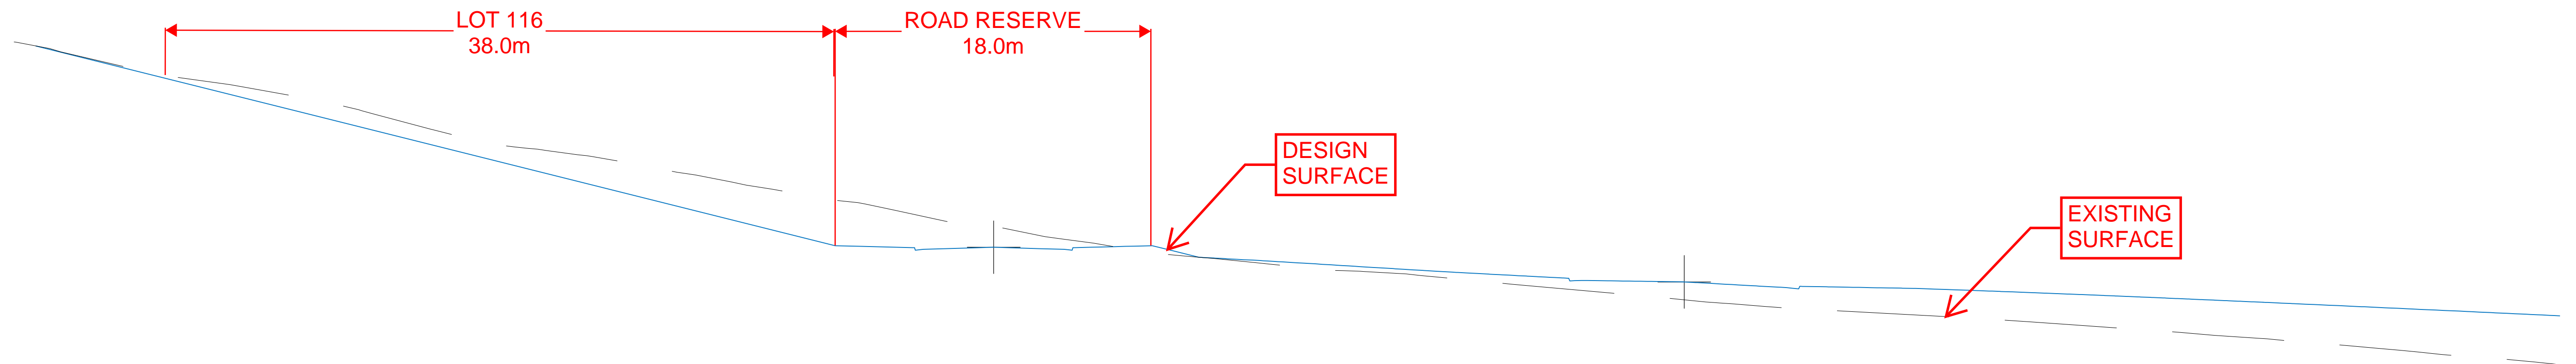
**SECTION A-A**  
1:200

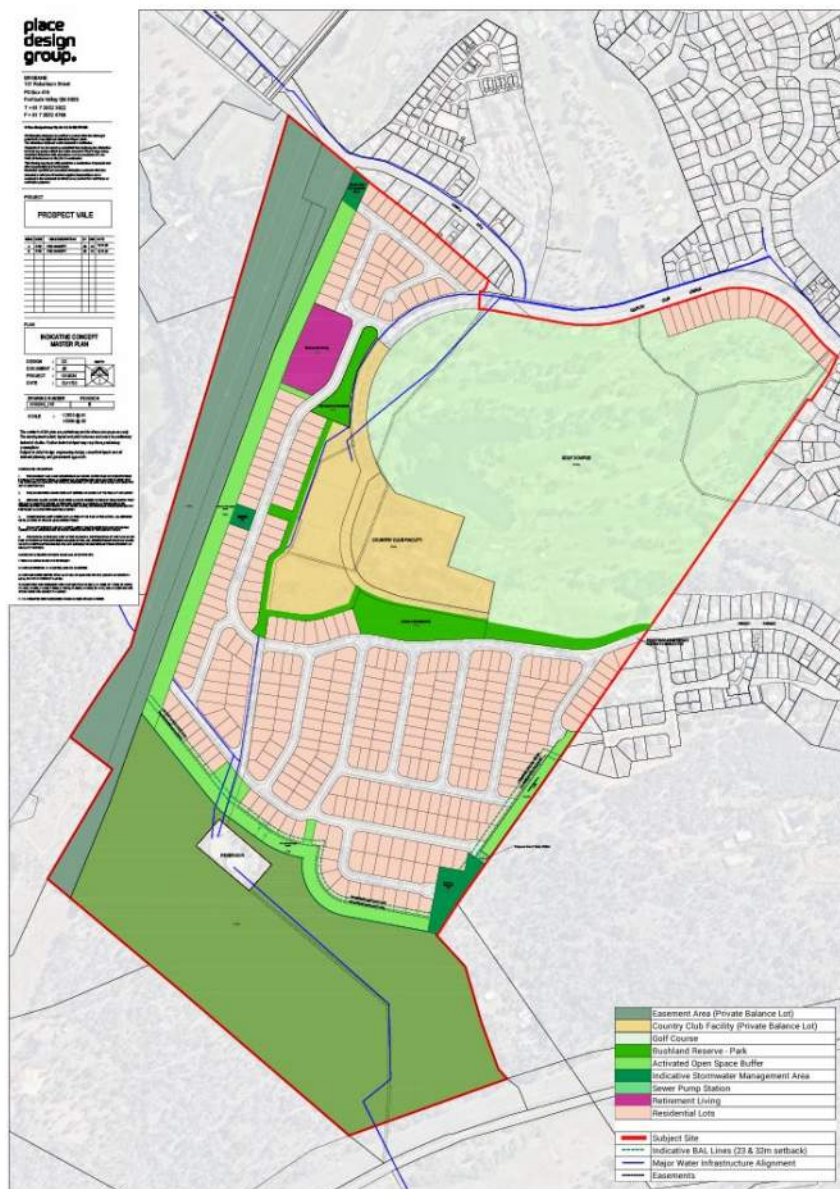
Figure 1 - Subdivision Layout (Revision-3; Taken from Place Design Group)

Scherzic Ground Investigations have undertaken a Geotechnical Investigation for the construction of a new residential subdivision to the perimeter of the existing Country Club facility in Prospect Vale, west of Launceston, Tasmania. This investigation has included all the proposed allotments highlighted as pink given in the figure below. The subdivisions will entail construction of pavements and services for residential construction in the existing vacant land. The layout of the proposed subdivisions is shown in the figure below:

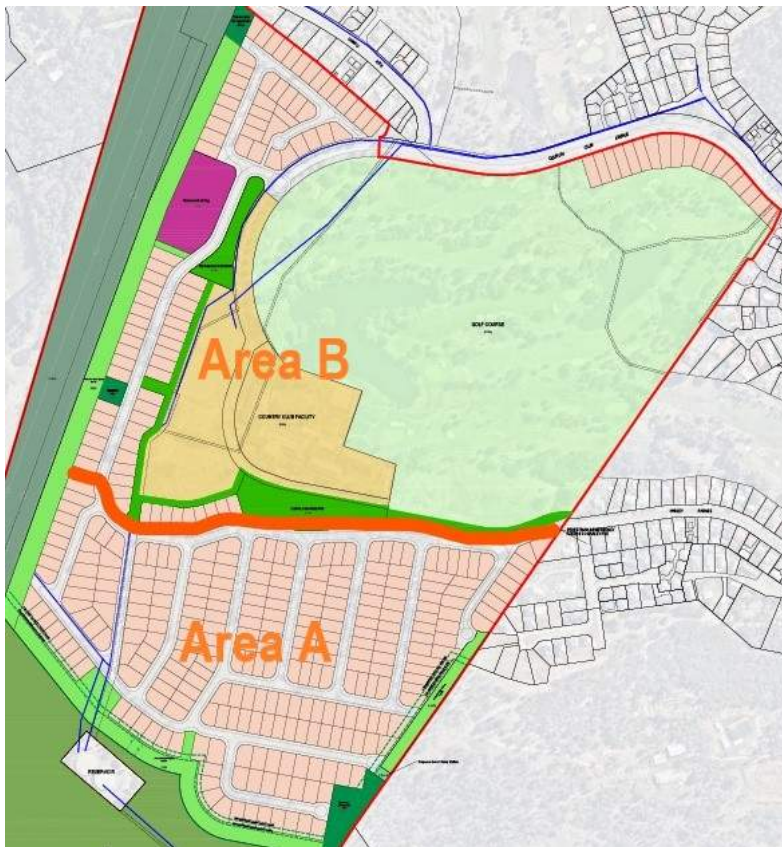
Figure 11 - Subgrade Design Areas

A design CBR of 2% is recommended for non-stabilised clays over Areas B as shown in Figure 11. A design CBR of 3% is recommended for Area A as shown in Figure 11. For competent rock, a design CBR of 20% is recommended.

As discussed above, the clay foundations at this site are highly reactive/expansive and stabilising with Lime will improve pavement performance. It is estimated stabilizing with equivalent 2% Hydrated Lime to a depth of 400mm in clay subgrades will increase the design CBR to greater than 10%, however further analysis should be undertaken to determine the lime percent and CBR improvement.

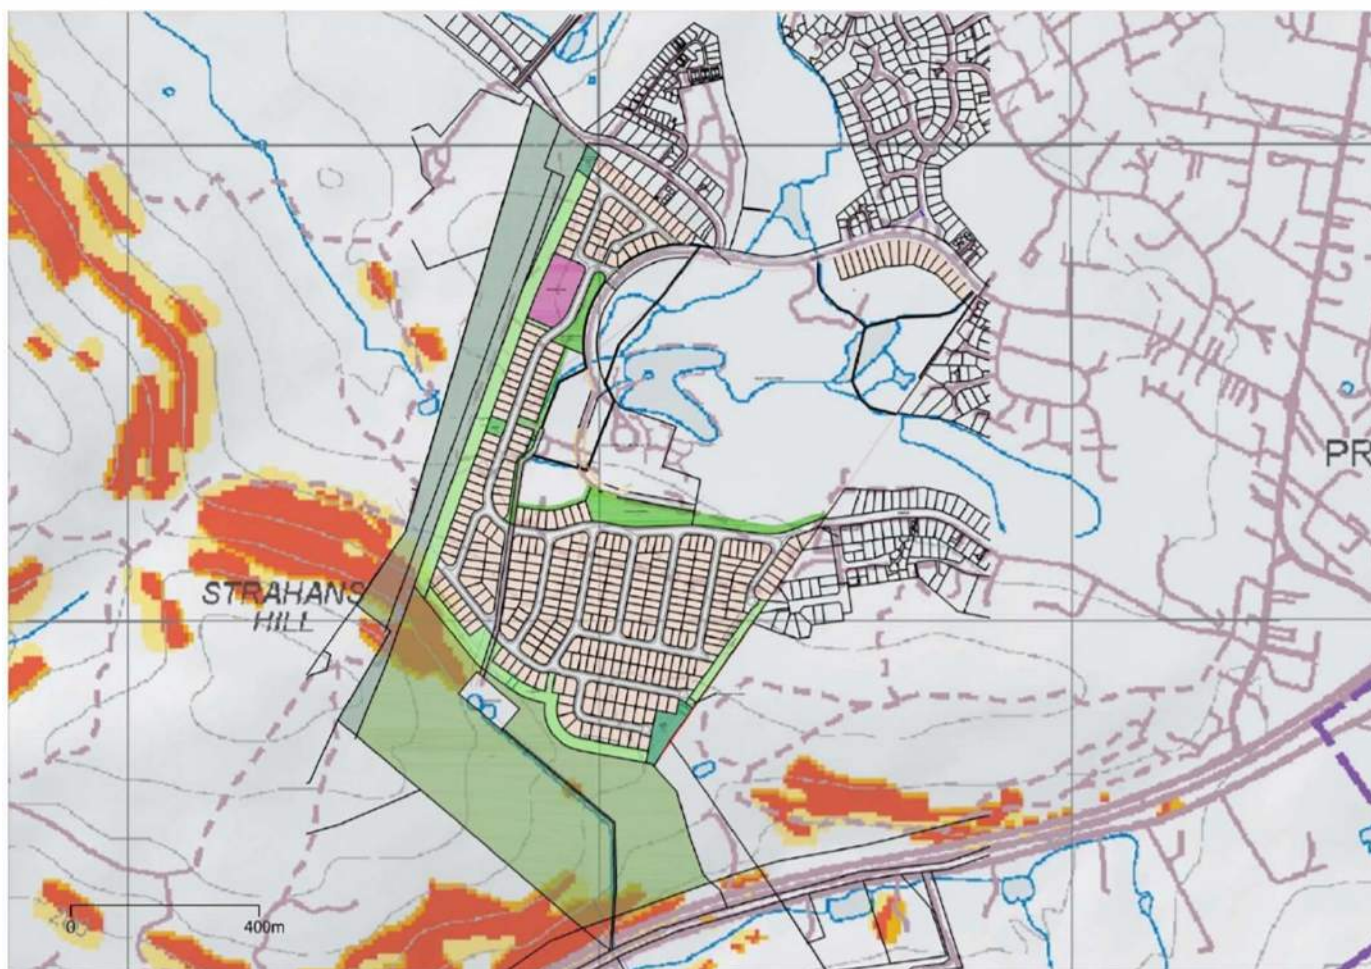
Figure 3 – Shallow Slide and/or Flow Susceptibility Map (Taken from Mineral Resources Tasmania) of Country Club Estate (Revision 3)

**Regression area:** An area up- slope of a source area that could fail following a landslide movement (a.k.a retrogression or set- back area).

**Source area:** An area of hillside with the potential to form a slope failure, identified largely on the basis of slope angle and geology.

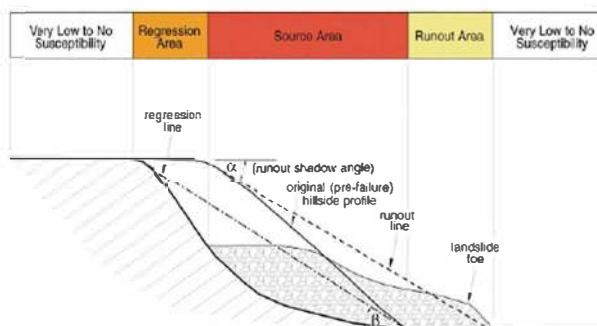
### Conceptual Diagram Illustrating Slide- Susceptibility Modelling Techniques

Hillside showing pre- failure and post failure profiles. Runout and regression lines for a hypothetical landslide are defined with their relationship to the modelled susceptibility zones for the pre- failure landscape.

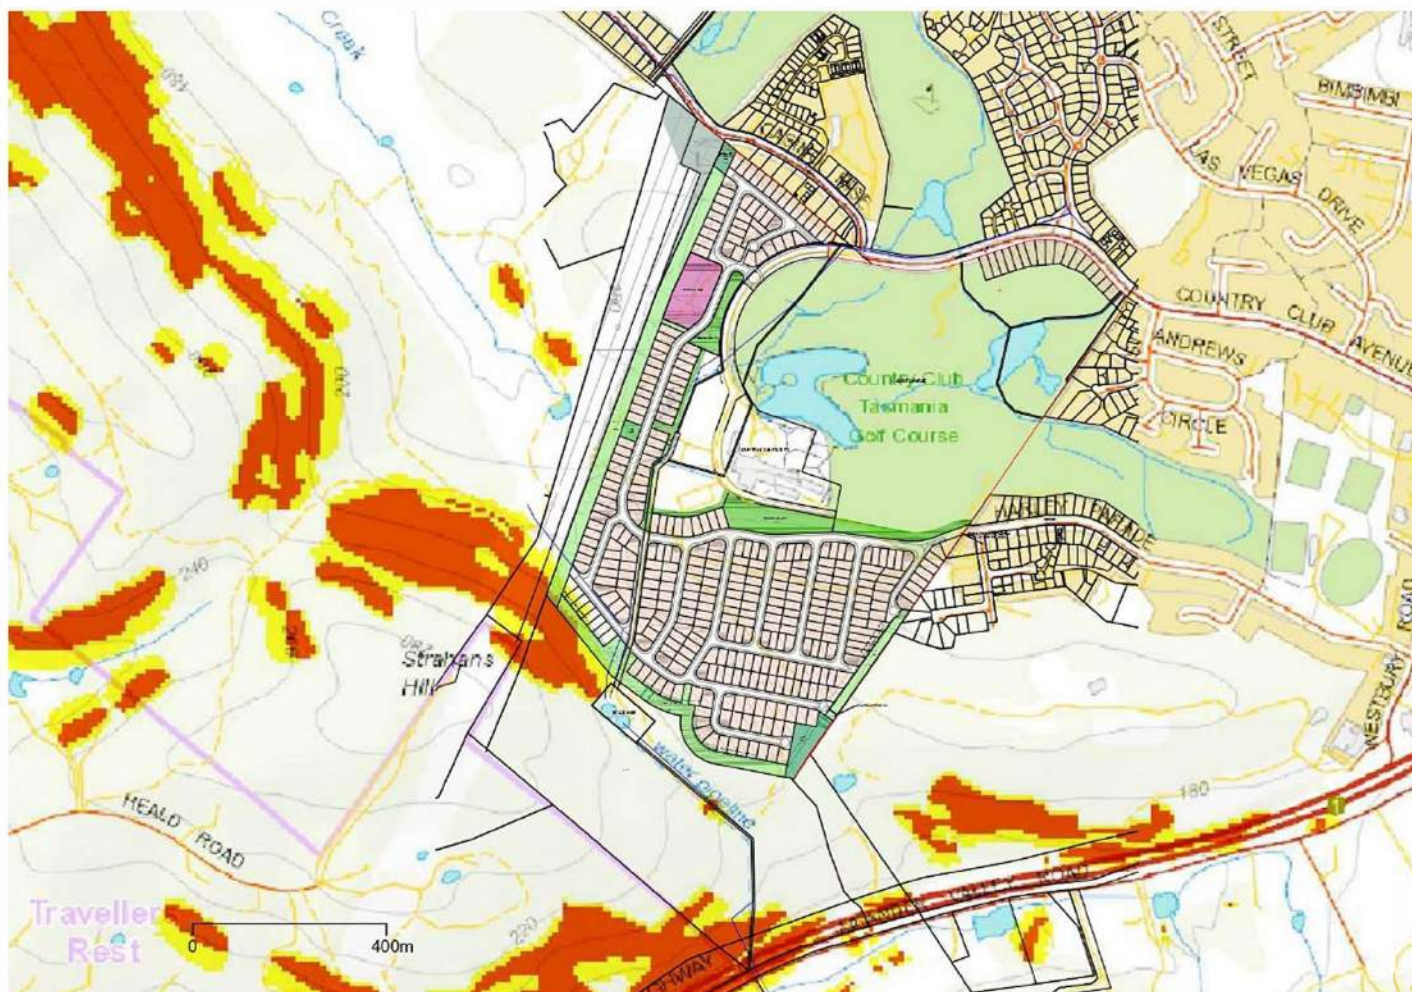
Figure 5 – Landslide Hazard Bands Map (Taken from Mineral Resources Tasmania) of Country Club Estate

- Low
- Medium
- Medium to Active
- High

The Department of Premier & Cabinet landslip overlay noted in the Local Provisions Schedule for the proposed Tasmanian Planning Scheme is provided in The LIST website **Landslide Hazard Bands** which are reproduced in Appendix F. These hazard bands show a LOW risk immediately to seven (7) proposed allotments to the south west extent of the proposed development with a Moderate Risk shown further upslope. These risks are discussed below.

However, the Landslide Hazard Bands of the LPS, indicates LOW risk to the south west corner (3 allotments) of the proposed subdivision with MEDIUM risk immediately upslope. The nominated Hazard Bands are a desk top assessment of general slope angle only and do not provide any landslide analysis and therefore are a guide only for further assessment. Where a credible risk is identified, an assessment to the Australian Geomechanics Society (AGS) 2007 Guidelines should be adopted. In this instance our field investigations (test pit 7453-11) and site walkover by a Principal Geotechnical Engineer do not indicate any credible landslide risk to the proposed subdivision and the risk to life & property is 0.00.

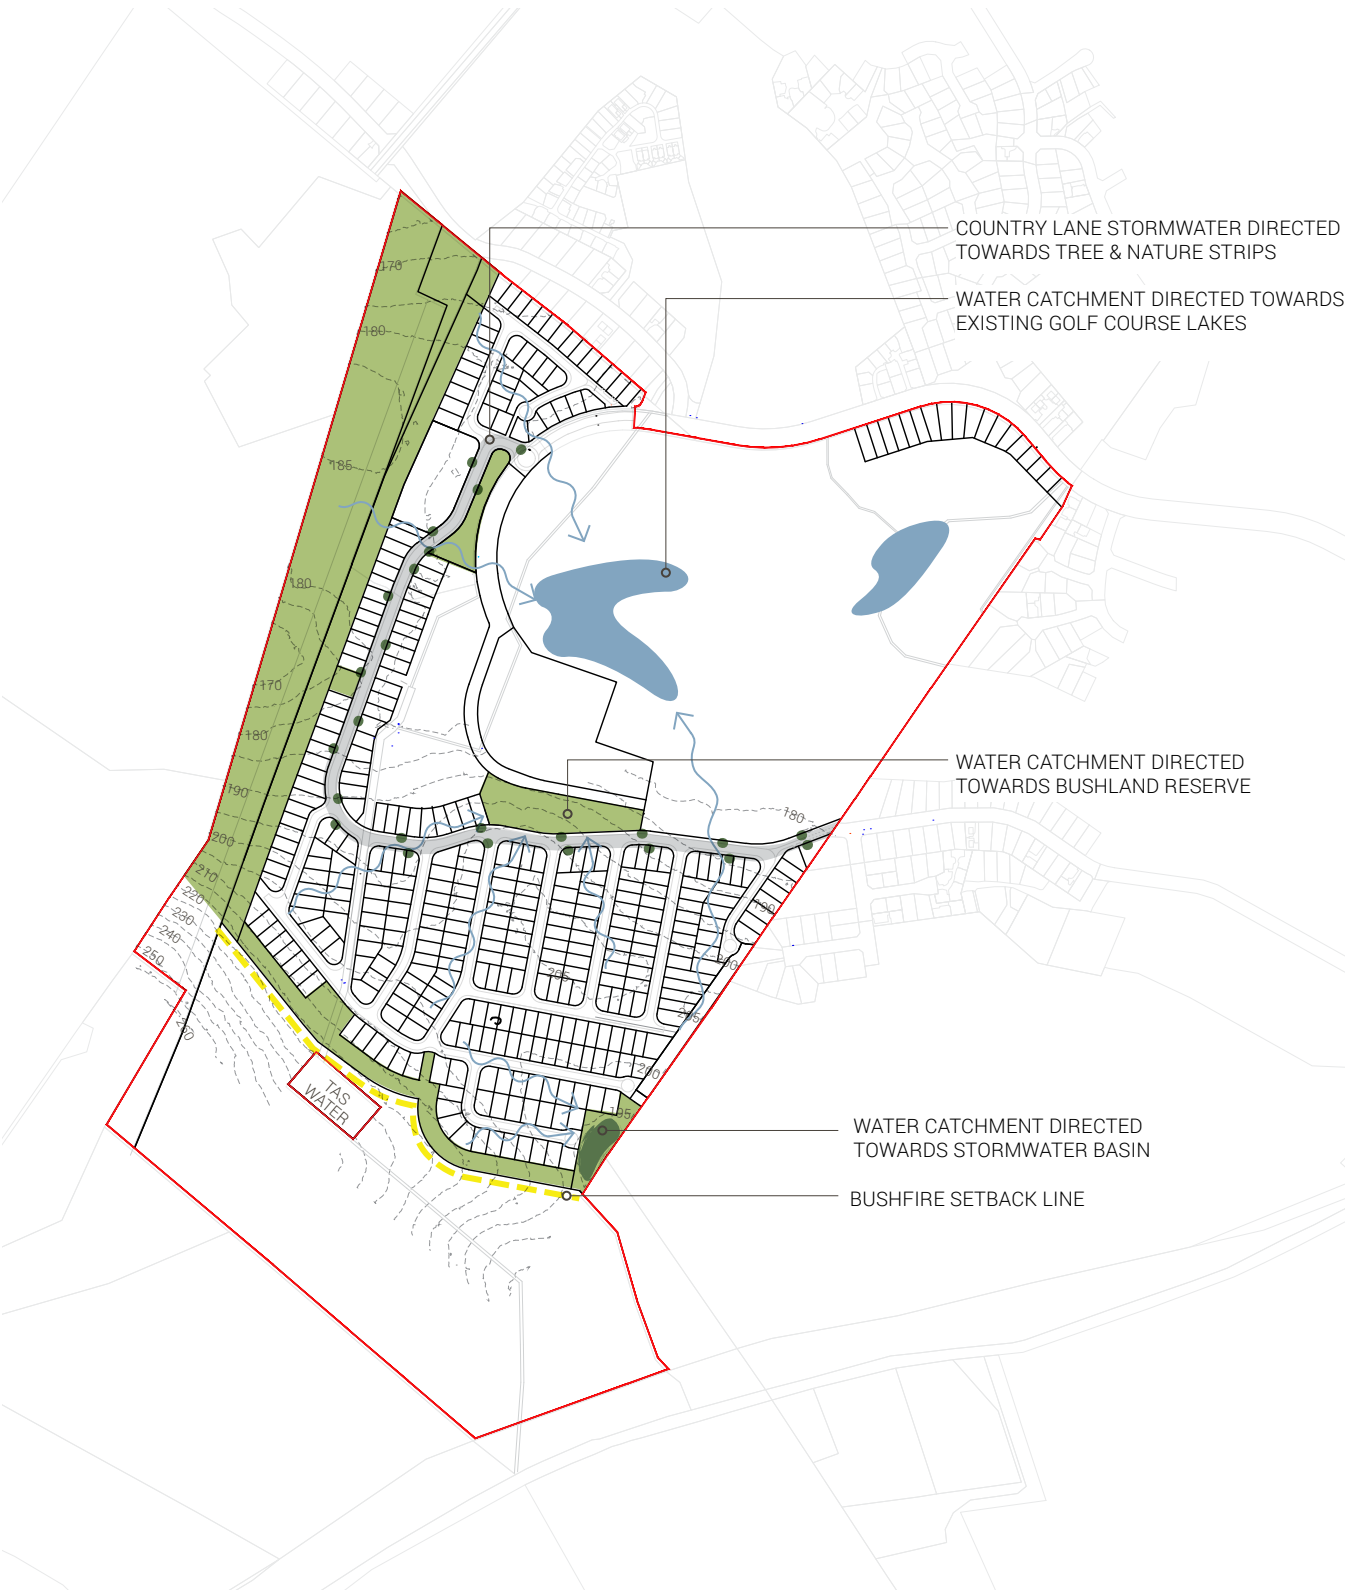
WATER SUSTAINABILITY

The project proposes a sustainable approach to water usage by using the topography to direct surface water runoff to street trees, nature strips and the Bushland Reserve.

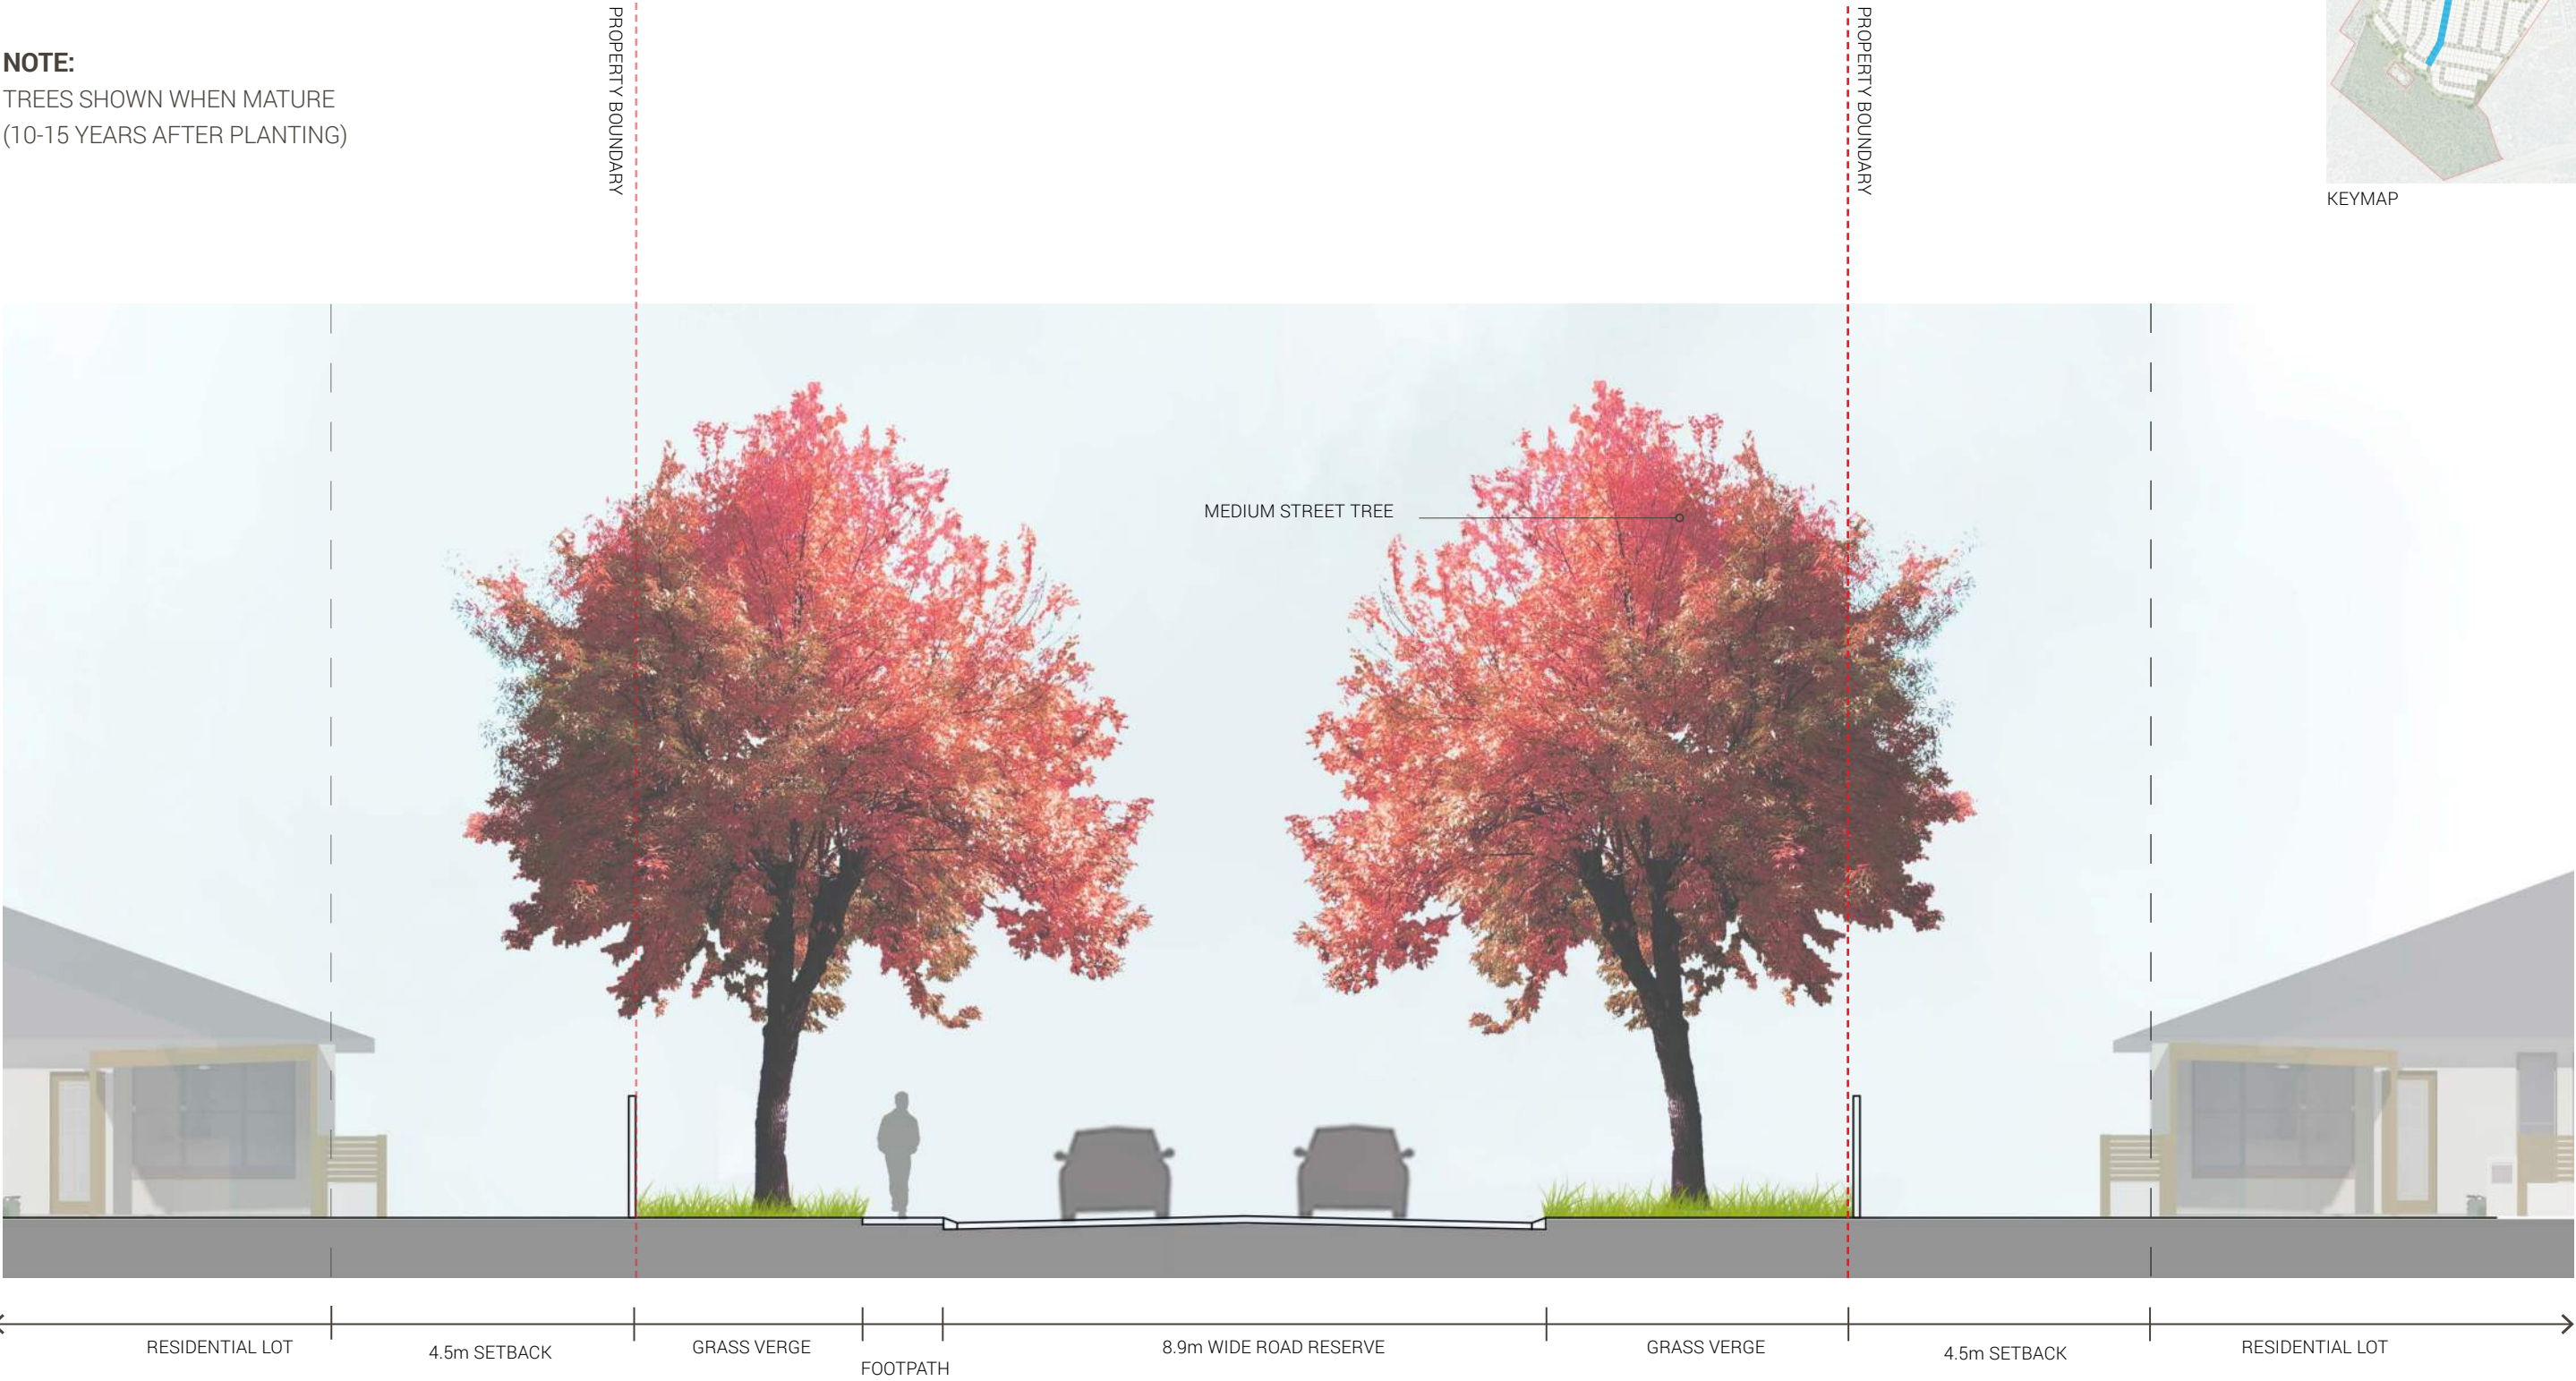
TYPICAL STREETSCAPE SECTIONS
