# Macquarie Point Stadium Development

## Geotechnical Factual Report

June 2024

## Macquarie Point Stadium Development Geotechnical Factual Report

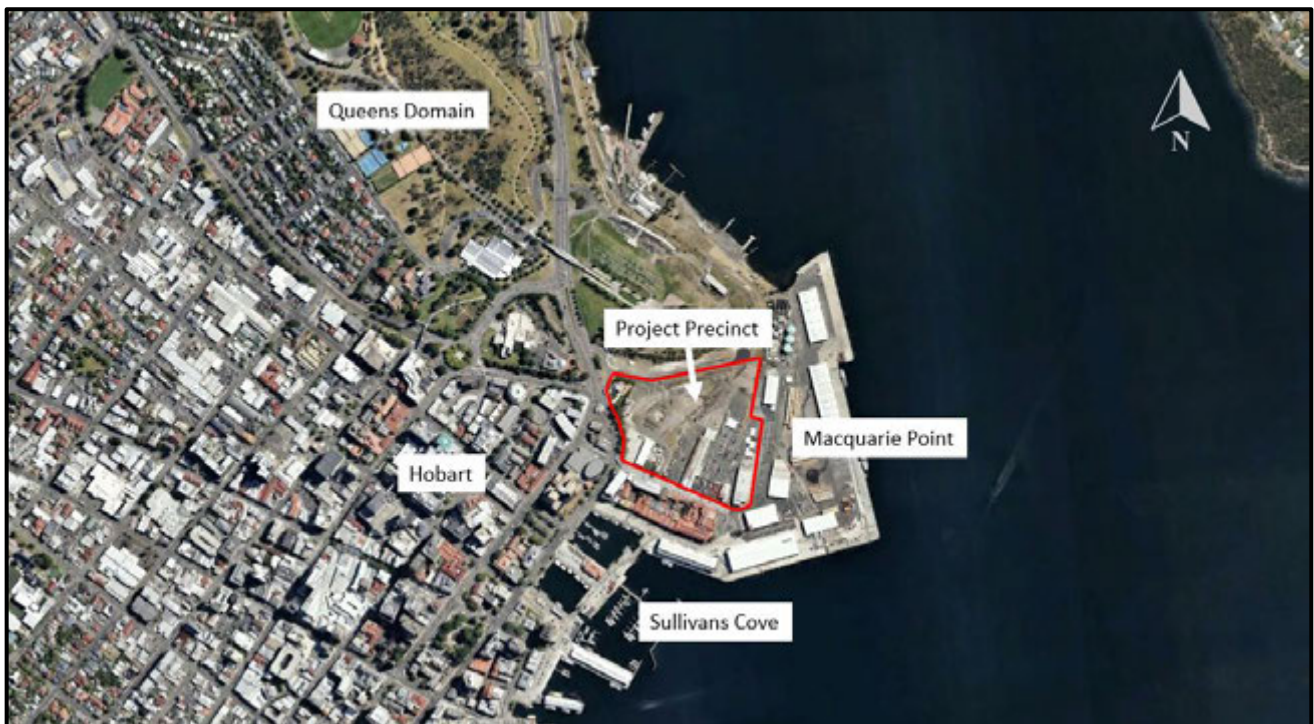
Figure 1.1 Project Precinct Location

The proposed Macquarie Point stadium project comprises the design and construction of a multi-purpose stadium to provide a premier sporting, arts, events and entertainment facility. The proposed stadium site is to the north of Sullivans Cove, adjacent to the Hobart City Centre as shown in Figure 1.1. The precinct is approximately 9.3 hectares in size and is bounded by Davey Street to the West, Evans Street to the south, Hunter Street and the ports facility on the Derwent River to the east and the Hobart Cenotaph and Royal Hobart Regatta grounds to the north. The channelised Hobart Rivulet lies to the west and north, crossing the precinct near the northern boundary extent.

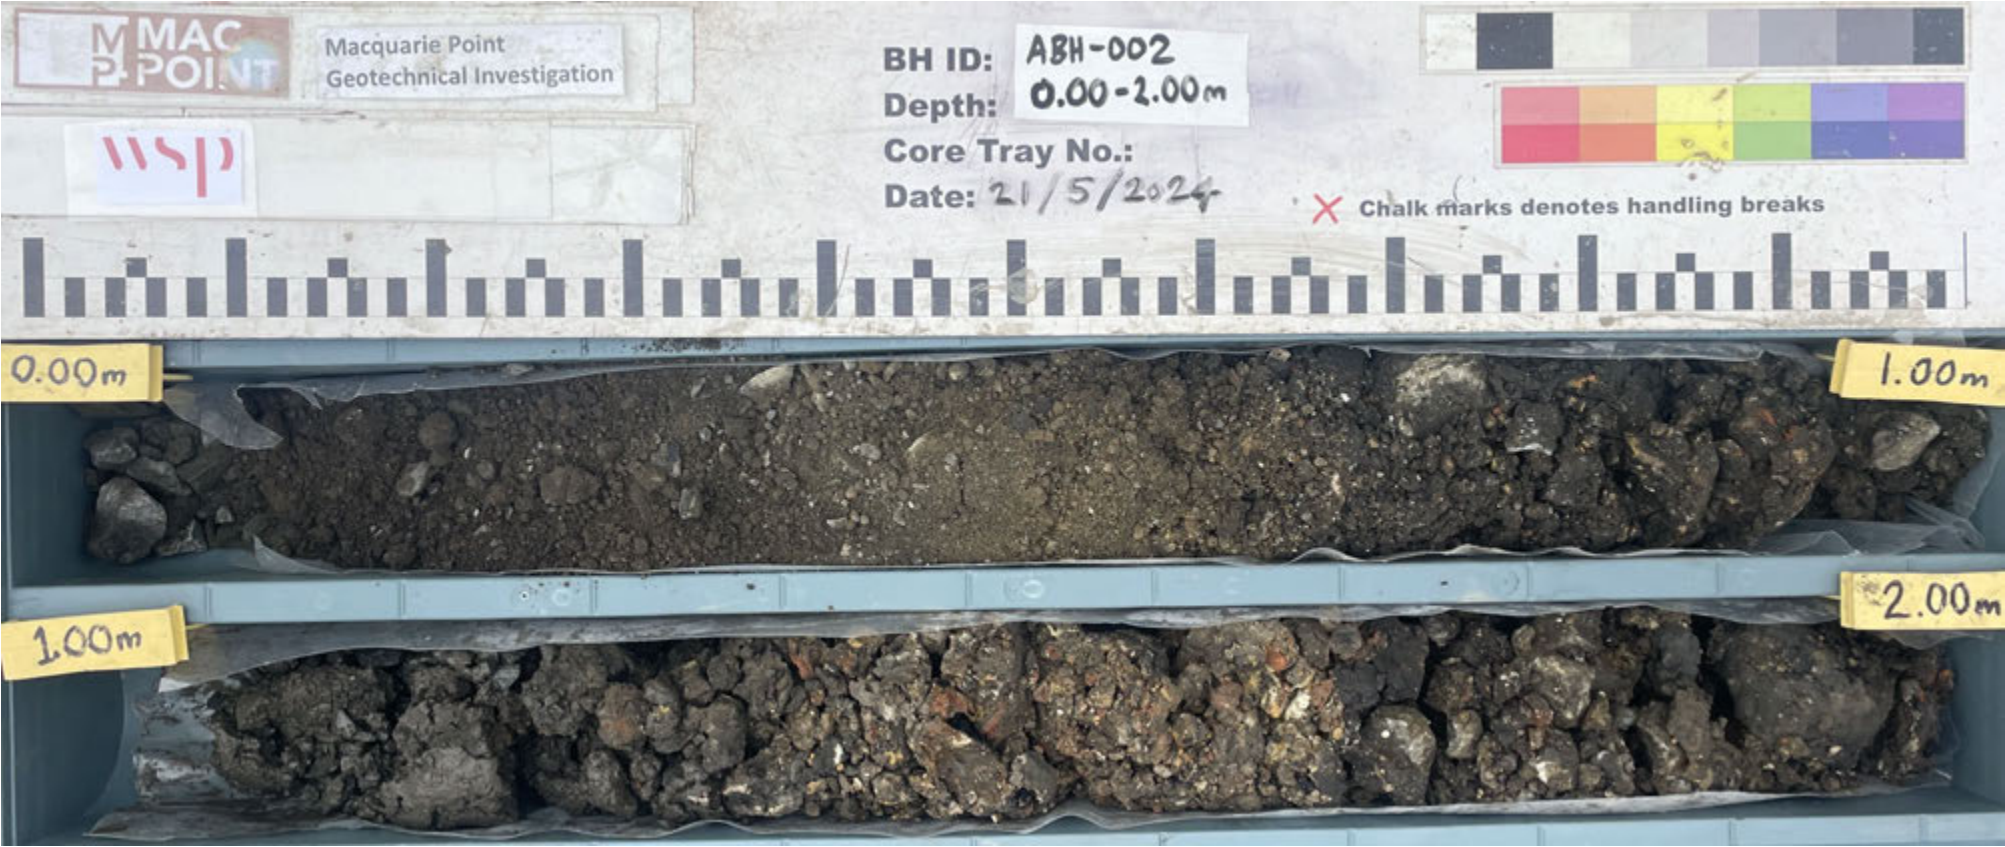
| | TITLE<br><br>MPDC<br>Macquarie Point<br>Macquarie Point GI<br>Core Photo - ABH-002 | DRAWN | DATE<br>18/6/2024 |

PointID : ABH-002 Depth Range: 0.00 - 2.00 m

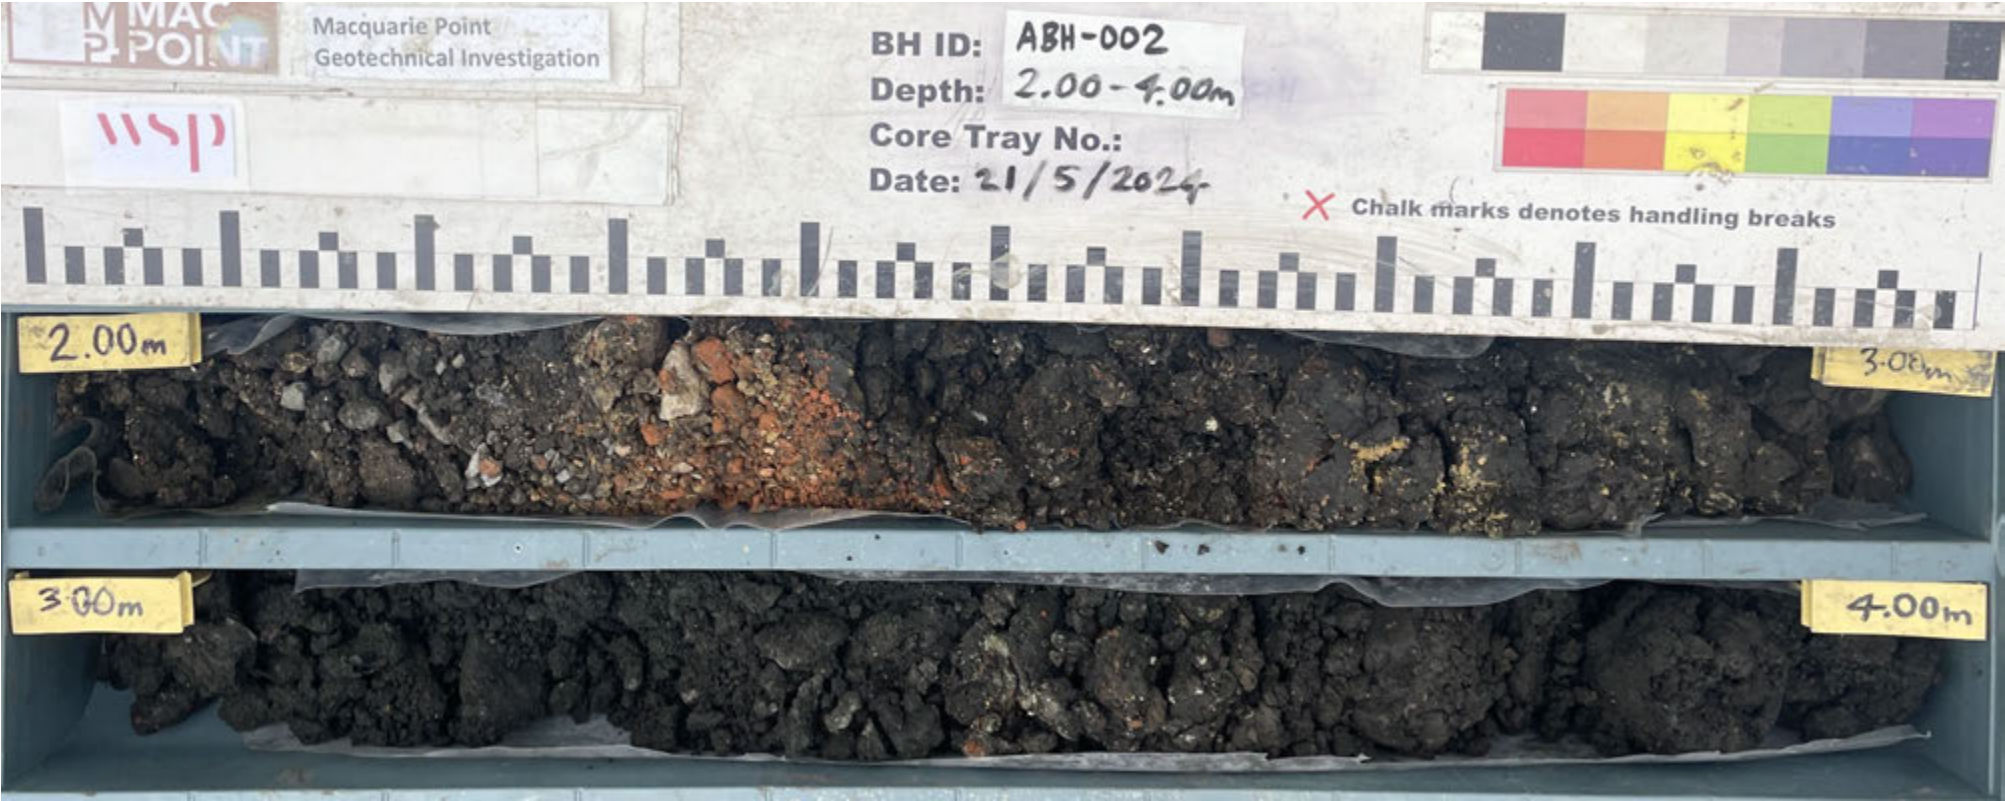
| | TITLE<br><br>MPDC<br>Macquarie Point<br>Macquarie Point GI<br>Core Photo - ABH-002 | DRAWN | DATE<br>18/6/2024 |

PointID : ABH-002 Depth Range: 2.00 - 4.00 m

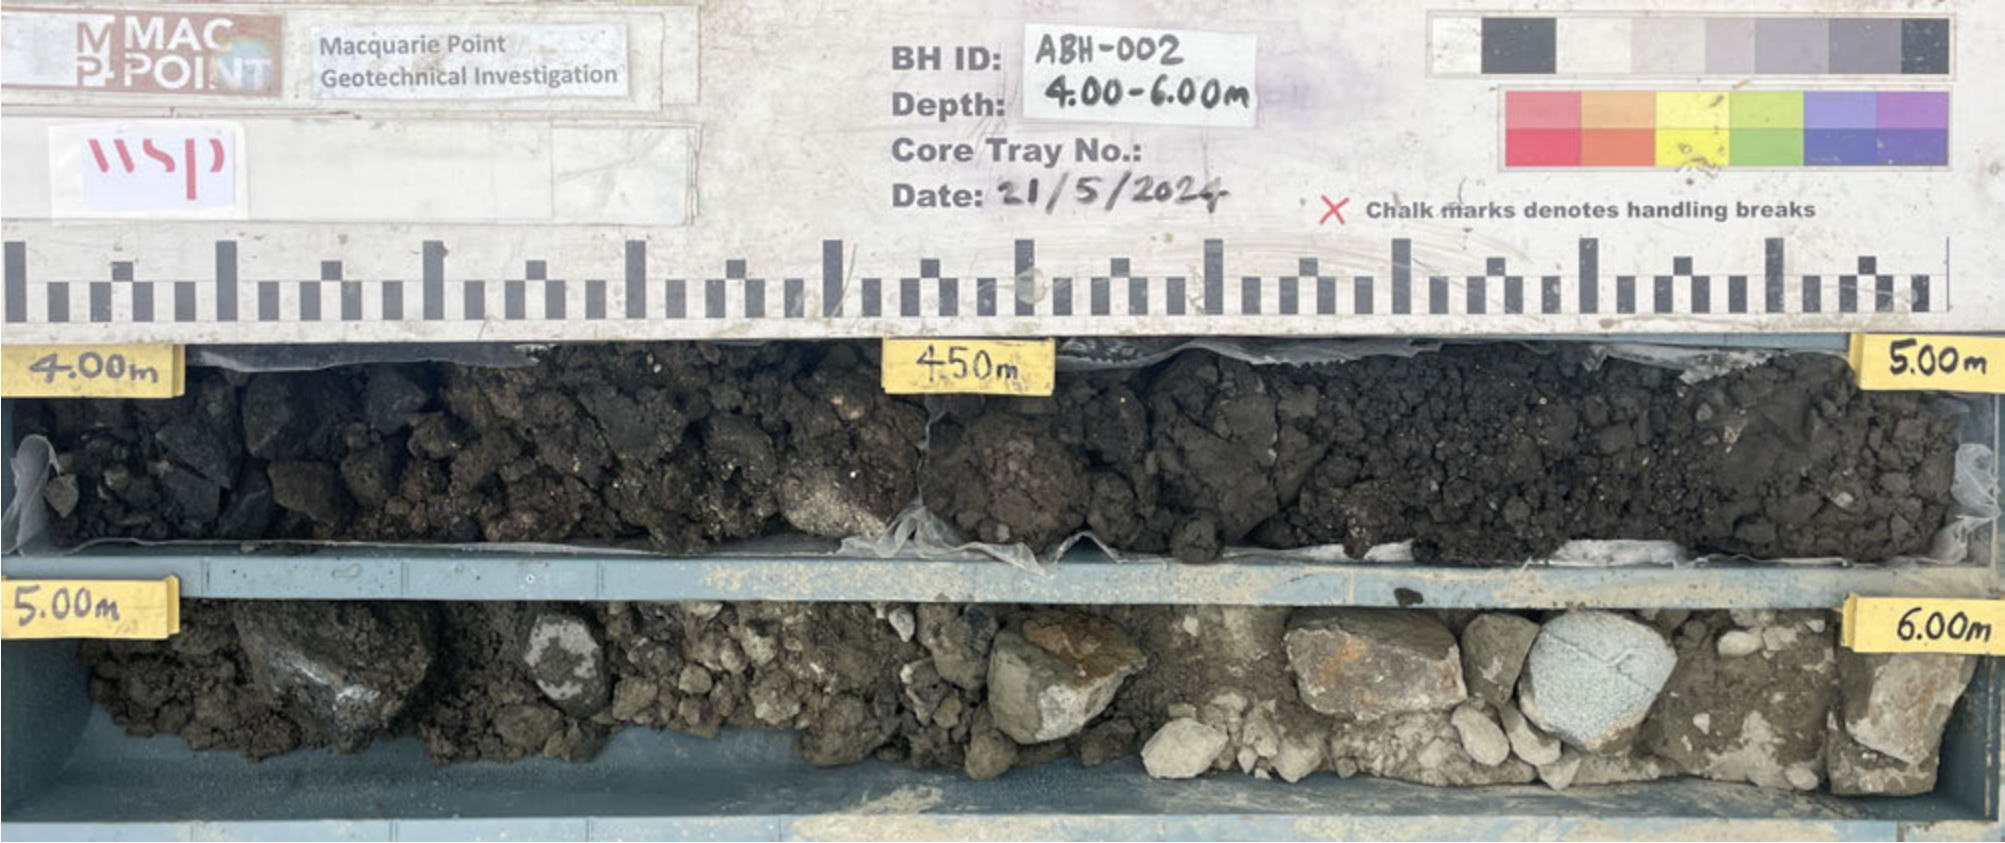
| | TITLE<br><br>MPDC<br>Macquarie Point<br>Macquarie Point GI<br>Core Photo - ABH-002 | DRAWN | DATE<br>18/6/2024 |

PointID : ABH-002 Depth Range: 4.00 - 6.00 m

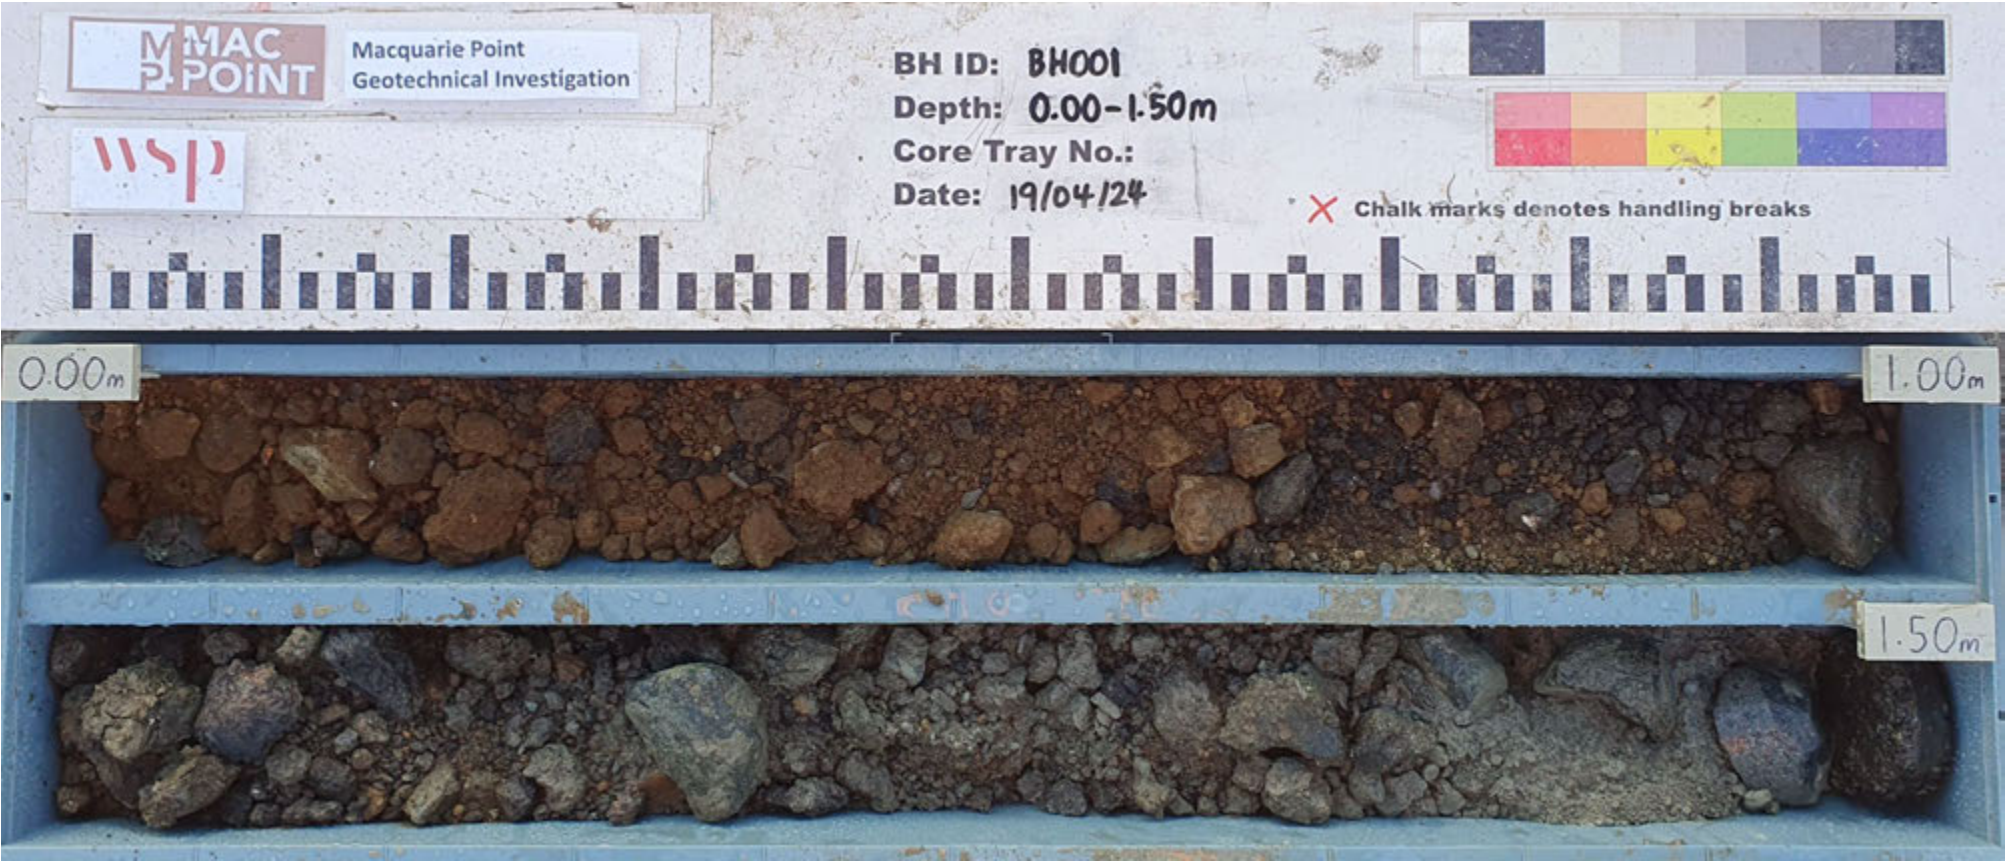
| | TITLE<br><br>MPDC<br>Macquarie Point<br>Macquarie Point GI<br>Core Photo - BH-001 | DRAWN | DATE<br>18/6/2024 |

PointID : BH-001 Depth Range: 0.00 - 1.50 m

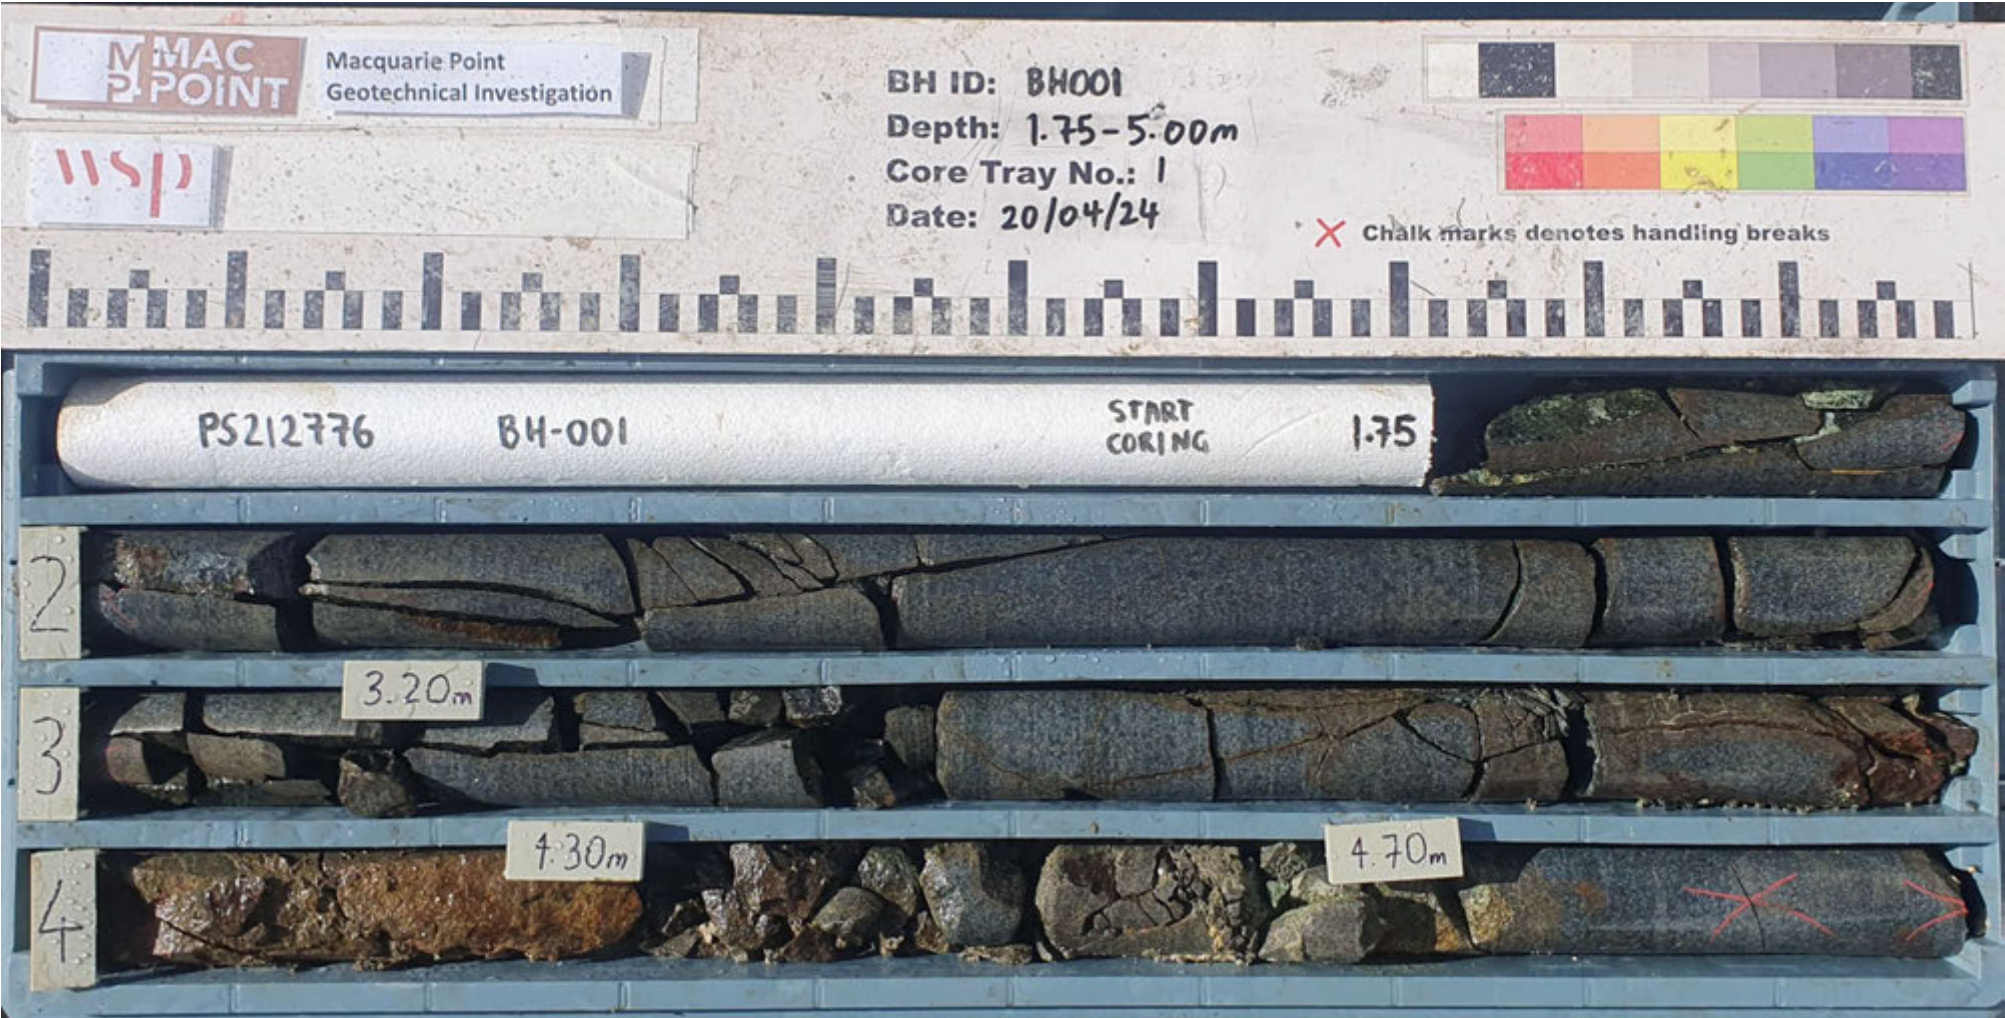
PointID : BH-001 Depth Range: 1.75 - 5.00 m

| | TITLE<br><br>MPDC<br>Macquarie Point<br>Macquarie Point GI<br>Core Photo - BH-001 | DRAWN | DATE |

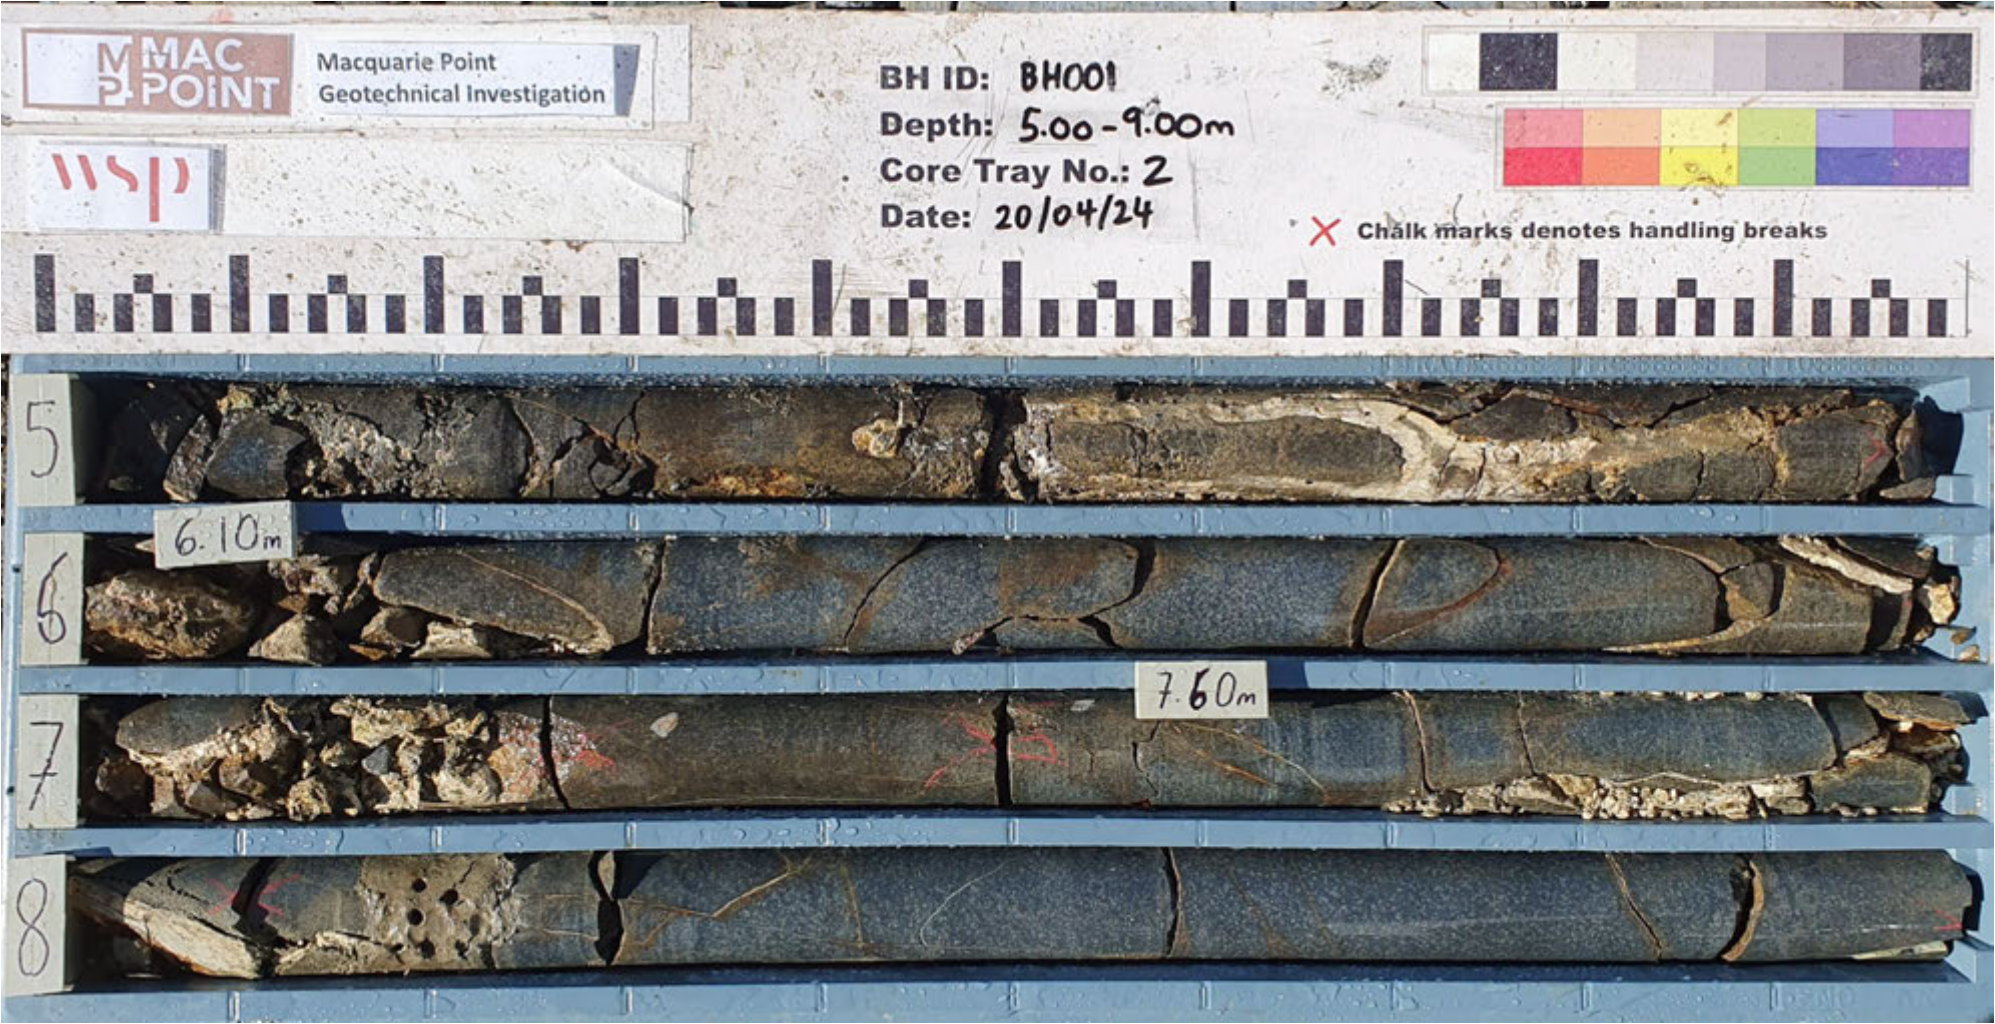
PointID : BH-001 Depth Range: 5.00 - 9.00 m

| | TITLE<br><br>MPDC<br>Macquarie Point<br>Macquarie Point GI<br>Core Photo - BH-001 | DRAWN | DATE<br>18/6/2024 |

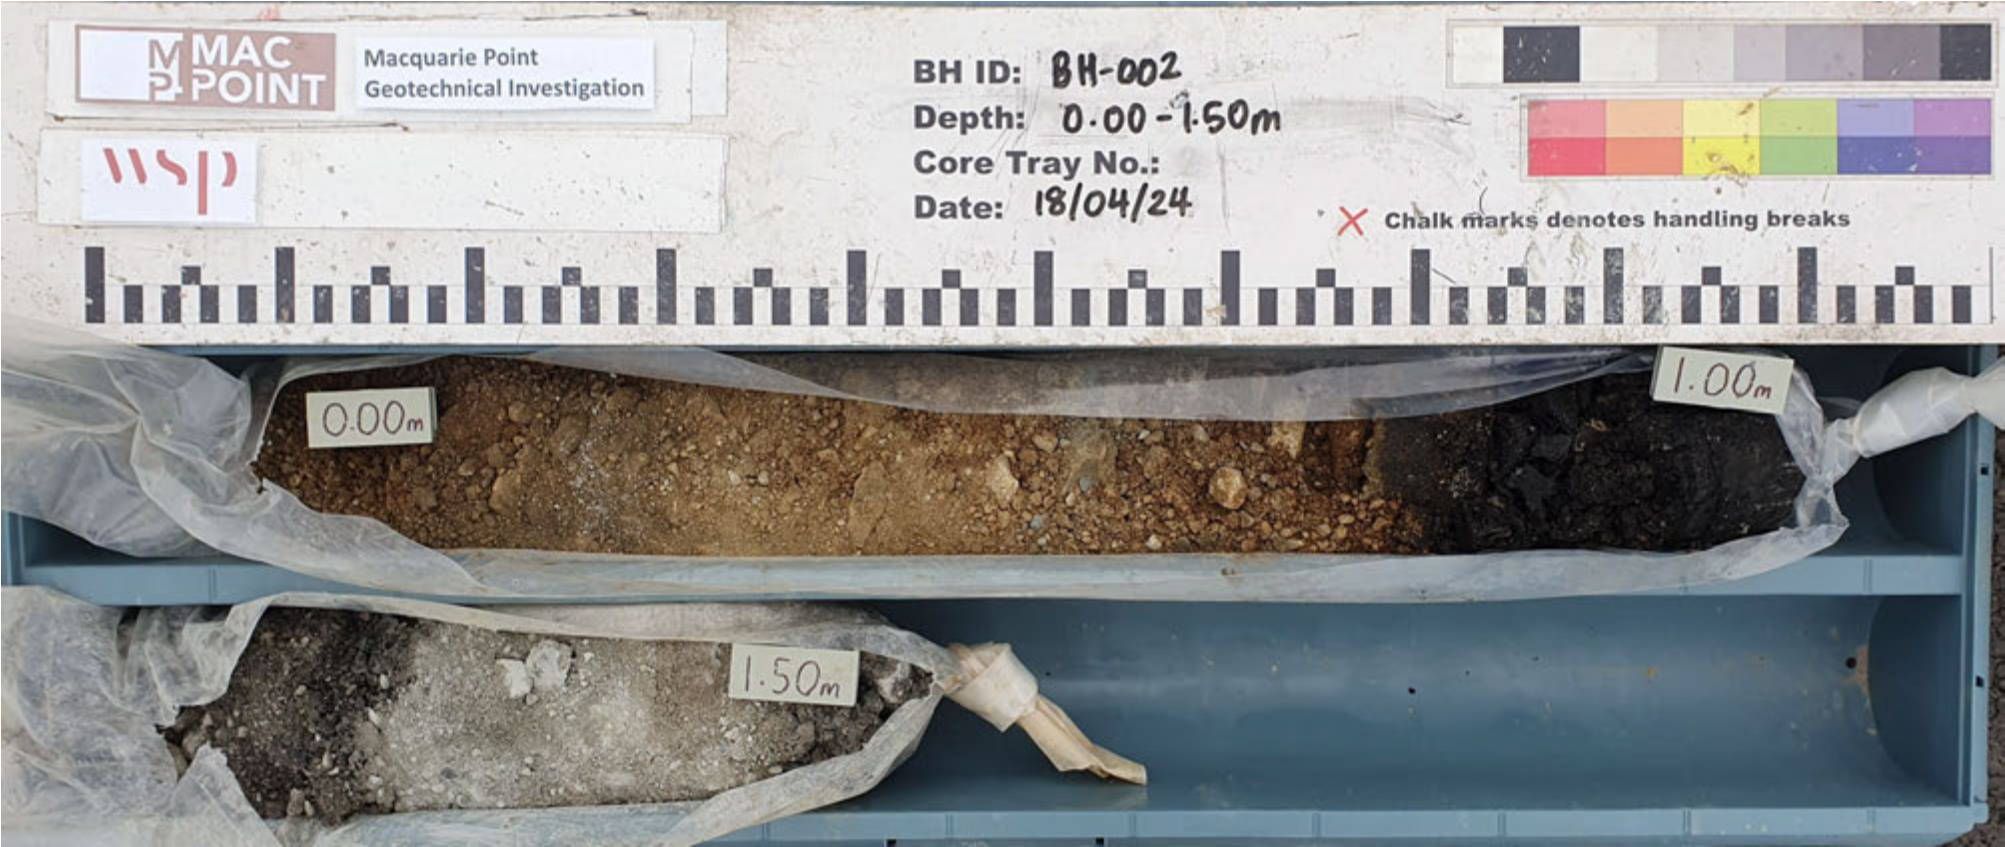
| | TITLE<br><br>MPDC<br>Macquarie Point<br>Macquarie Point GI<br>Core Photo - BH-002 | DRAWN | DATE<br>18/6/2024 |

PointID : BH-002 Depth Range: 0.00 - 1.50 m

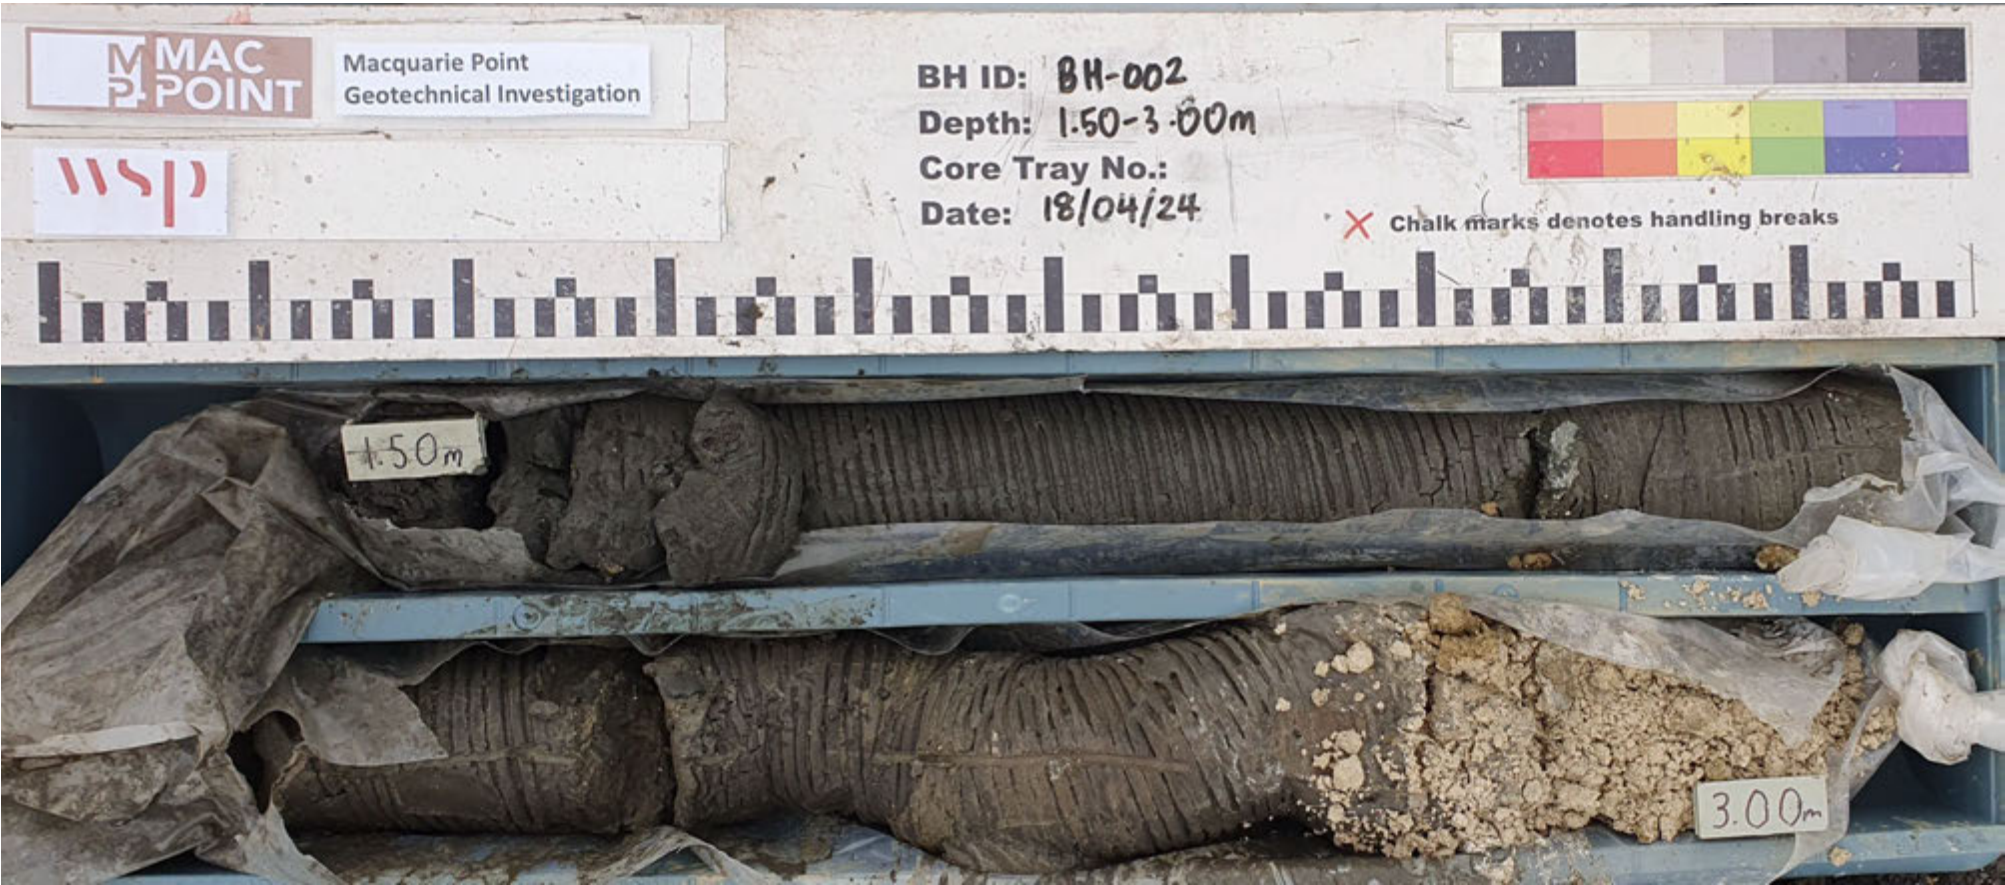
| | TITLE<br><br>MPDC<br>Macquarie Point<br>Macquarie Point GI<br>Core Photo - BH-002 | DRAWN | DATE<br>18/6/2024 |

PointID : BH-002 Depth Range: 1.50 - 3.00 m

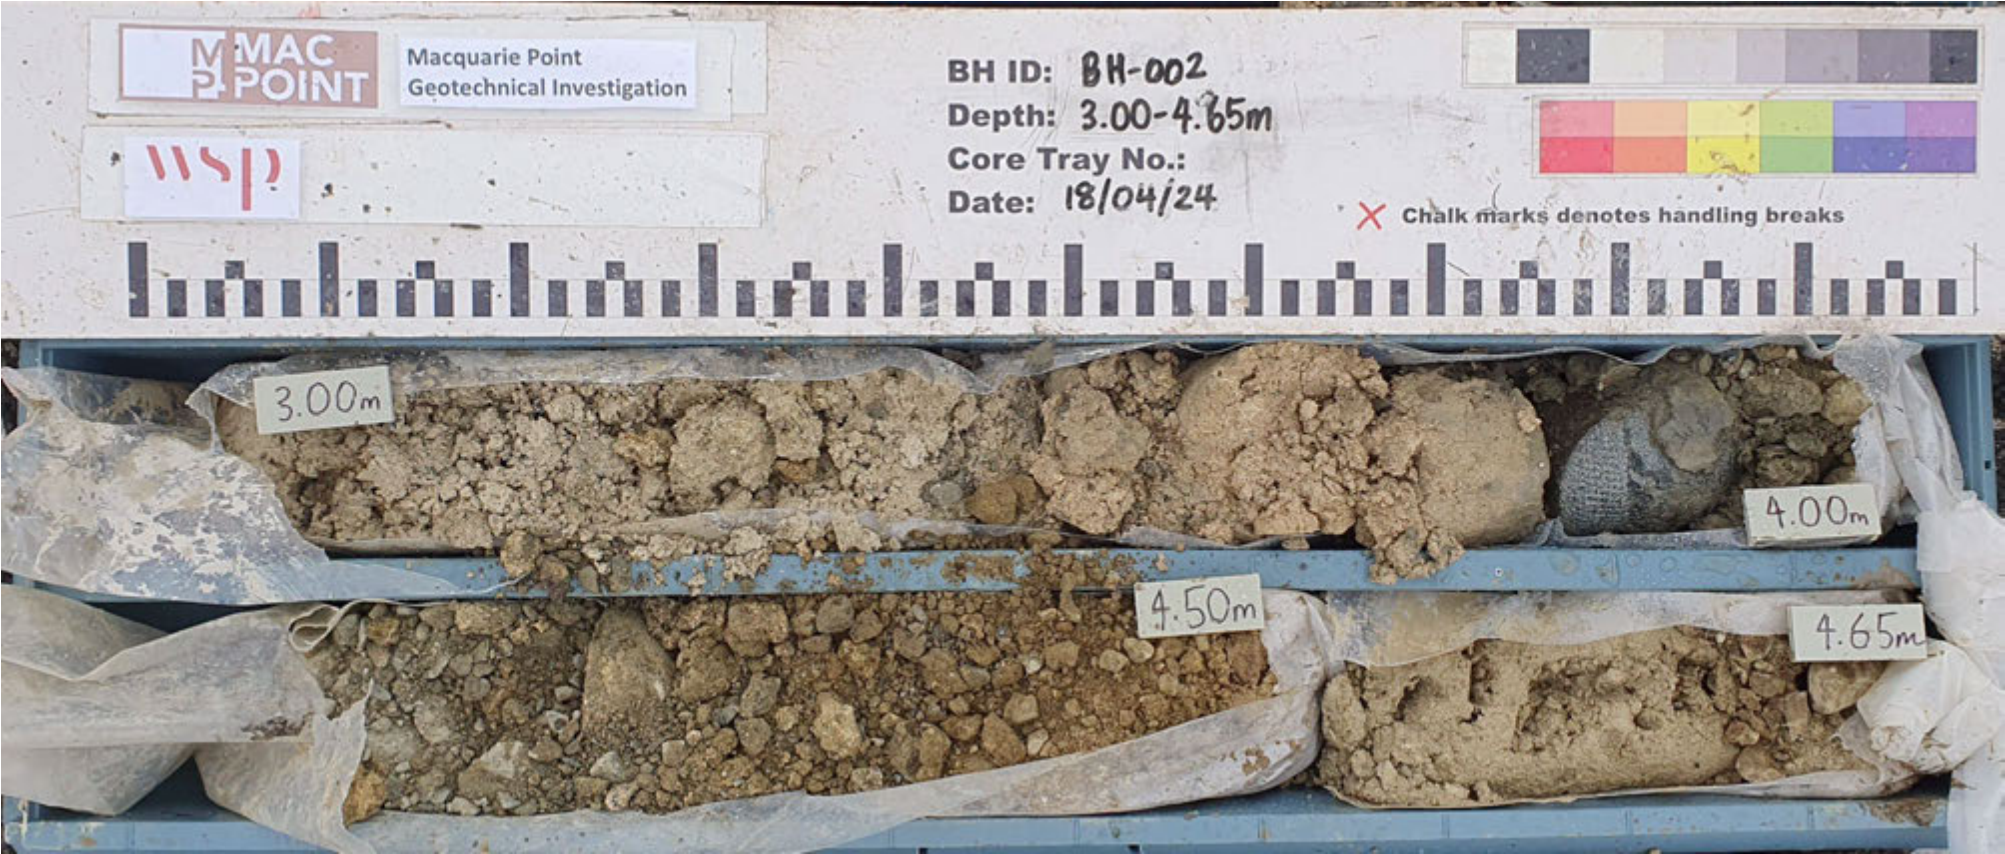
| | TITLE<br><br>MPDC<br>Macquarie Point<br>Macquarie Point GI<br>Core Photo - BH-002 | DRAWN | DATE<br>18/6/2024 |

PointID : BH-002 Depth Range: 3.00 - 4.65 m

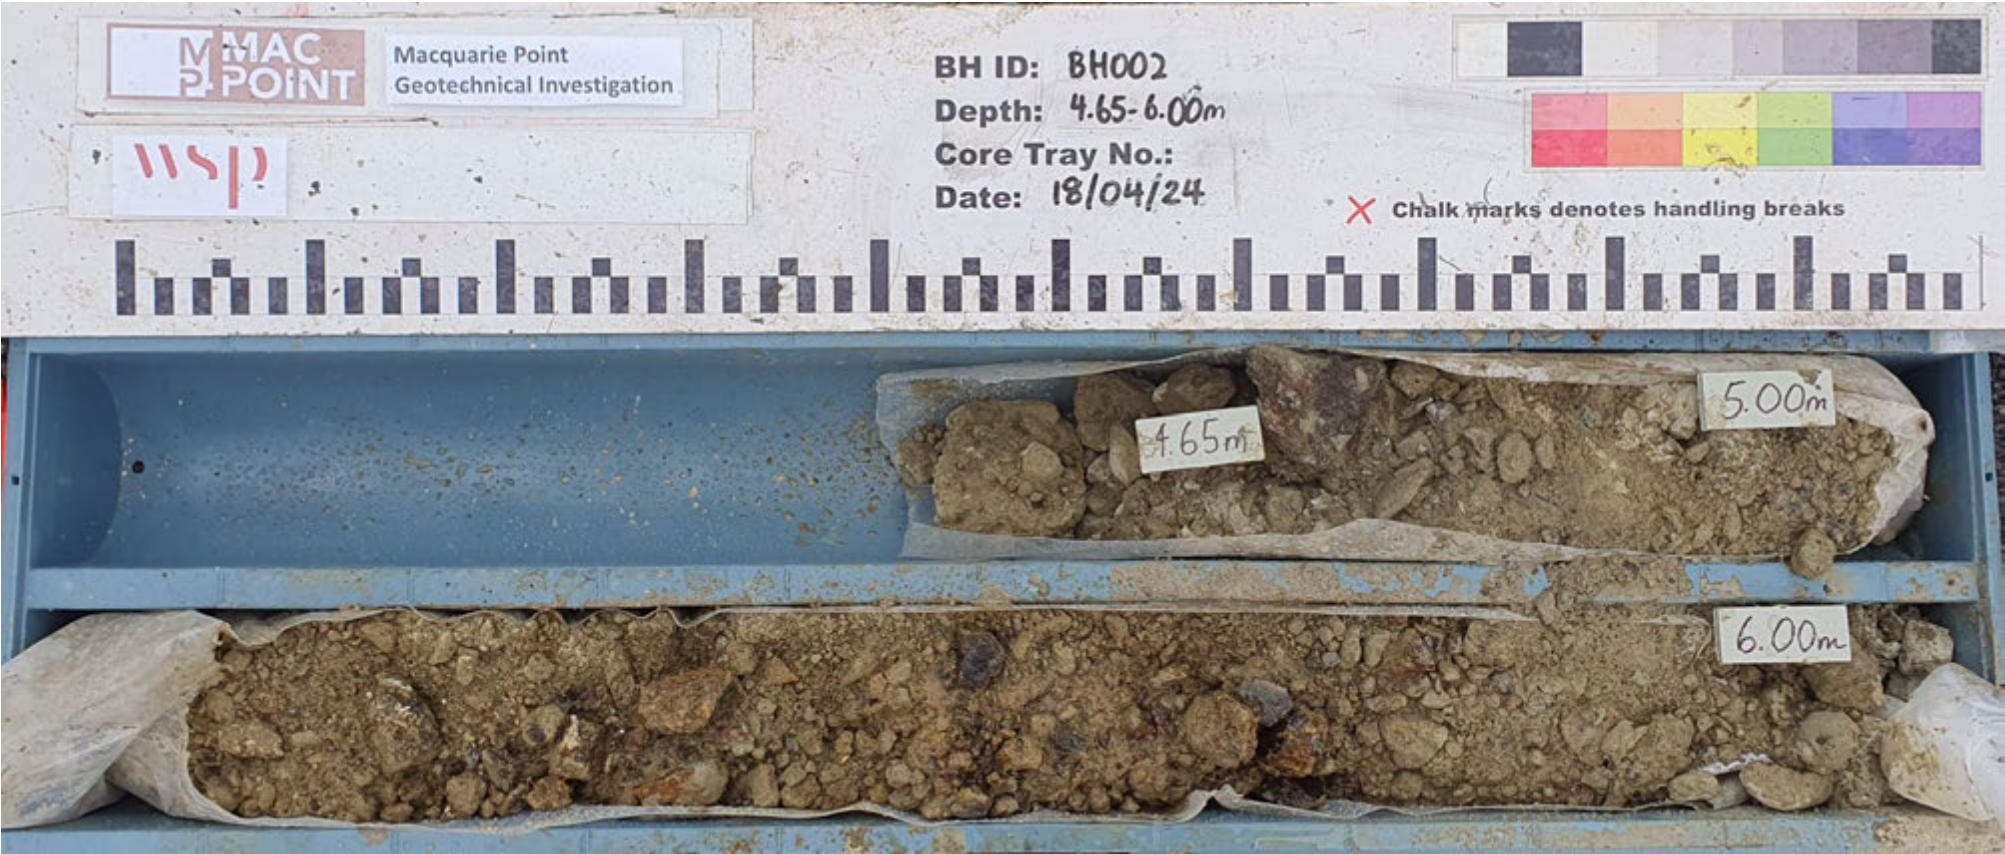
| | TITLE<br><br>MPDC<br>Macquarie Point<br>Macquarie Point GI<br>Core Photo - BH-002 | DRAWN | DATE<br>18/6/2024 |

PointID : BH-002 Depth Range: 4.65 - 6.00 m

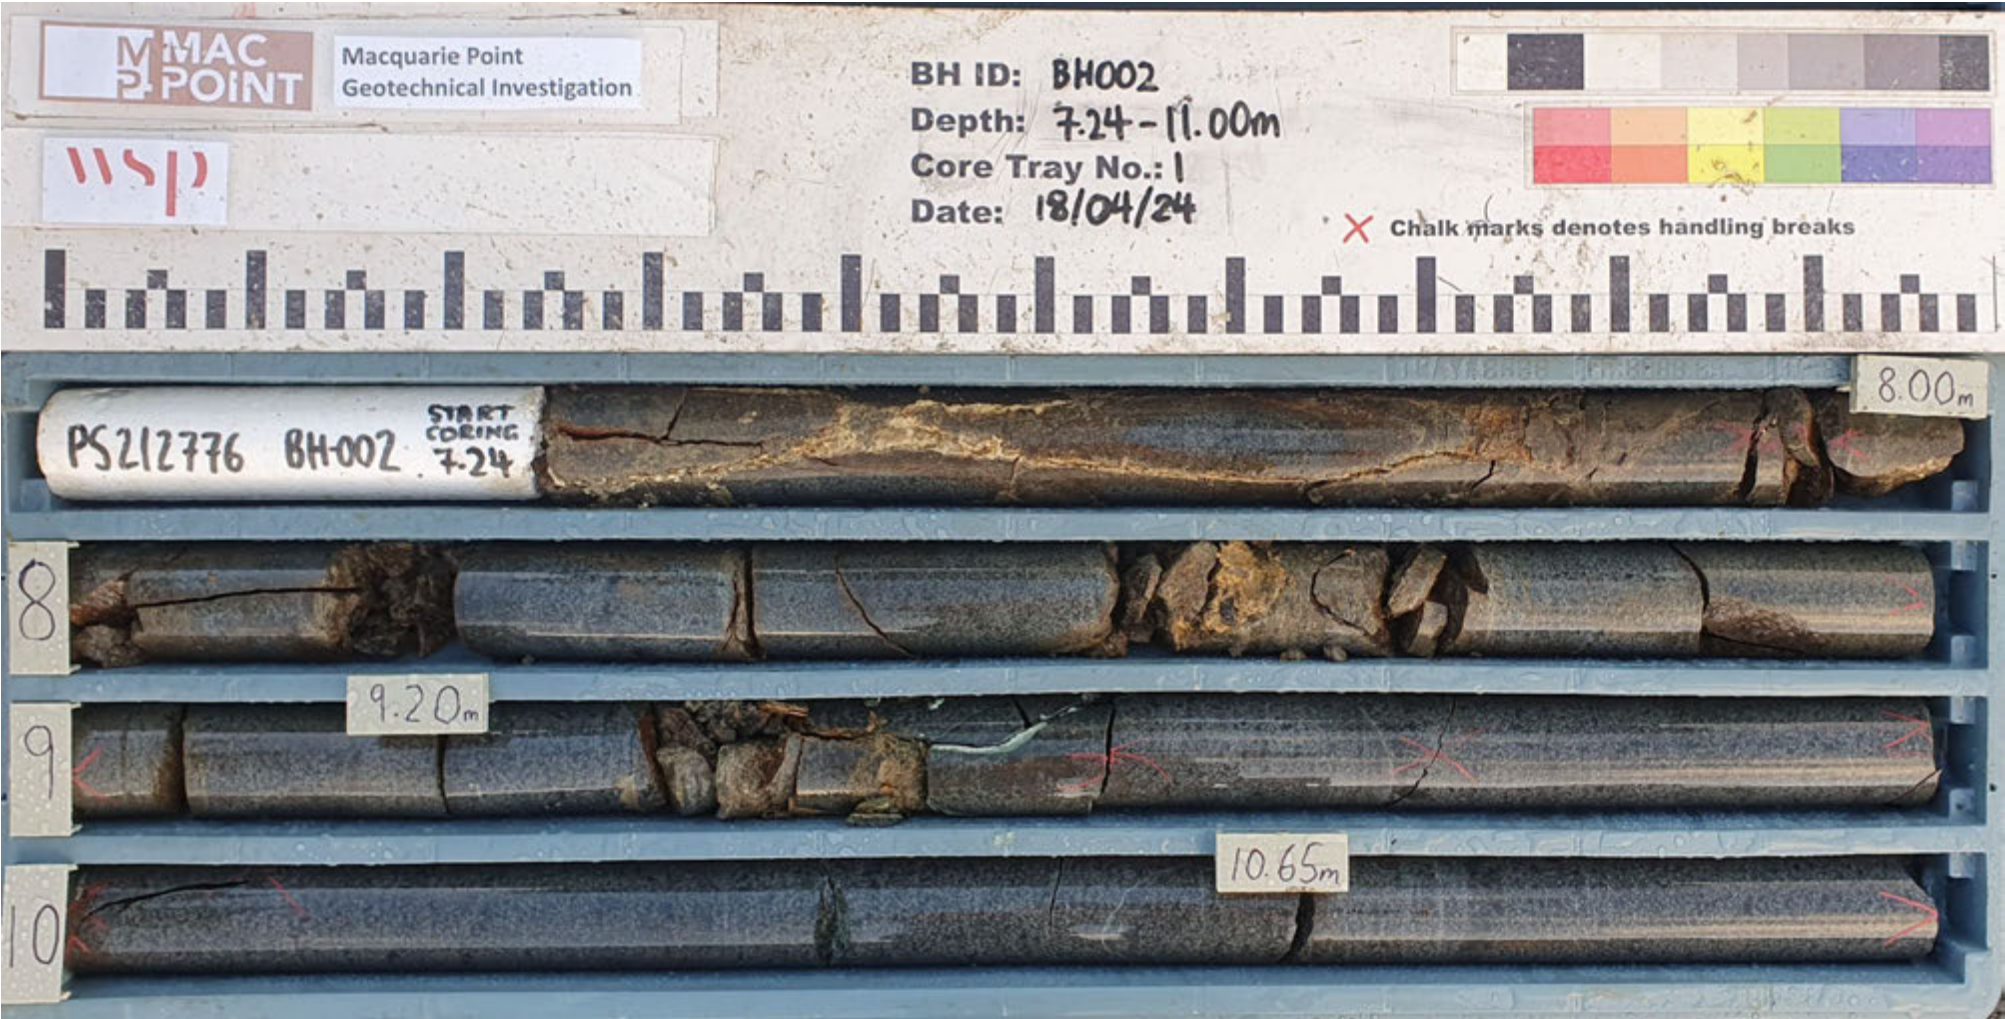
PointID : BH-002 Depth Range: 7.24 - 11.00 m

| | TITLE<br><br>MPDC<br>Macquarie Point<br>Macquarie Point GI<br>Core Photo - BH-002 | DRAWN | DATE<br>18/6/2024 |
