# Macquarie Point Stadium Development

## Geotechnical Factual Report

June 2024

## Macquarie Point Stadium Development Geotechnical Factual Report

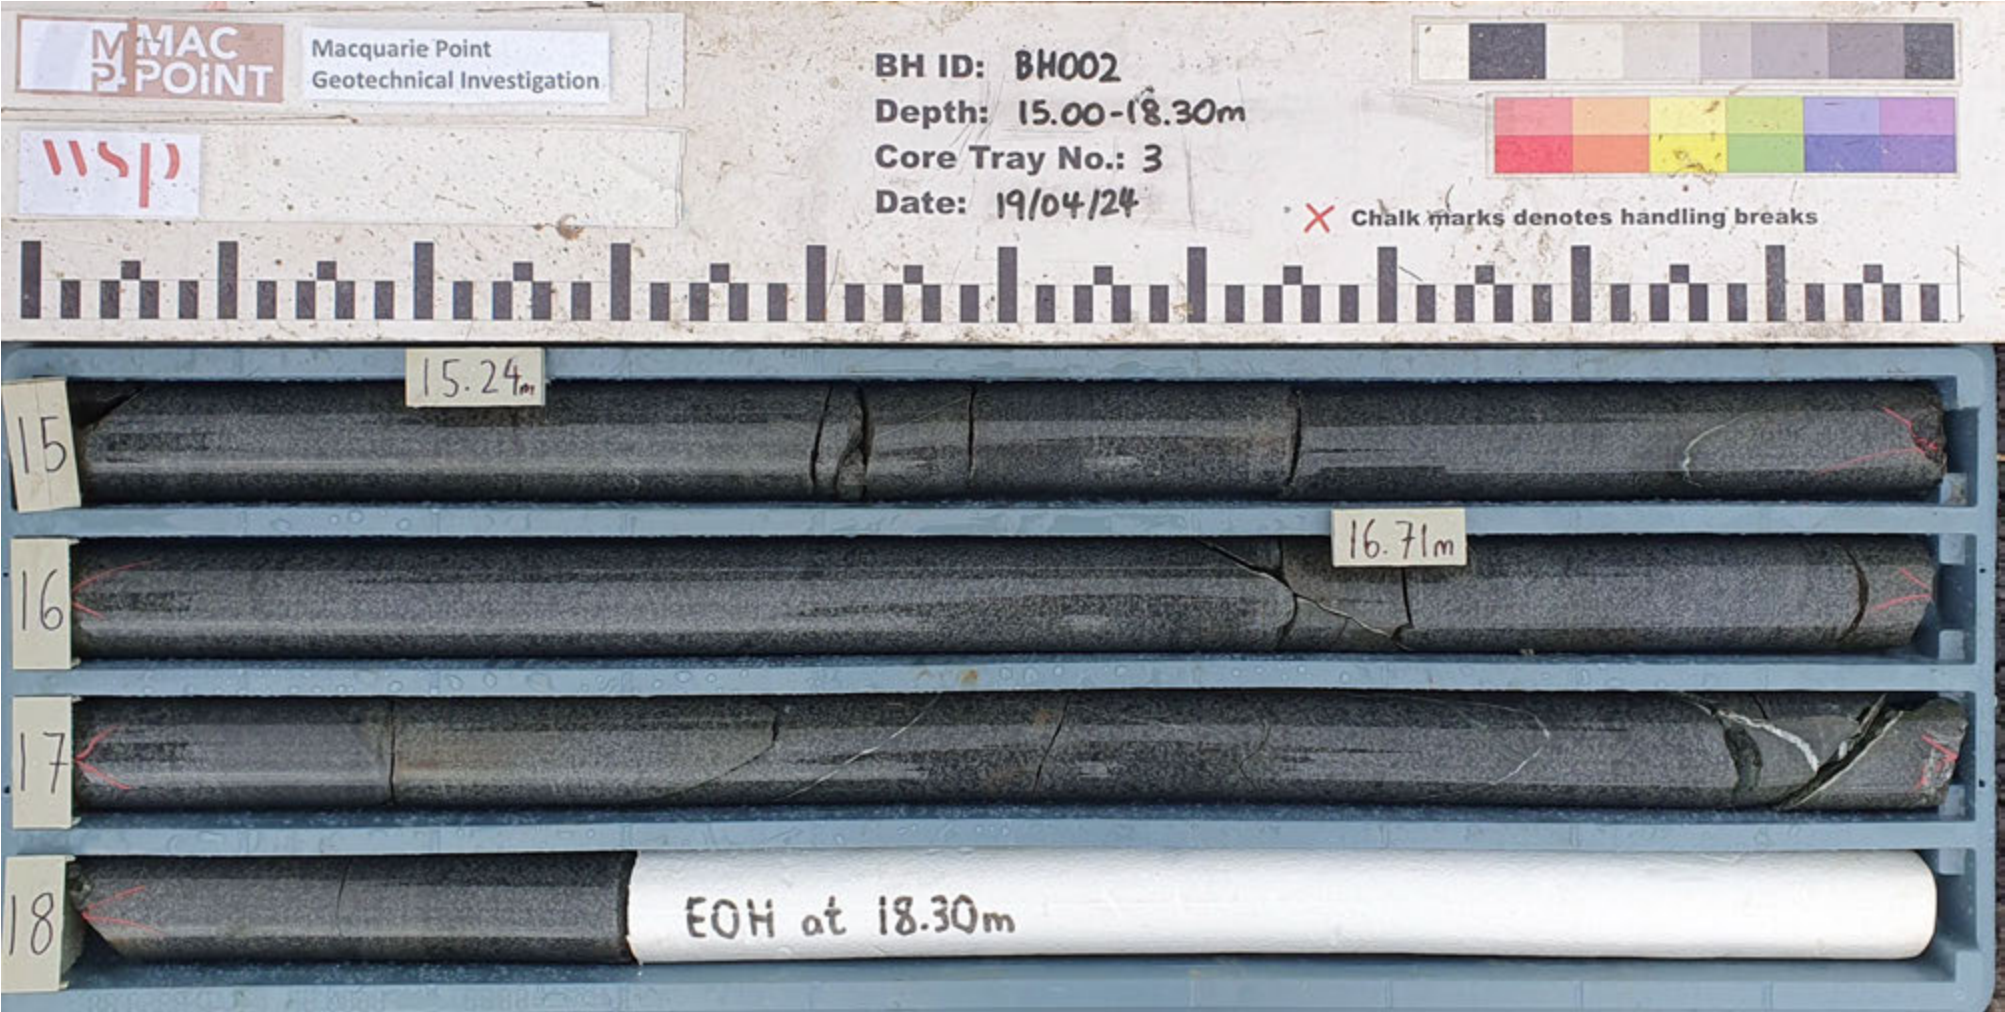
PointID : BH-002 Depth Range: 15.00 - 18.30 m

| | TITLE<br><br>MPDC<br>Macquarie Point<br>Macquarie Point GI<br>Core Photo - BH-002 | DRAWN | DATE<br>18/6/2024 |

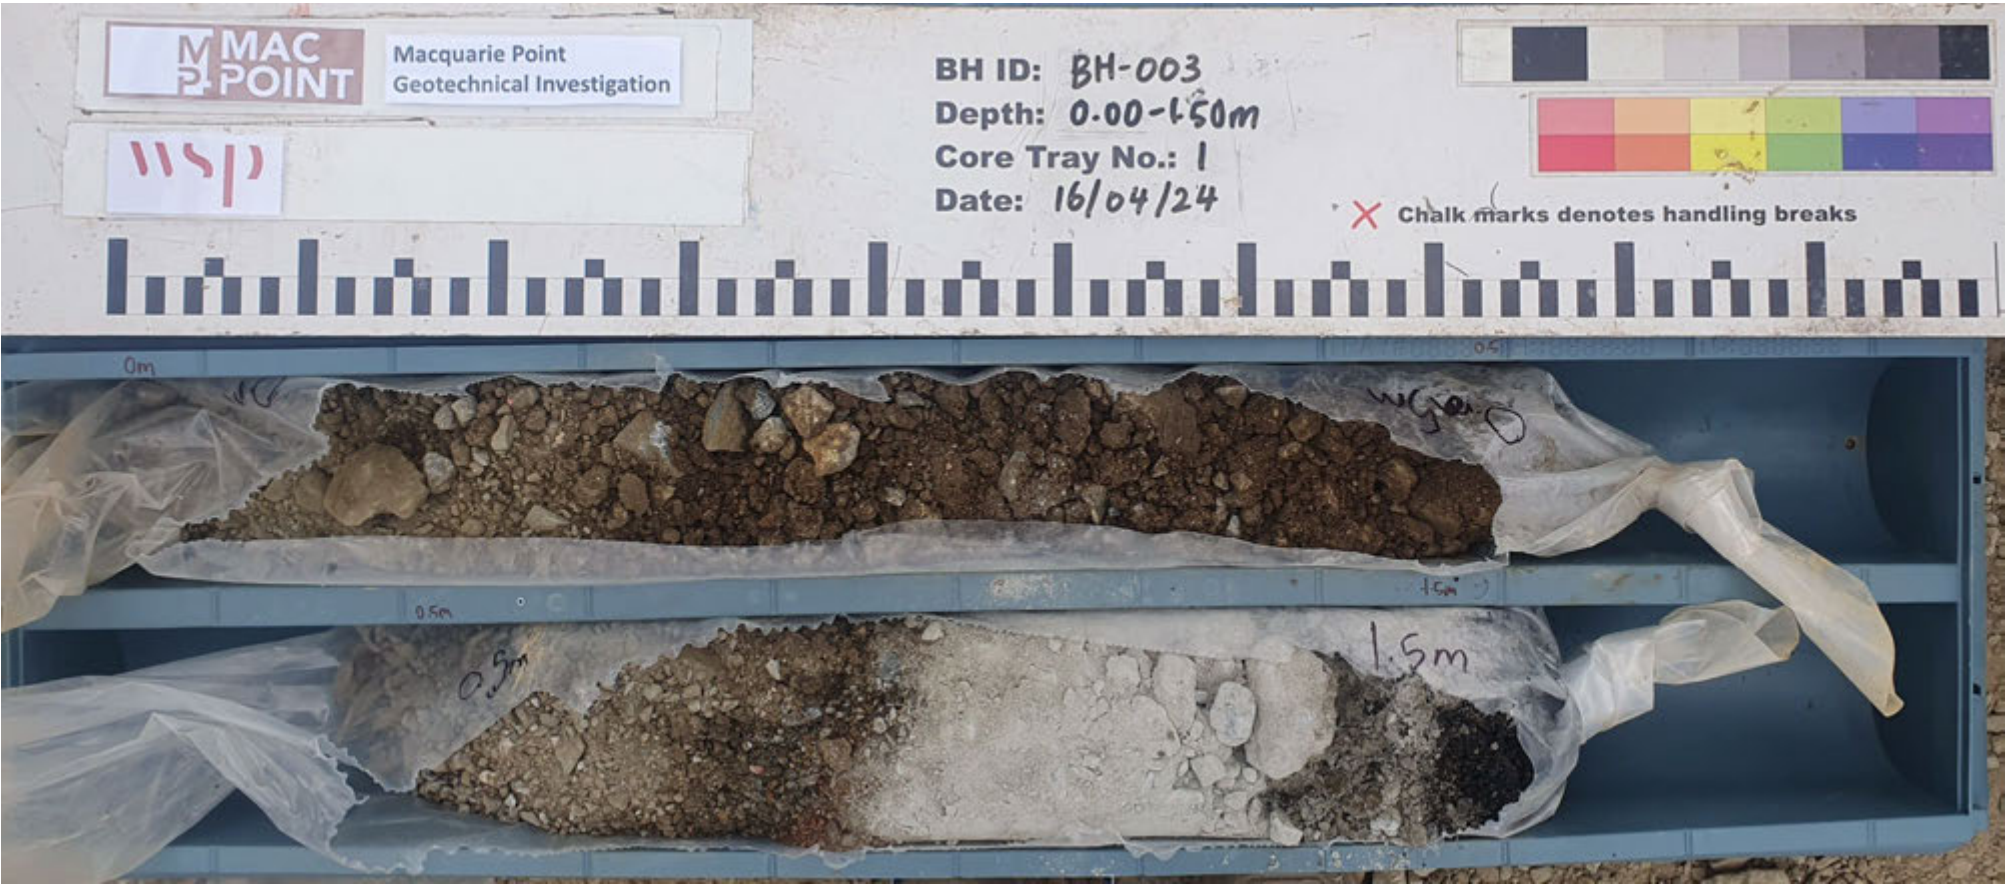
| | TITLE<br><br>MPDC<br>Macquarie Point<br>Macquarie Point GI<br>Core Photo - BH-003 | DRAWN | DATE |

PointID : BH-003 Depth Range: 0.00 - 1.50 m

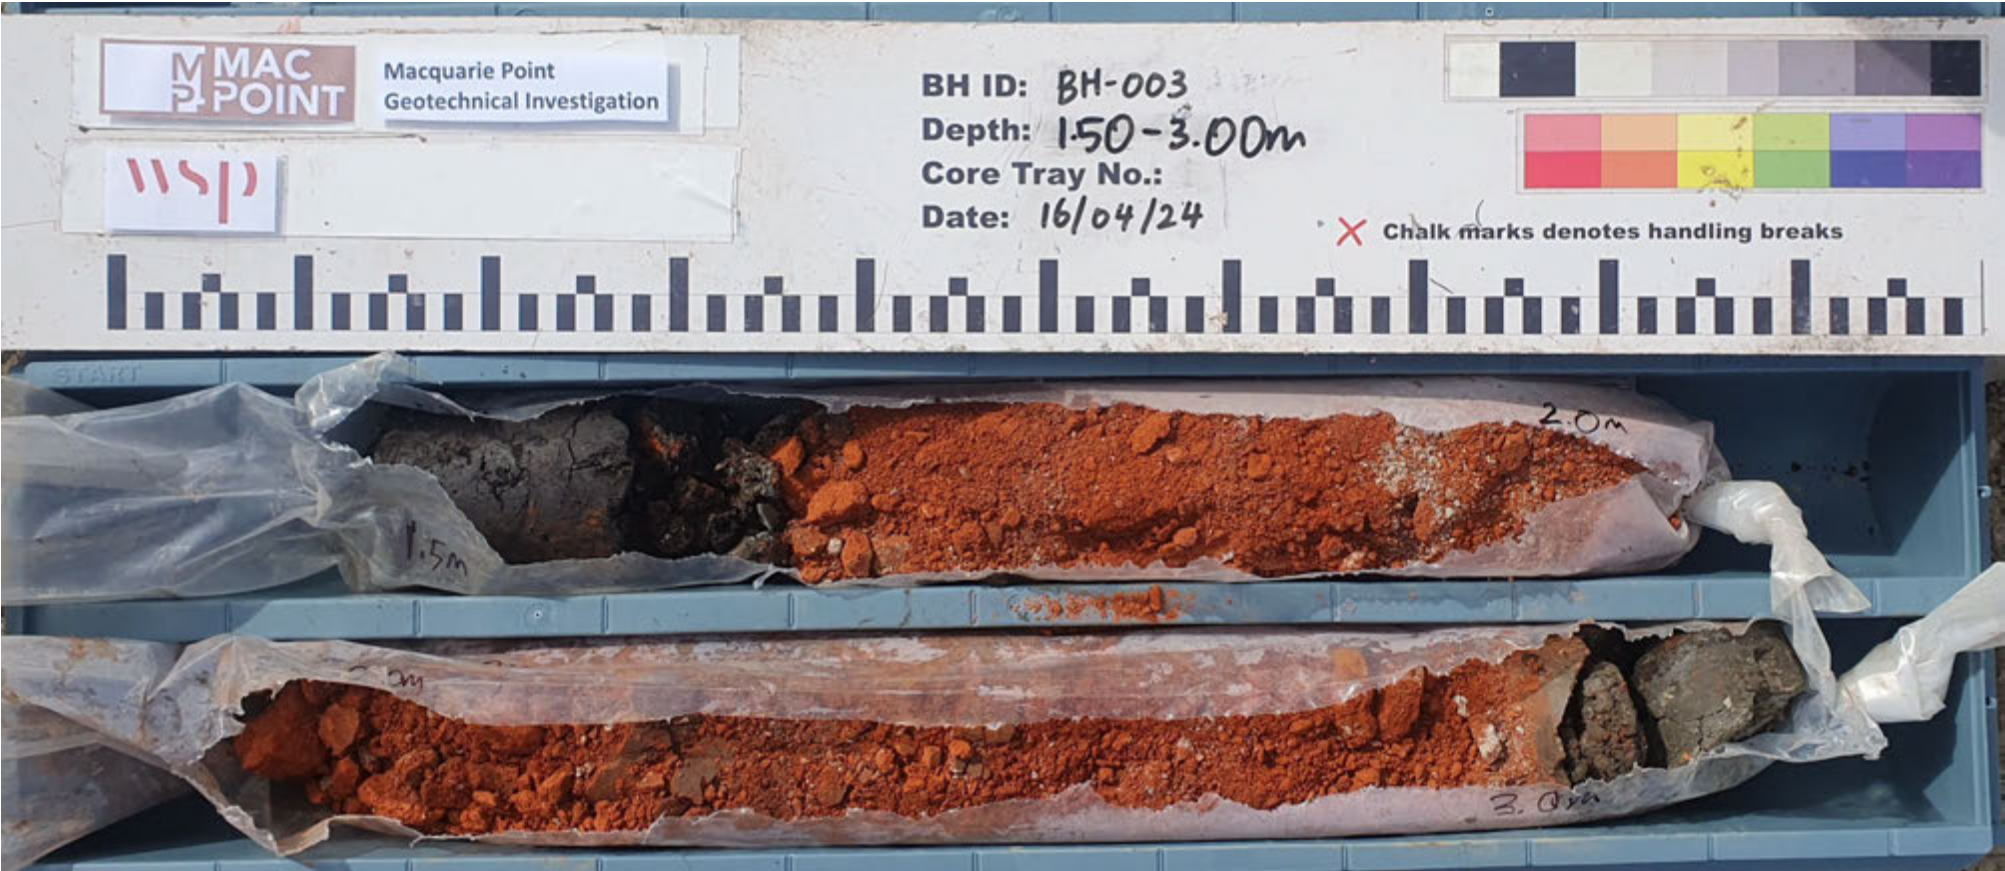
| | TITLE<br><br>MPDC<br>Macquarie Point<br>Macquarie Point GI<br>Core Photo - BH-003 | DRAWN | DATE<br>18/6/2024 |

PointID : BH-003 Depth Range: 1.50 - 3.00 m

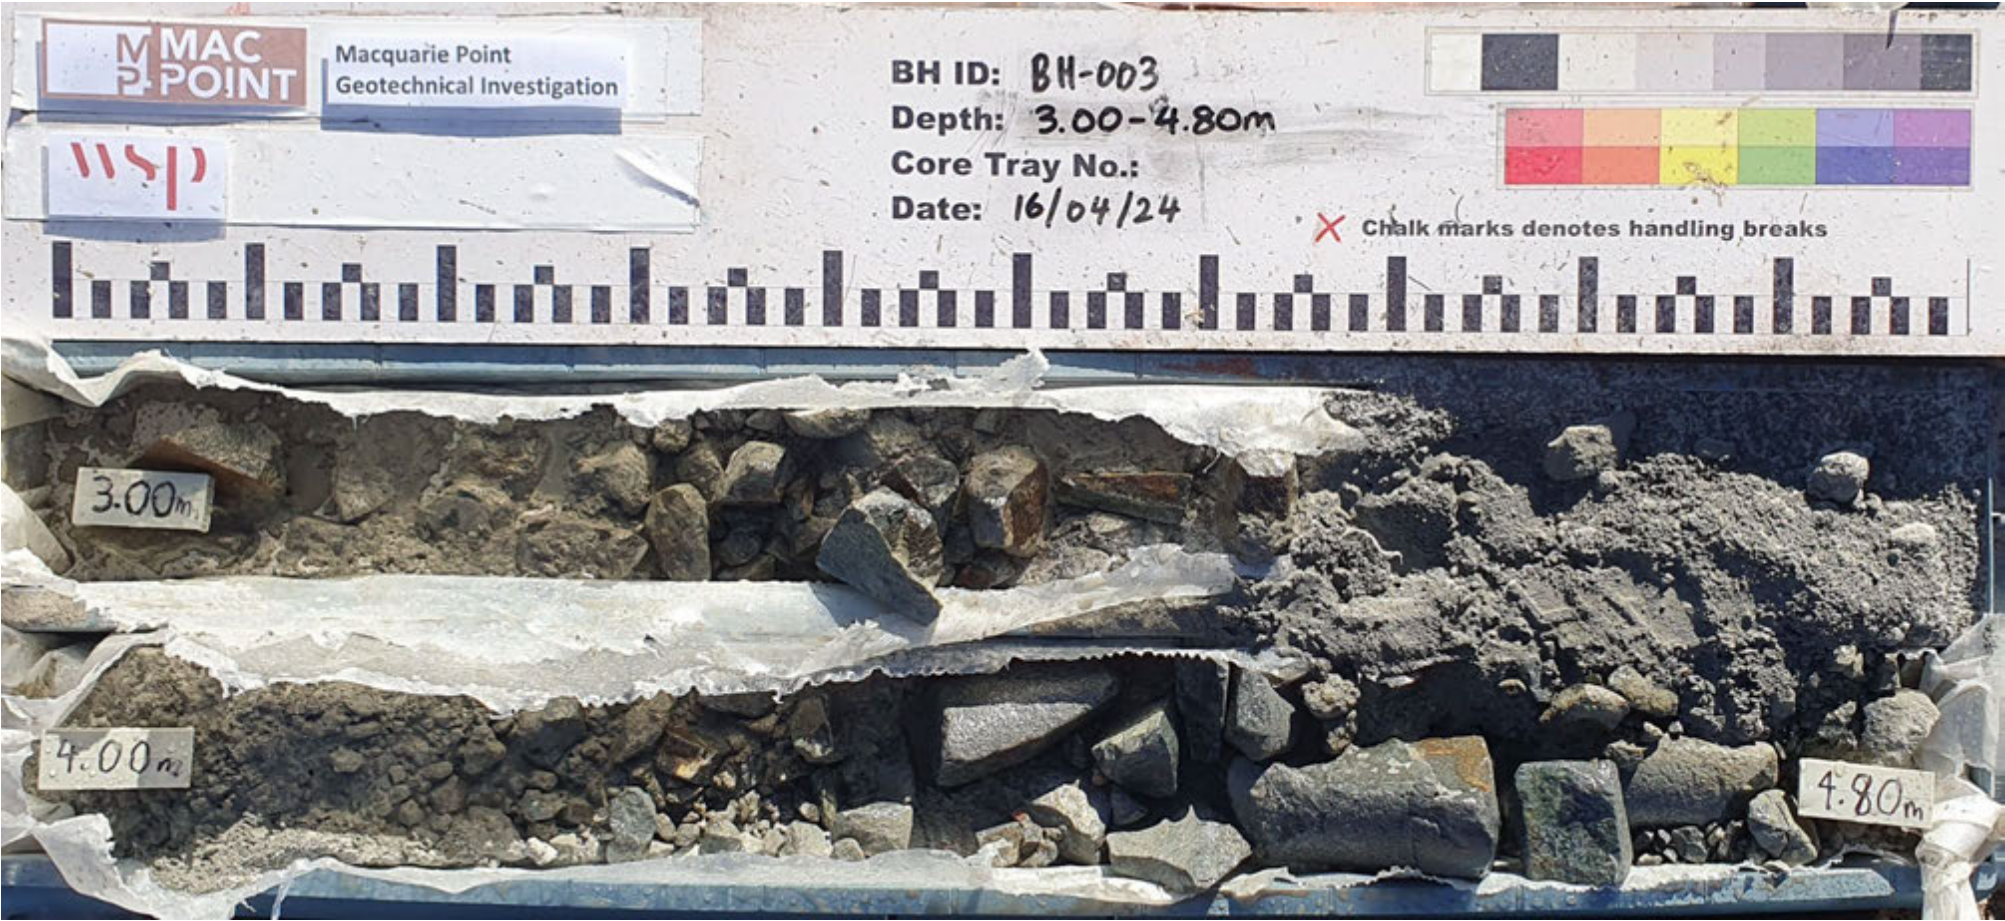
| | TITLE<br><br>MPDC<br>Macquarie Point<br>Macquarie Point GI<br>Core Photo - BH-003 | DRAWN | DATE<br>18/6/2024 |

PointID : BH-003 Depth Range: 3.00 - 4.80 m

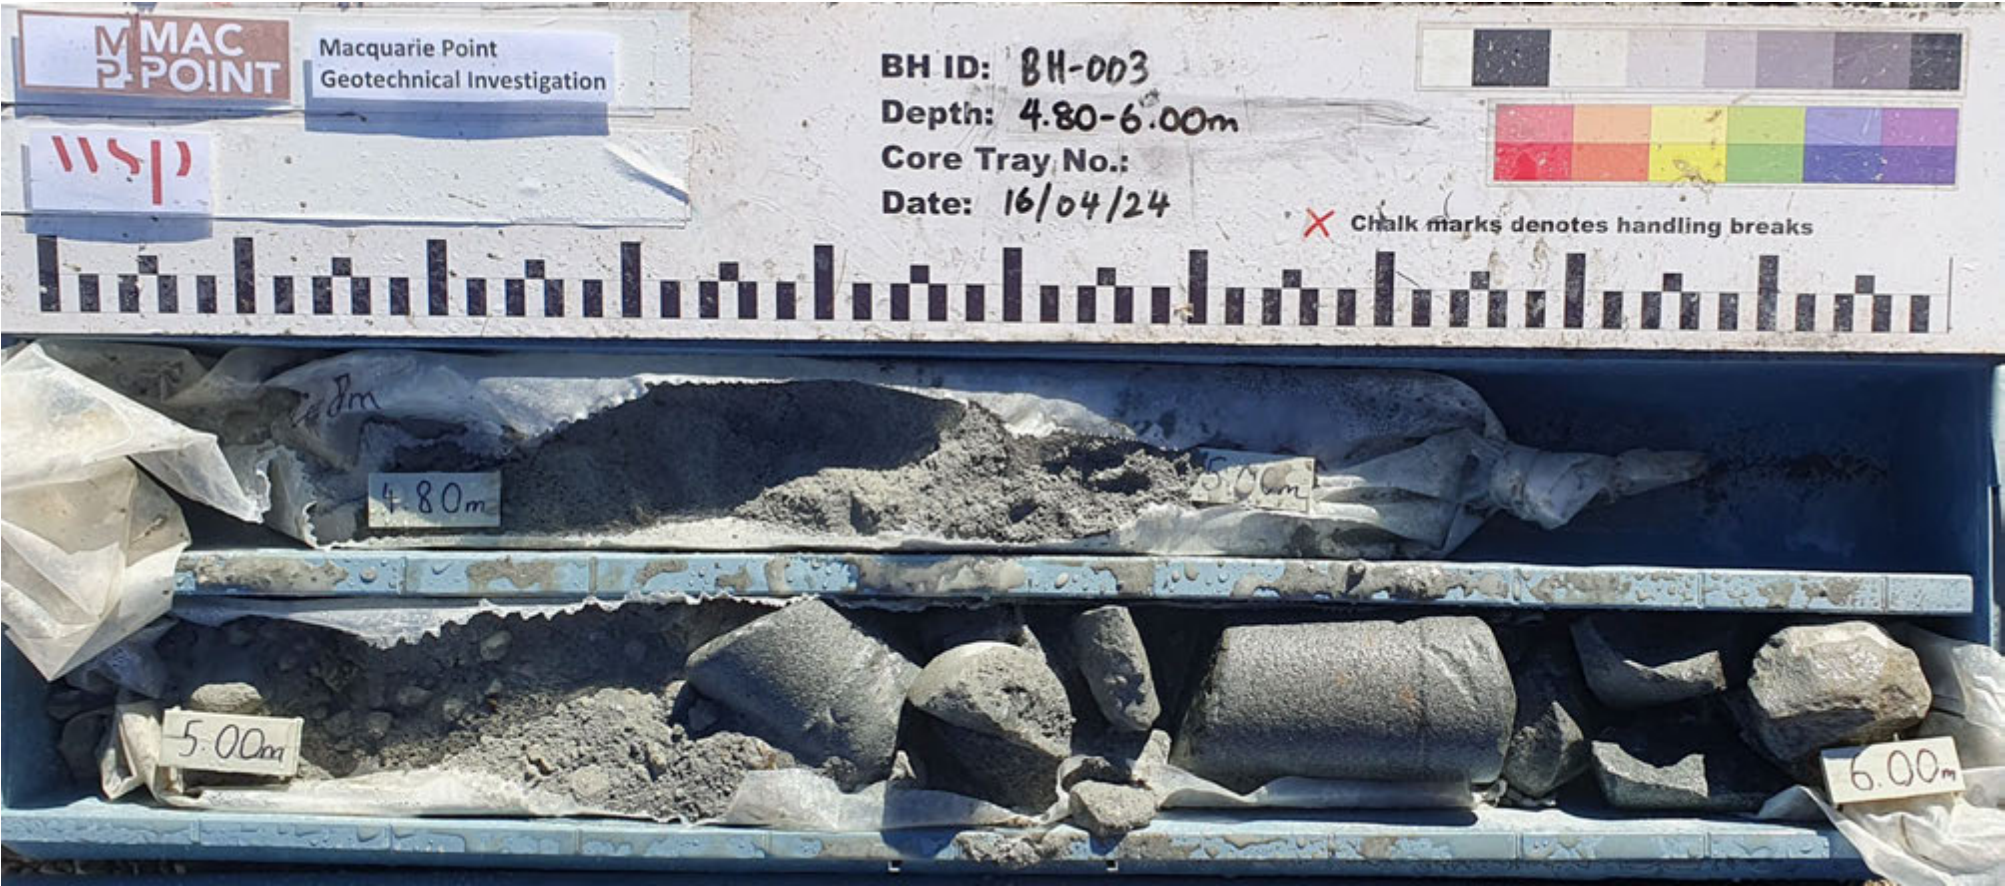
| | TITLE<br><br>MPDC<br>Macquarie Point<br>Macquarie Point GI<br>Core Photo - BH-003 | DRAWN | DATE<br>18/6/2024 |

PointID : BH-003 Depth Range: 4.80 - 6.00 m

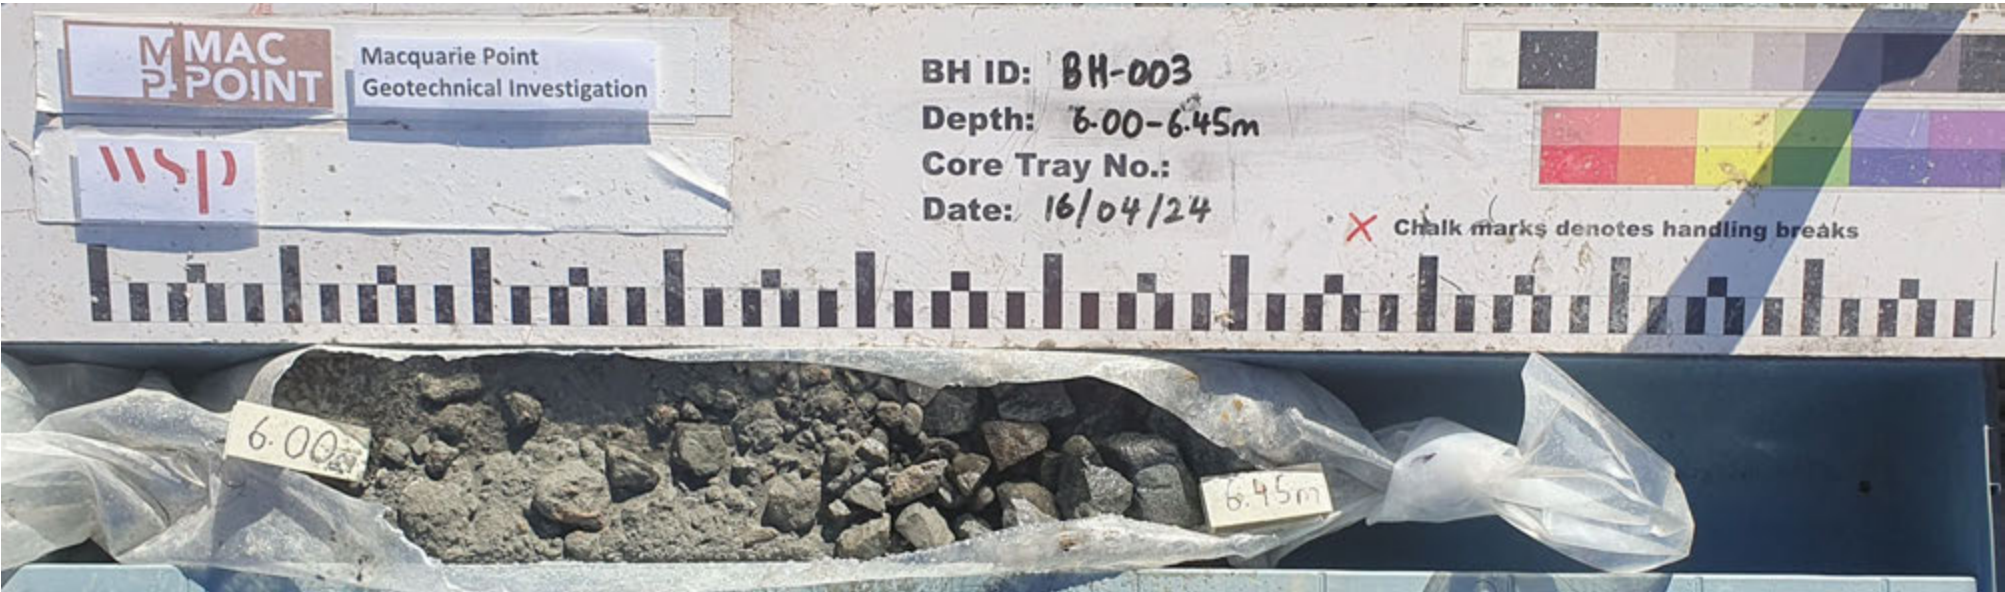
| | TITLE<br><br>MPDC<br>Macquarie Point<br>Macquarie Point GI<br>Core Photo - BH-003 | DRAWN | DATE<br>18/6/2024 |

PointID : BH-003 Depth Range: 6.00 - 6.45 m

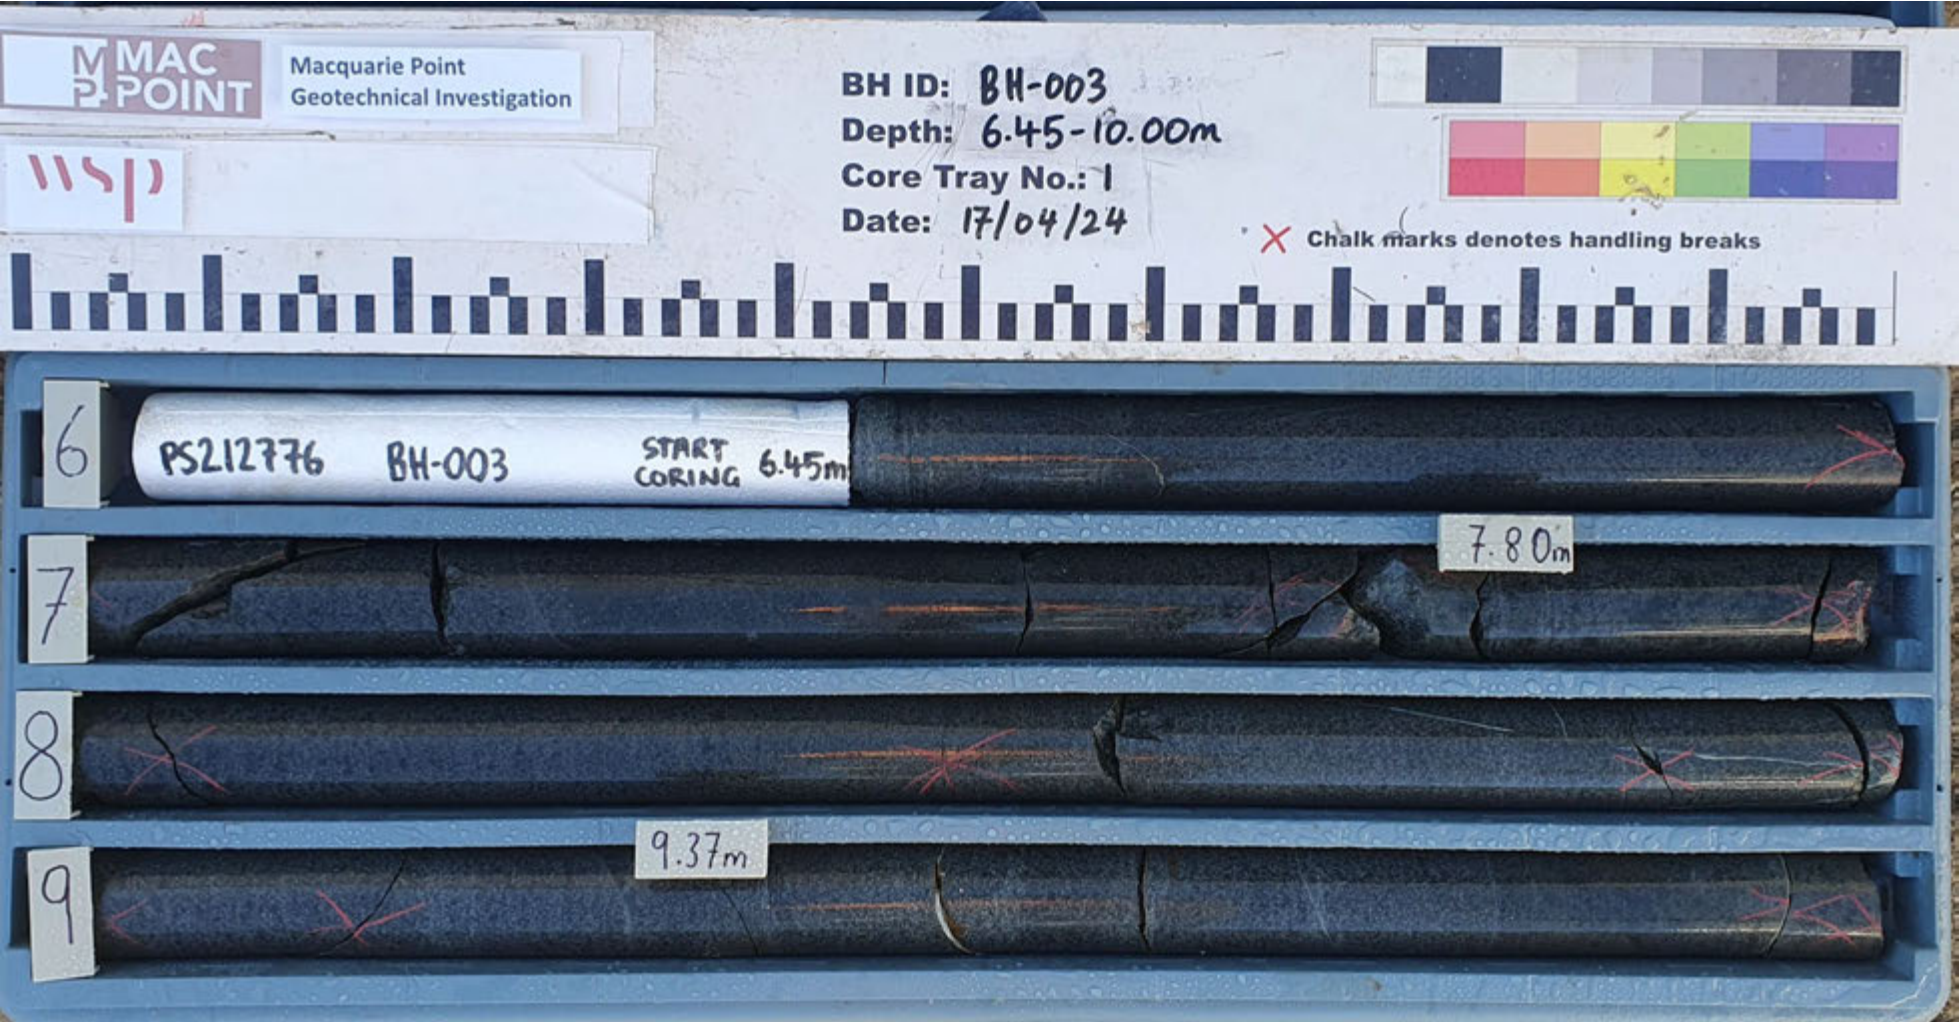
| | TITLE<br><br>MPDC<br>Macquarie Point<br>Macquarie Point GI<br>Core Photo - BH-003 | DRAWN | DATE<br>18/6/2024 |

PointID : BH-003 Depth Range: 6.45 - 10.00 m

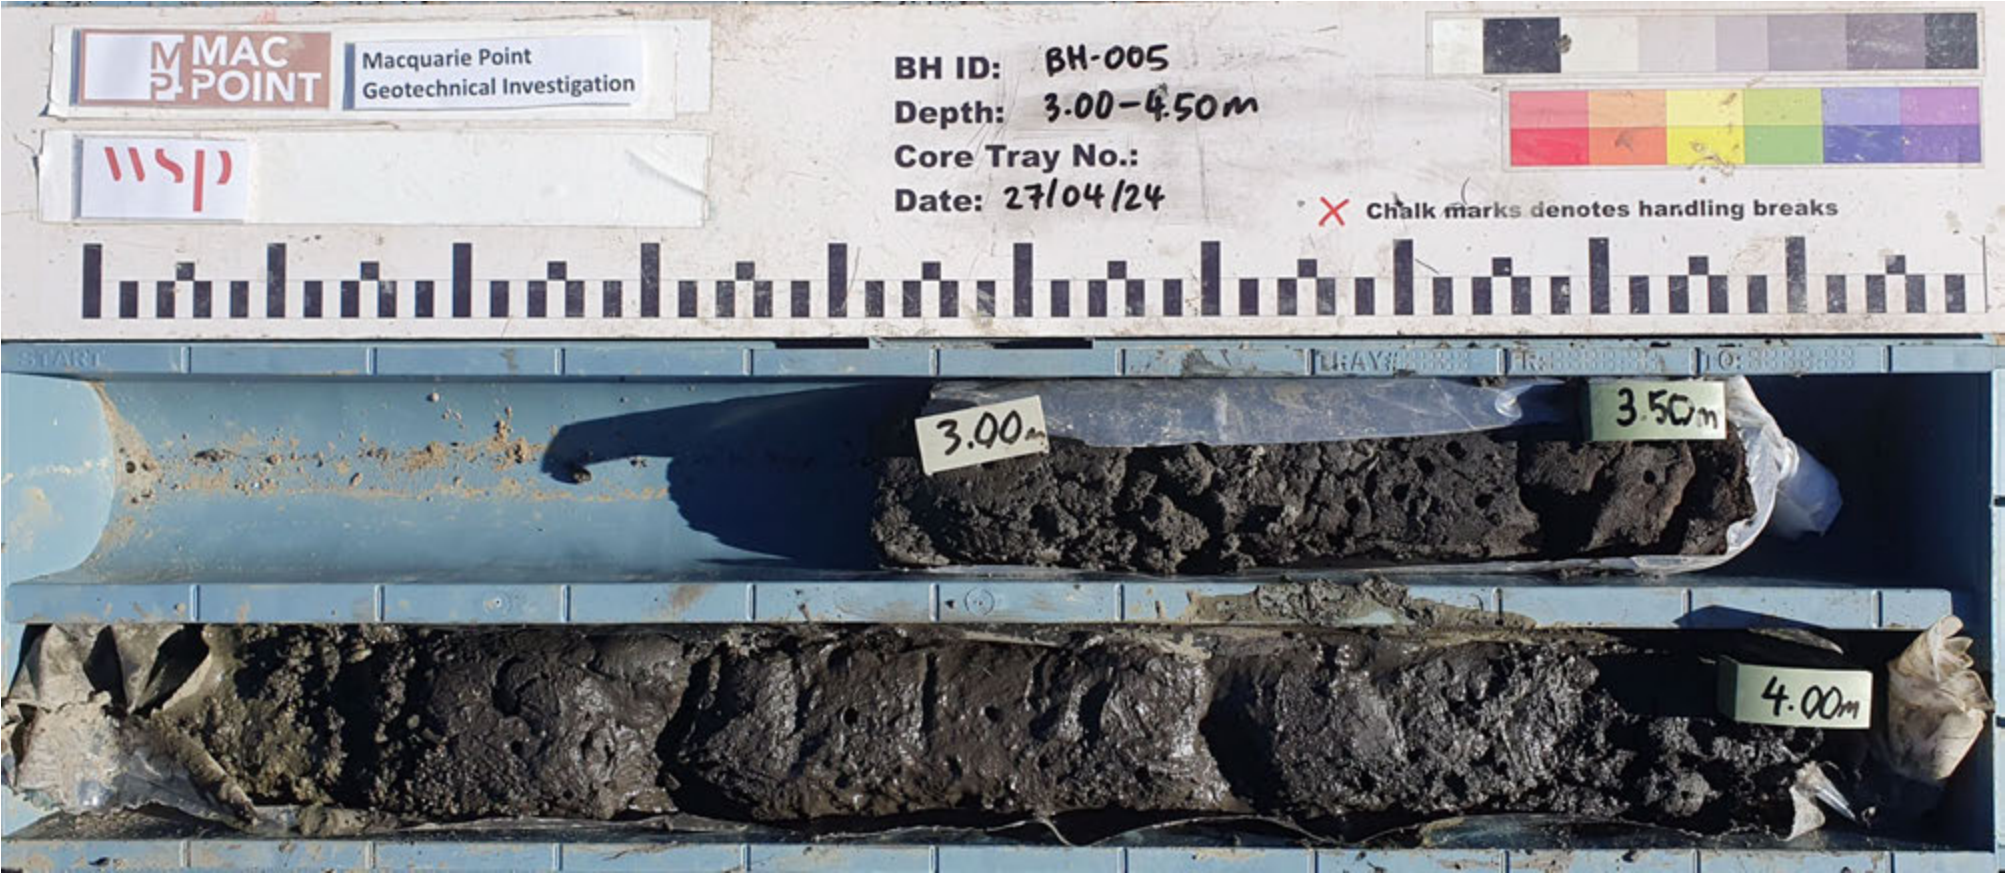
| | TITLE<br><br>MPDC<br>Macquarie Point<br>Macquarie Point GI<br>Core Photo - BH-005 | DRAWN | DATE<br>18/6/2024 |

PointID : BH-005 Depth Range: 3.00 - 4.00 m

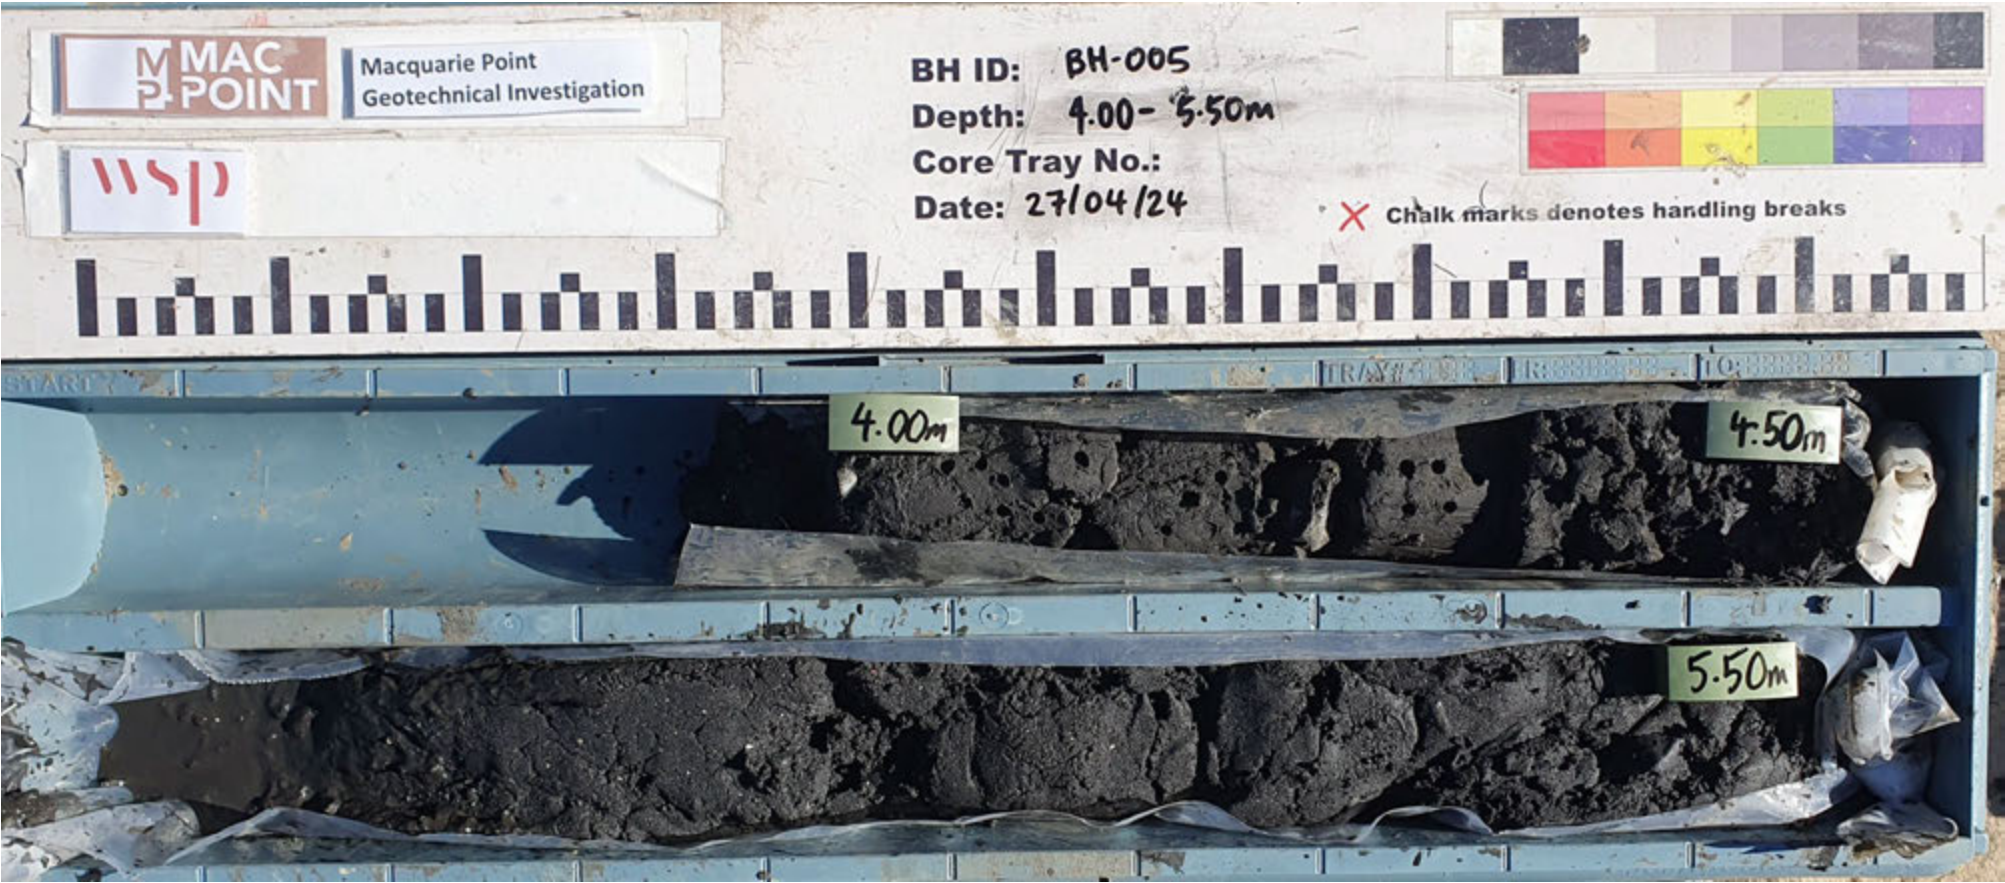
| | TITLE<br><br>MPDC<br>Macquarie Point<br>Macquarie Point GI<br>Core Photo - BH-005 | DRAWN | DATE<br>18/6/2024 |

PointID : BH-005 Depth Range: 4.00 - 5.50 m

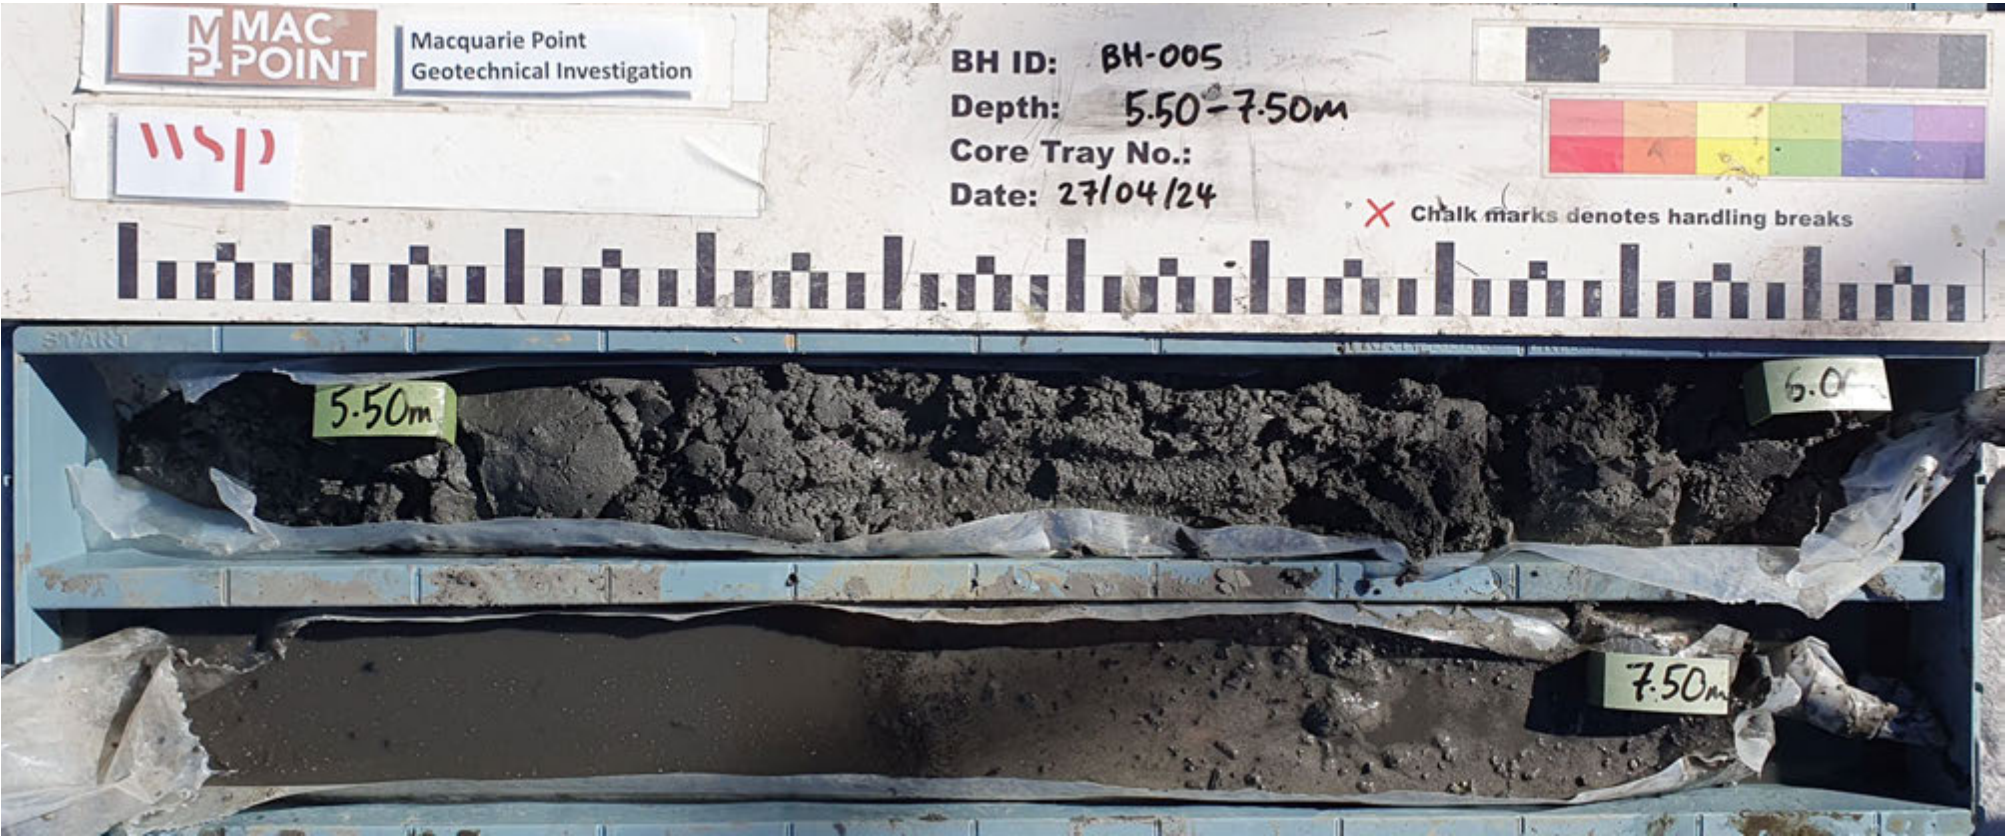
| | TITLE<br><br>MPDC<br>Macquarie Point<br>Macquarie Point GI<br>Core Photo - BH-005 | DRAWN | DATE<br>18/6/2024 |

PointID : BH-005 Depth Range: 5.50 - 7.50 m

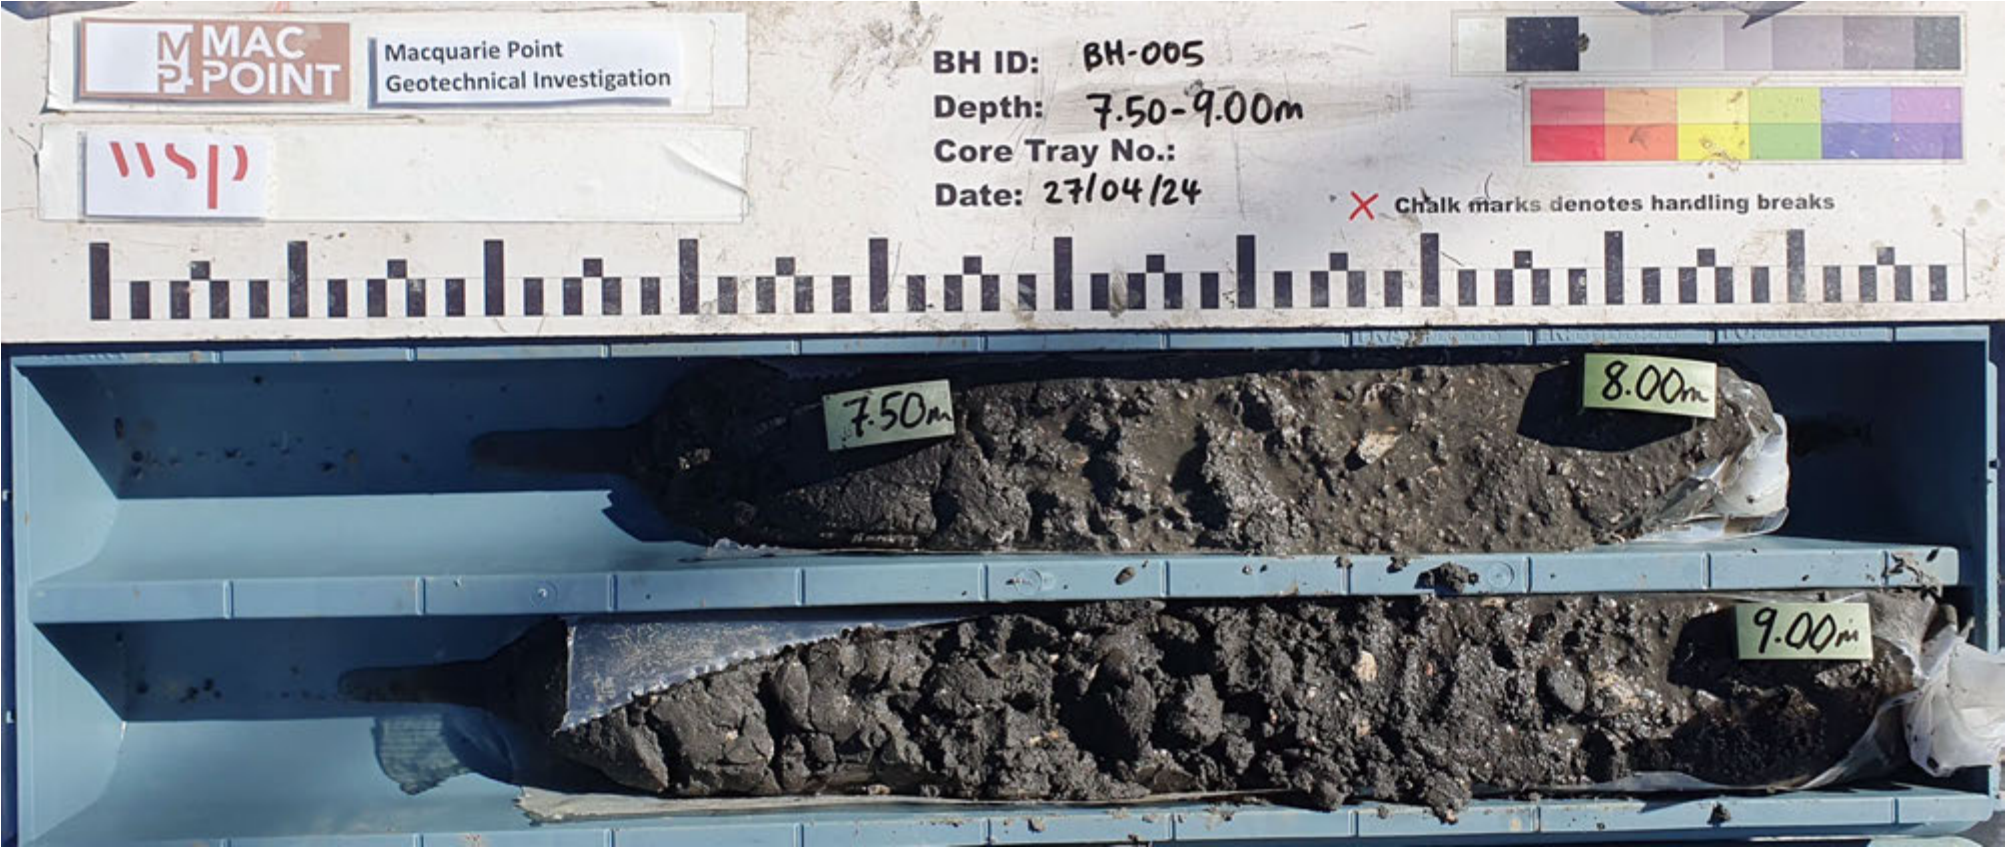
| | TITLE<br><br>MPDC<br>Macquarie Point<br>Macquarie Point GI<br>Core Photo - BH-005 | DRAWN | DATE 18/6/2024 | |

PointID : BH-005 Depth Range: 7.50 - 9.00 m

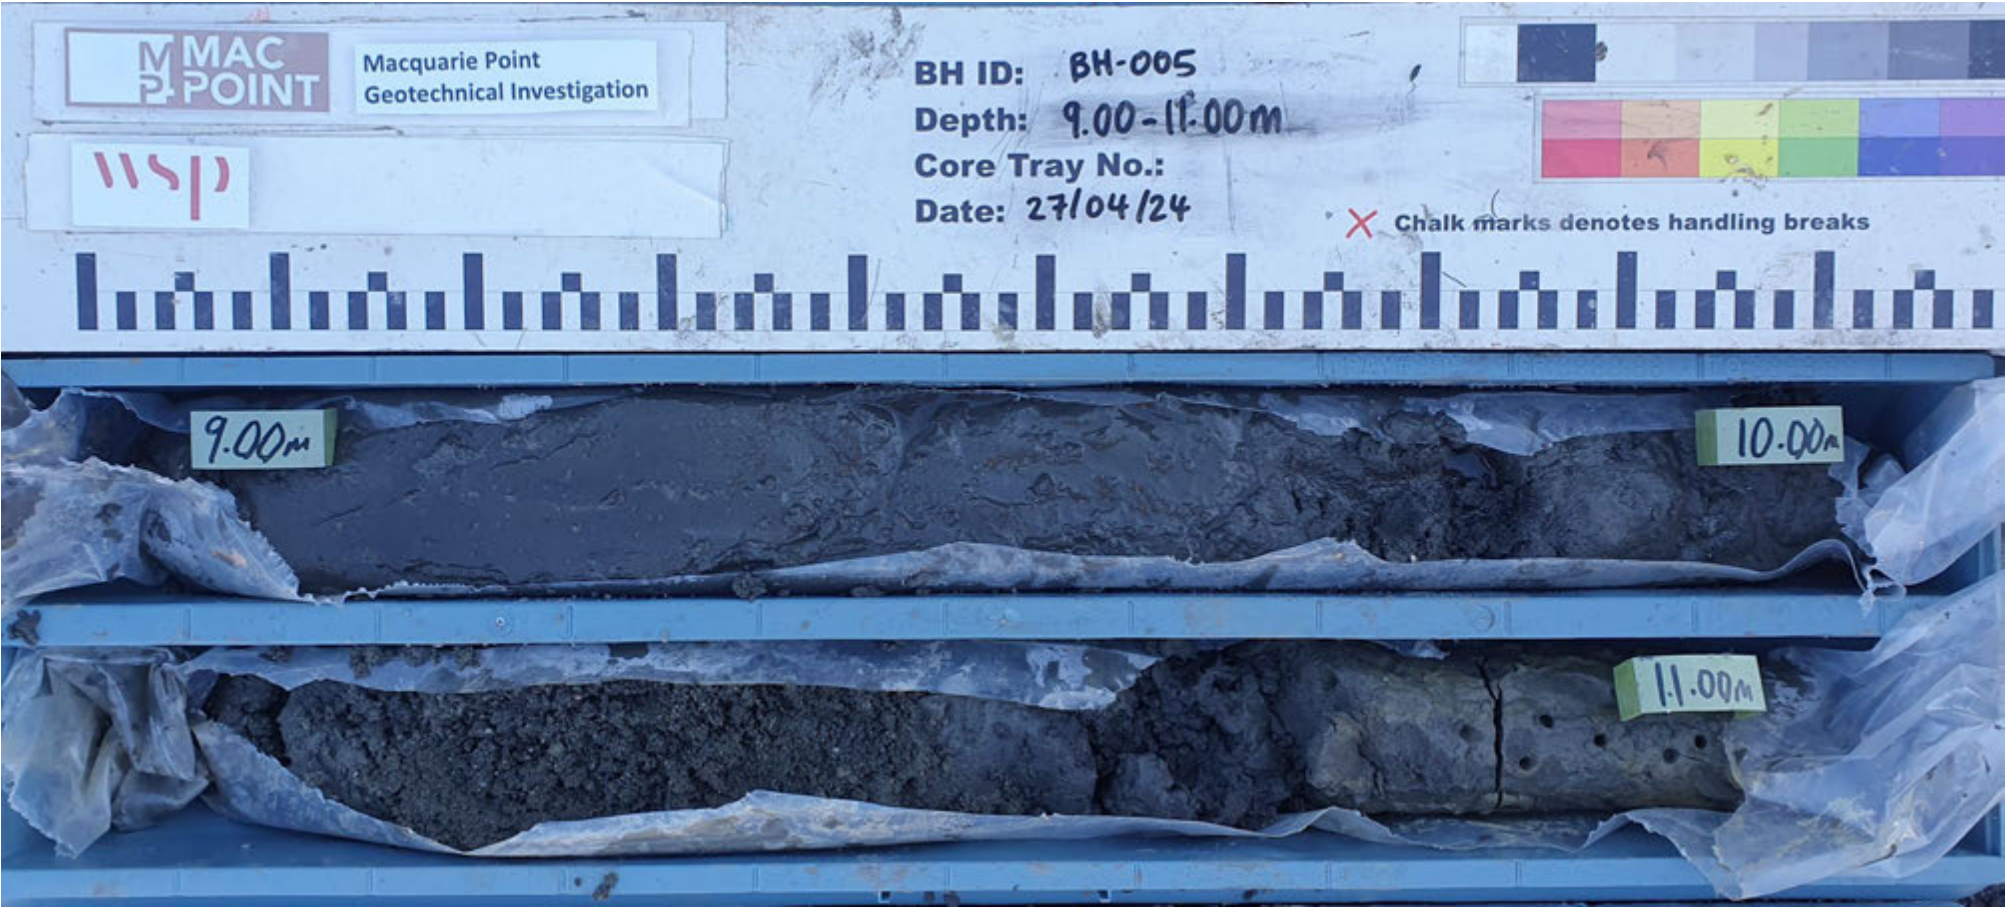
| | TITLE<br><br>MPDC<br>Macquarie Point<br>Macquarie Point GI<br>Core Photo - BH-005 | DRAWN | DATE<br>18/6/2024 |

PointID : BH-005 Depth Range: 9.00 - 11.00 m

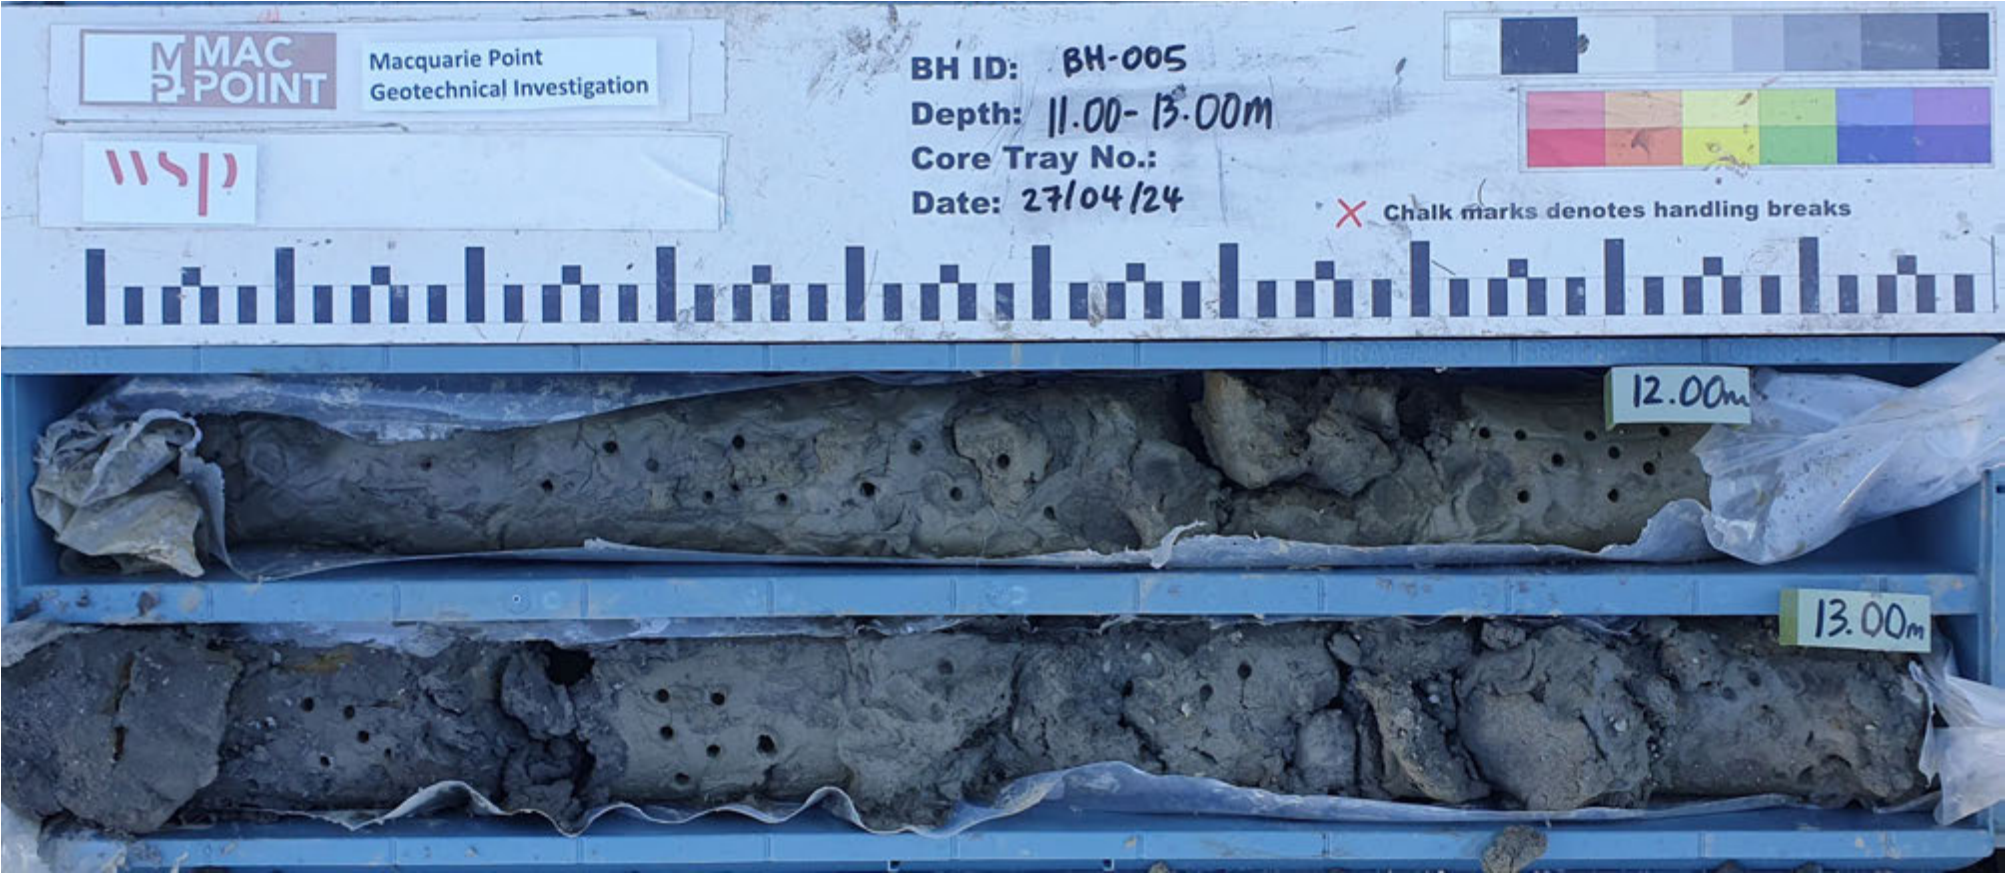
| | TITLE<br><br>MPDC<br>Macquarie Point<br>Macquarie Point GI<br>Core Photo - BH-005 | DRAWN | DATE<br>18/6/2024 |

PointID : BH-005 Depth Range: 11.00 - 13.00 m
