# Macquarie Point Stadium Development

## Geotechnical Factual Report

June 2024

## Macquarie Point Stadium Development Geotechnical Factual Report

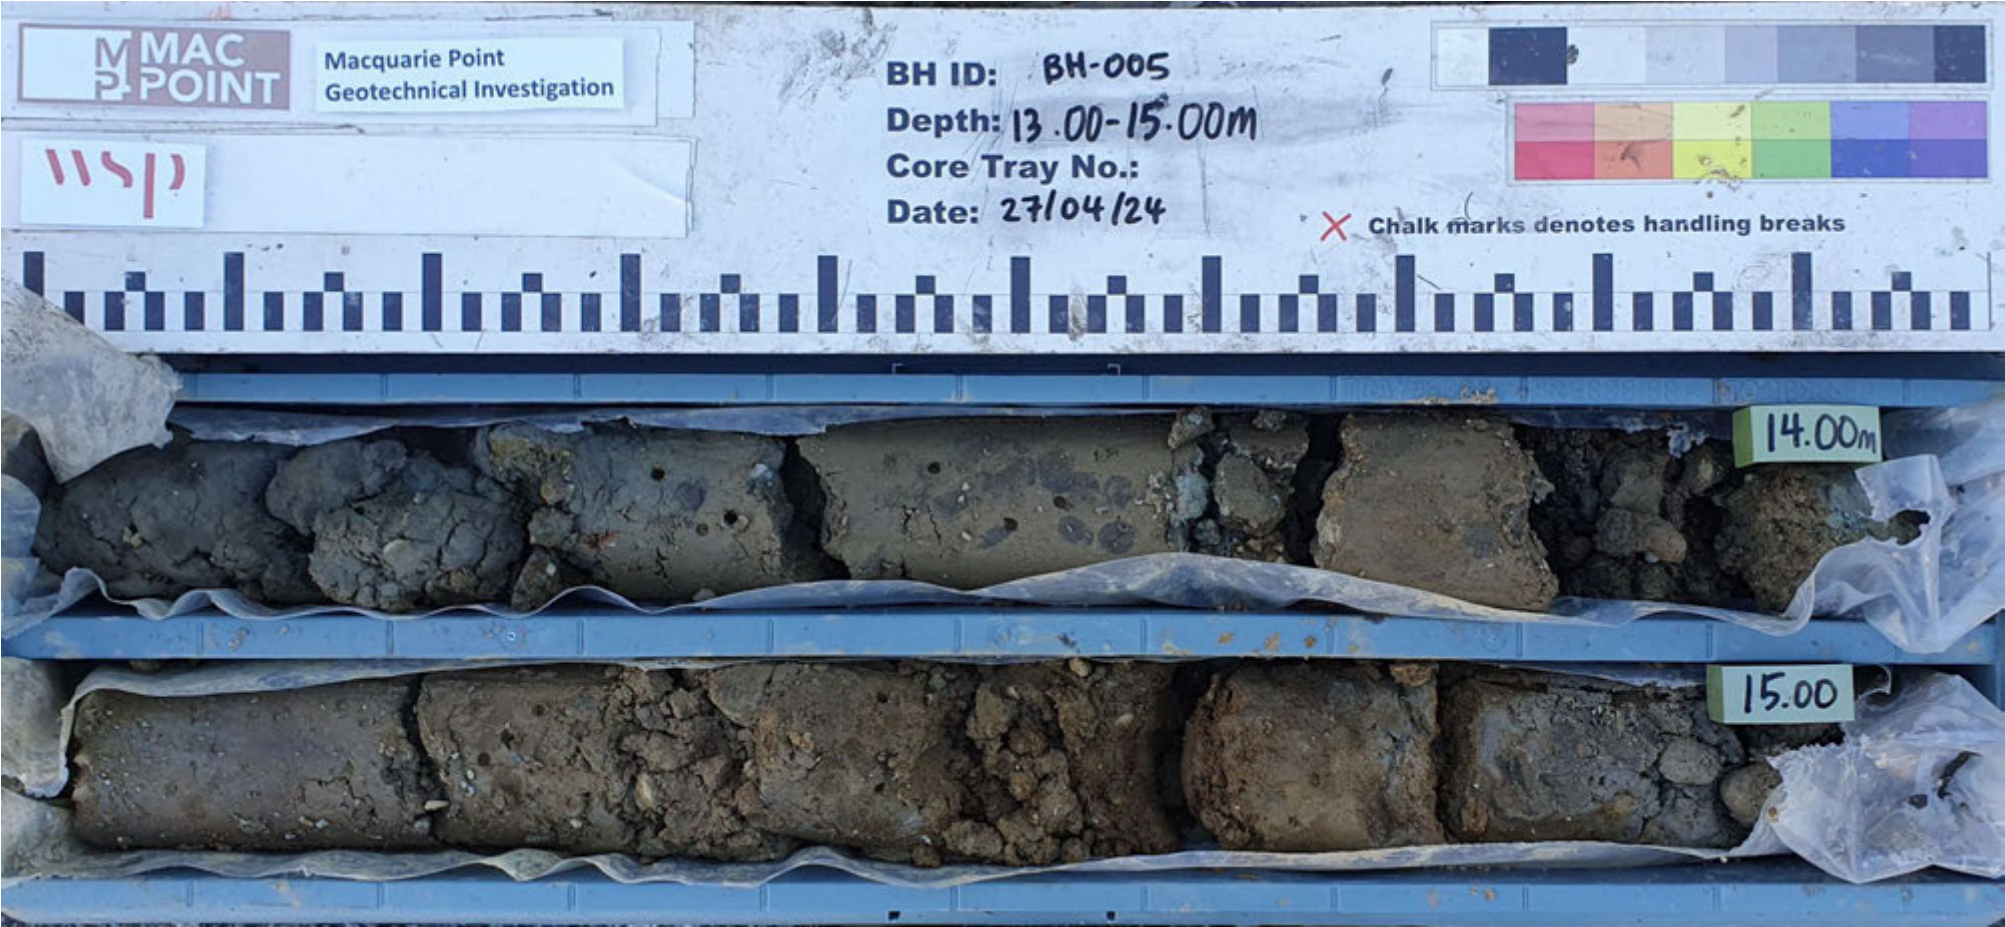
| | TITLE<br><br>MPDC<br>Macquarie Point<br>Macquarie Point GI<br>Core Photo - BH-005 | DRAWN | DATE<br>18/6/2024 |

PointID : BH-005 Depth Range: 13.00 - 15.00 m

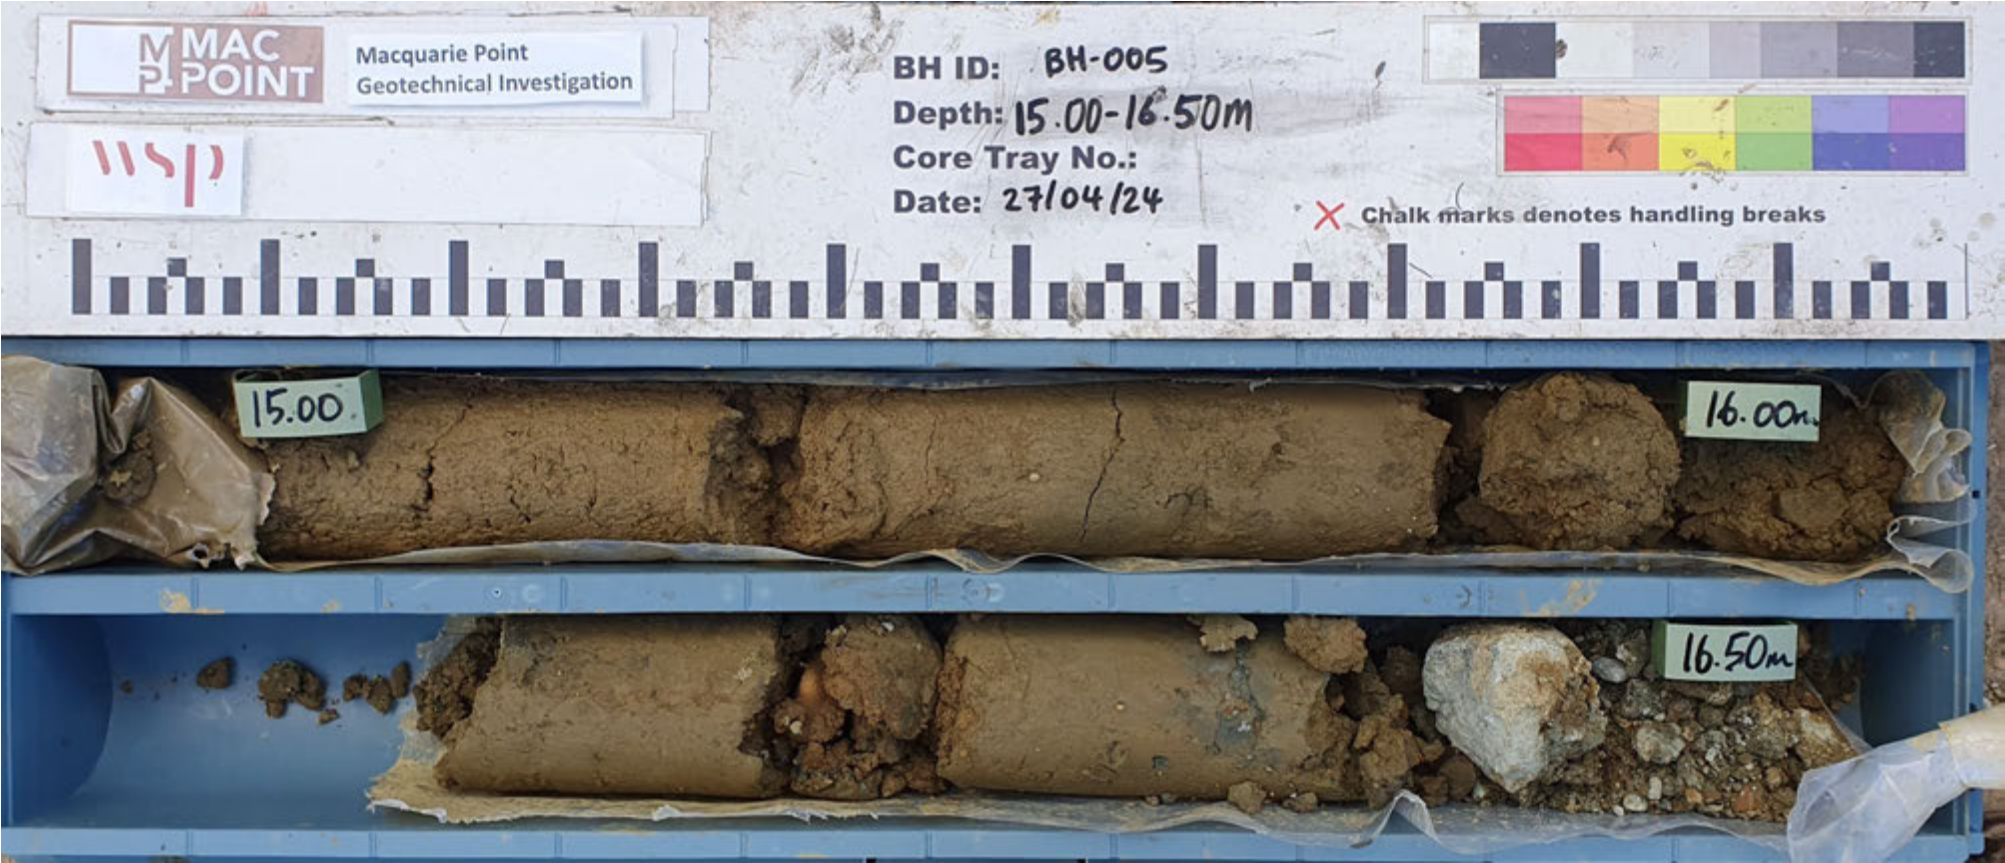
| | TITLE<br><br>MPDC<br>Macquarie Point<br>Macquarie Point GI<br>Core Photo - BH-005 | DRAWN | DATE<br>18/6/2024 |

PointID : BH-005 Depth Range: 15.00 - 16.50 m

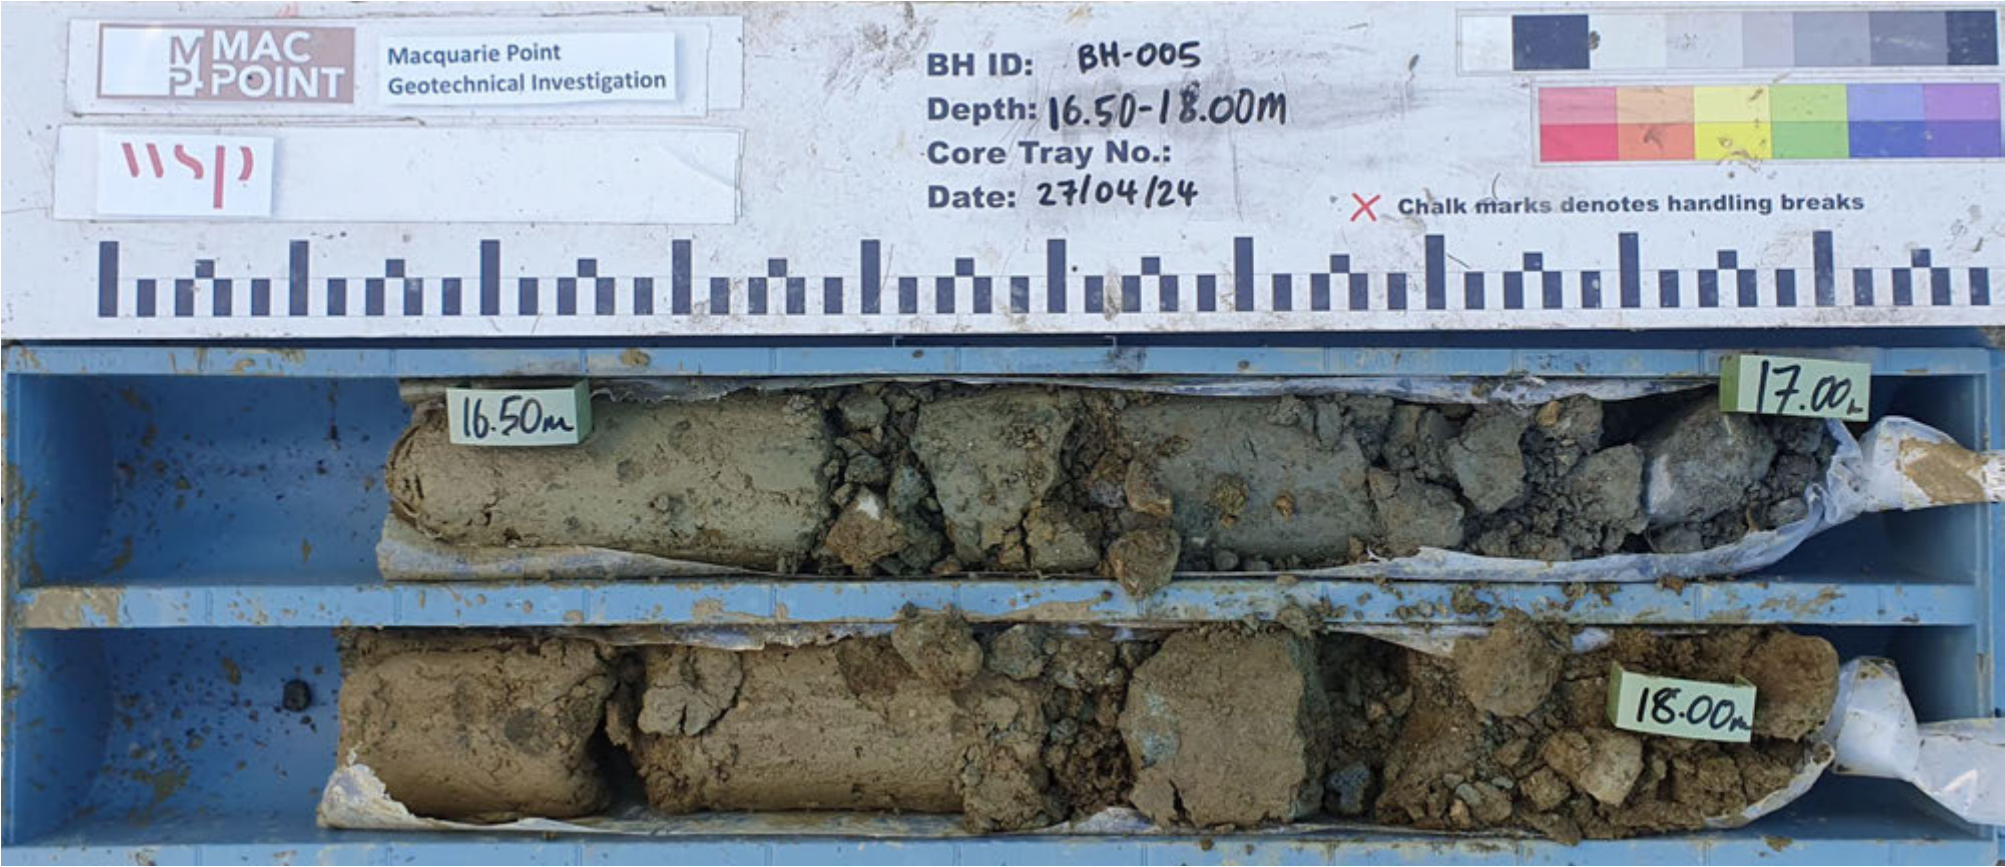
| | TITLE<br><br>MPDC<br>Macquarie Point<br>Macquarie Point GI<br>Core Photo - BH-005 | DRAWN | DATE<br>18/6/2024 | | |

PointID : BH-005 Depth Range: 16.50 - 18.00 m

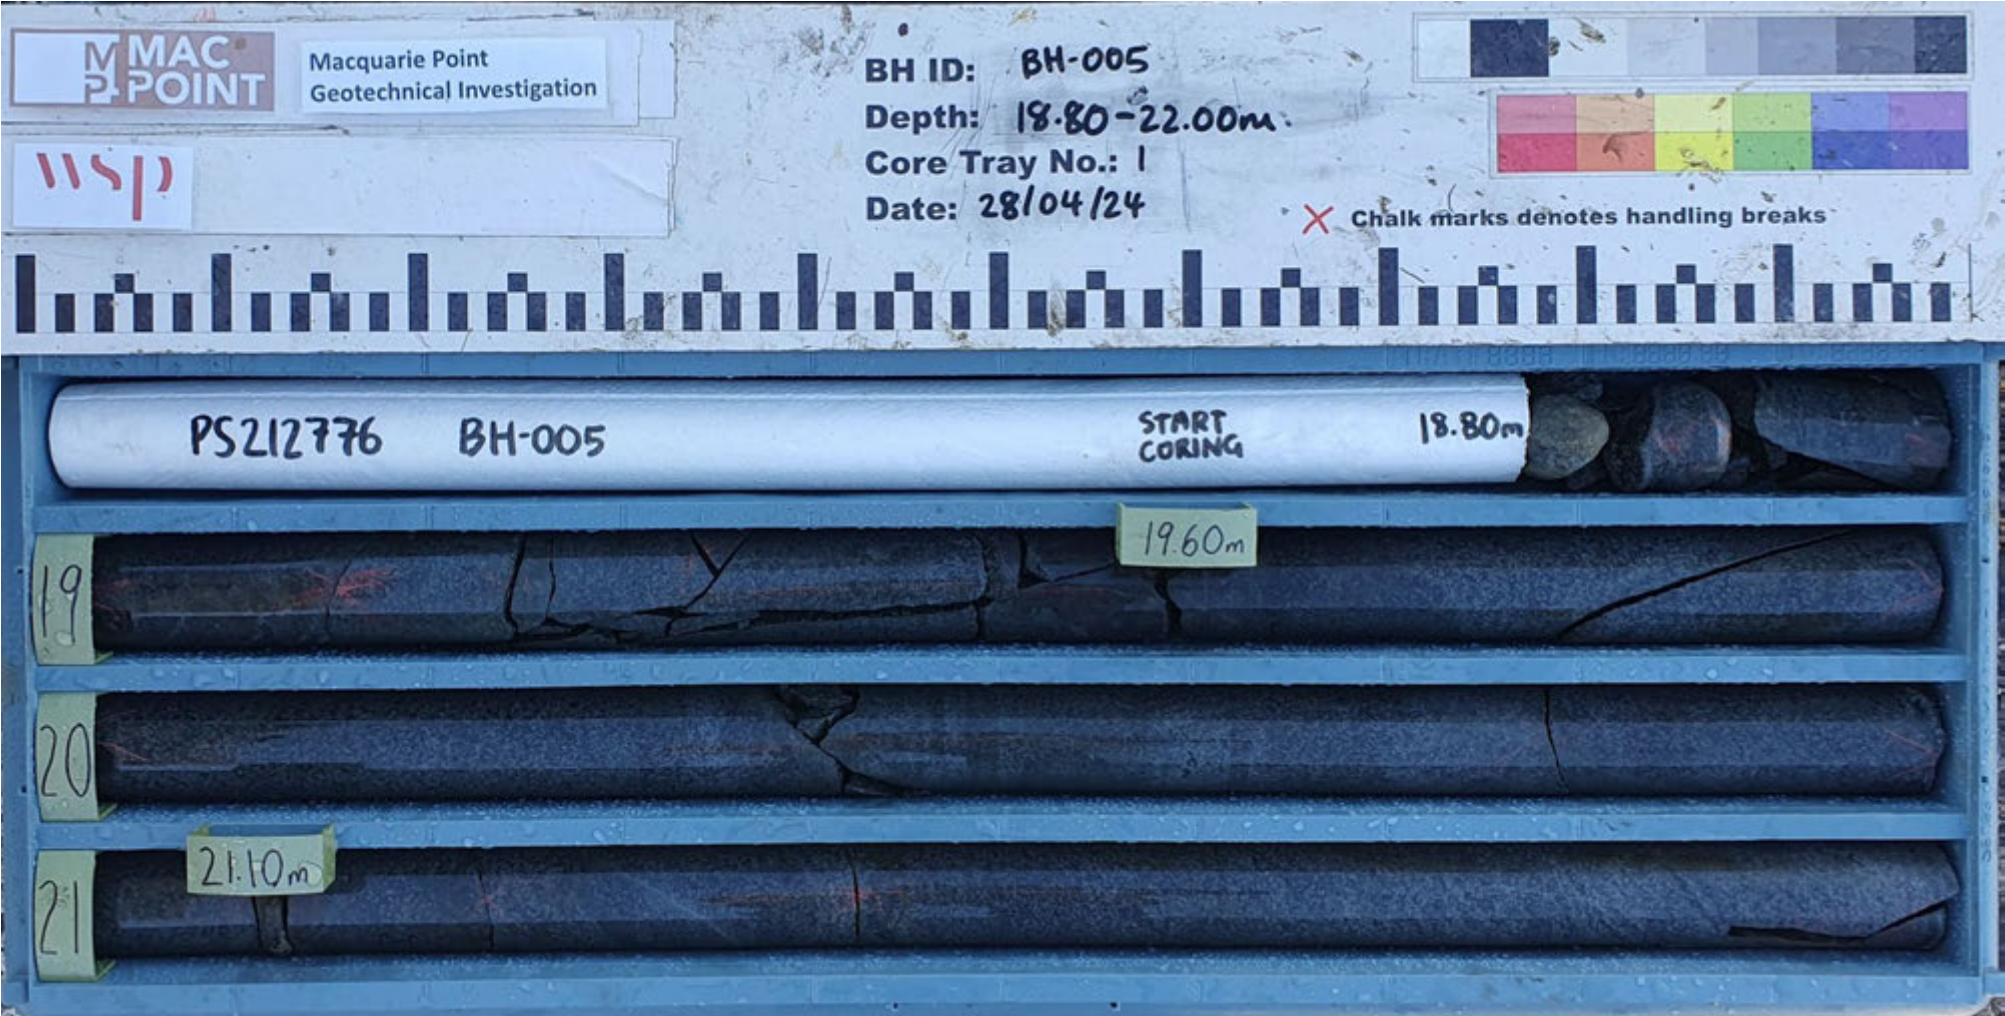
PointID : BH-005 Depth Range: 18.80 - 22.00 m

| | TITLE<br><br>MPDC<br>Macquarie Point<br>Macquarie Point GI<br>Core Photo - BH-005 | DRAWN | DATE<br>18/6/2024 |

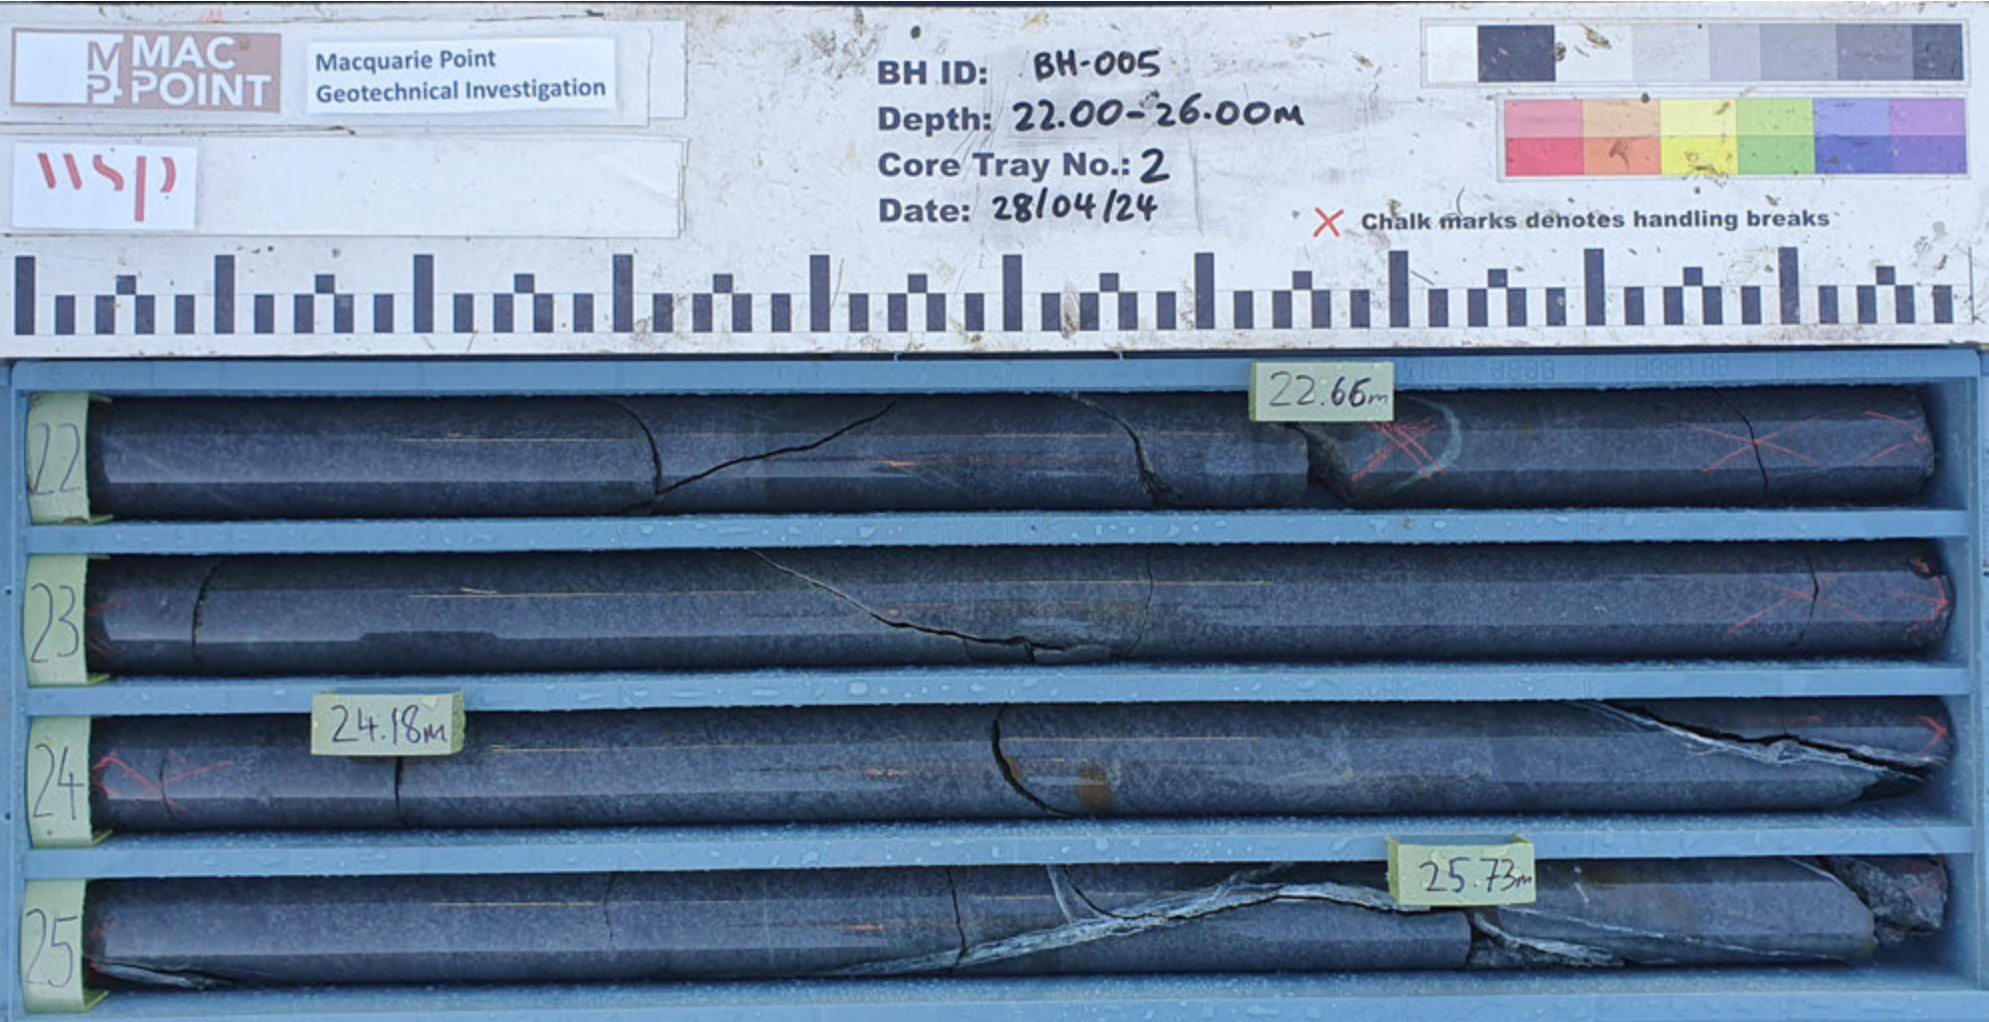
PointID : BH-005 Depth Range: 22.00 - 26.00 m

| | TITLE<br><br>MPDC<br>Macquarie Point<br>Macquarie Point GI<br>Core Photo - BH-005 | DRAWN | DATE<br>18/6/2024 |

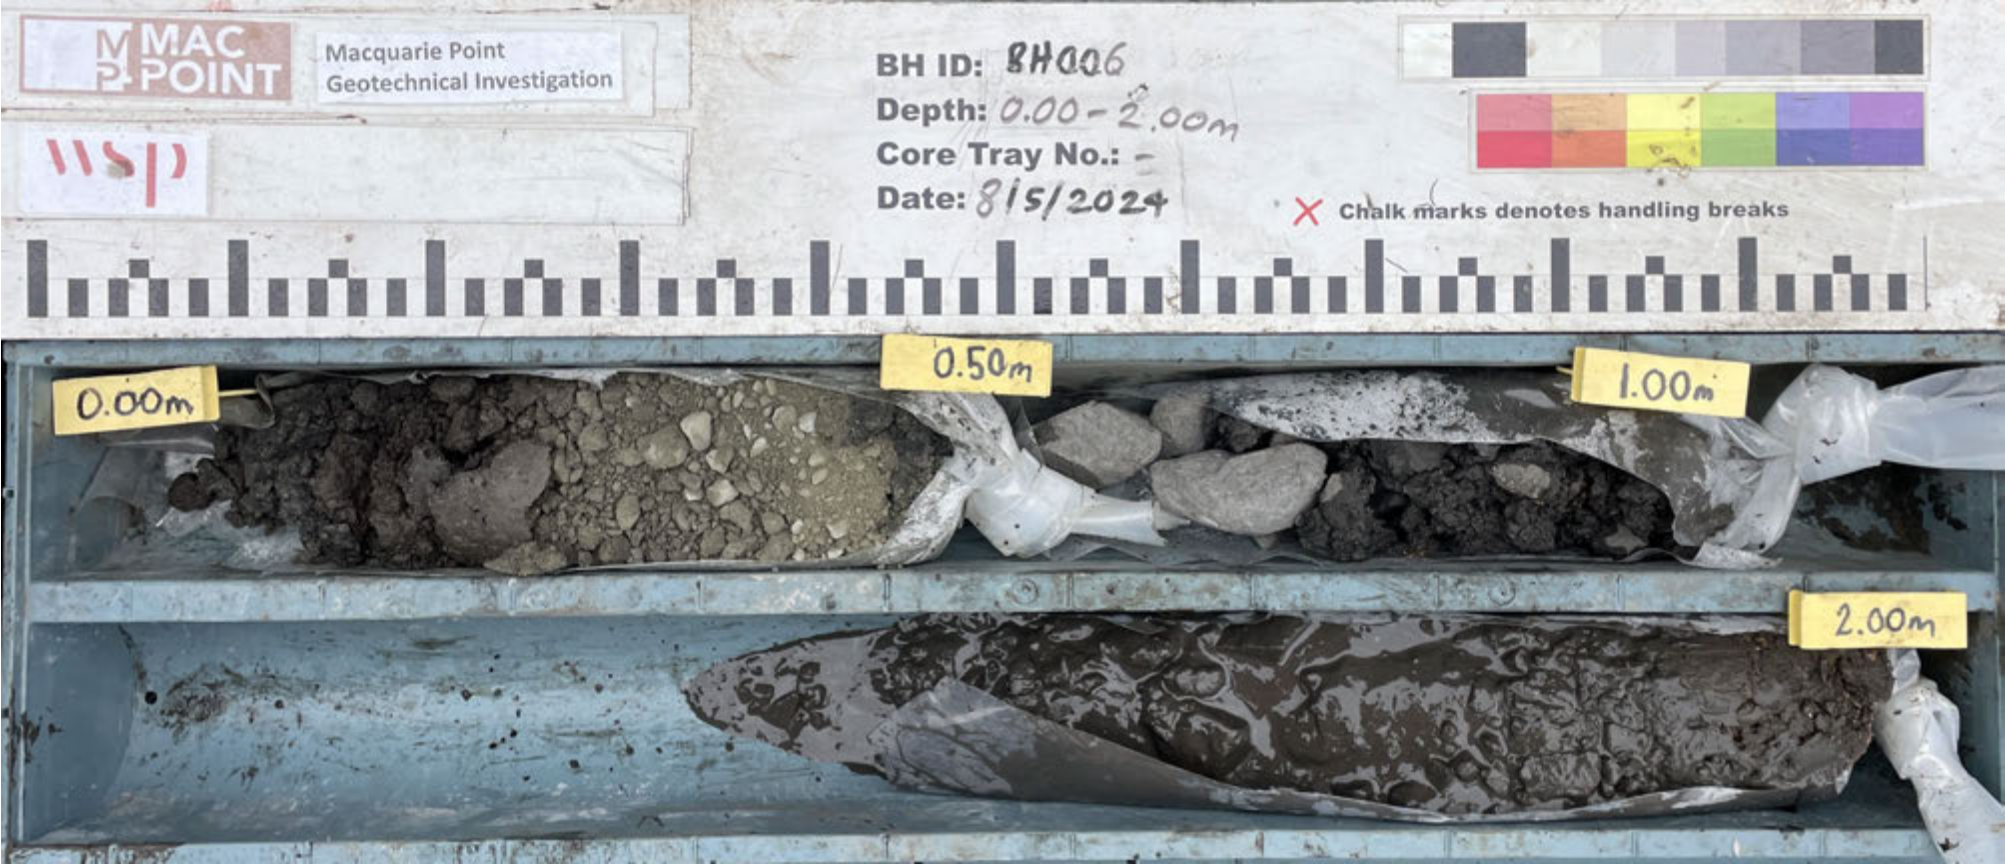
| | TITLE<br><br>MPDC<br>Macquarie Point<br>Macquarie Point GI<br>Core Photo - BH-006 | DRAWN | DATE<br>18/6/2024 |

PointID : BH-006 Depth Range: 0.00 - 2.00 m

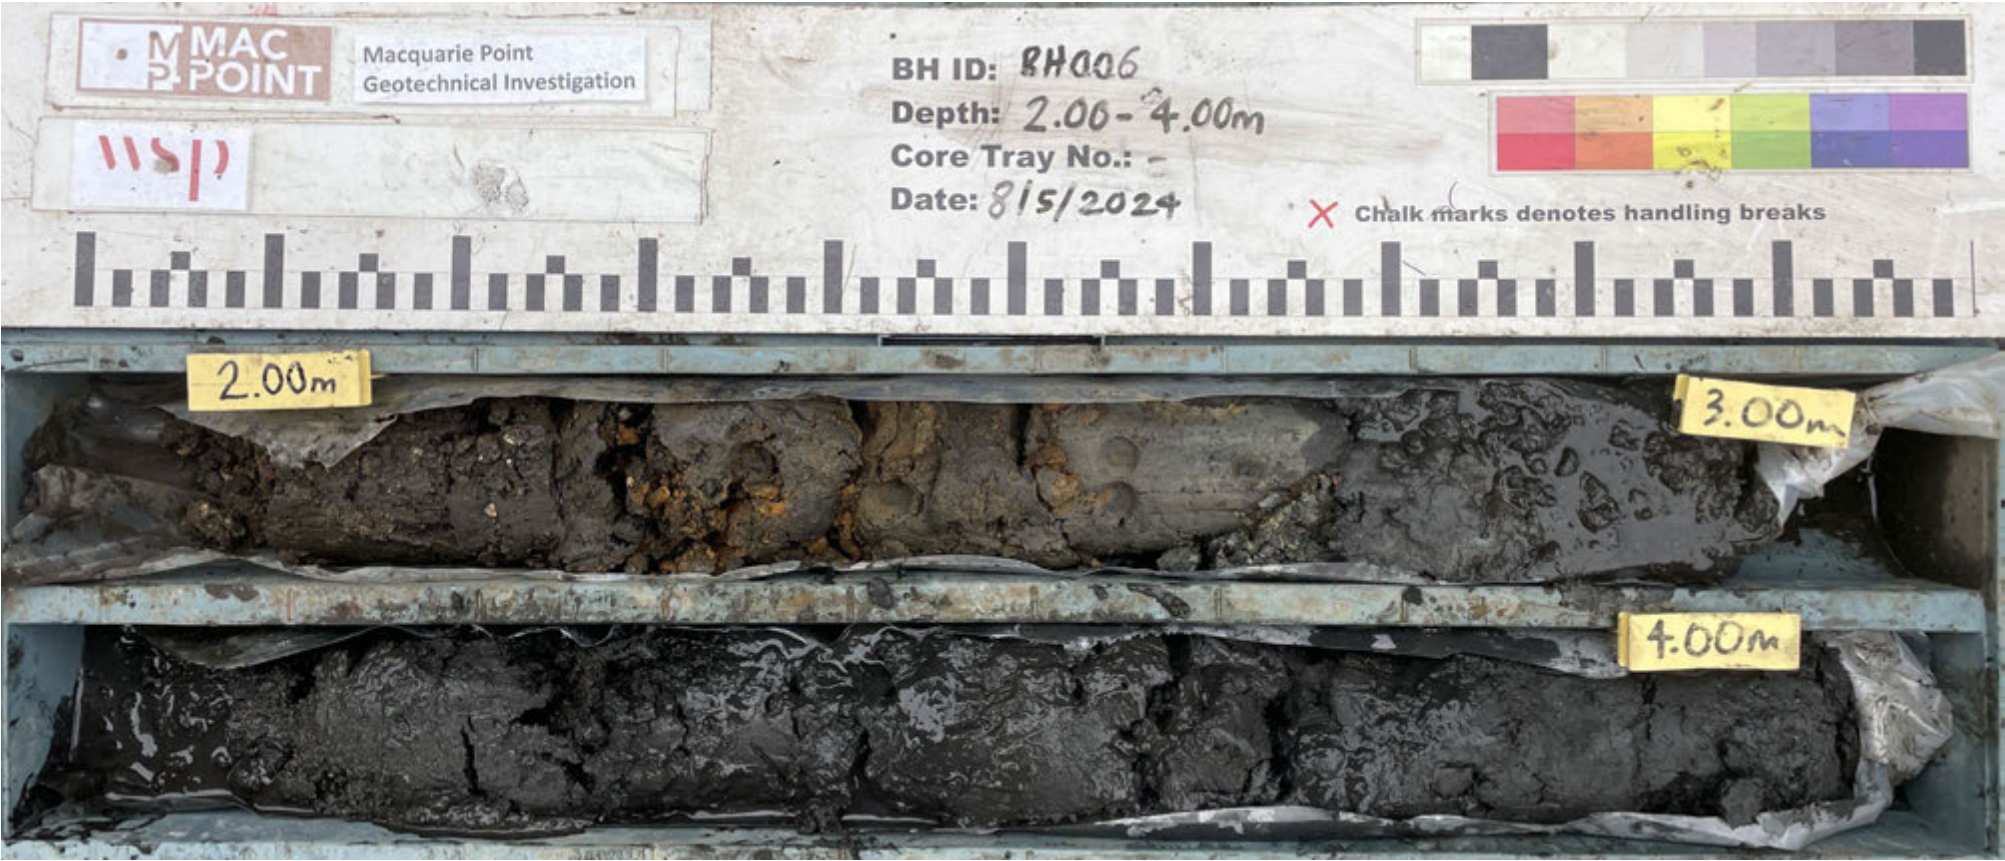
| | TITLE<br><br>MPDC<br>Macquarie Point<br>Macquarie Point GI<br>Core Photo - BH-006 | DRAWN | DATE<br>18/6/2024 |

PointID : BH-006 Depth Range: 2.00 - 4.00 m

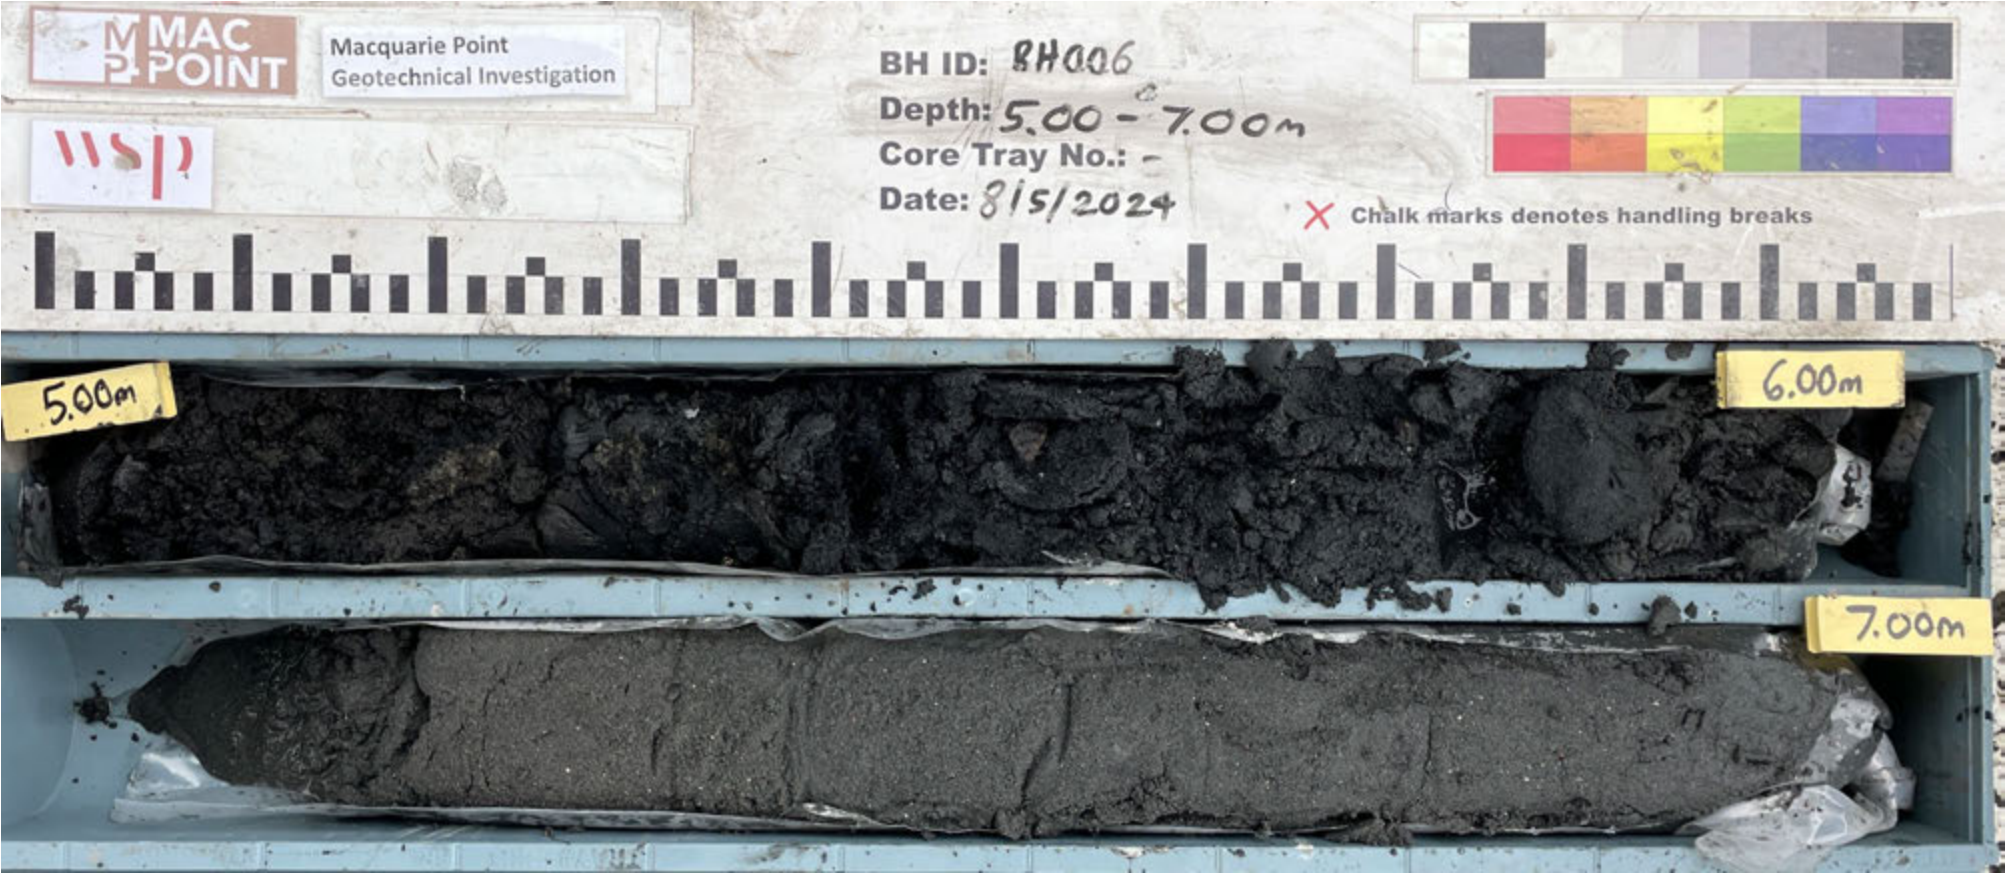
PointID : BH-006 Depth Range: 5.00 - 7.00 m

| | TITLE<br><br>MPDC<br>Macquarie Point<br>Macquarie Point GI<br>Core Photo - BH-006 | DRAWN | DATE<br>18/6/2024 |

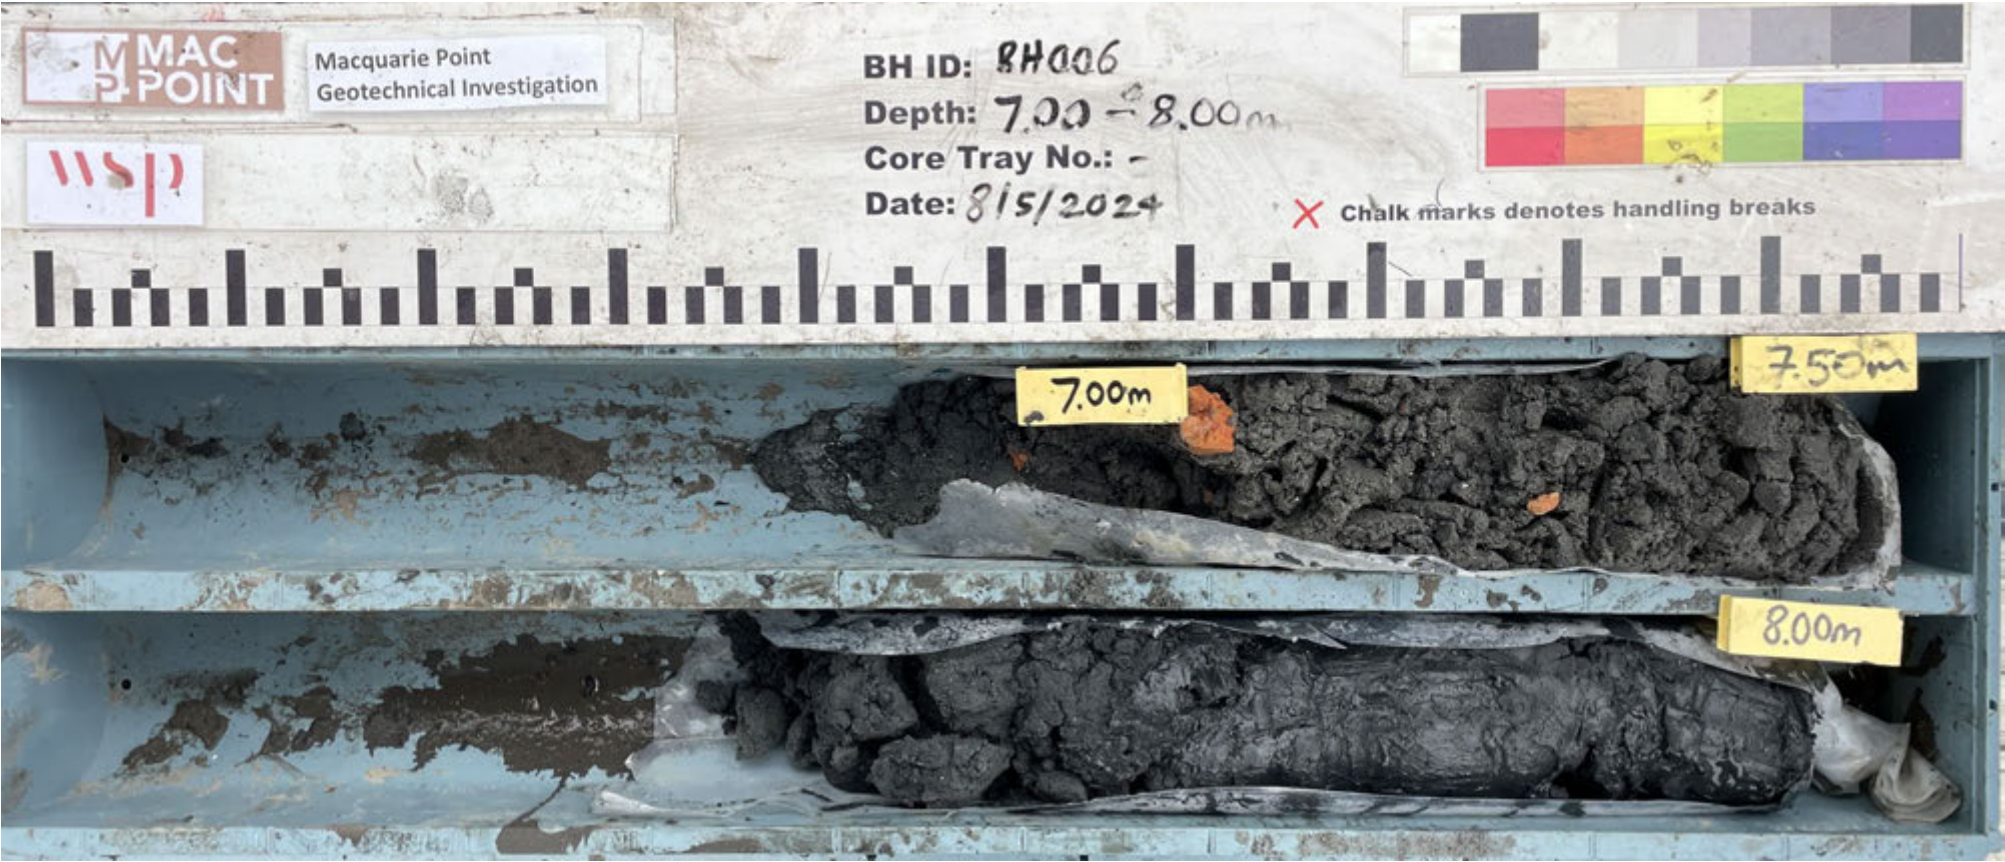
PointID : BH-006 Depth Range: 7.00 - 8.00 m

| | TITLE<br><br>MPDC<br>Macquarie Point<br>Macquarie Point GI<br>Core Photo - BH-006 | DRAWN | DATE<br>18/6/2024 |

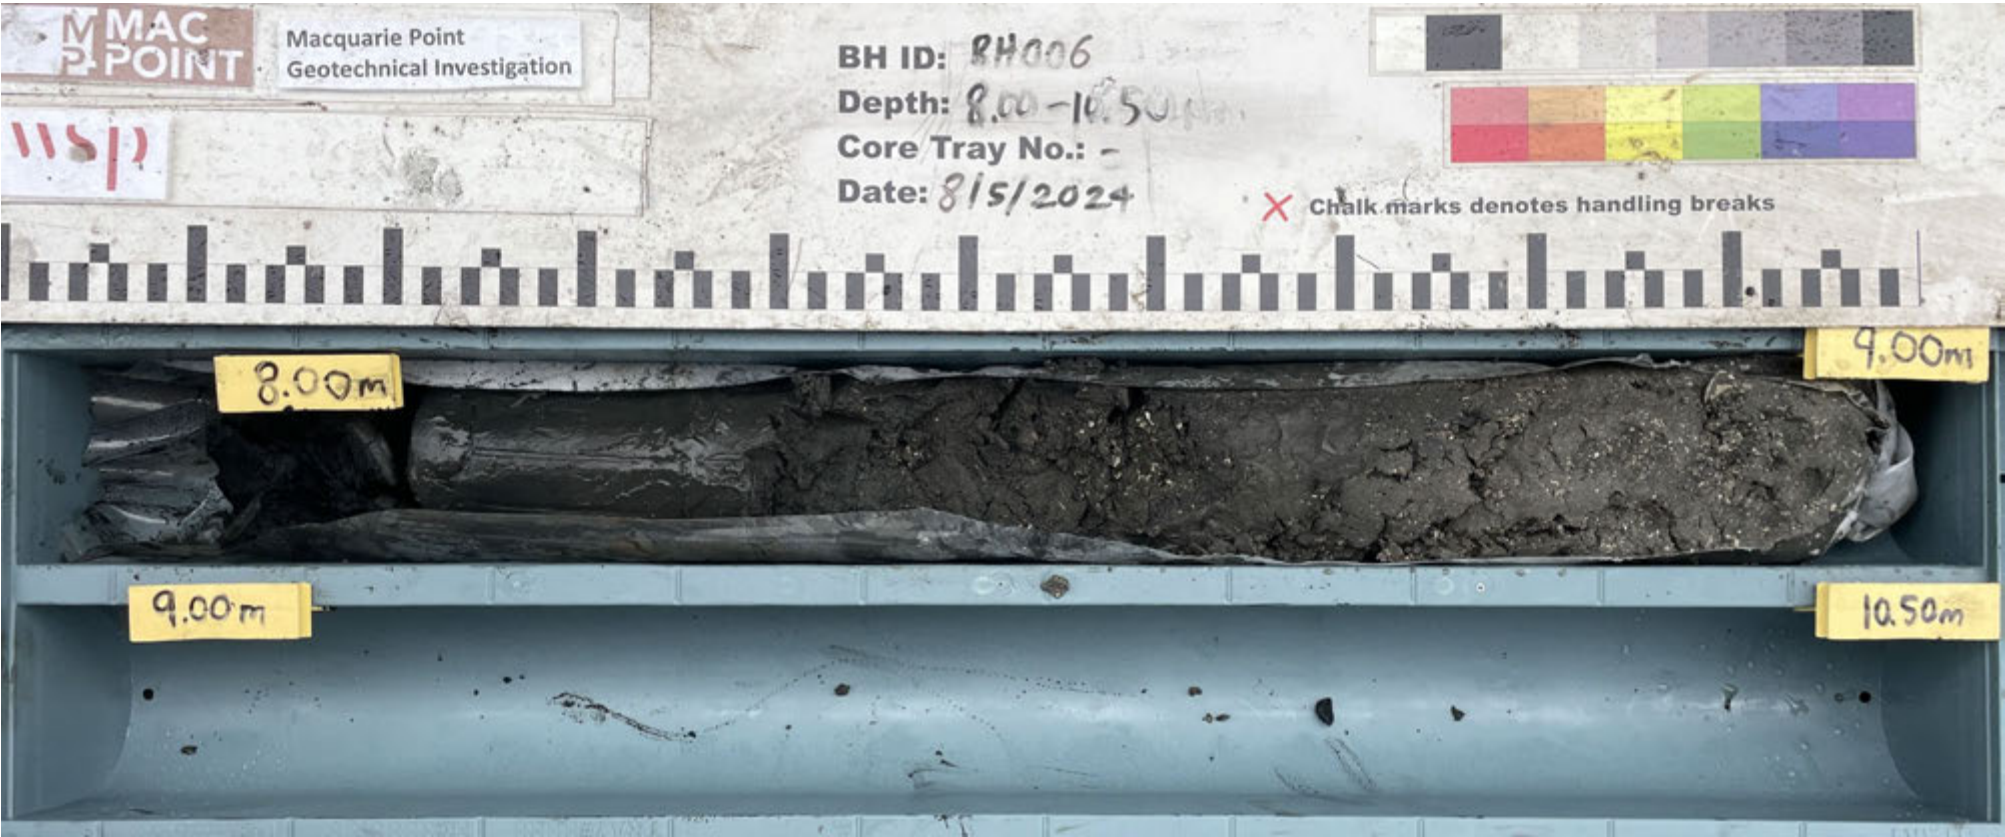
PointID : BH-006 Depth Range: 8.00 - 10.50 m

| | TITLE<br><br>MPDC<br>Macquarie Point<br>Macquarie Point GI<br>Core Photo - BH-006 | DRAWN | DATE<br>18/6/2024 | |

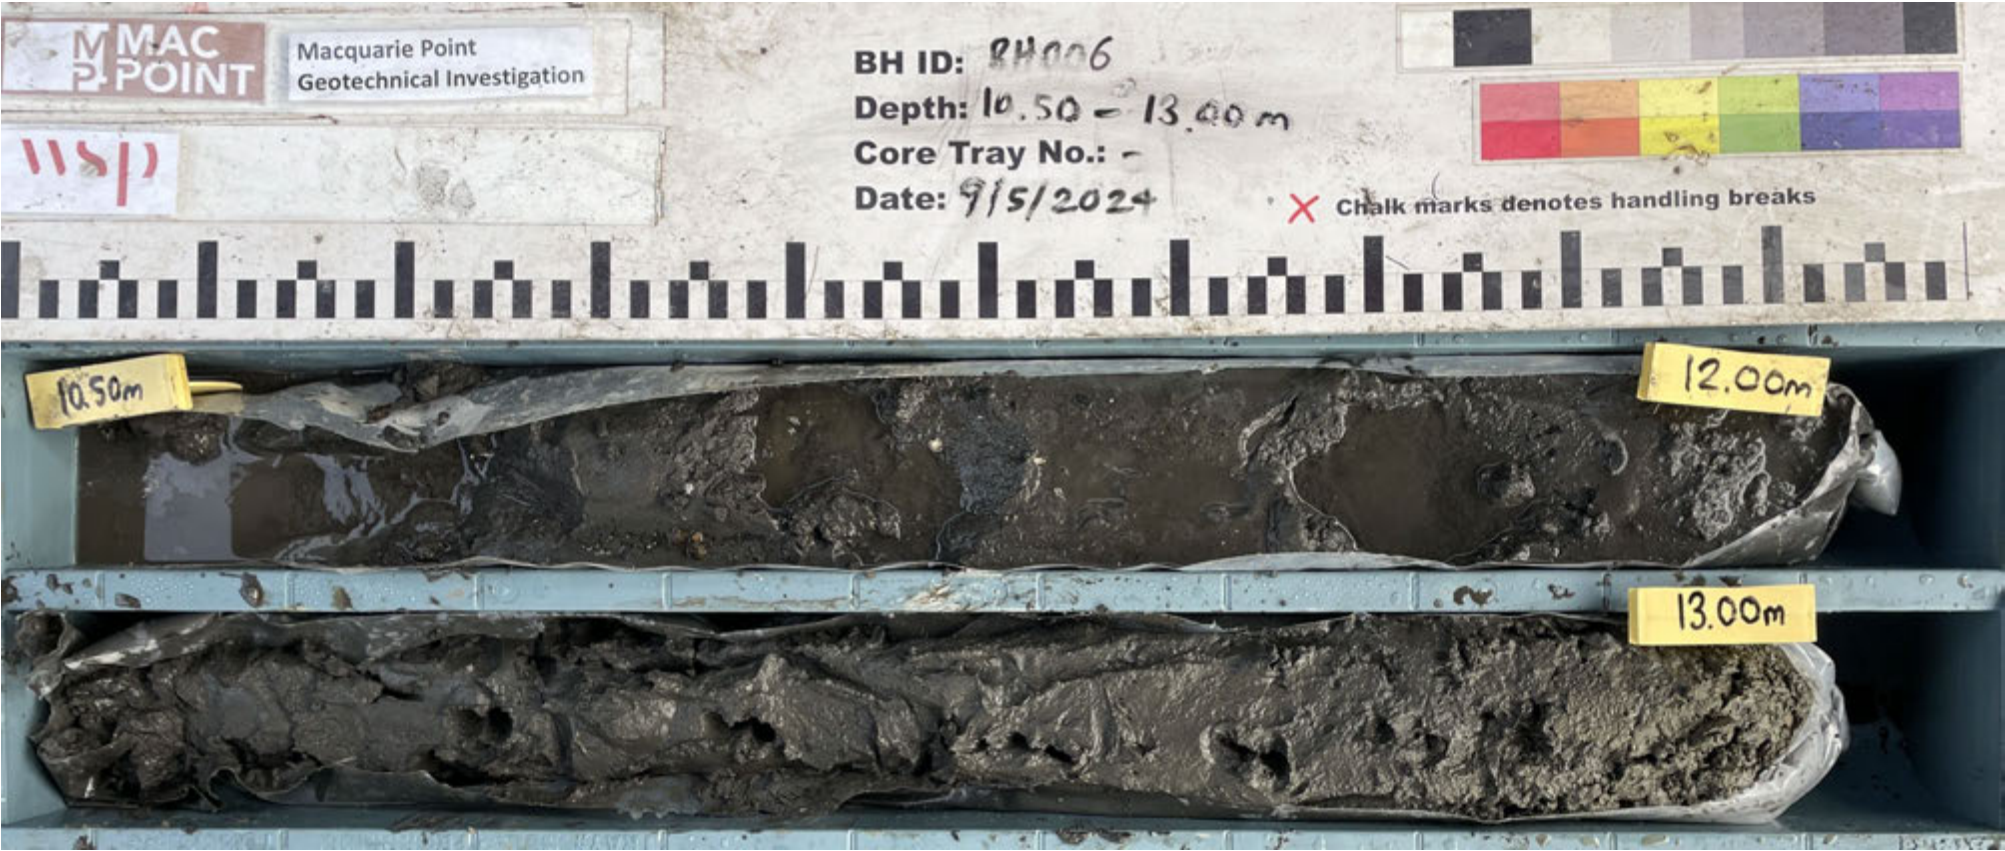
PointID : BH-006 Depth Range: 10.50 - 13.00 m

| | TITLE<br><br>MPDC<br>Macquarie Point<br>Macquarie Point GI<br>Core Photo - BH-006 | DRAWN | DATE<br>18/6/2024 |

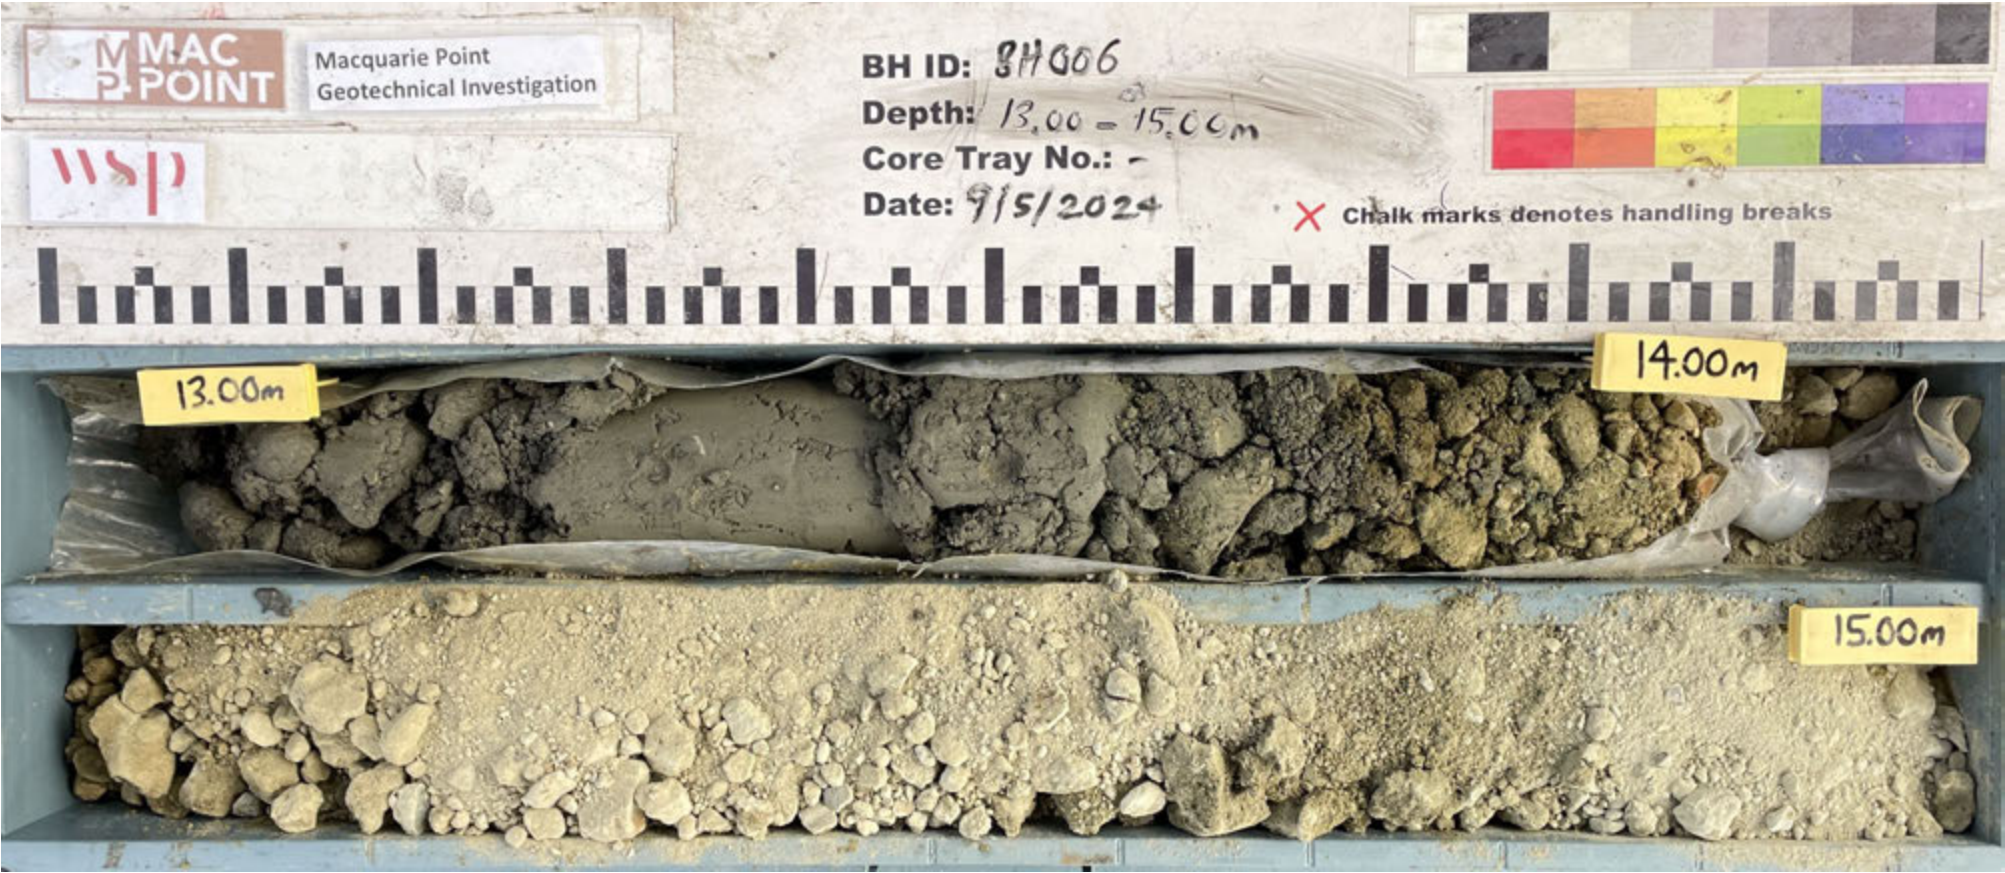
PointID : BH-006 Depth Range: 13.00 - 15.00 m

| | TITLE<br><br>MPDC<br>Macquarie Point<br>Macquarie Point GI<br>Core Photo - BH-006 | DRAWN | DATE<br>18/6/2024 |

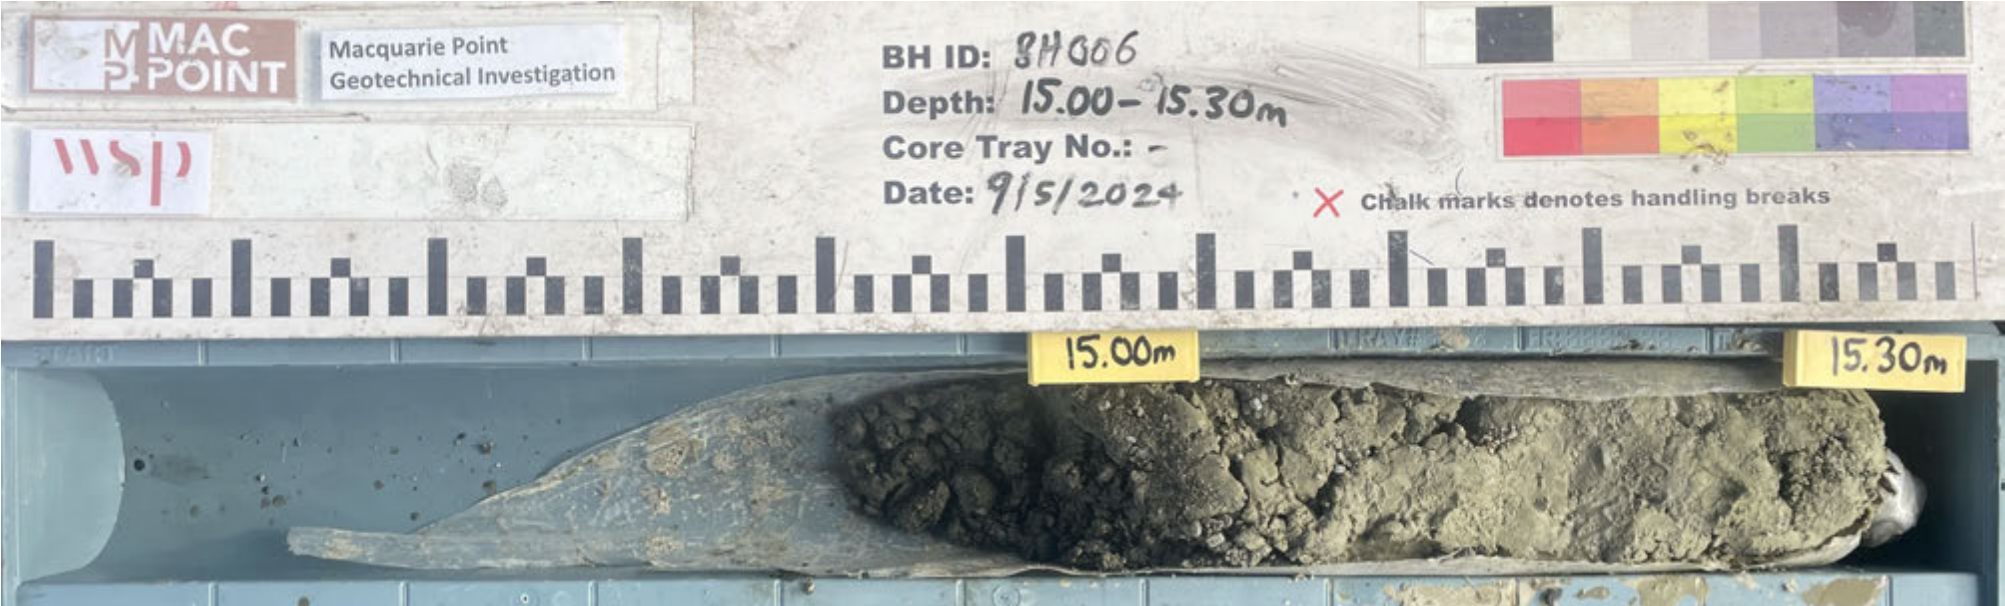
PointID : BH-006 Depth Range: 15.00 - 15.30 m

| | TITLE<br><br>MPDC<br>Macquarie Point<br>Macquarie Point GI<br>Core Photo - BH-006 | DRAWN | DATE<br>18/6/2024 |
