# Macquarie Point Stadium Development

## Geotechnical Factual Report

June 2024

## Macquarie Point Stadium Development Geotechnical Factual Report

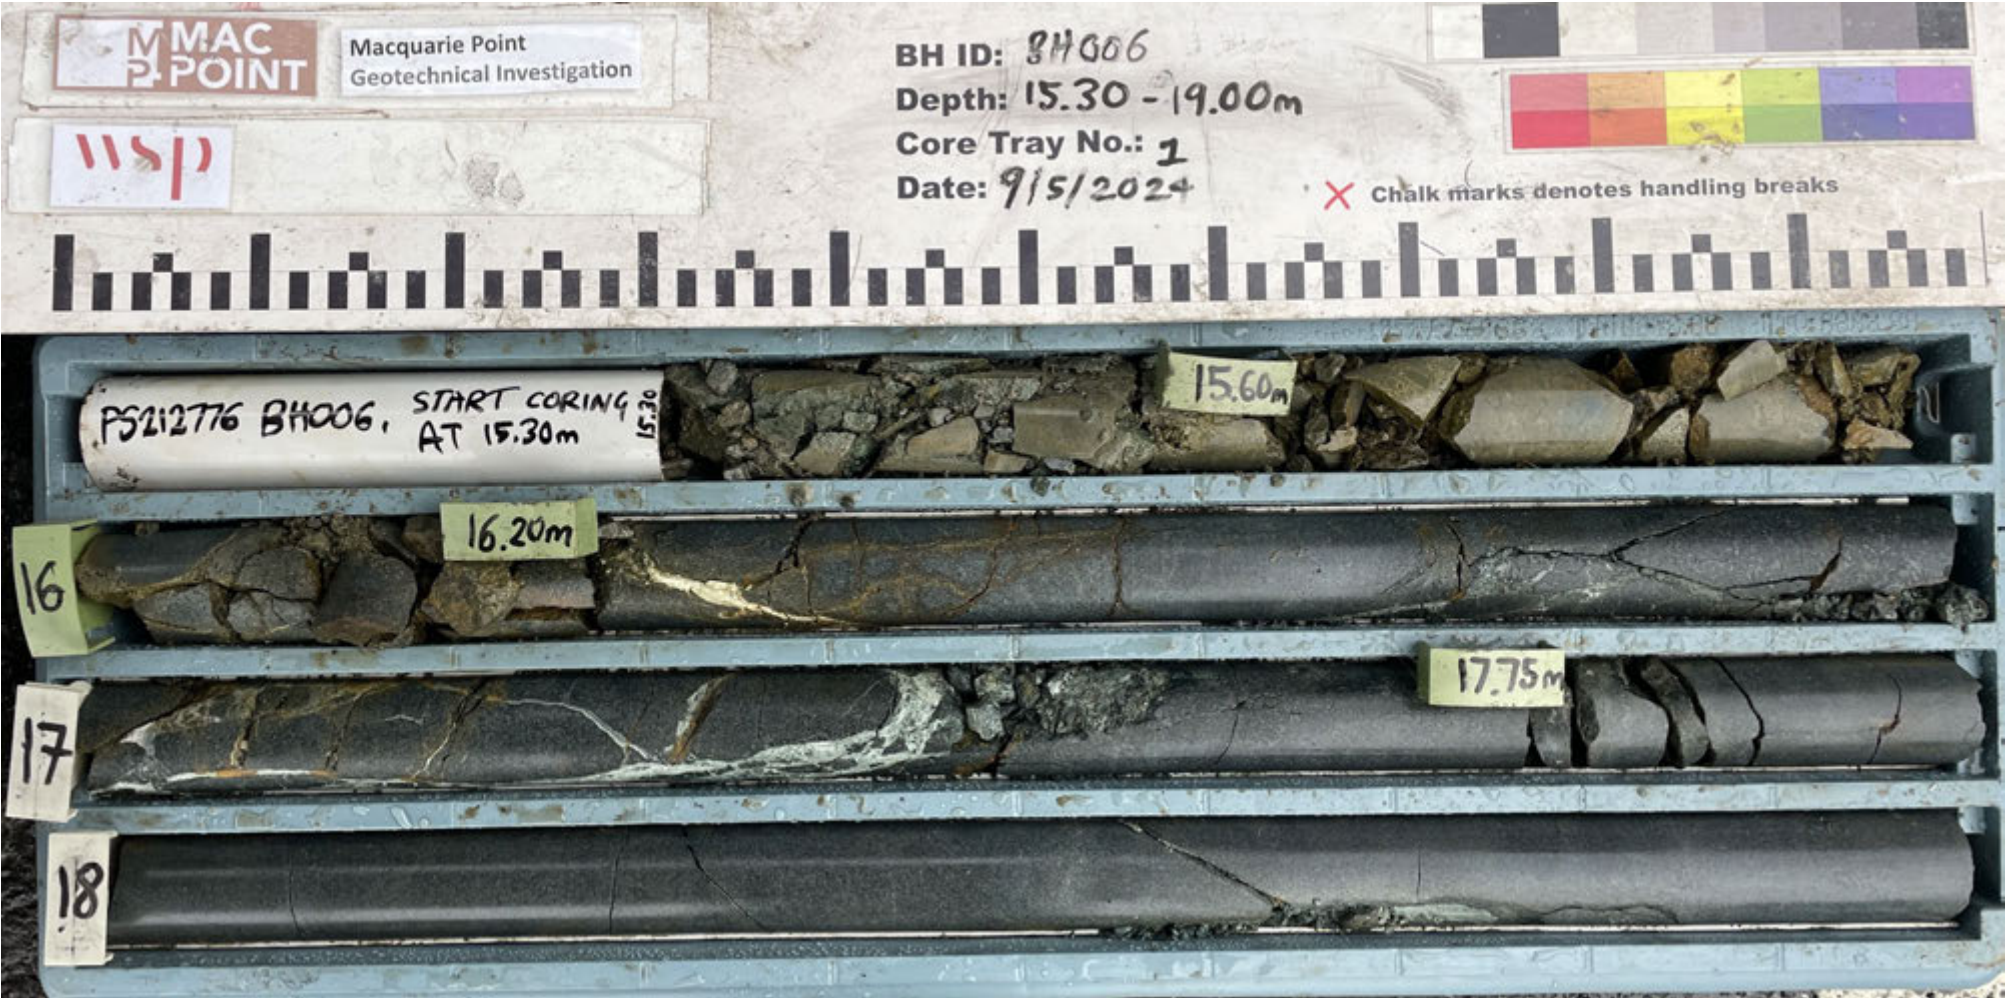
PointID : BH-006 Depth Range: 15.30 - 19.00 m

| | TITLE<br><br>MPDC<br>Macquarie Point<br>Macquarie Point GI<br>Core Photo - BH-006 | DRAWN | DATE<br>18/6/2024 |

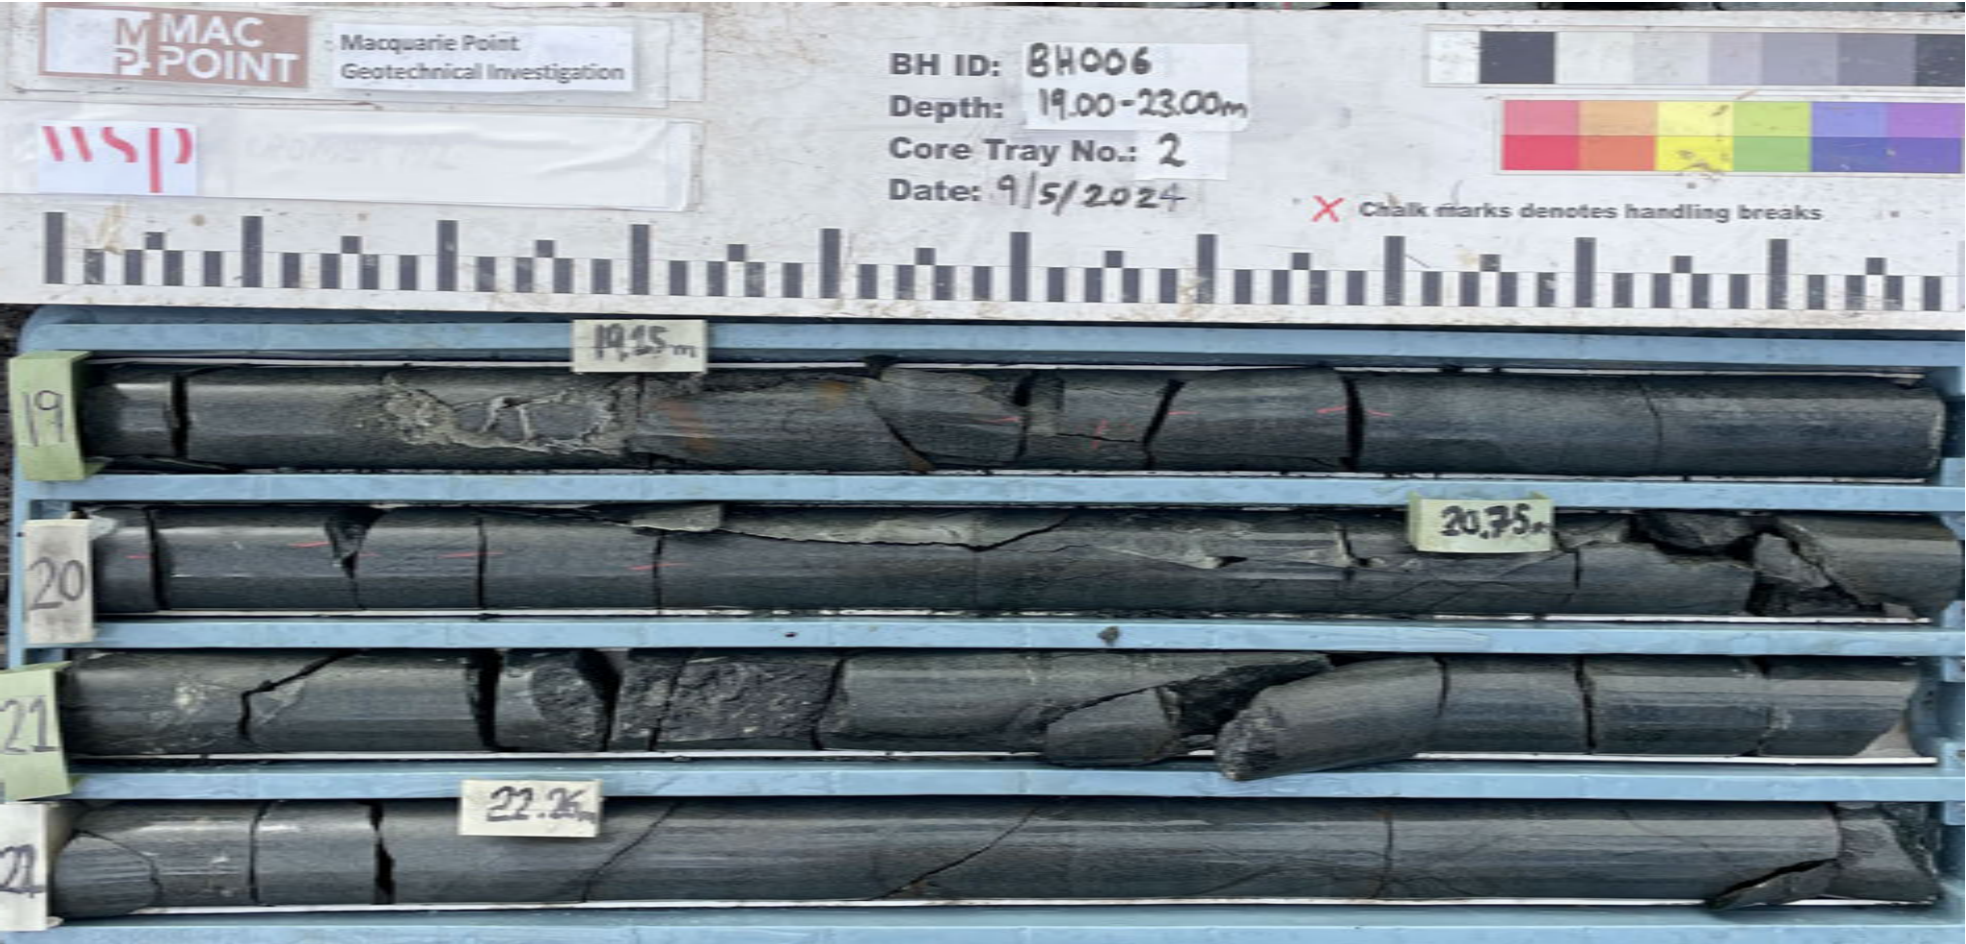
PointID : BH-006 Depth Range: 19.00 - 23.00 m

| | TITLE<br><br>MPDC<br>Macquarie Point<br>Macquarie Point GI<br>Core Photo - BH-006 | DRAWN | DATE<br>18/6/2024 |

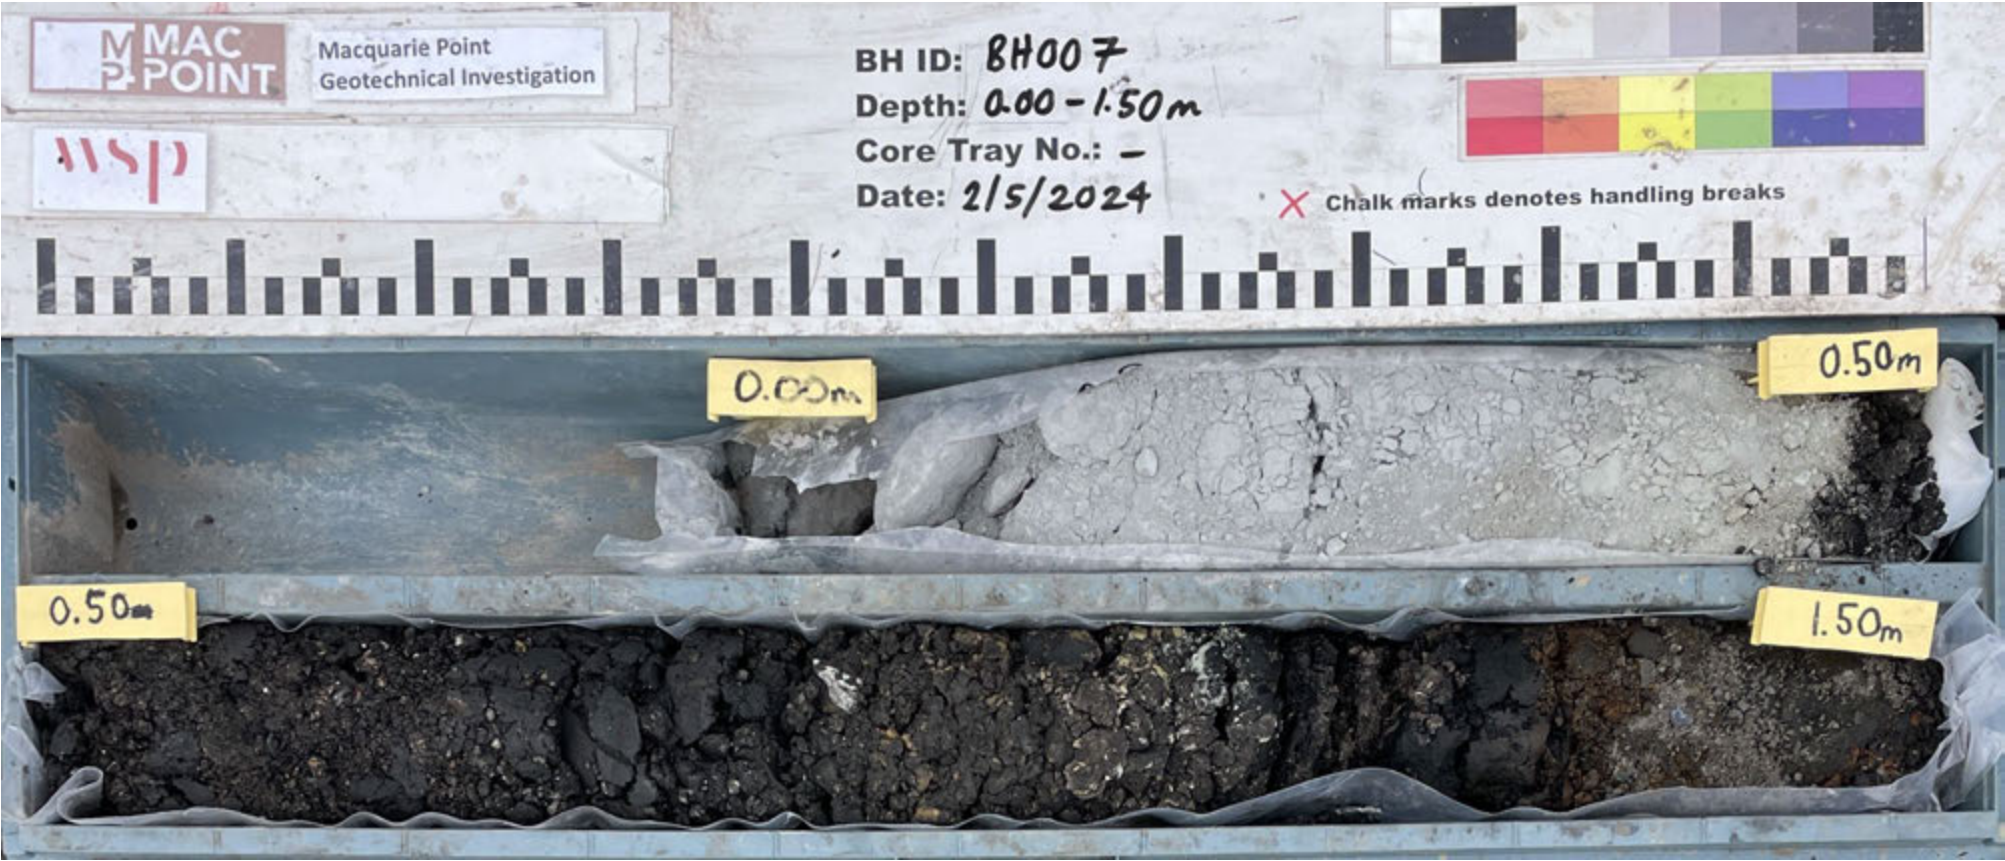
PointID : BH-007 Depth Range: 0.00 - 1.50 m

| | TITLE<br><br>MPDC<br>Macquarie Point<br>Macquarie Point GI<br>Core Photo - BH-007 | DRAWN | DATE<br>18/6/2024 |

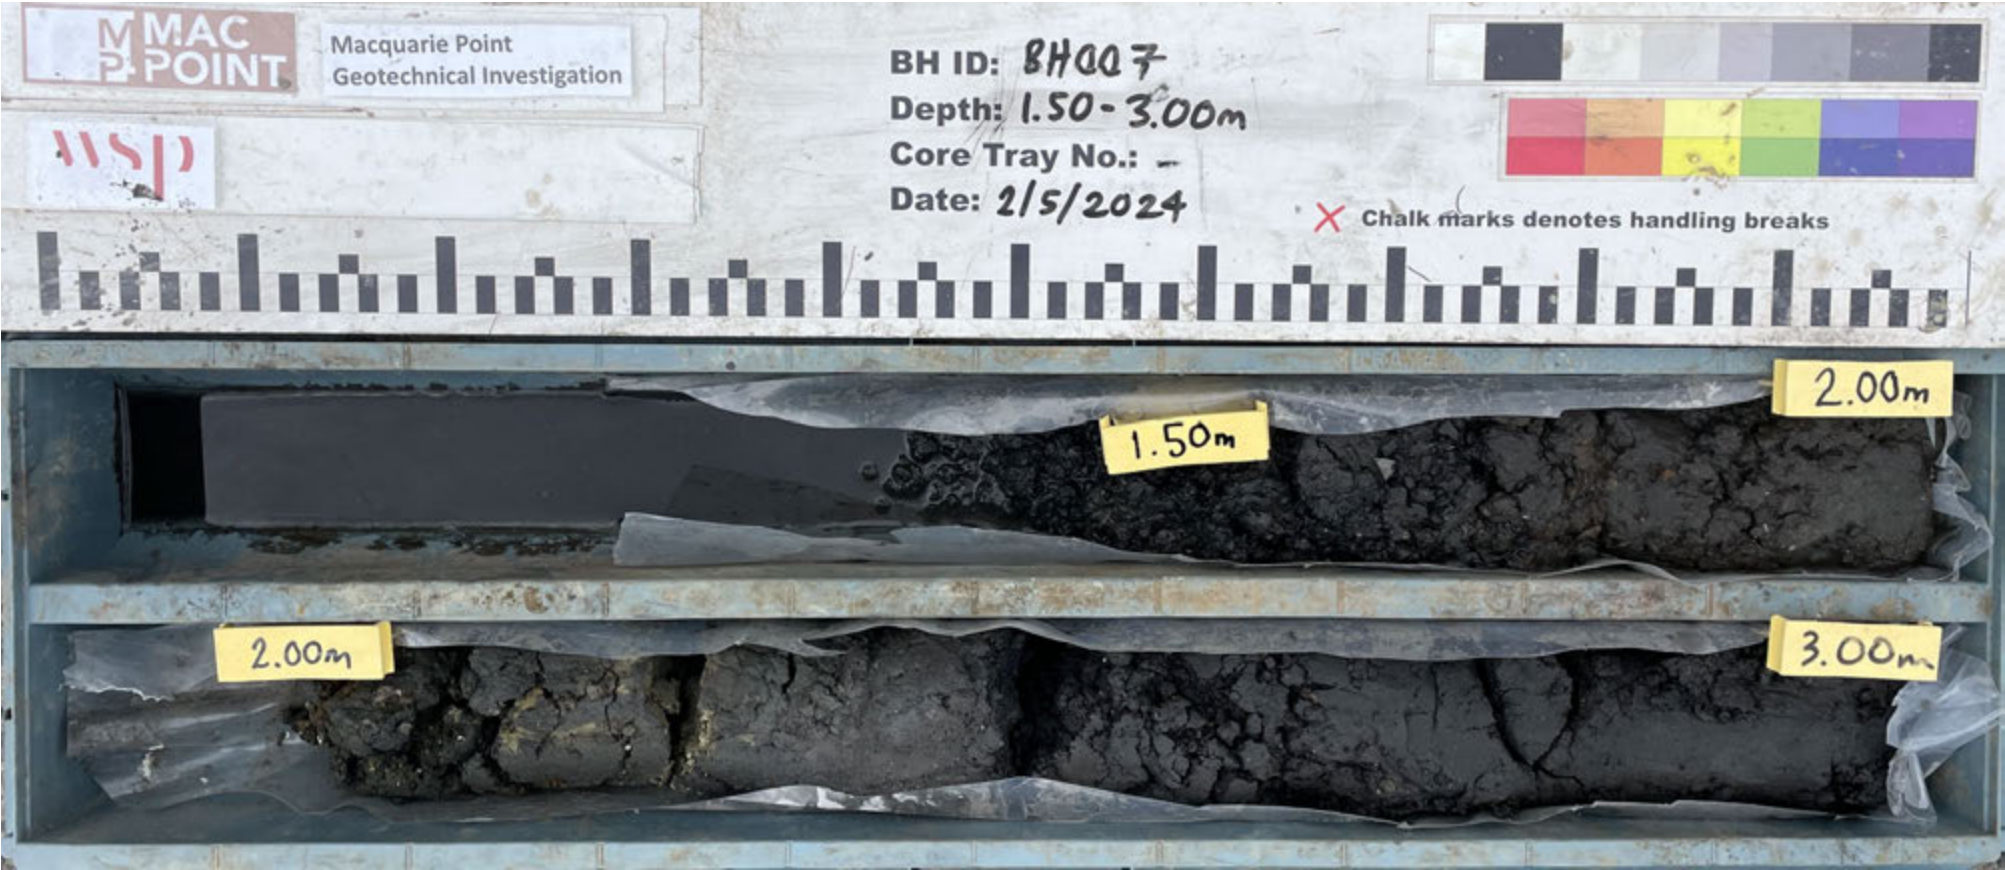
PointID : BH-007 Depth Range: 1.50 - 3.00 m

| | TITLE<br><br>MPDC<br>Macquarie Point<br>Macquarie Point GI<br>Core Photo - BH-007 | DRAWN | DATE<br>18/6/2024 |

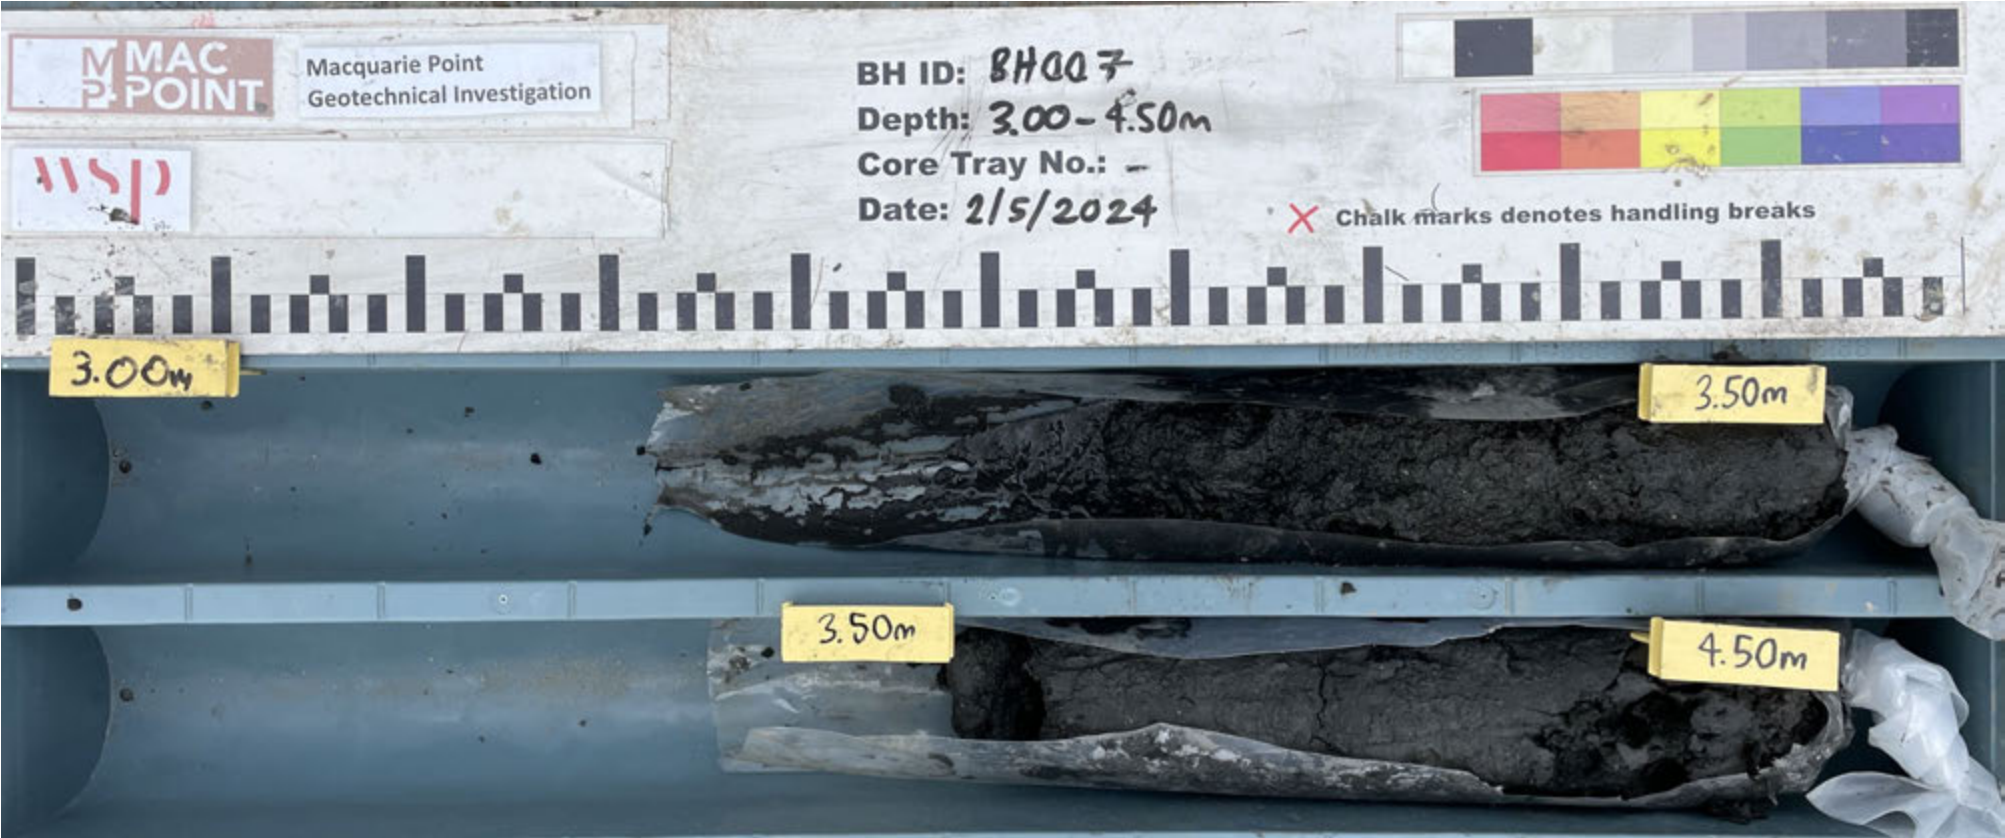
PointID : BH-007 Depth Range: 3.00 - 4.50 m

| | TITLE<br><br>MPDC<br>Macquarie Point<br>Macquarie Point GI<br>Core Photo - BH-007 | DRAWN | DATE<br>18/6/2024 |

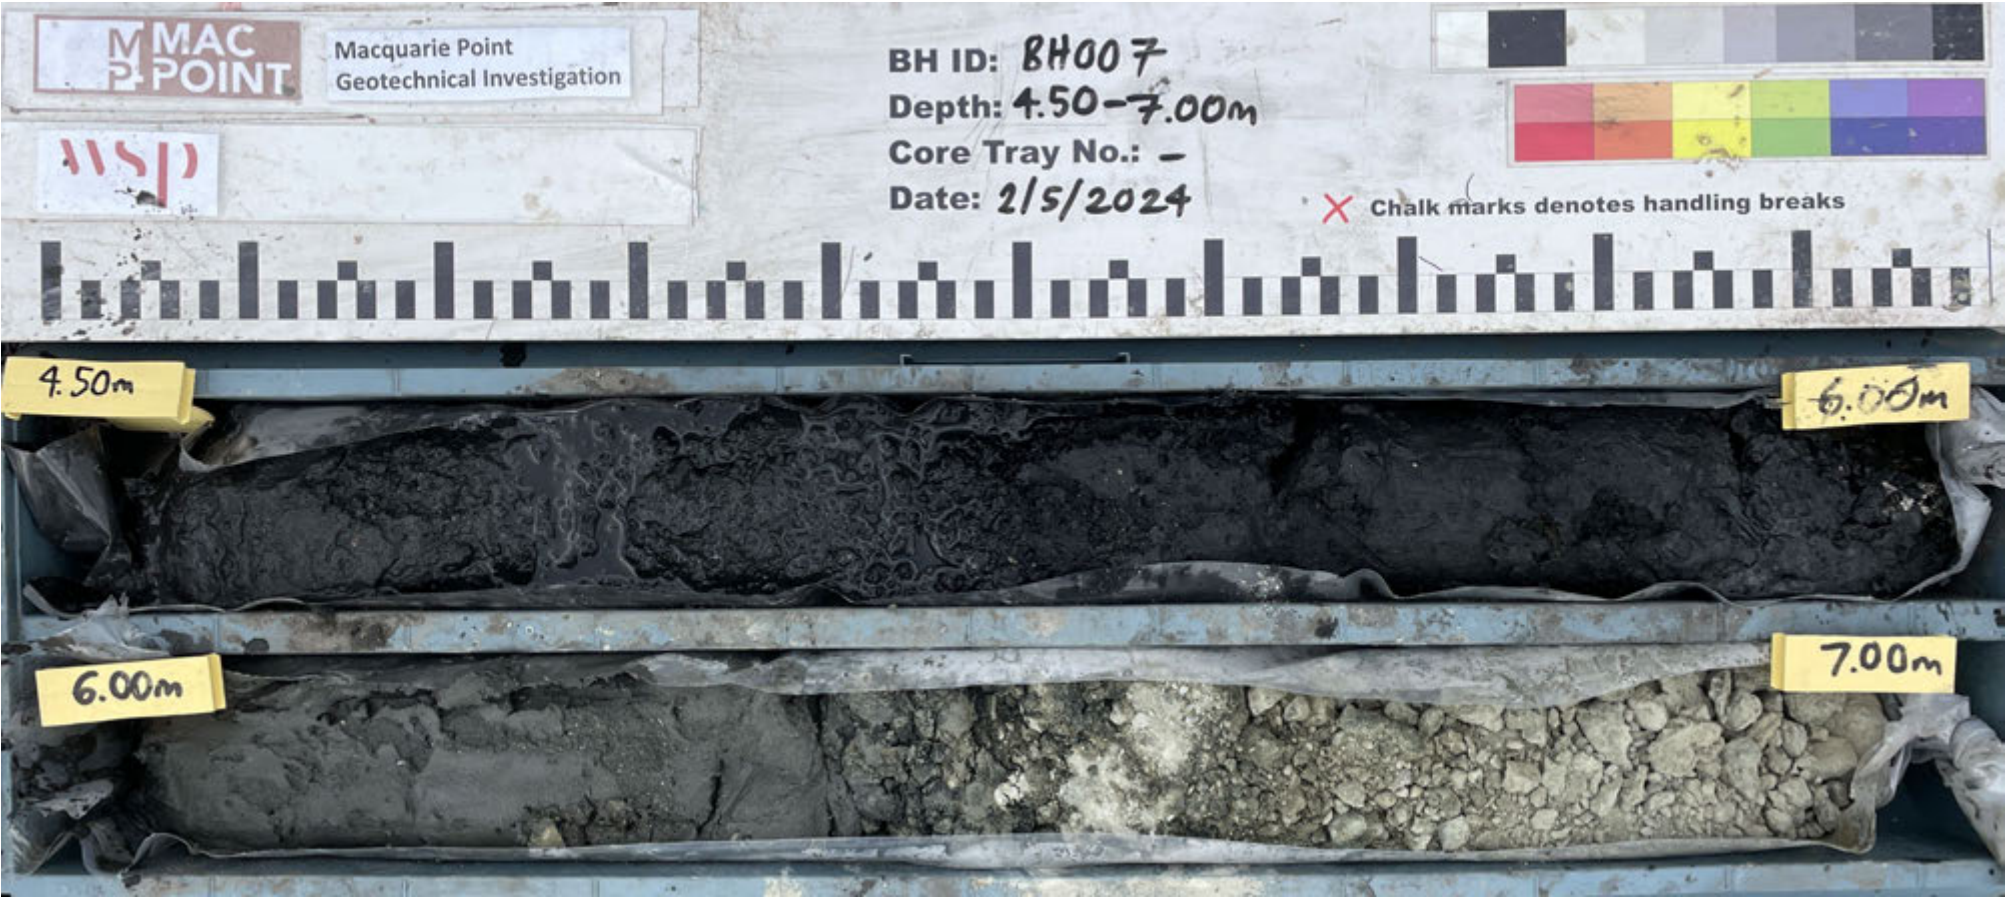
PointID : BH-007 Depth Range: 4.50 - 7.00 m

| | TITLE<br><br>MPDC<br>Macquarie Point<br>Macquarie Point GI<br>Core Photo - BH-007 | DRAWN | DATE<br>18/6/2024 |

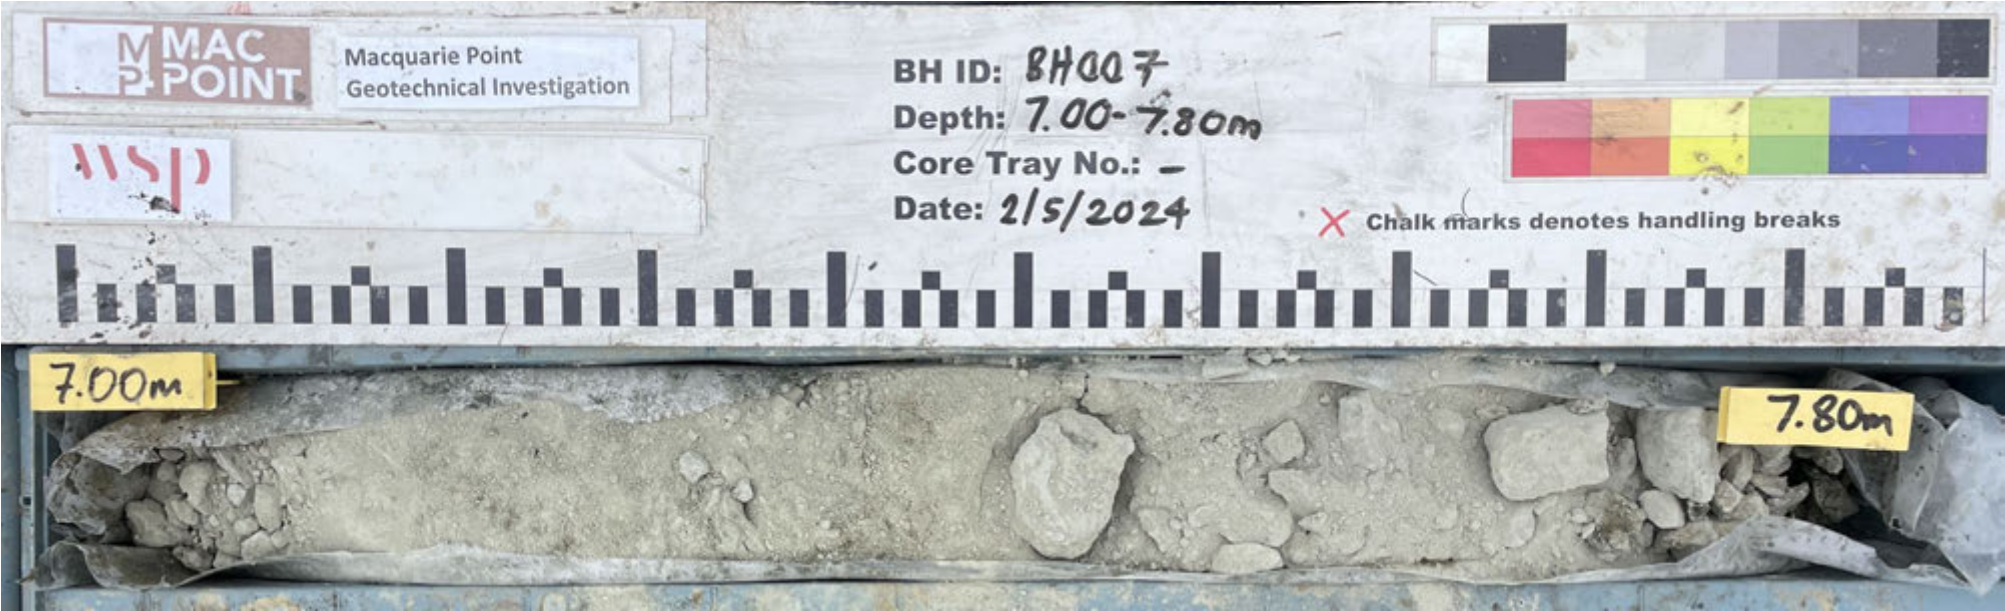
PointID : BH-007 Depth Range: 7.00 - 7.80 m

| | TITLE<br><br>MPDC<br>Macquarie Point<br>Macquarie Point GI<br>Core Photo - BH-007 | DRAWN | DATE<br>18/6/2024 |

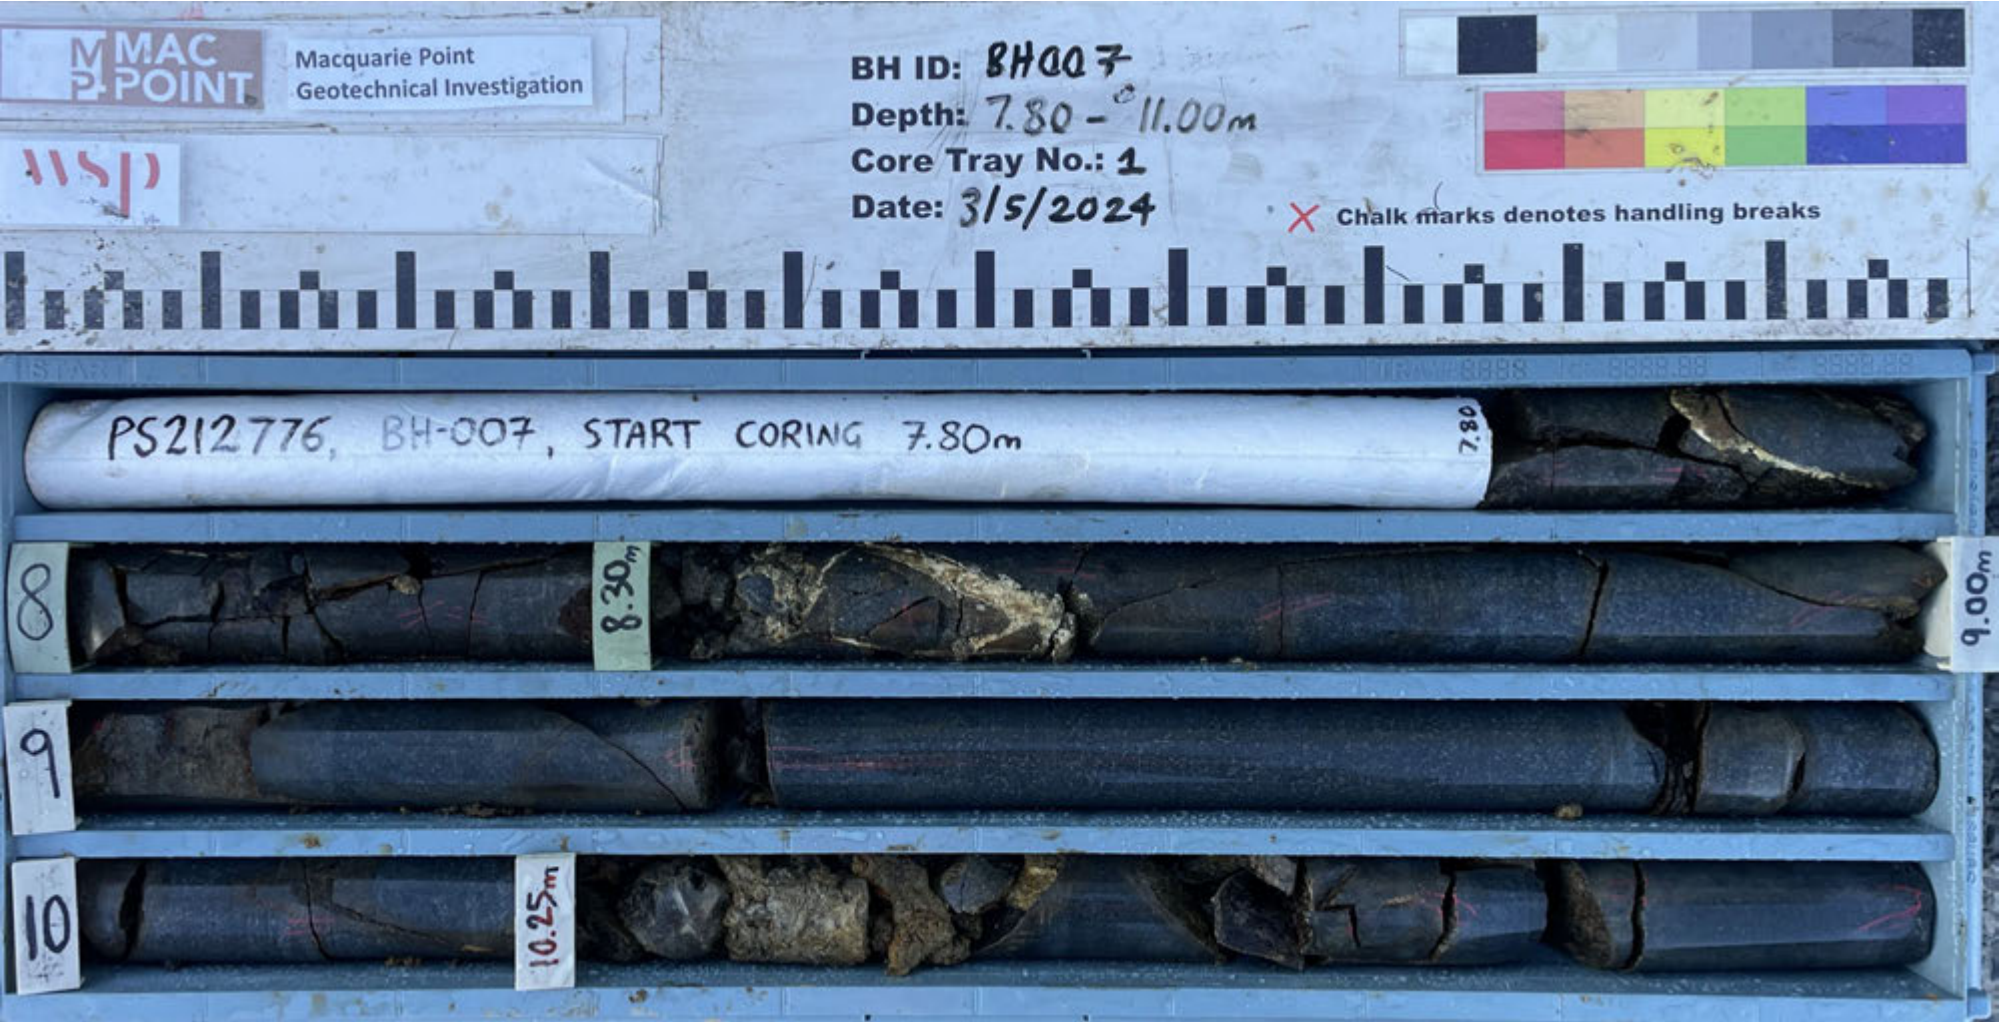
PointID : BH-007 Depth Range: 7.80 - 11.00 m

| | TITLE<br><br>MPDC<br>Macquarie Point<br>Macquarie Point GI<br>Core Photo - BH-007 | DRAWN | DATE<br>18/6/2024 |

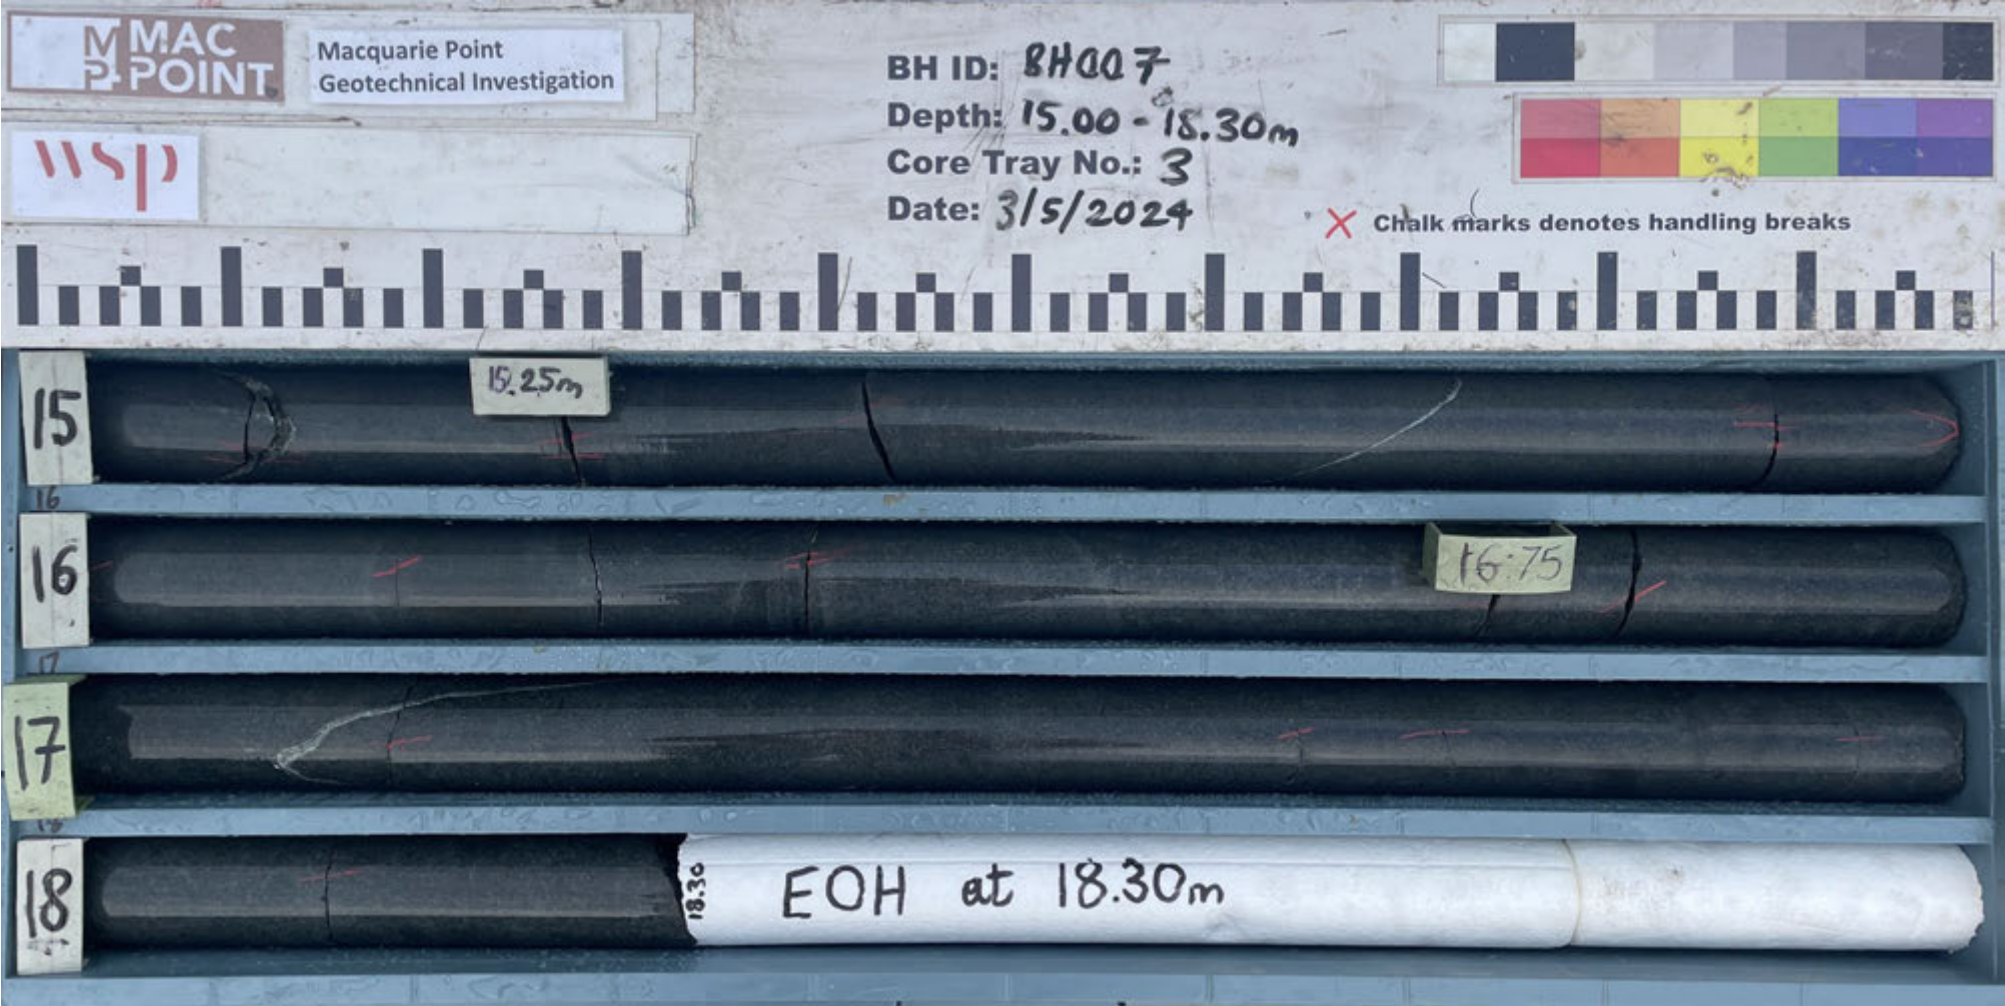
PointID : BH-007 Depth Range: 15.00 - 18.30 m

| | TITLE<br><br>MPDC<br>Macquarie Point<br>Macquarie Point GI<br>Core Photo - BH-007 | DRAWN | DATE<br>18/6/2024 |

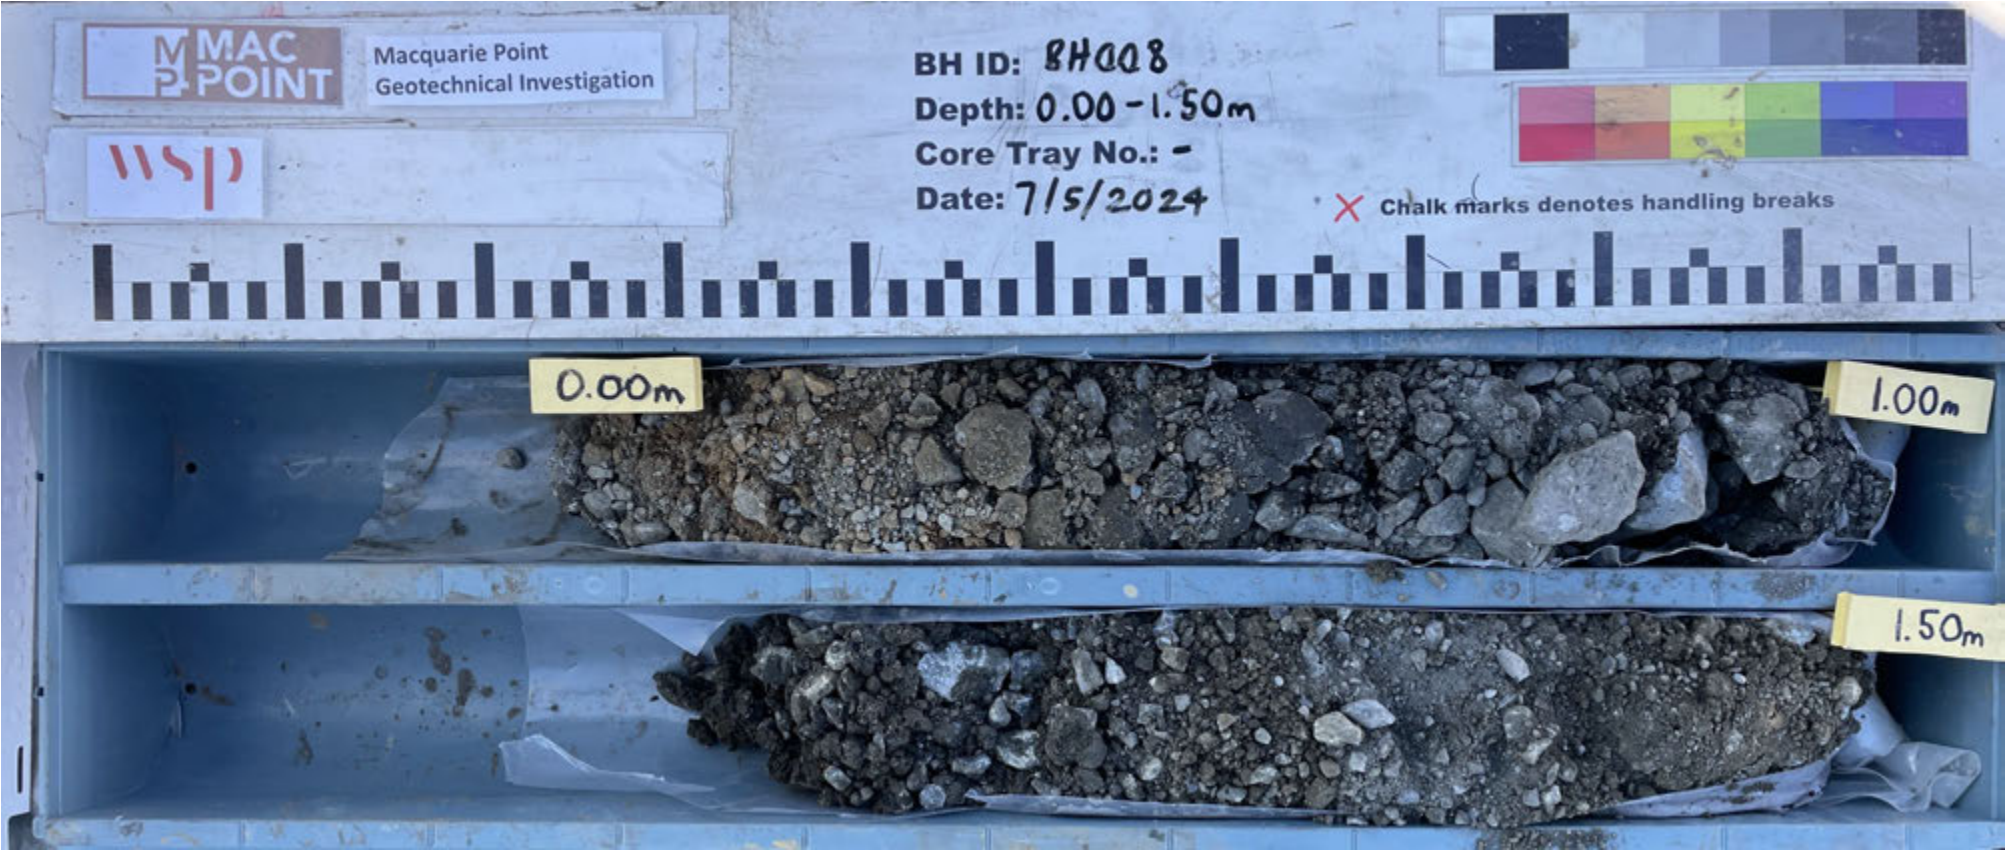
PointID : BH-008 Depth Range: 0.00 - 1.50 m

| | TITLE<br><br>MPDC<br>Macquarie Point<br>Macquarie Point GI<br>Core Photo - BH-008 | DRAWN | DATE<br>18/6/2024 | |

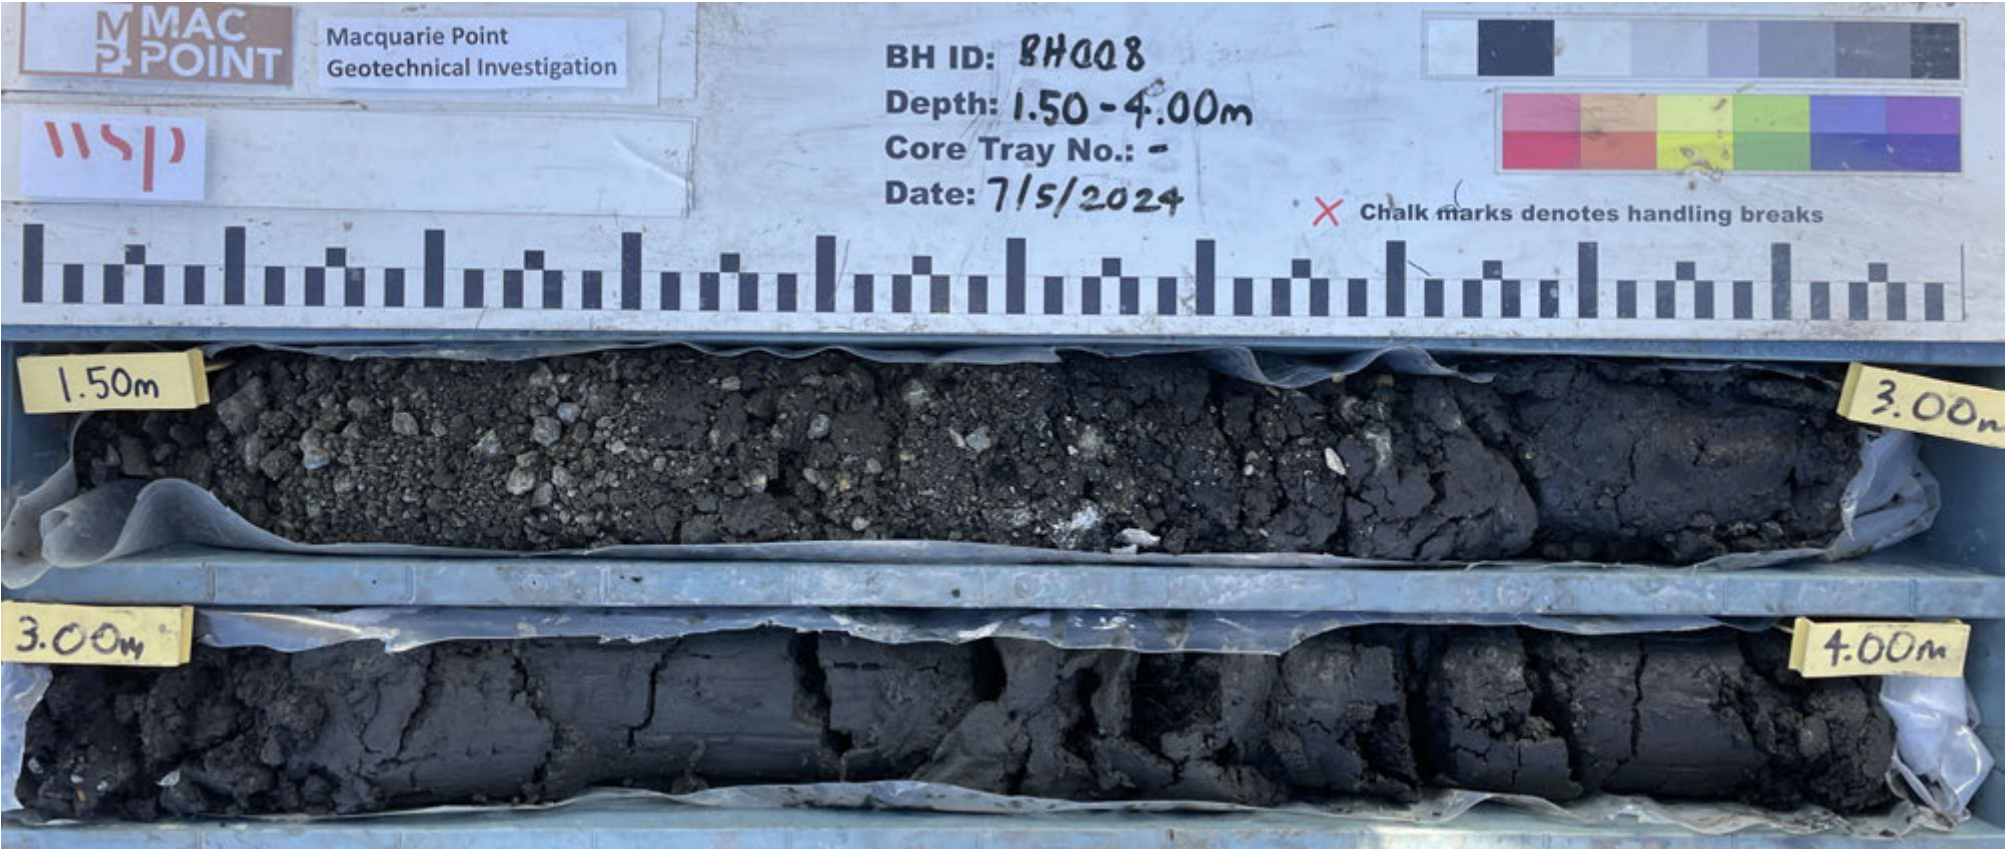
PointID : BH-008 Depth Range: 1.50 - 4.00 m

| | TITLE<br><br>MPDC<br>Macquarie Point<br>Macquarie Point GI<br>Core Photo - BH-008 | DRAWN | DATE<br>18/6/2024 |

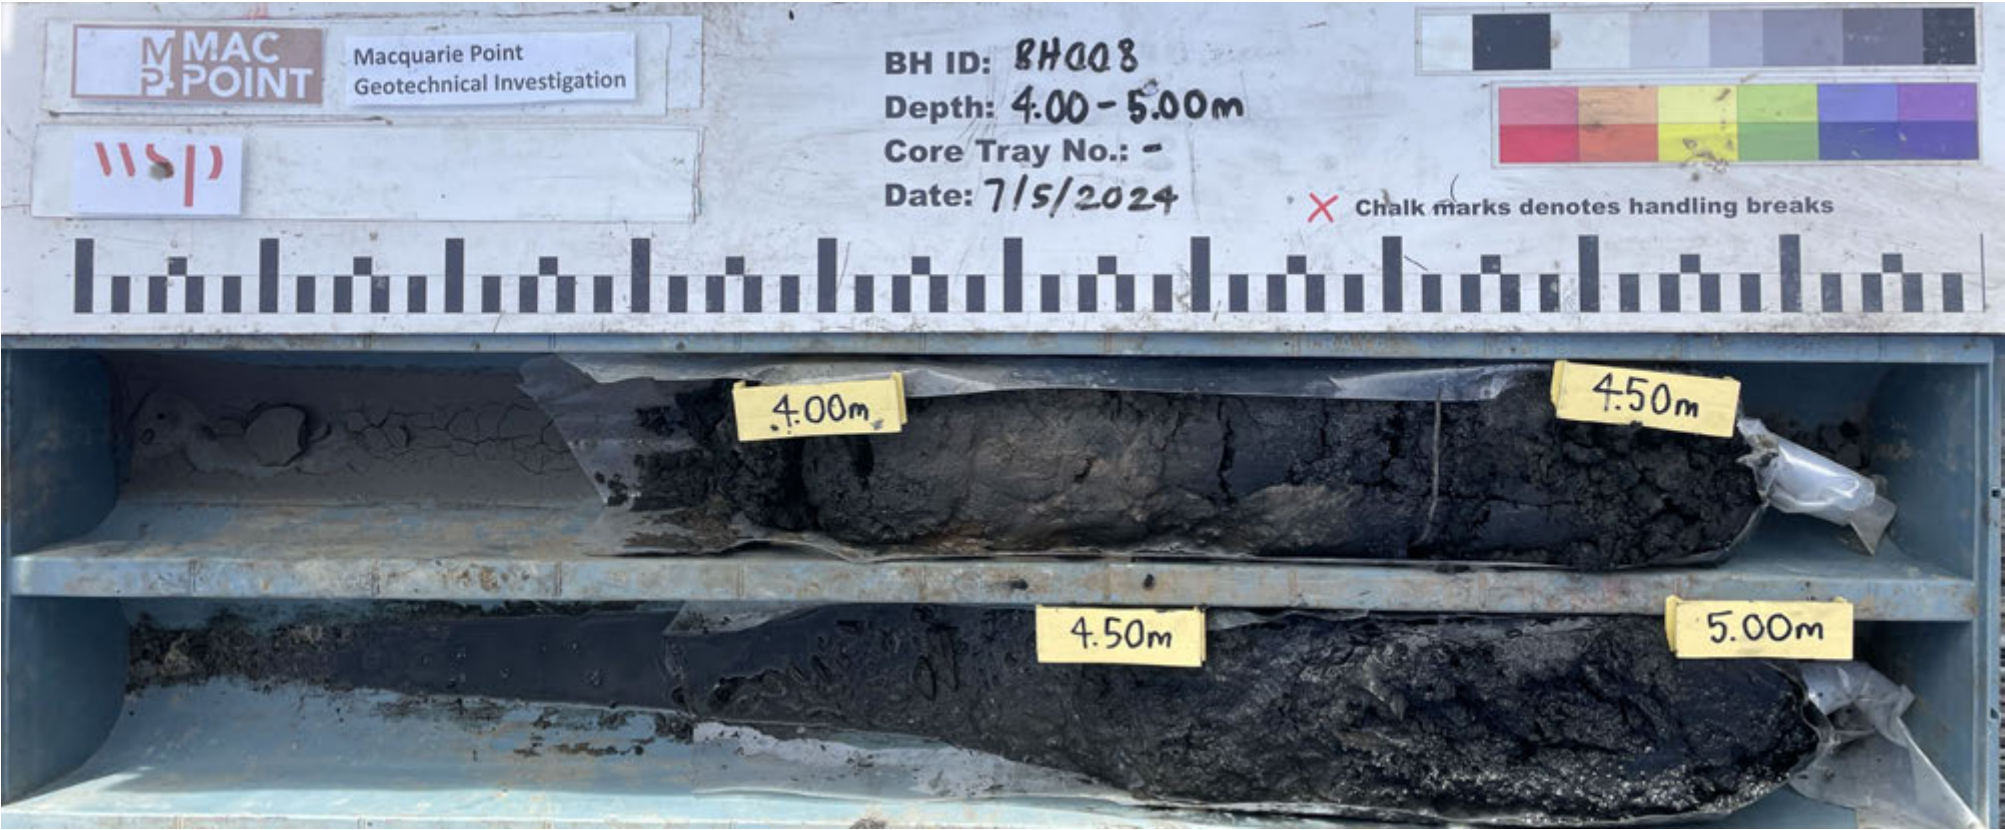
PointID : BH-008 Depth Range: 4.00 - 5.00 m

| | TITLE<br><br>MPDC<br>Macquarie Point<br>Macquarie Point GI<br>Core Photo - BH-008 | DRAWN | DATE<br>18/6/2024 |
