# Macquarie Point Stadium Development

## Geotechnical Factual Report

June 2024

## Macquarie Point Stadium Development Geotechnical Factual Report

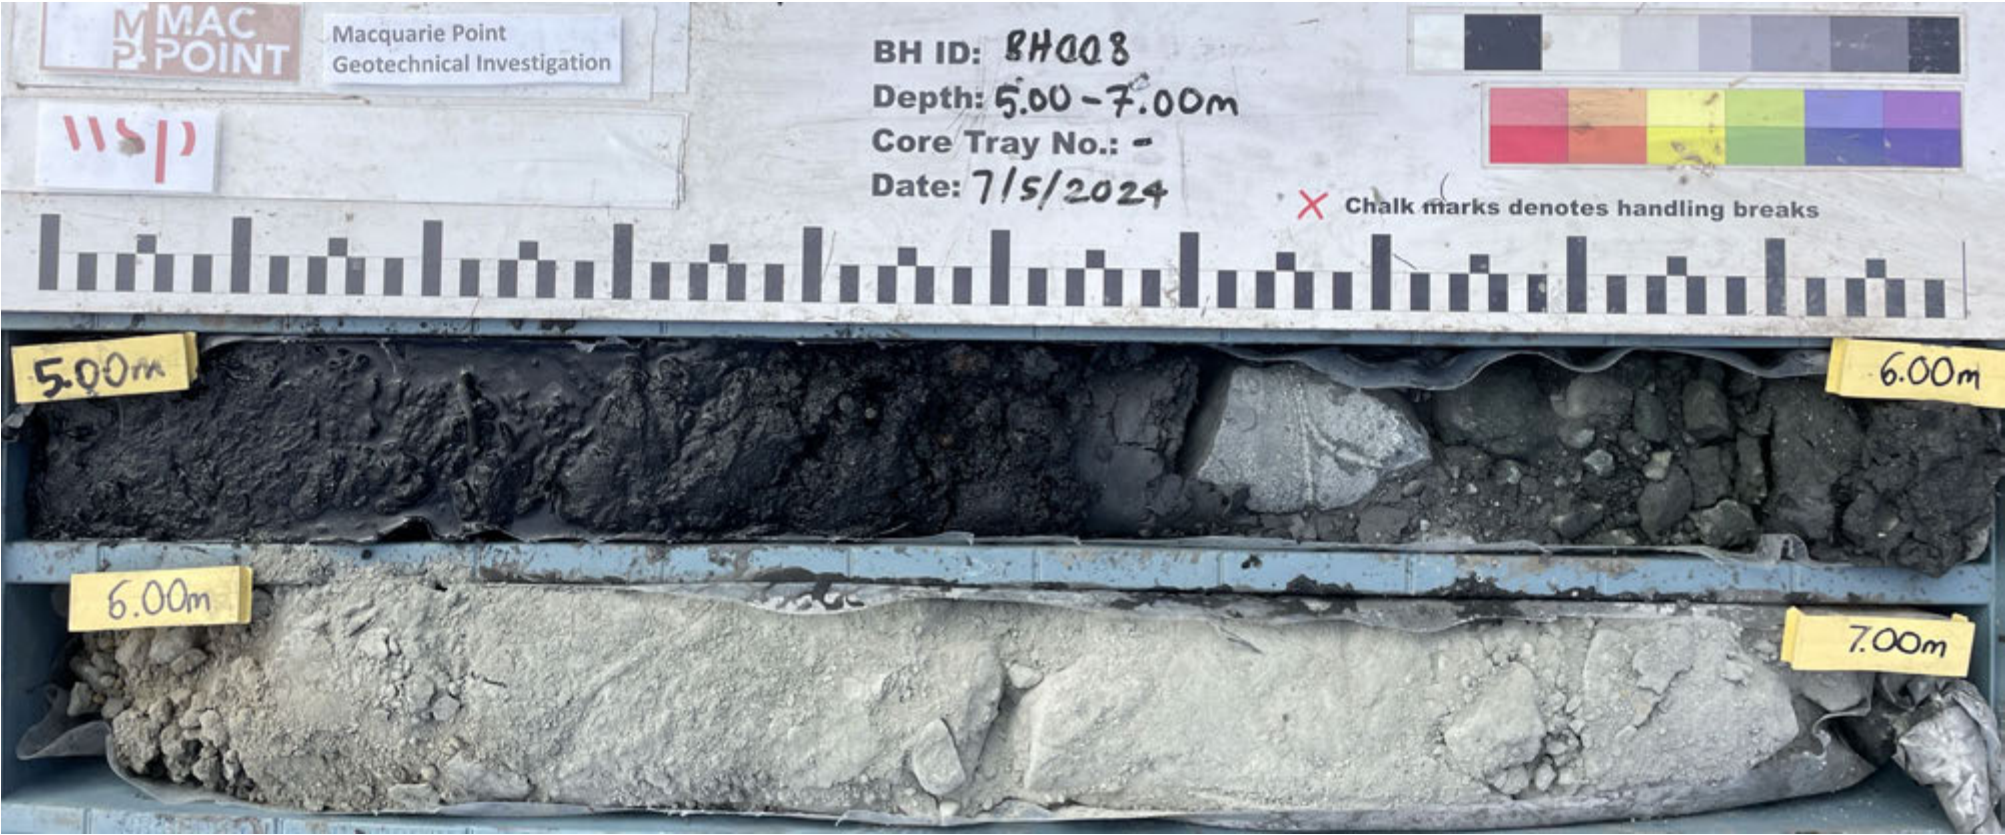
PointID : BH-008 Depth Range: 5.00 - 7.00 m

| | TITLE<br><br>MPDC<br>Macquarie Point<br>Macquarie Point GI<br>Core Photo - BH-008 | DRAWN | DATE<br>18/6/2024 |

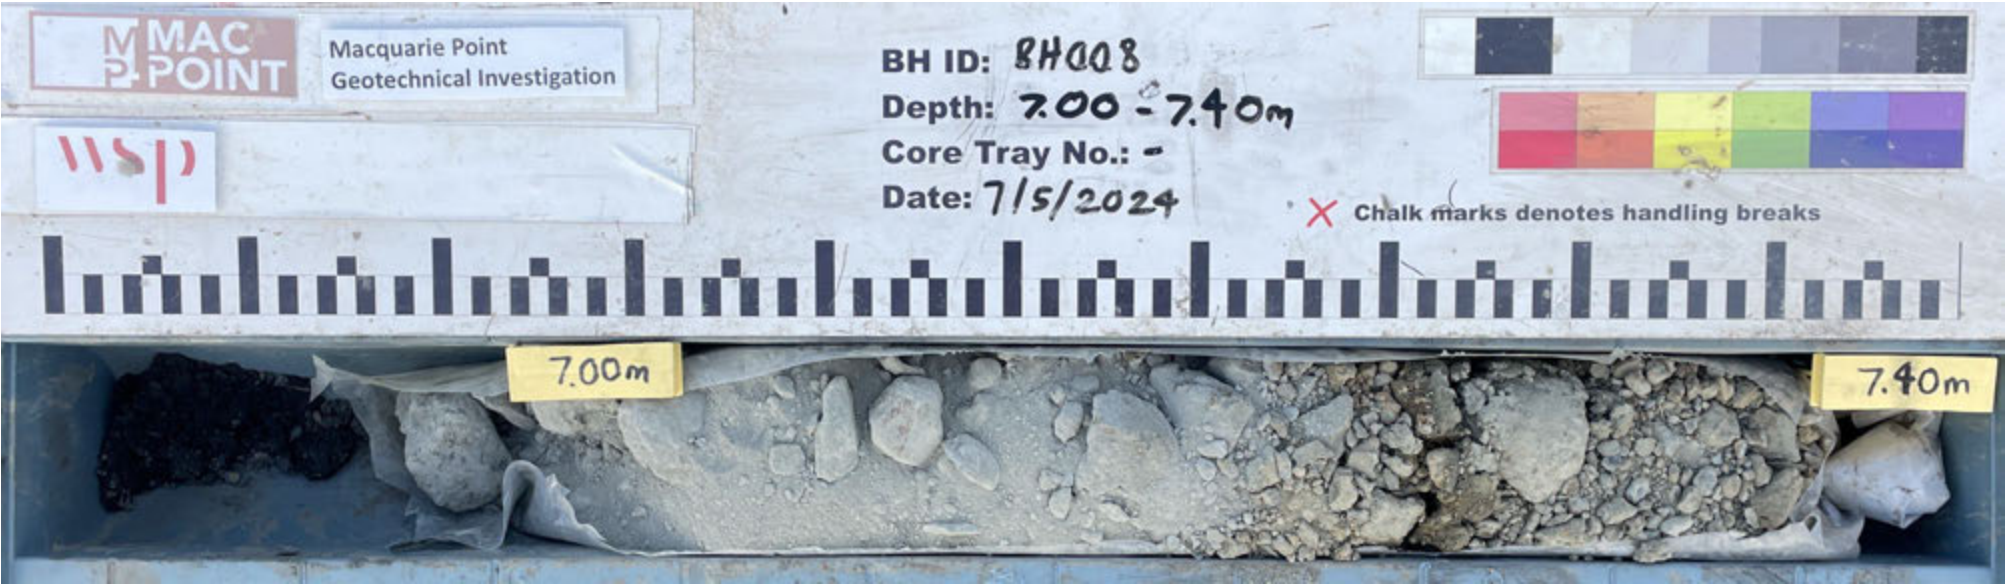
PointID : BH-008 Depth Range: 7.00 - 7.40 m

| | TITLE<br><br>MPDC<br>Macquarie Point<br>Macquarie Point GI<br>Core Photo - BH-008 | DRAWN | DATE<br>18/6/2024 |

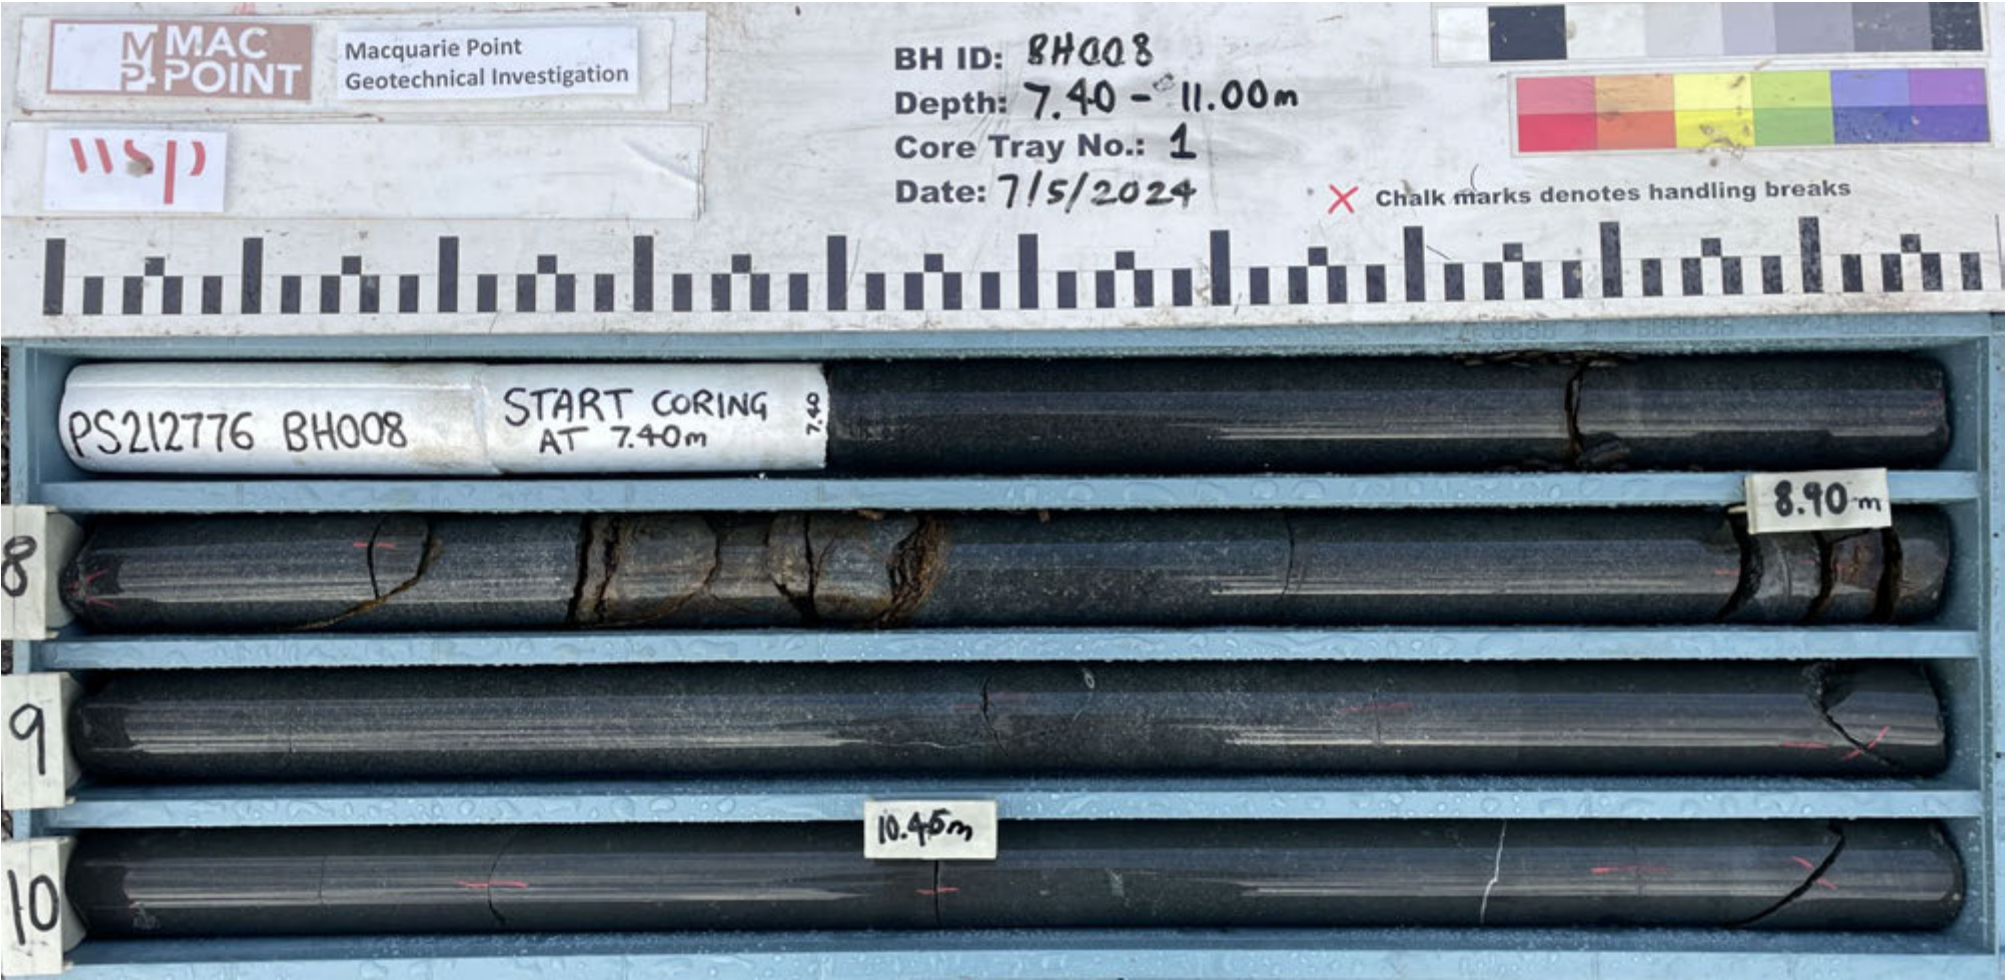
PointID : BH-008 Depth Range: 7.40 - 11.00 m

| | TITLE<br><br>MPDC<br>Macquarie Point<br>Macquarie Point GI<br>Core Photo - BH-008 | DRAWN | DATE<br>18/6/2024 |

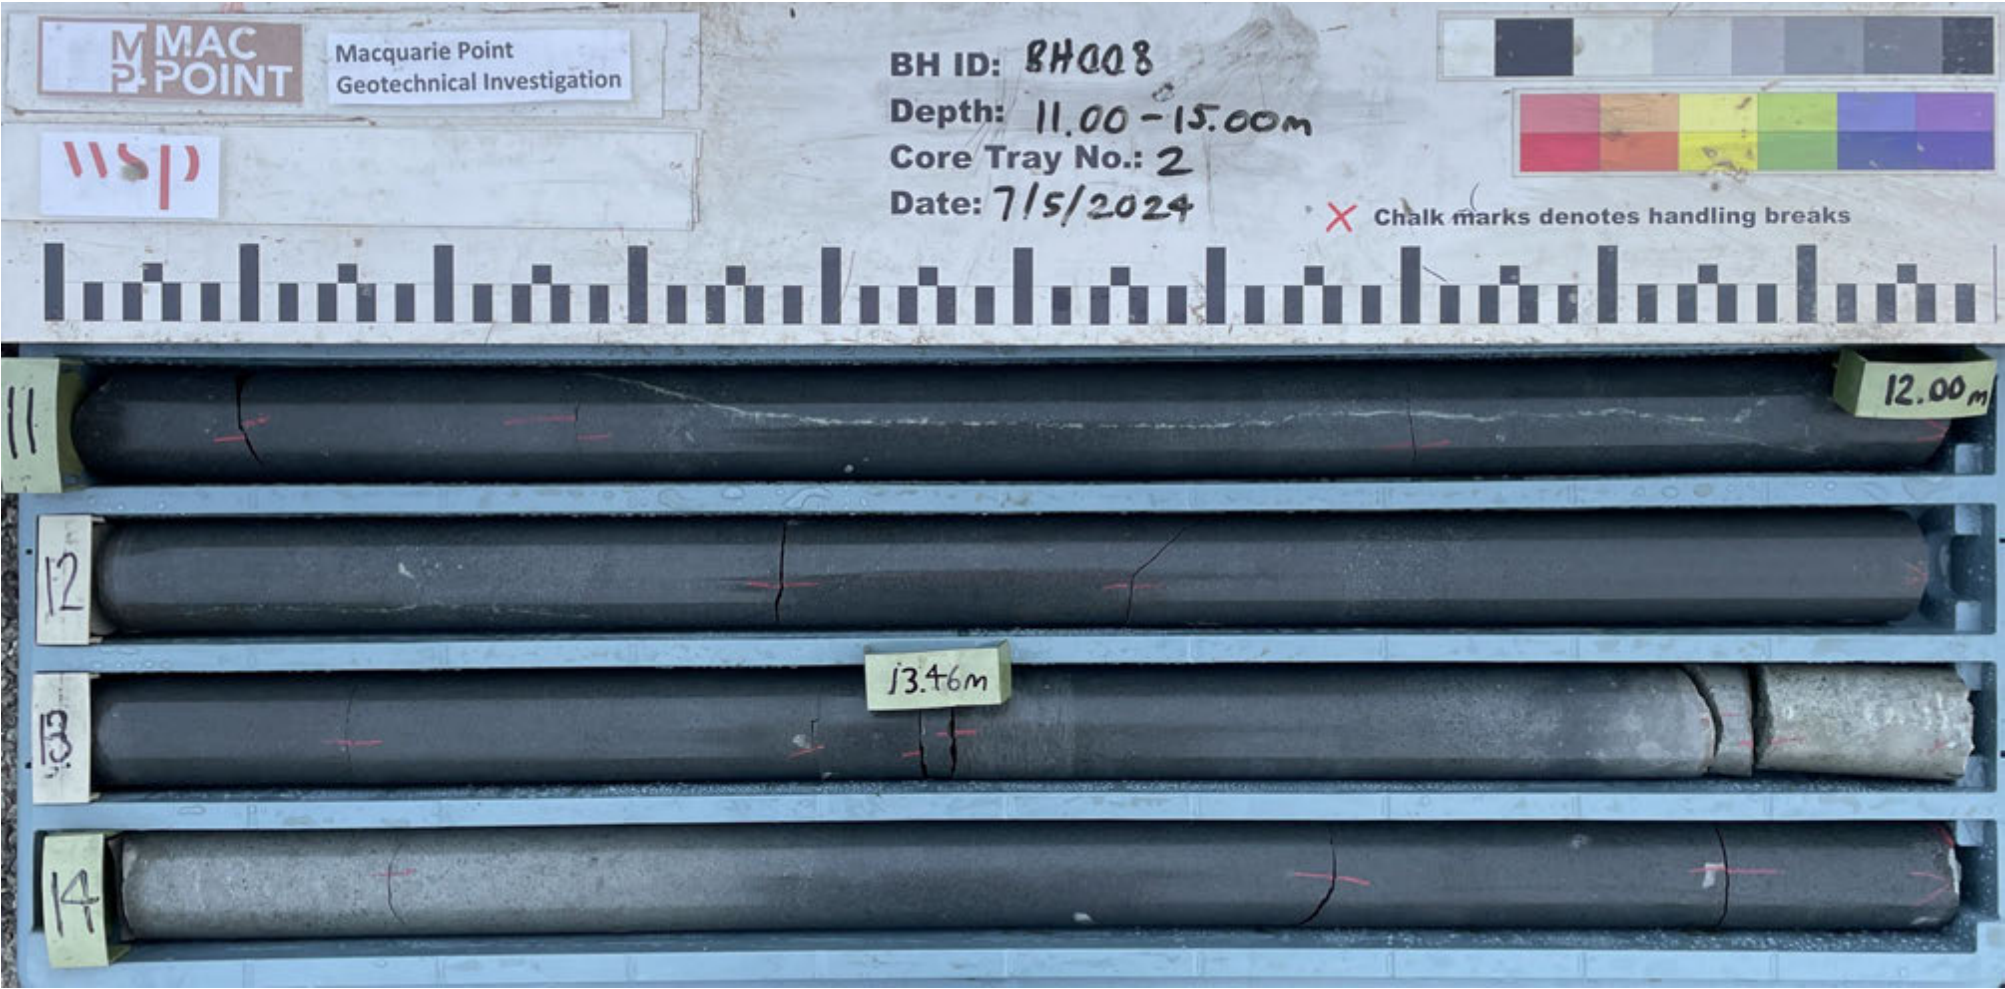
PointID : BH-008 Depth Range: 11.00 - 15.00 m

| | TITLE<br><br>MPDC<br>Macquarie Point<br>Macquarie Point GI<br>Core Photo - BH-008 | DRAWN | DATE<br>18/6/2024 |

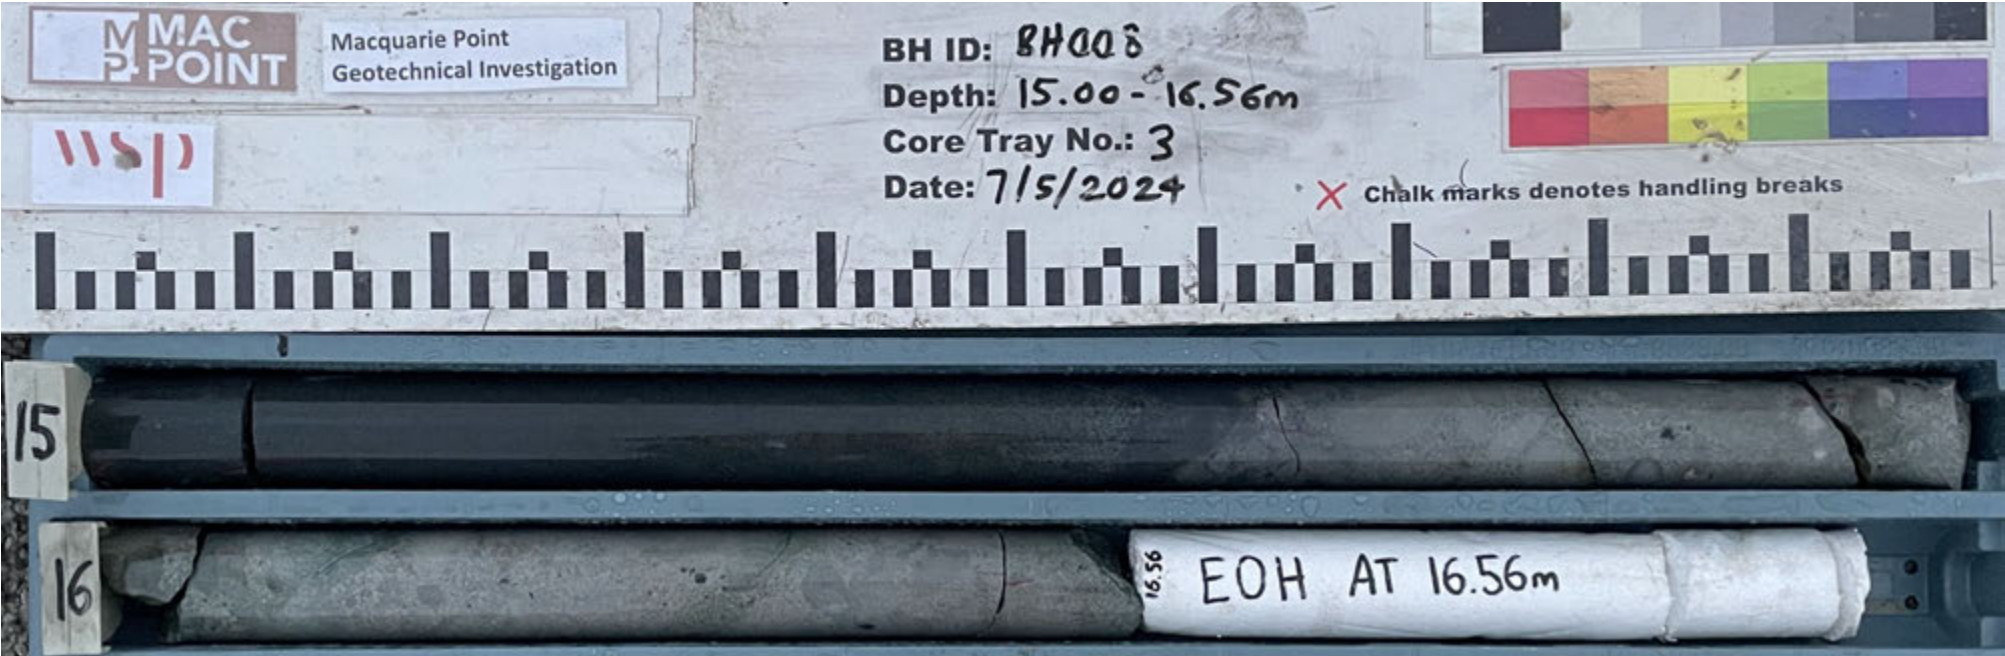
PointID : BH-008 Depth Range: 15.00 - 16.56 m

| | TITLE<br><br>MPDC<br>Macquarie Point<br>Macquarie Point GI<br>Core Photo - BH-008 | DRAWN | DATE<br>18/6/2024 |

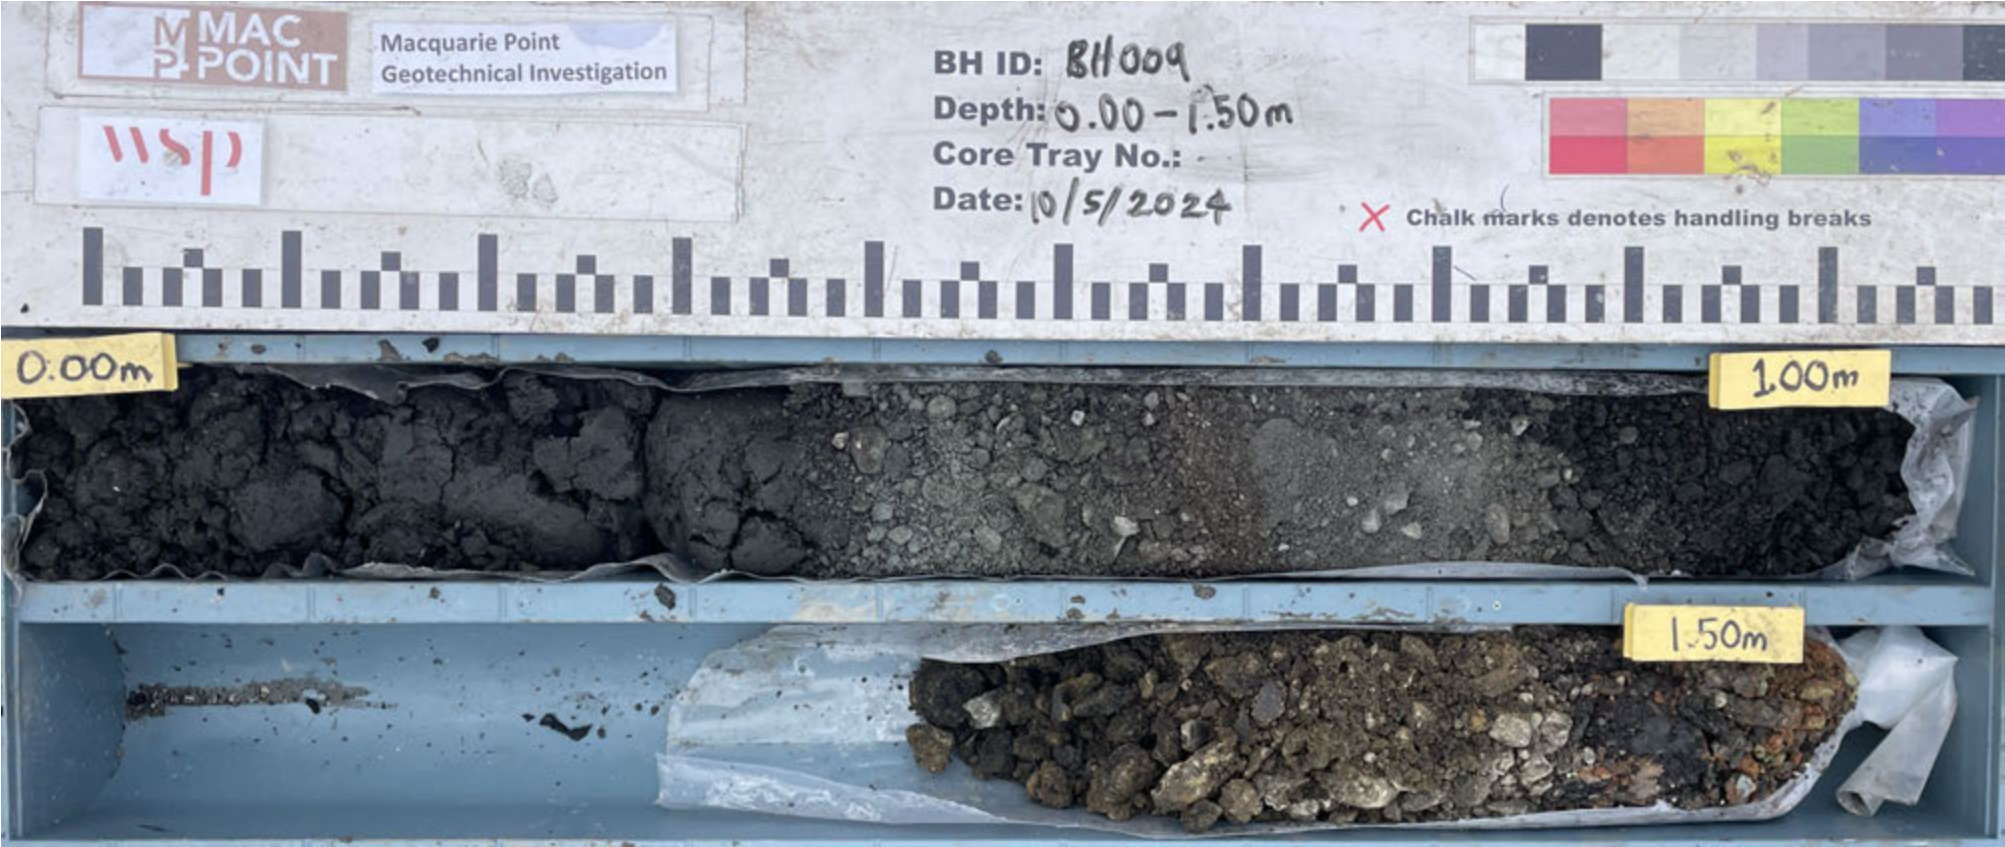
PointID : BH-009 Depth Range: 0.00 - 1.50 m

| | TITLE<br><br>MPDC<br>Macquarie Point<br>Macquarie Point GI<br>Core Photo - BH-009 | DRAWN | DATE<br>18/6/2024 |

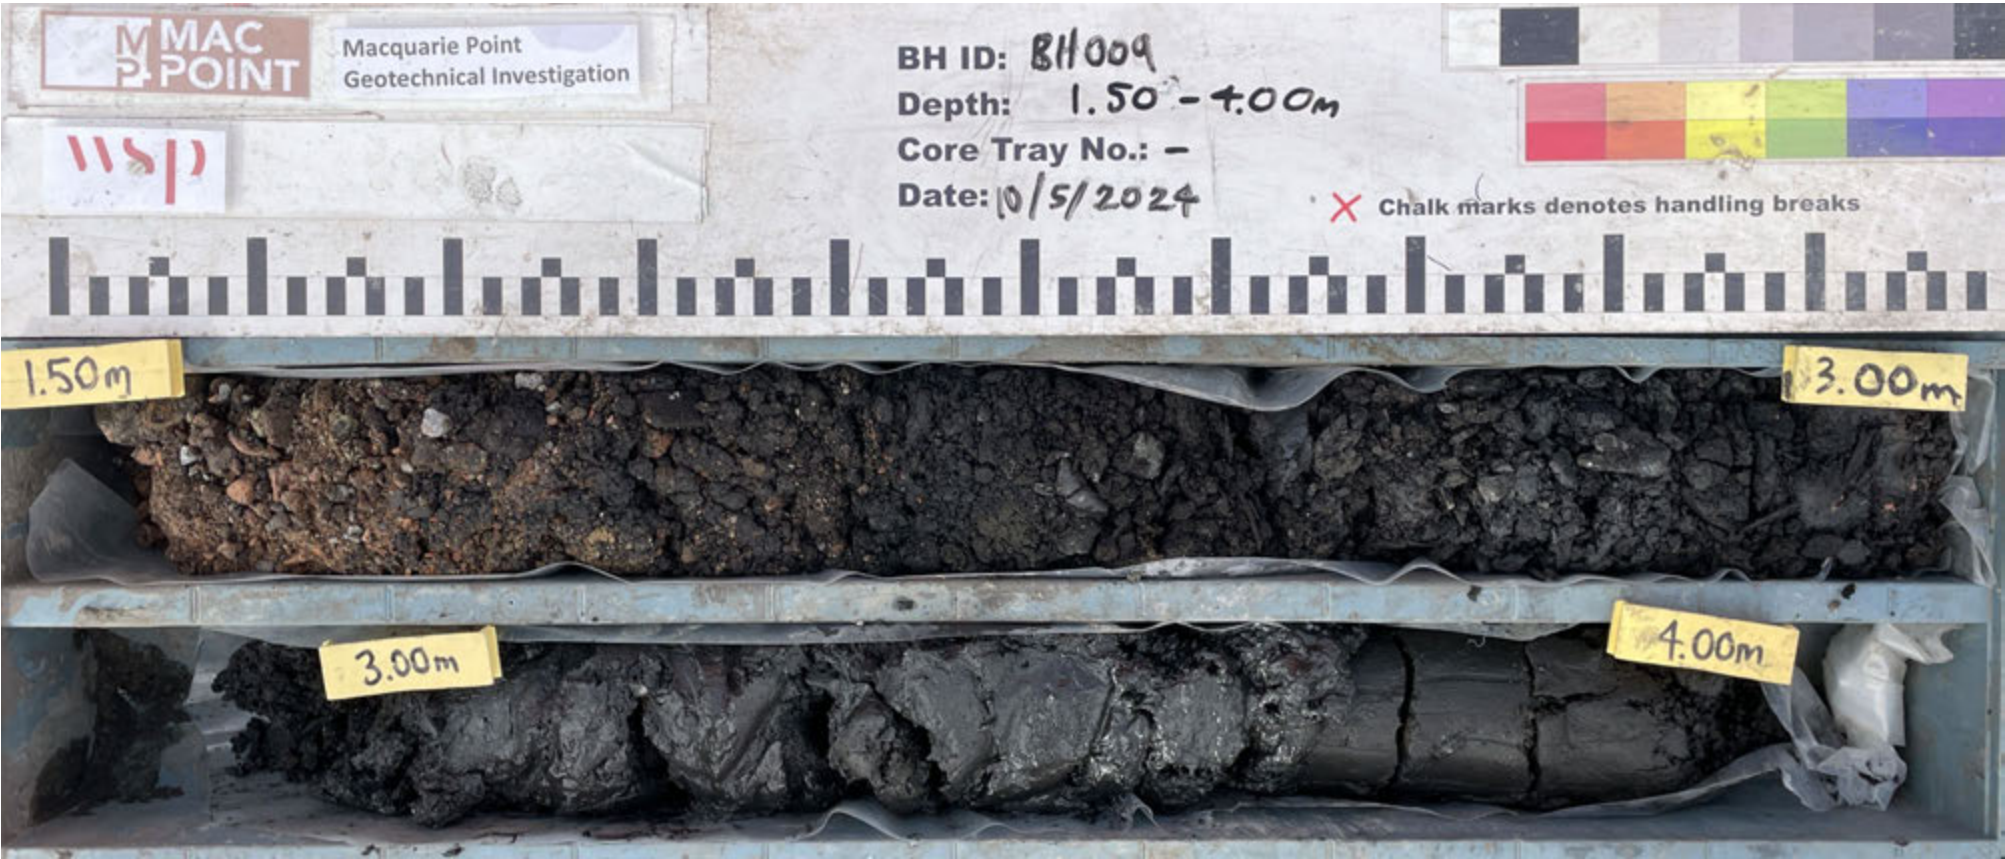
PointID : BH-009 Depth Range: 1.50 - 4.00 m

| | TITLE<br><br>MPDC<br>Macquarie Point<br>Macquarie Point GI<br>Core Photo - BH-009 | DRAWN | DATE<br>18/6/2024 |

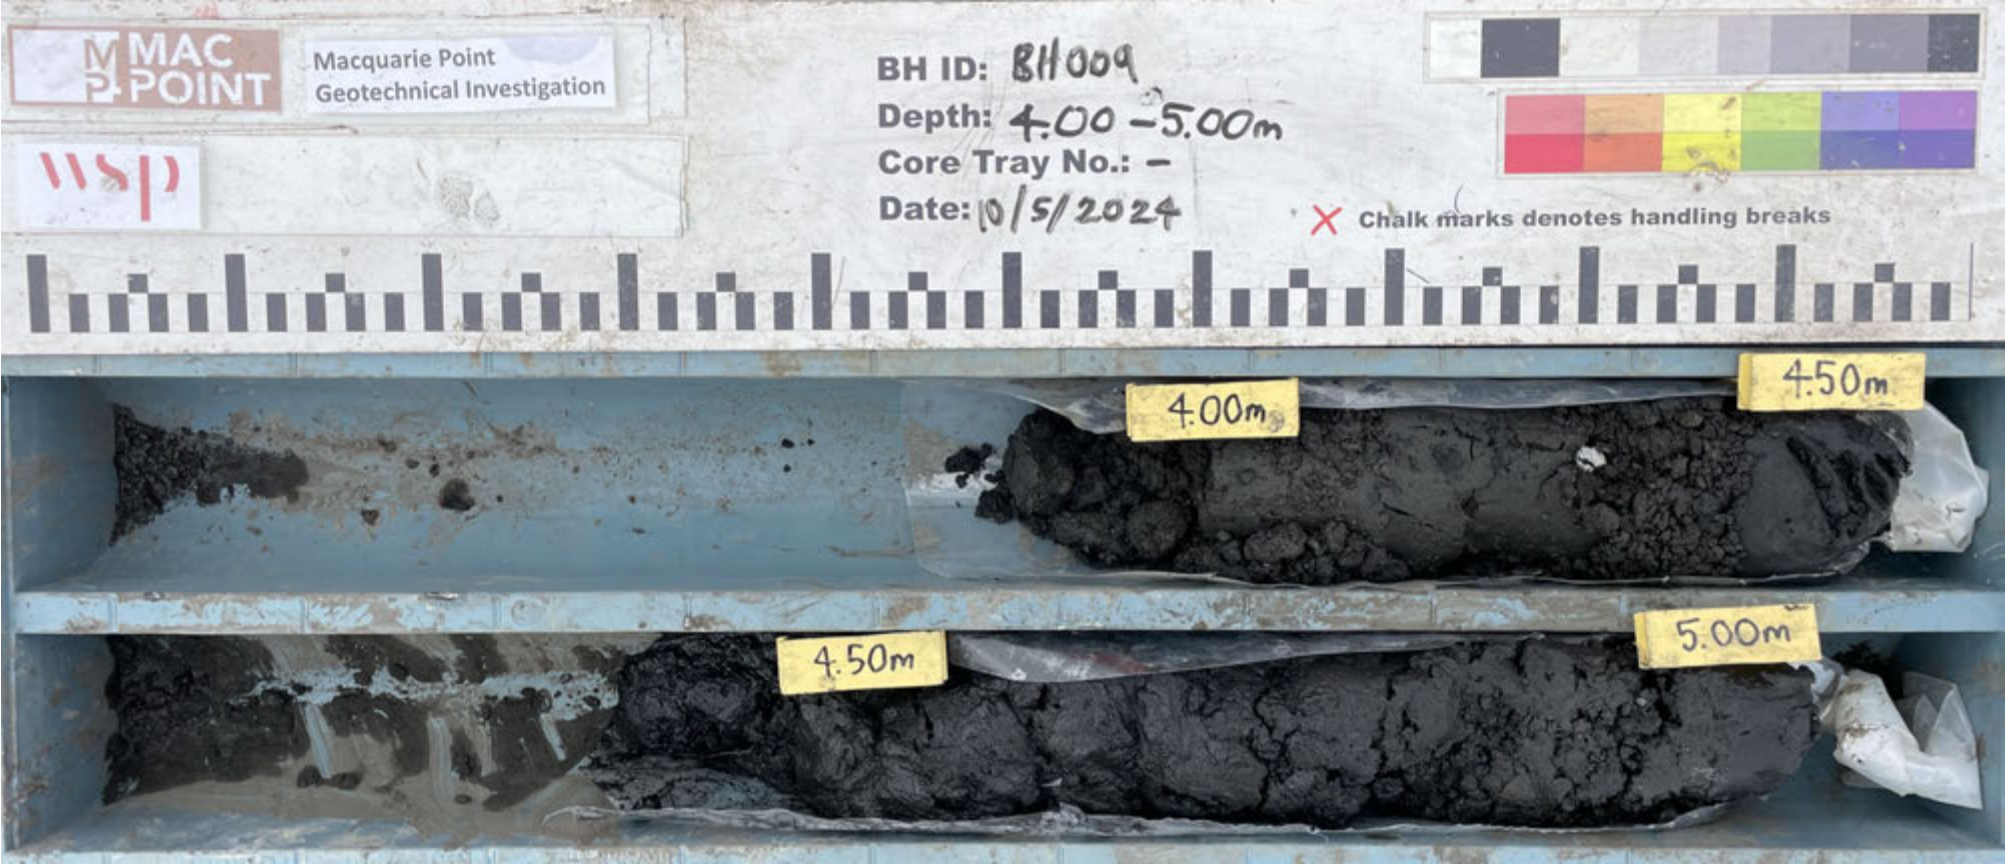
PointID : BH-009 Depth Range: 4.00 - 5.00 m

| | TITLE<br><br>MPDC<br>Macquarie Point<br>Macquarie Point GI<br>Core Photo - BH-009 | DRAWN | DATE 18/6/2024 | |

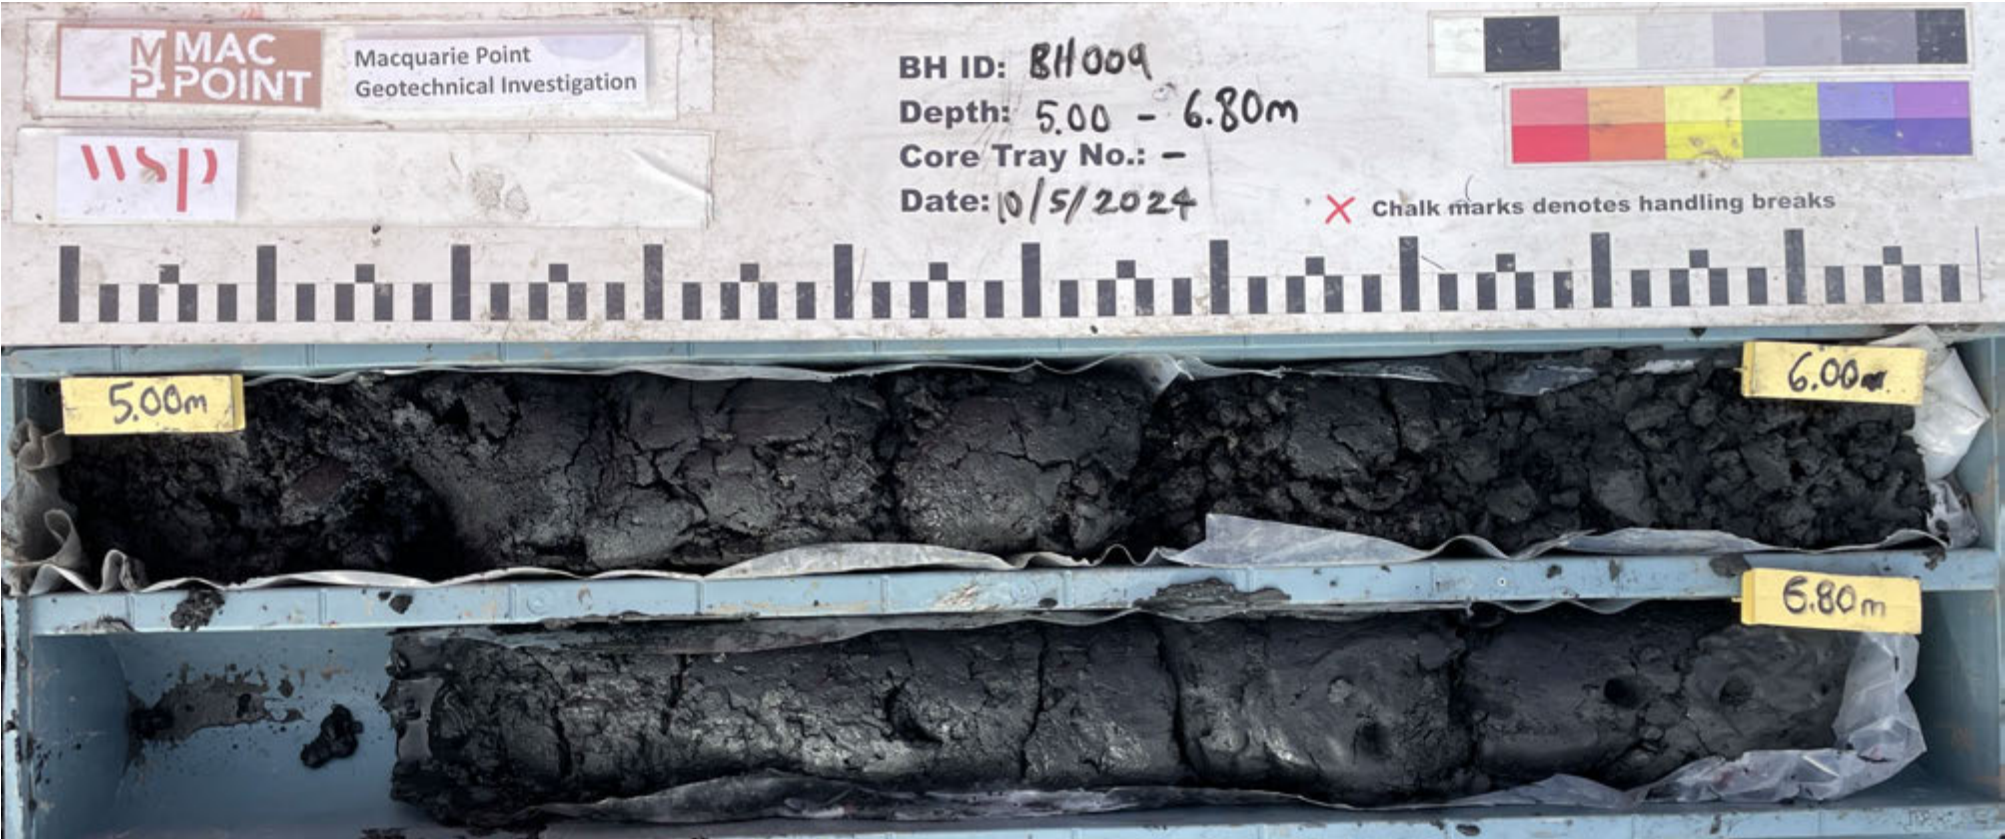
PointID : BH-009 Depth Range: 5.00 - 6.80 m

| | TITLE<br><br>MPDC<br>Macquarie Point<br>Macquarie Point GI<br>Core Photo - BH-009 | DRAWN | DATE<br>18/6/2024 |

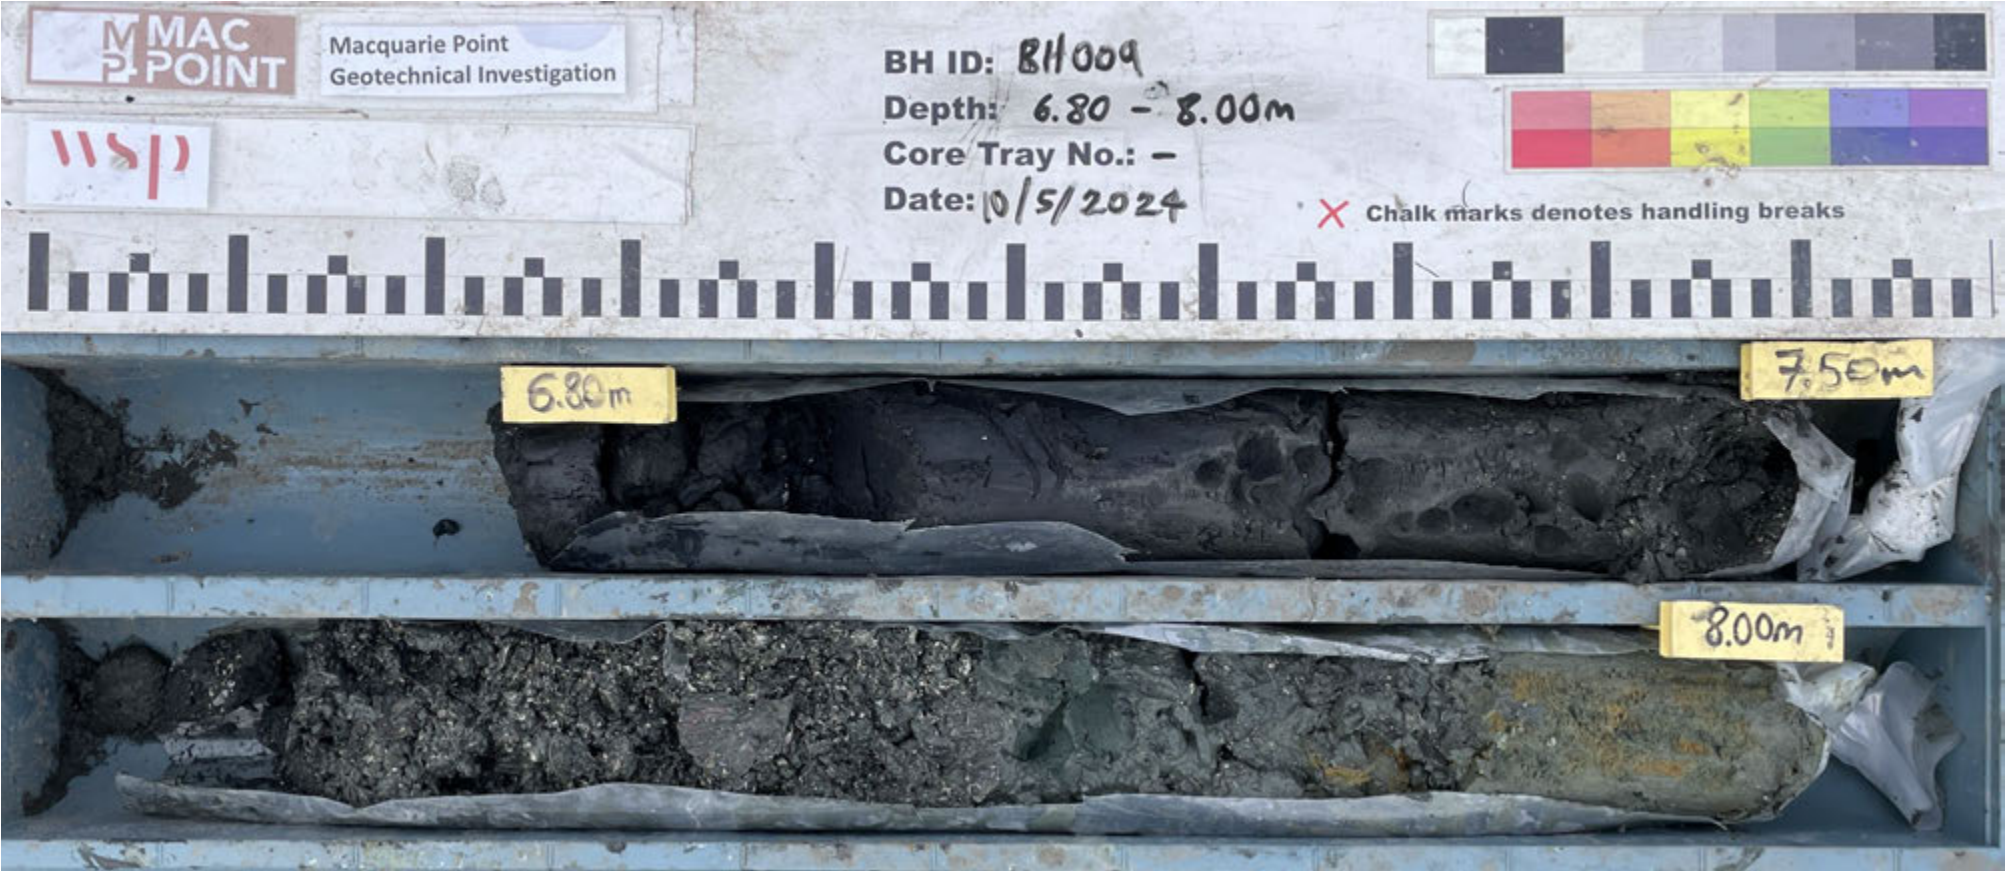
PointID : BH-009 Depth Range: 6.80 - 8.00 m

| | TITLE<br><br>MPDC<br>Macquarie Point<br>Macquarie Point GI<br>Core Photo - BH-009 | DRAWN | DATE<br>18/6/2024 |

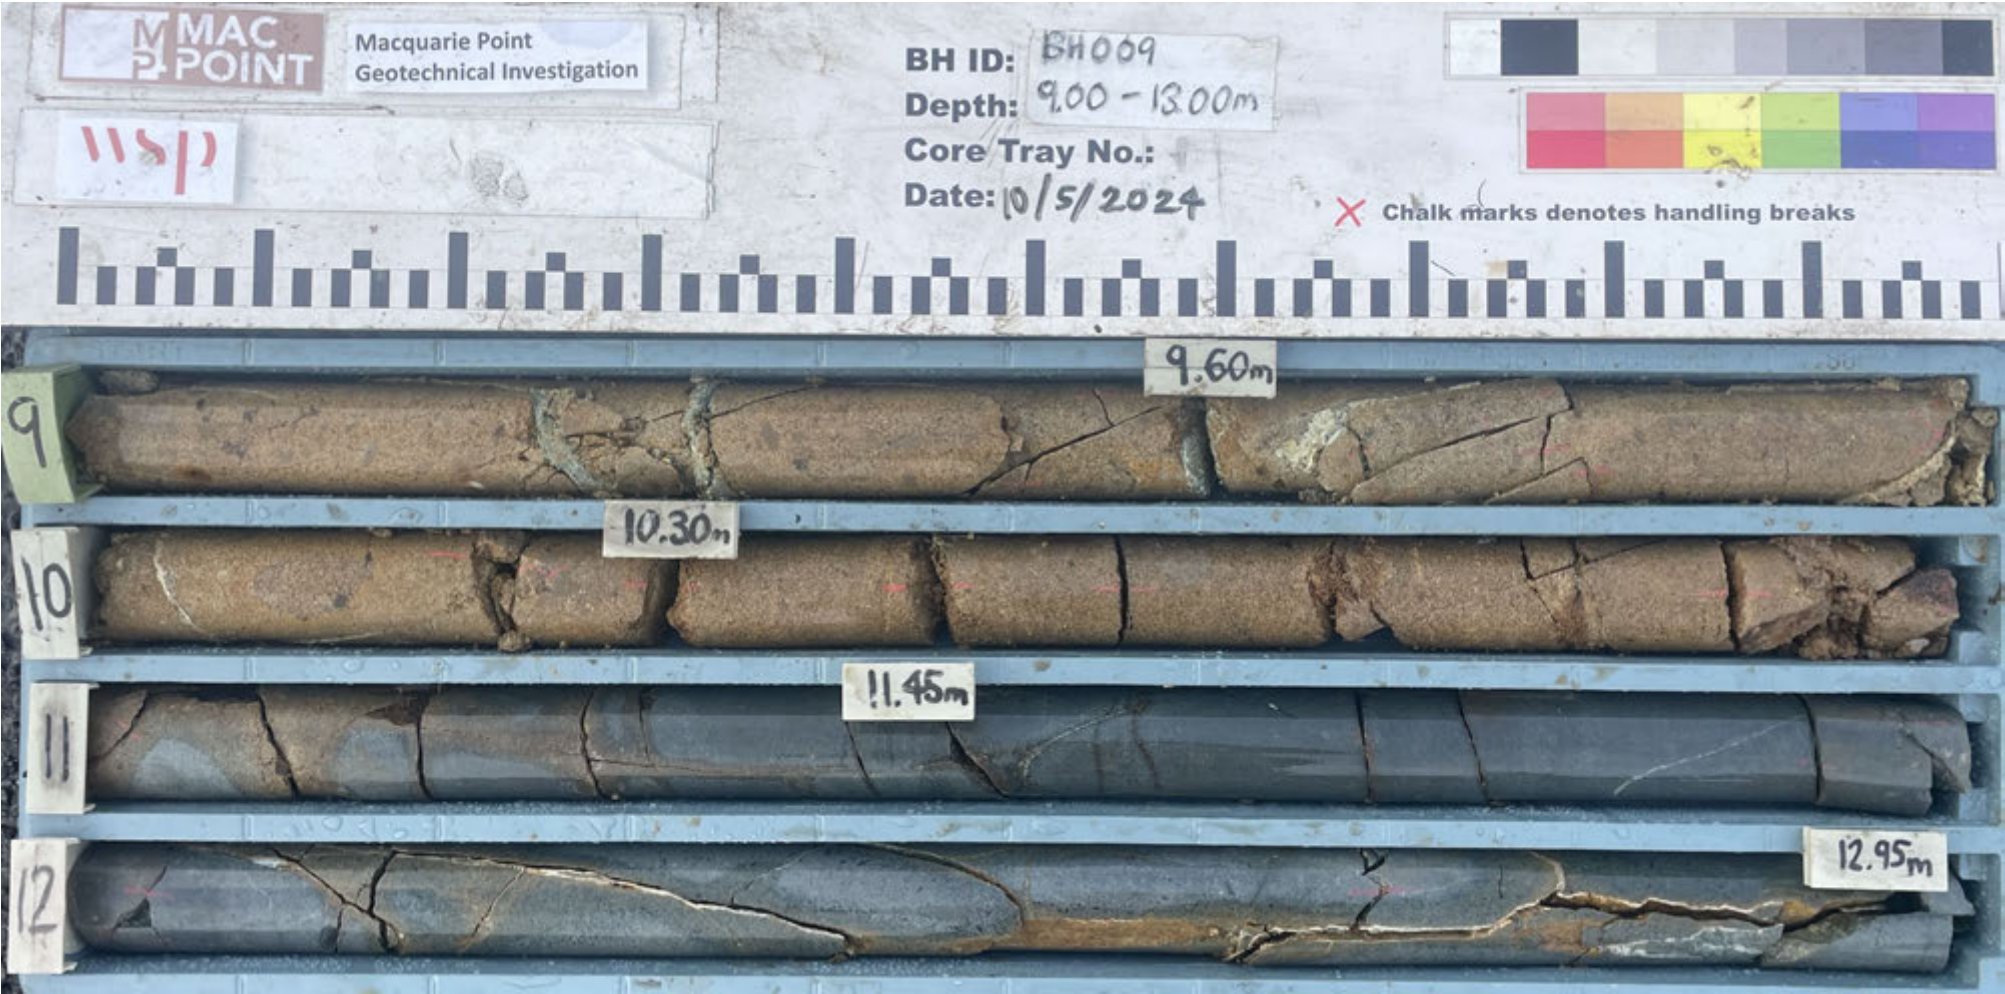
PointID : BH-009 Depth Range: 9.00 - 13.00 m

| | TITLE<br><br>MPDC<br>Macquarie Point<br>Macquarie Point GI<br>Core Photo - BH-009 | DRAWN | DATE<br>18/6/2024 |

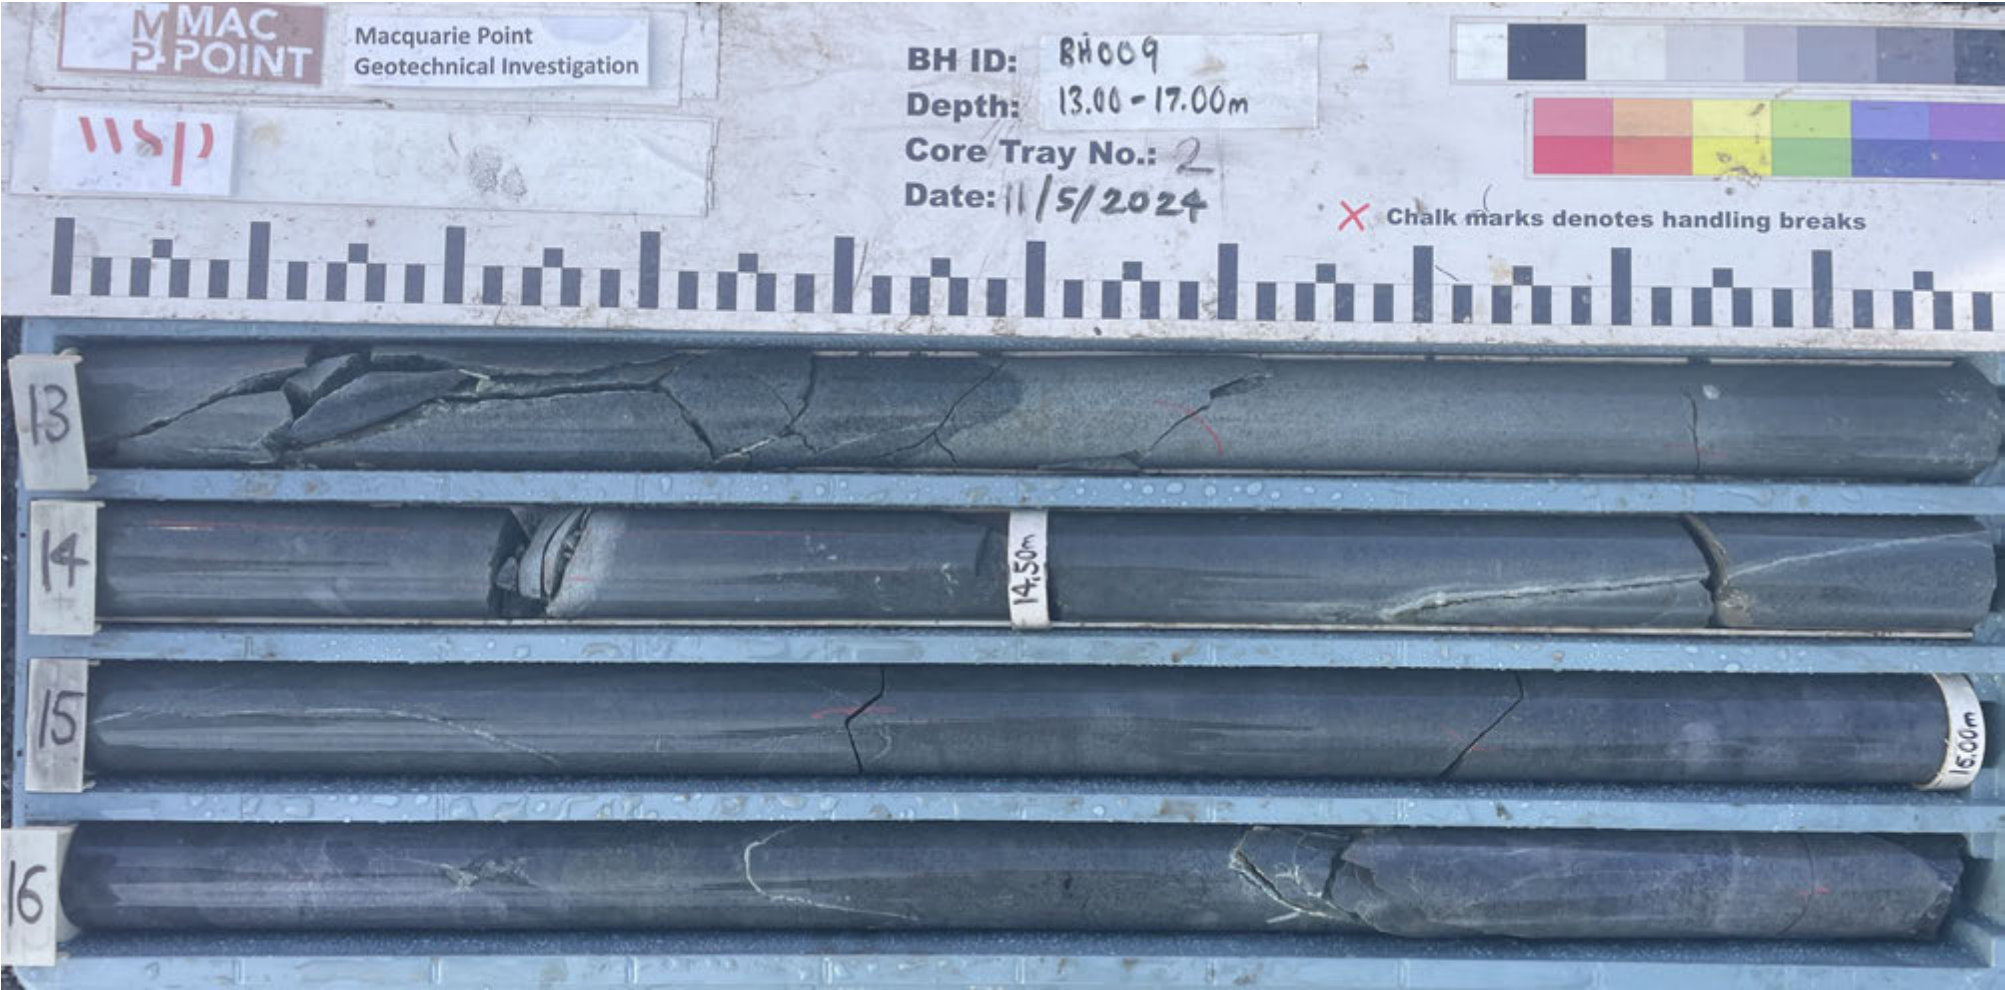
PointID : BH-009 Depth Range: 13.00 - 17.00 m

| | TITLE<br><br>MPDC<br>Macquarie Point<br>Macquarie Point GI<br>Core Photo - BH-009 | DRAWN | DATE<br>18/6/2024 |

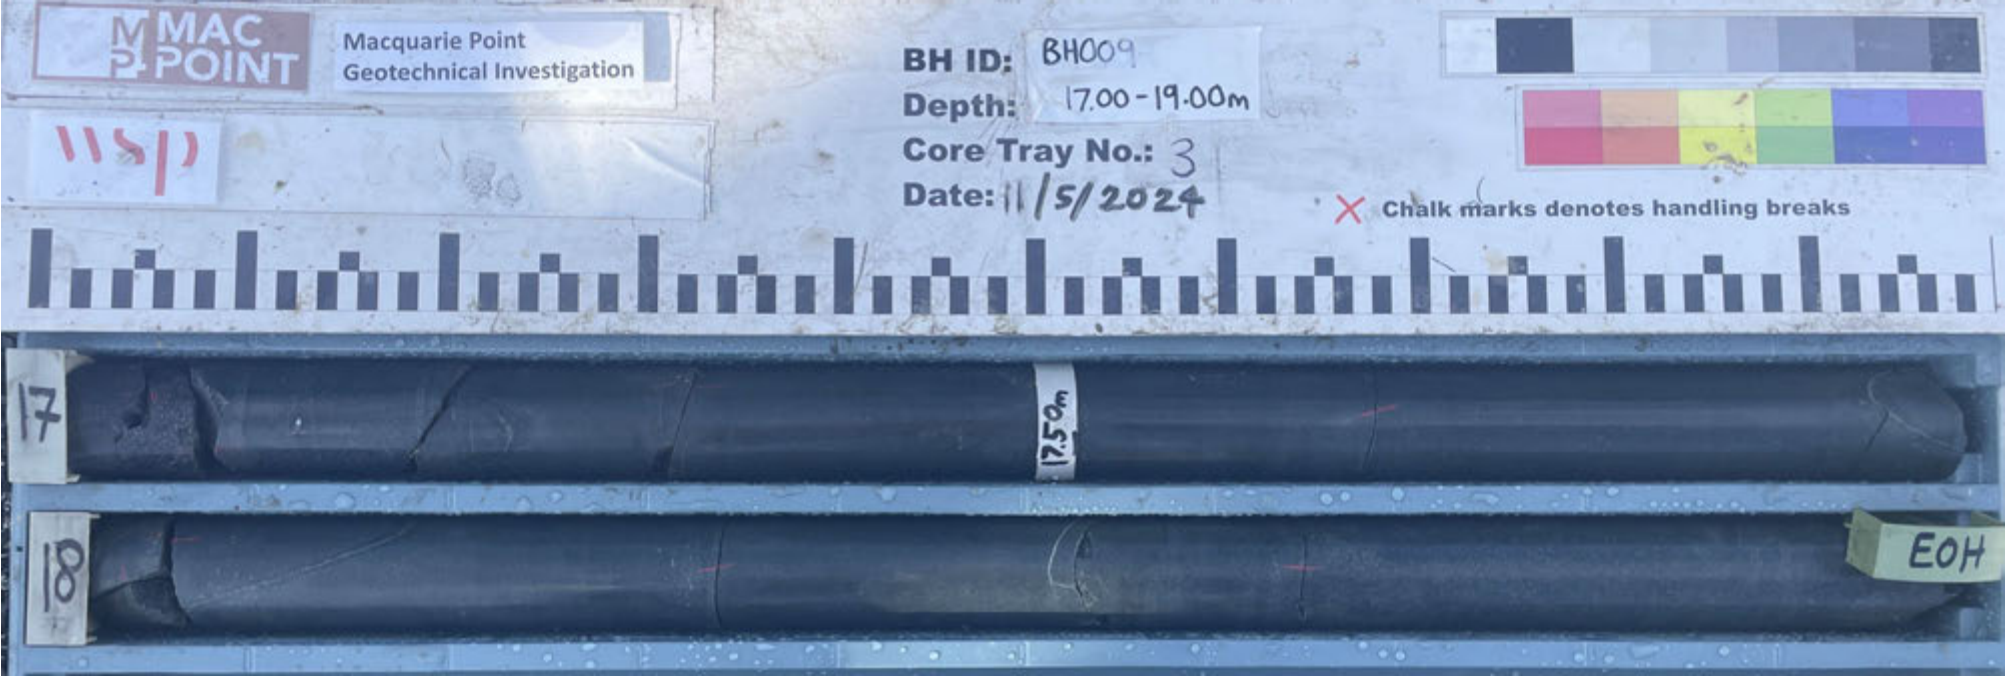
PointID : BH-009 Depth Range: 17.00 - 19.00 m

| | TITLE<br><br>MPDC<br>Macquarie Point<br>Macquarie Point GI<br>Core Photo - BH-009 | DRAWN | DATE<br>18/6/2024 |
