# Macquarie Point Stadium Development

## Geotechnical Factual Report

June 2024

## Macquarie Point Stadium Development Geotechnical Factual Report

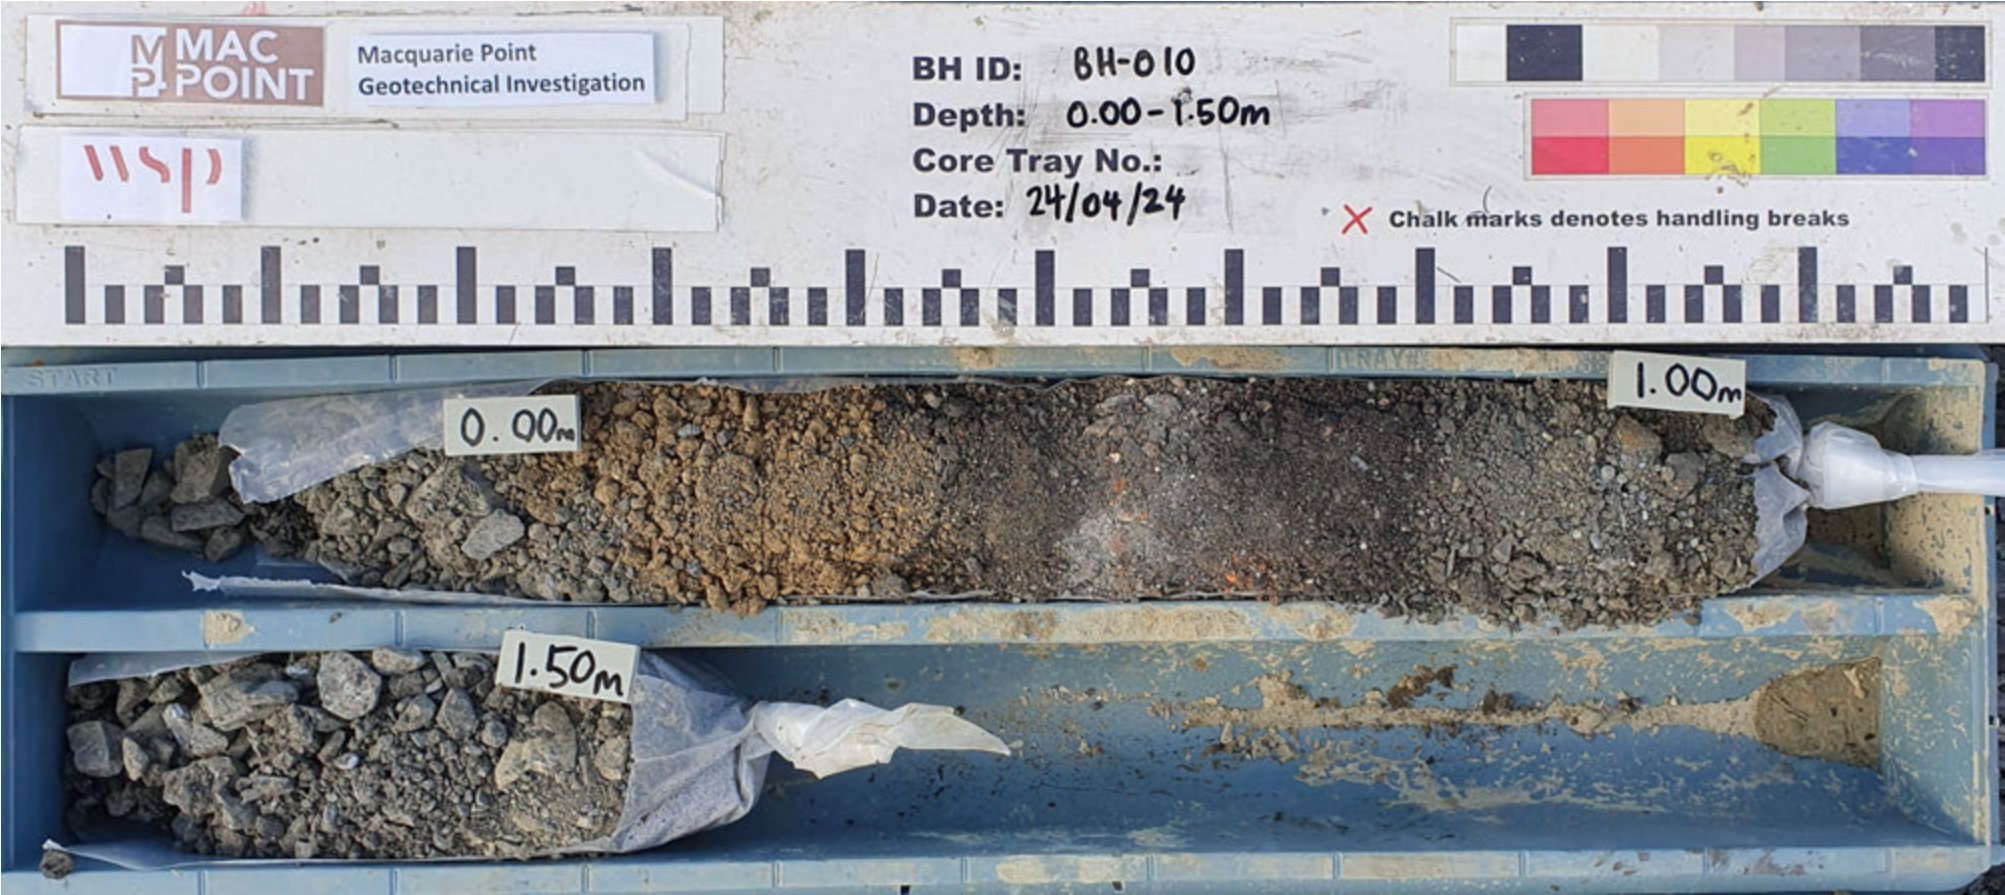
PointID : BH-010 Depth Range: 0.00 - 1.50 m

| | TITLE<br><br>MPDC<br>Macquarie Point<br>Macquarie Point GI<br>Core Photo - BH-010 | DRAWN | DATE<br>18/6/2024 |

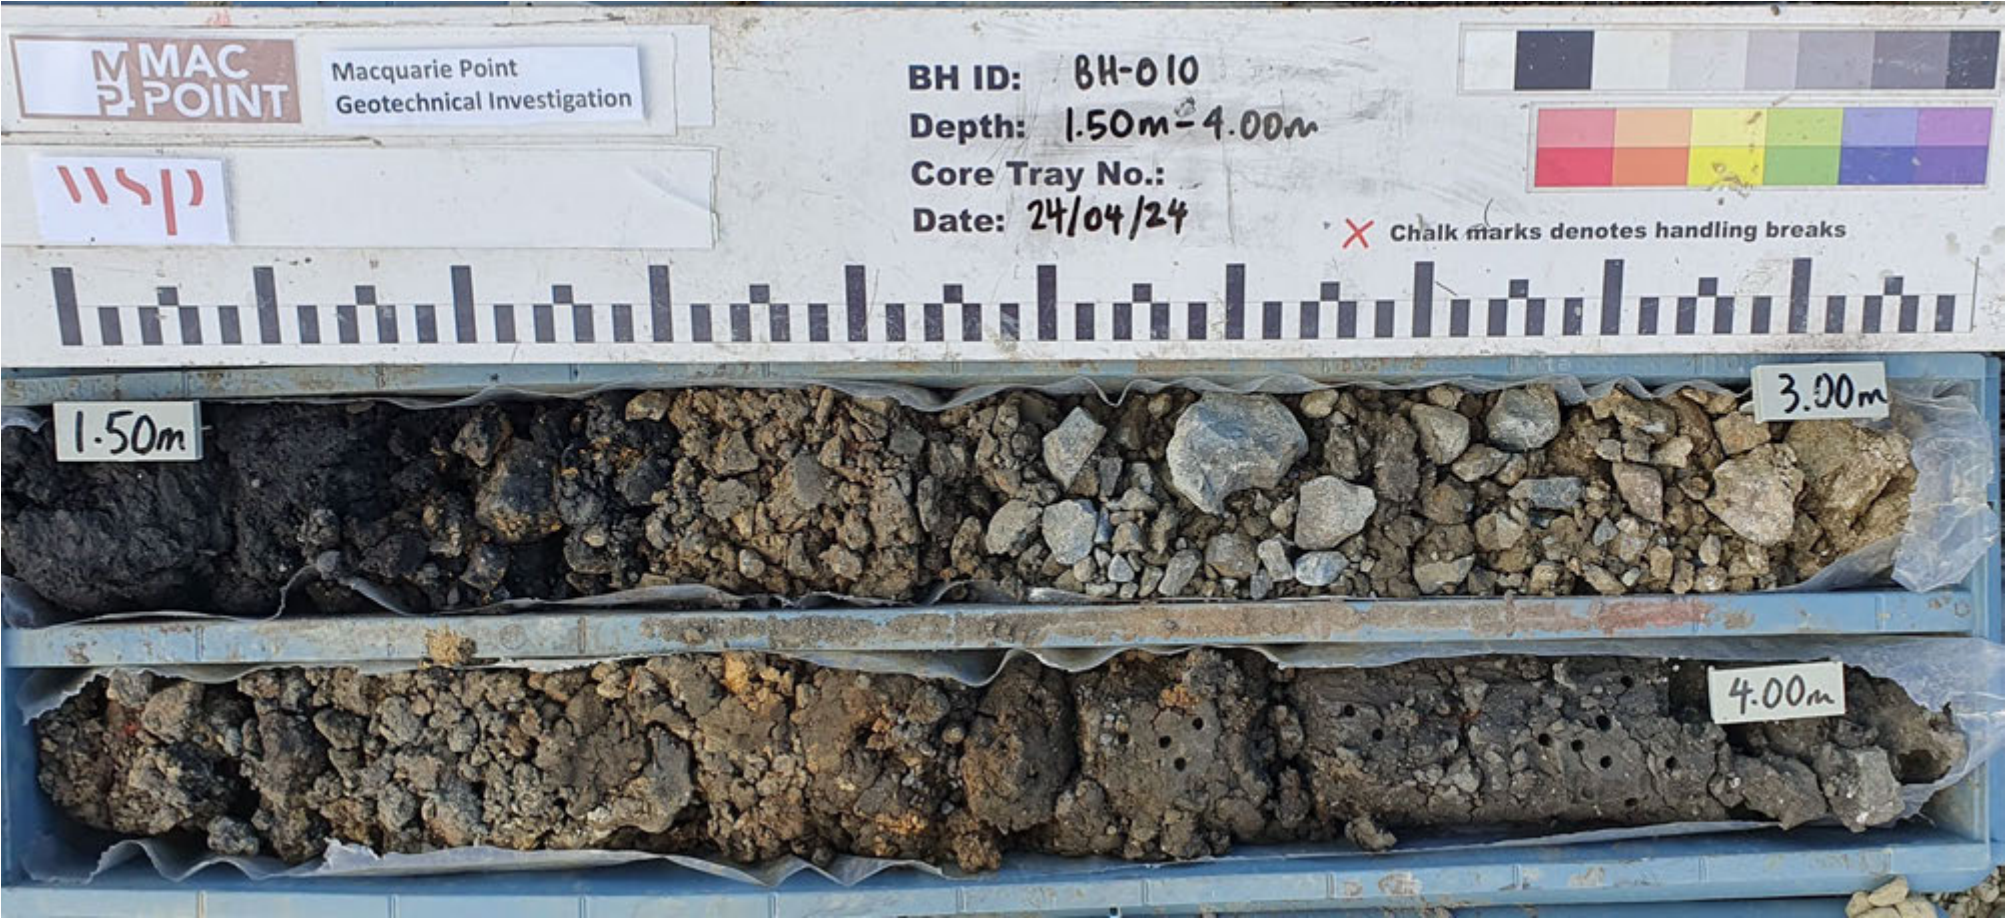
PointID : BH-010 Depth Range: 1.50 - 4.00 m

| | TITLE<br><br>MPDC<br>Macquarie Point<br>Macquarie Point GI<br>Core Photo - BH-010 | DRAWN | DATE<br>18/6/2024 | |

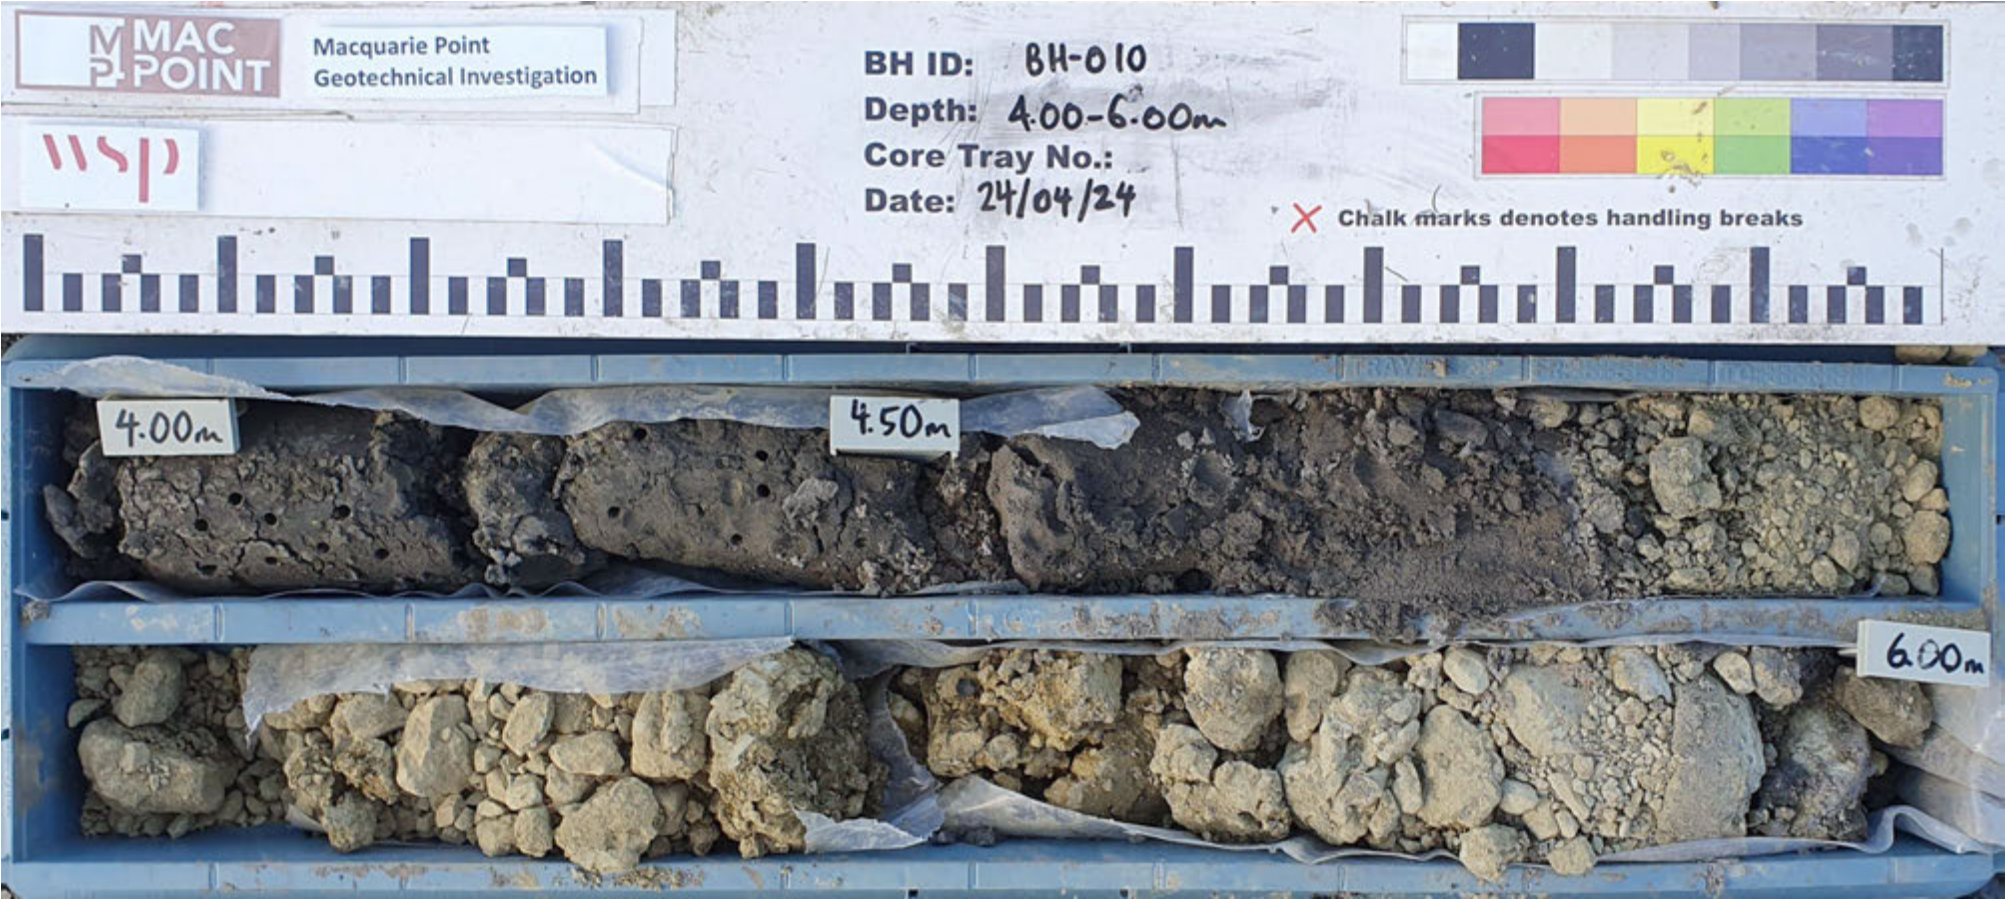
PointID : BH-010 Depth Range: 4.00 - 6.00 m

| | TITLE<br><br>MPDC<br>Macquarie Point<br>Macquarie Point GI<br>Core Photo - BH-010 | DRAWN | DATE<br>18/6/2024 |

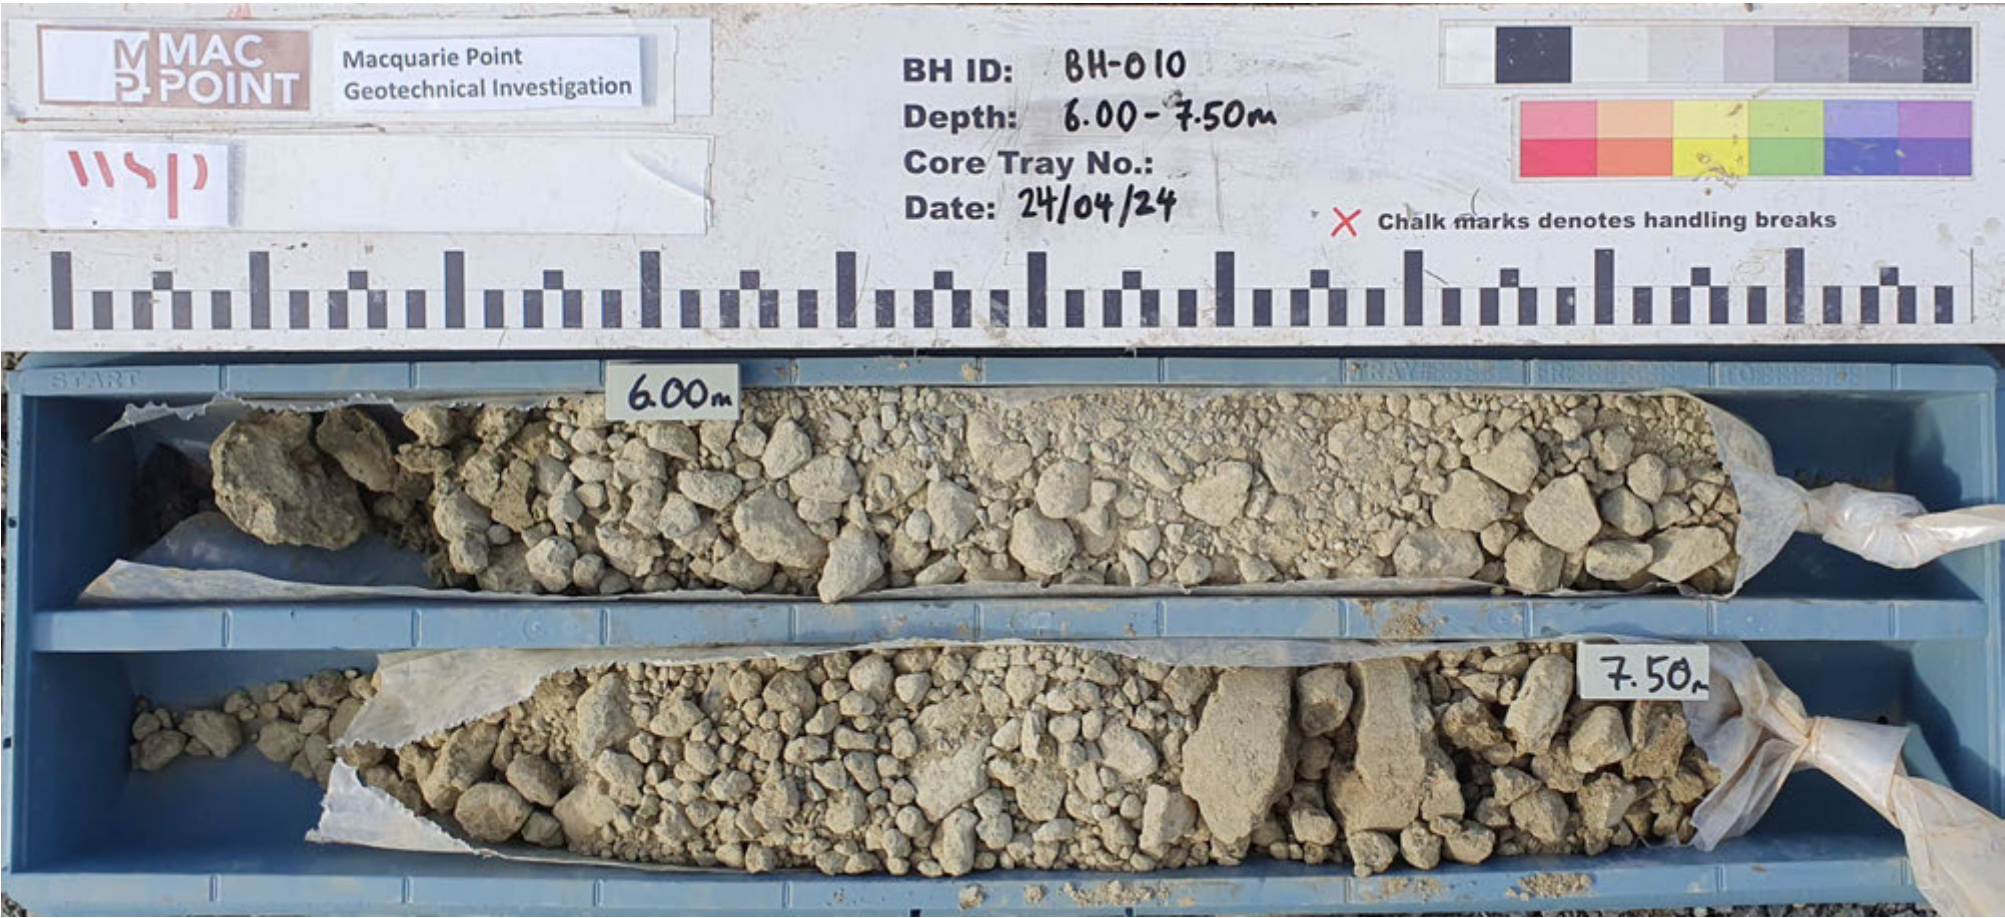
PointID : BH-010 Depth Range: 6.00 - 7.50 m

| | TITLE<br><br>MPDC<br>Macquarie Point<br>Macquarie Point GI<br>Core Photo - BH-010 | DRAWN | DATE<br>18/6/2024 | |

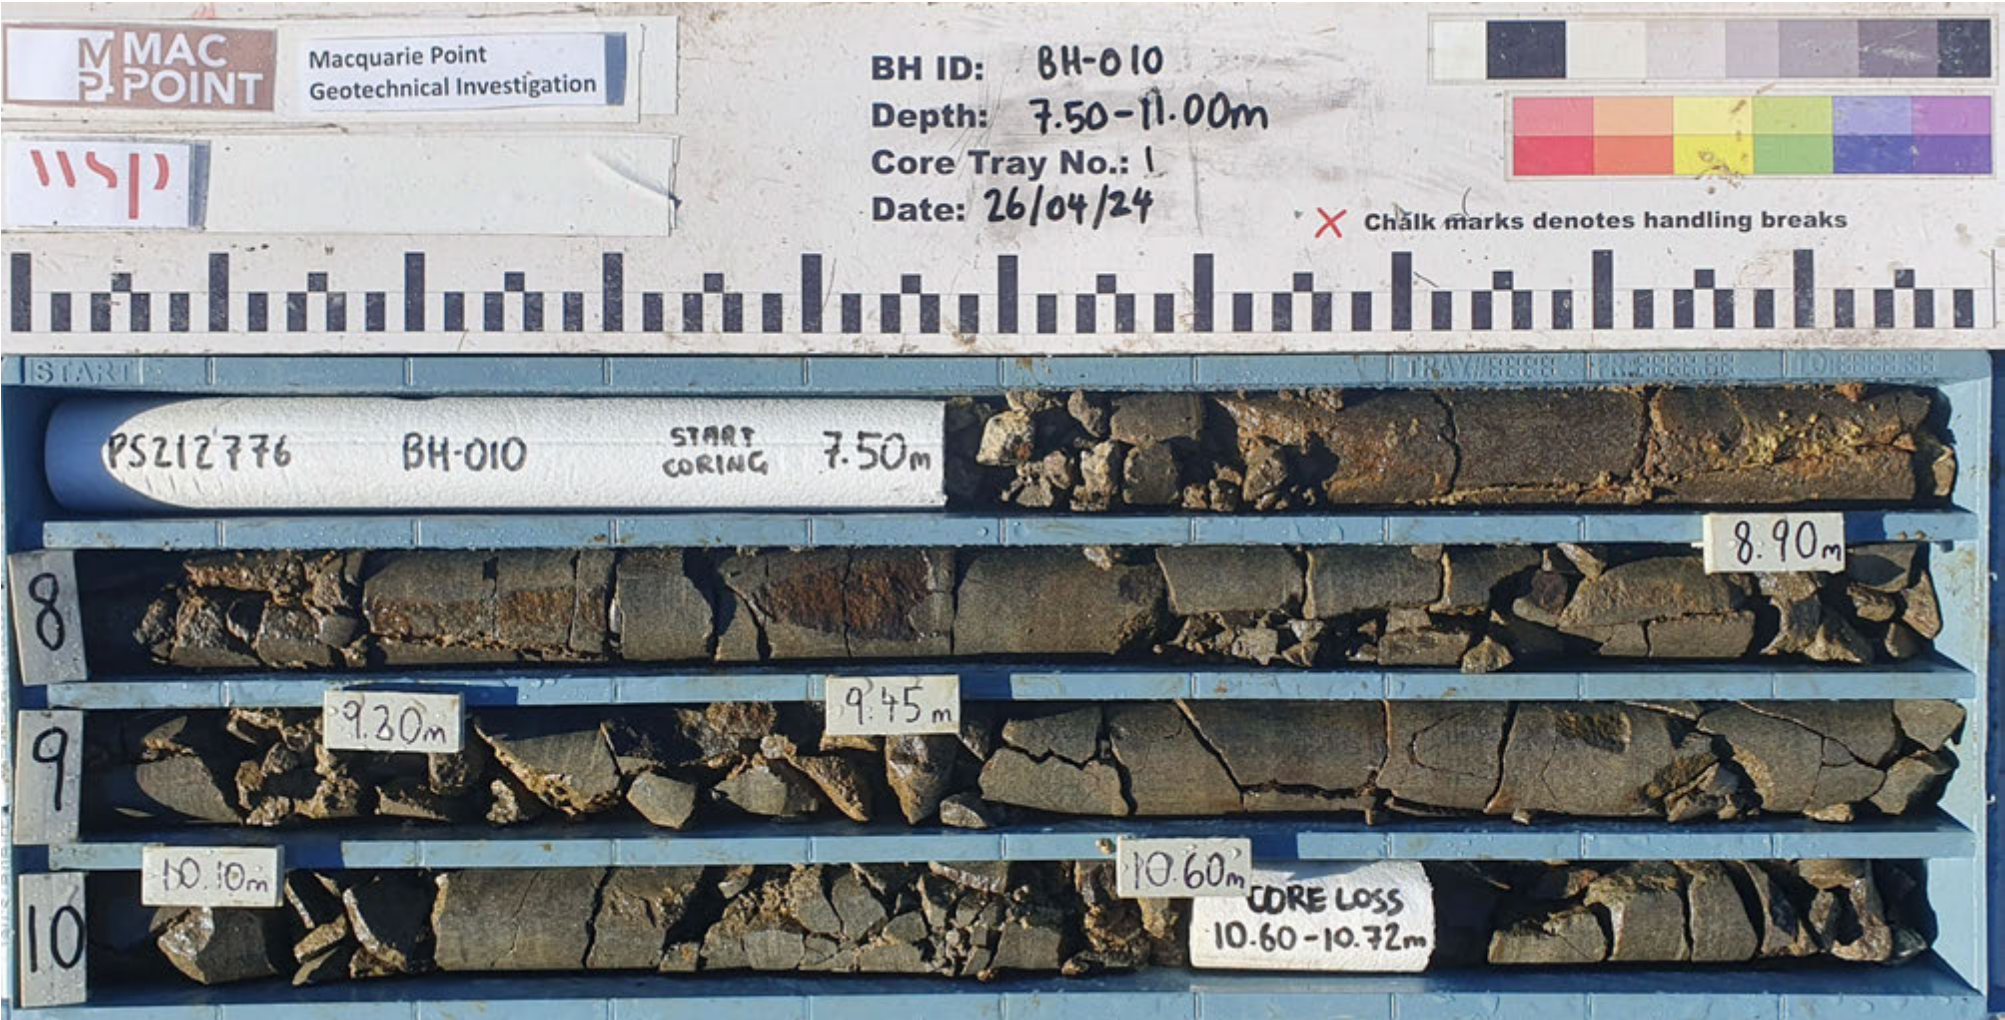
PointID : BH-010 Depth Range: 7.50 - 11.00 m

| | TITLE<br><br>MPDC<br>Macquarie Point<br>Macquarie Point GI<br>Core Photo - BH-010 | DRAWN | DATE<br>18/6/2024 |

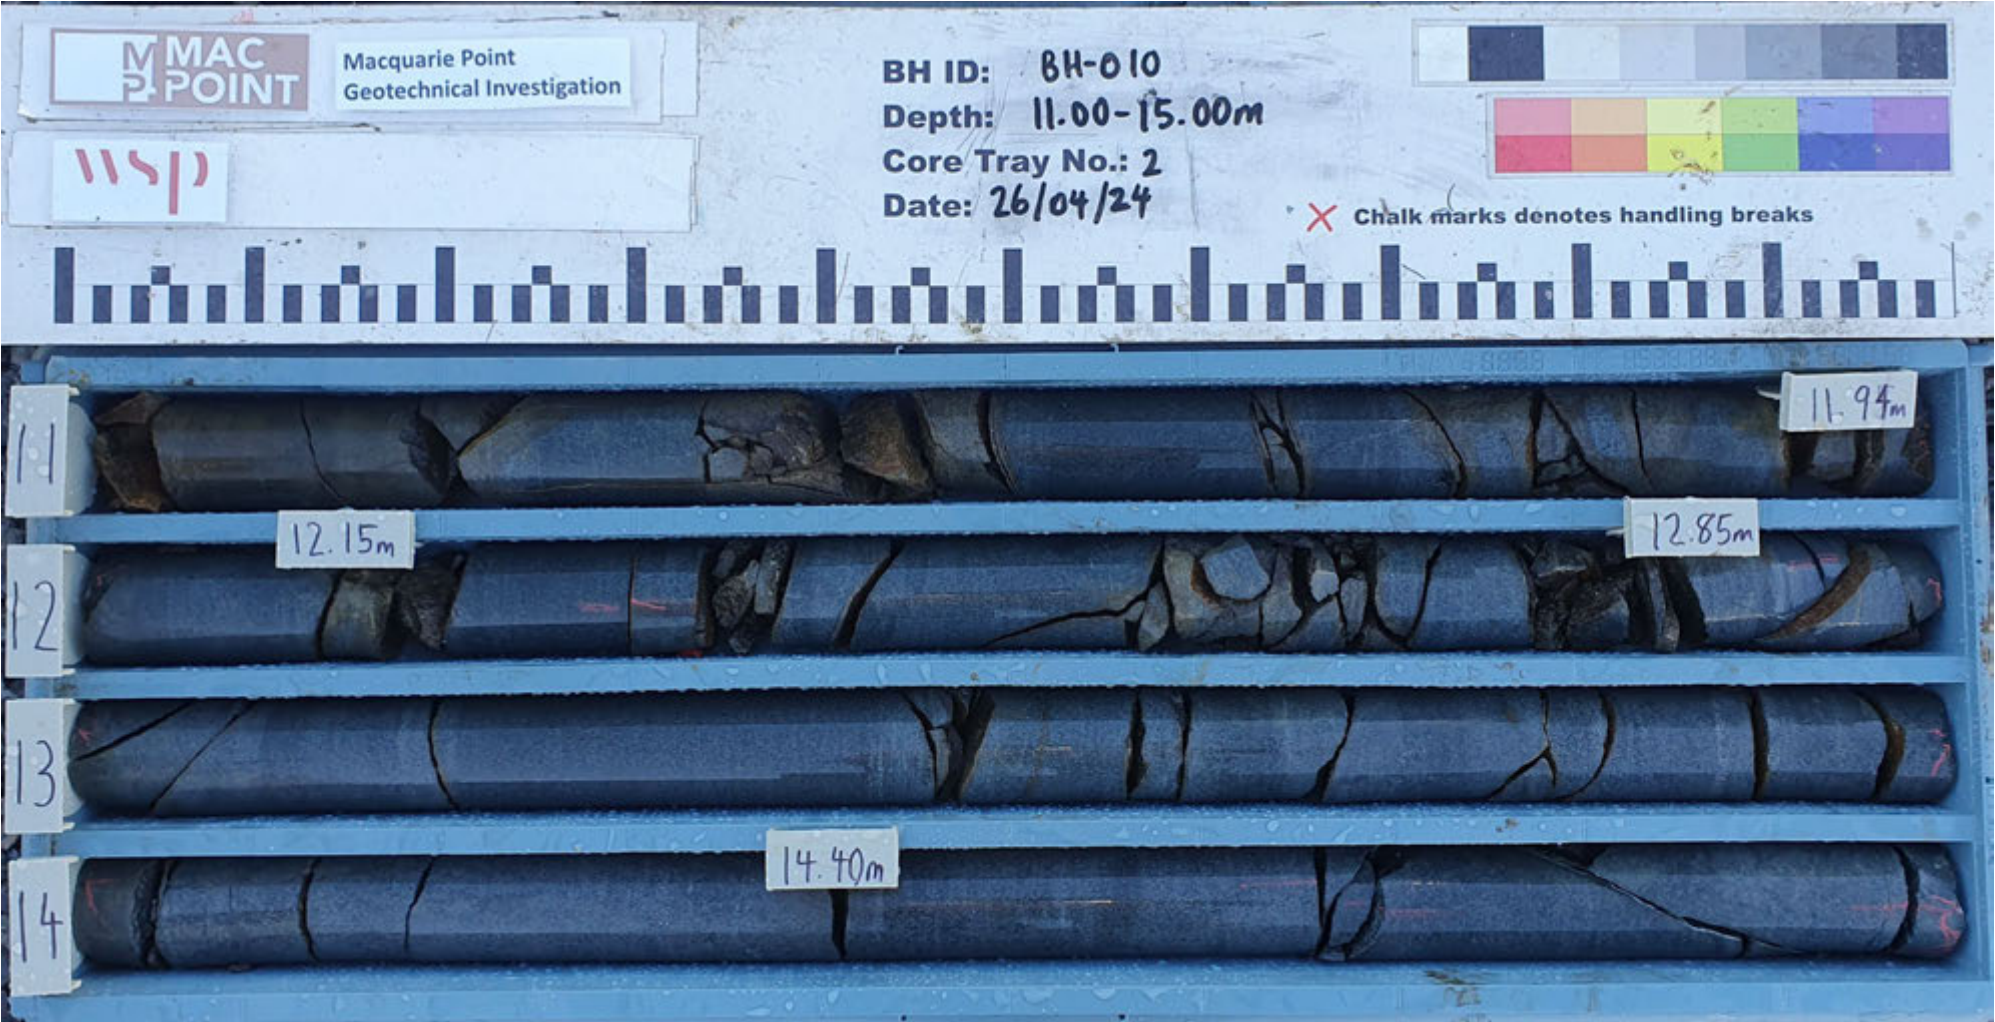
PointID : BH-010 Depth Range: 11.00 - 15.00 m

| | TITLE<br><br>MPDC<br>Macquarie Point<br>Macquarie Point GI<br>Core Photo - BH-010 | DRAWN | DATE<br>18/6/2024 |

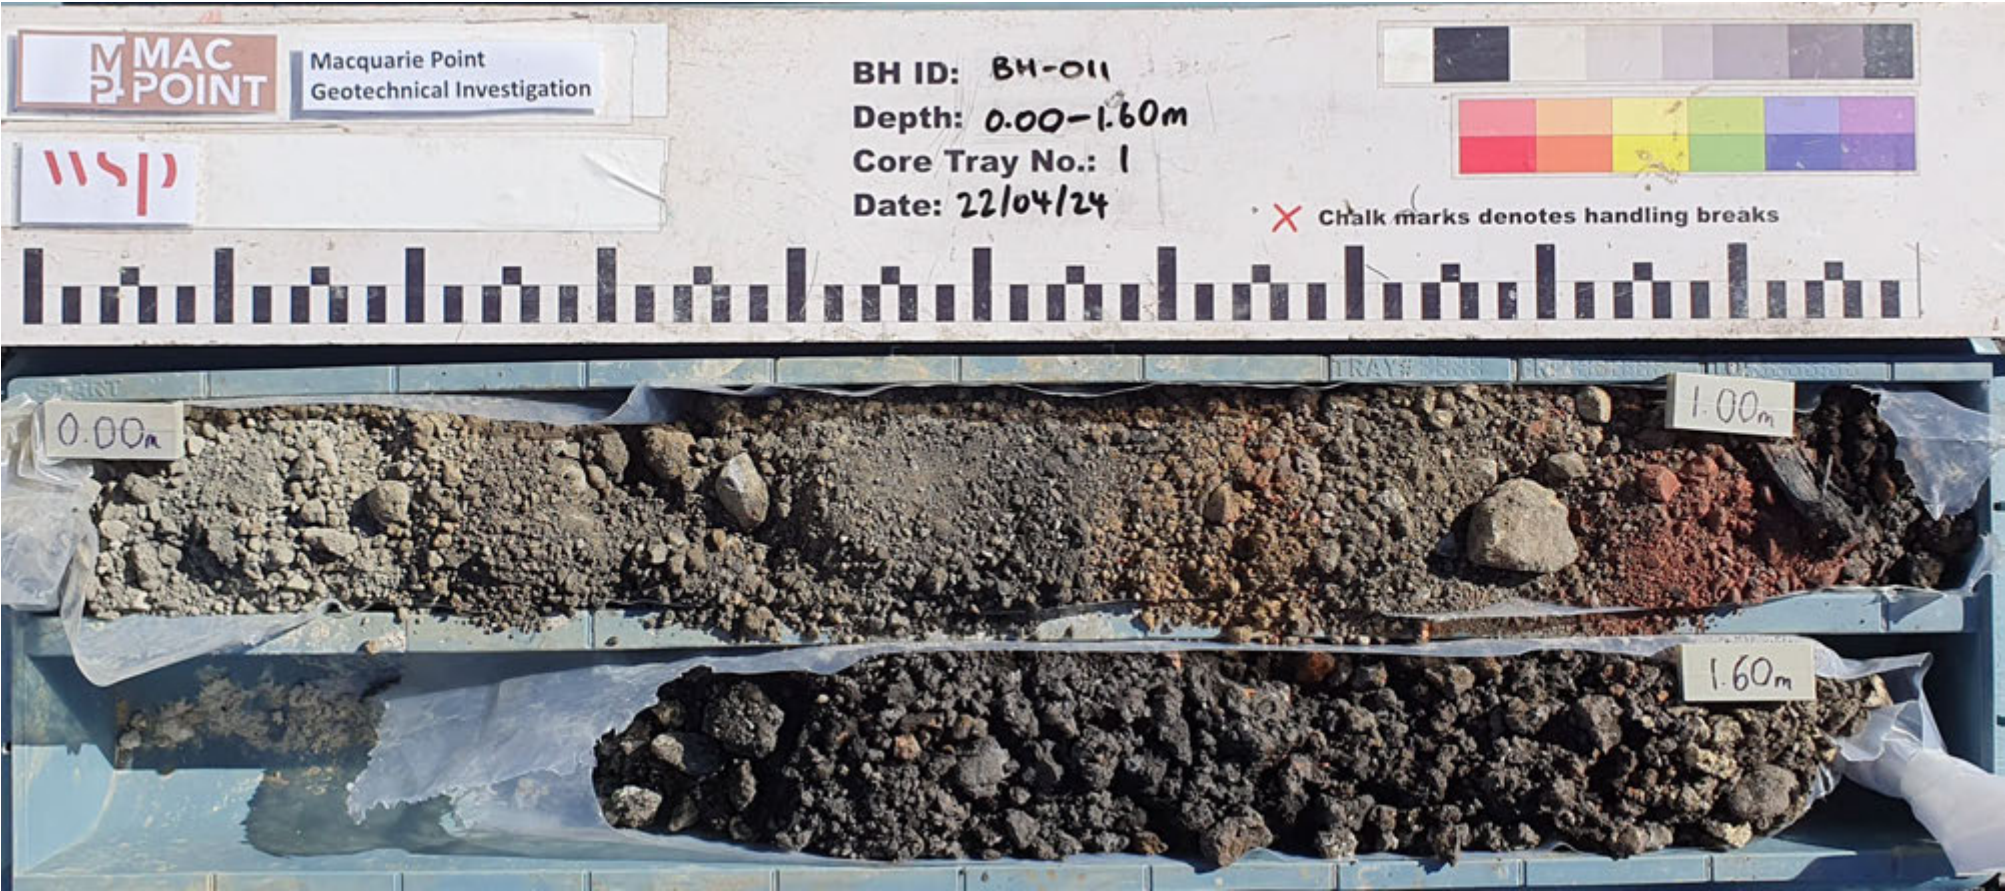
PointID : BH-011 Depth Range: 0.00 - 1.60 m

| | TITLE<br><br>MPDC<br>Macquarie Point<br>Macquarie Point GI<br>Core Photo - BH-011 | DRAWN | DATE<br>18/6/2024 |

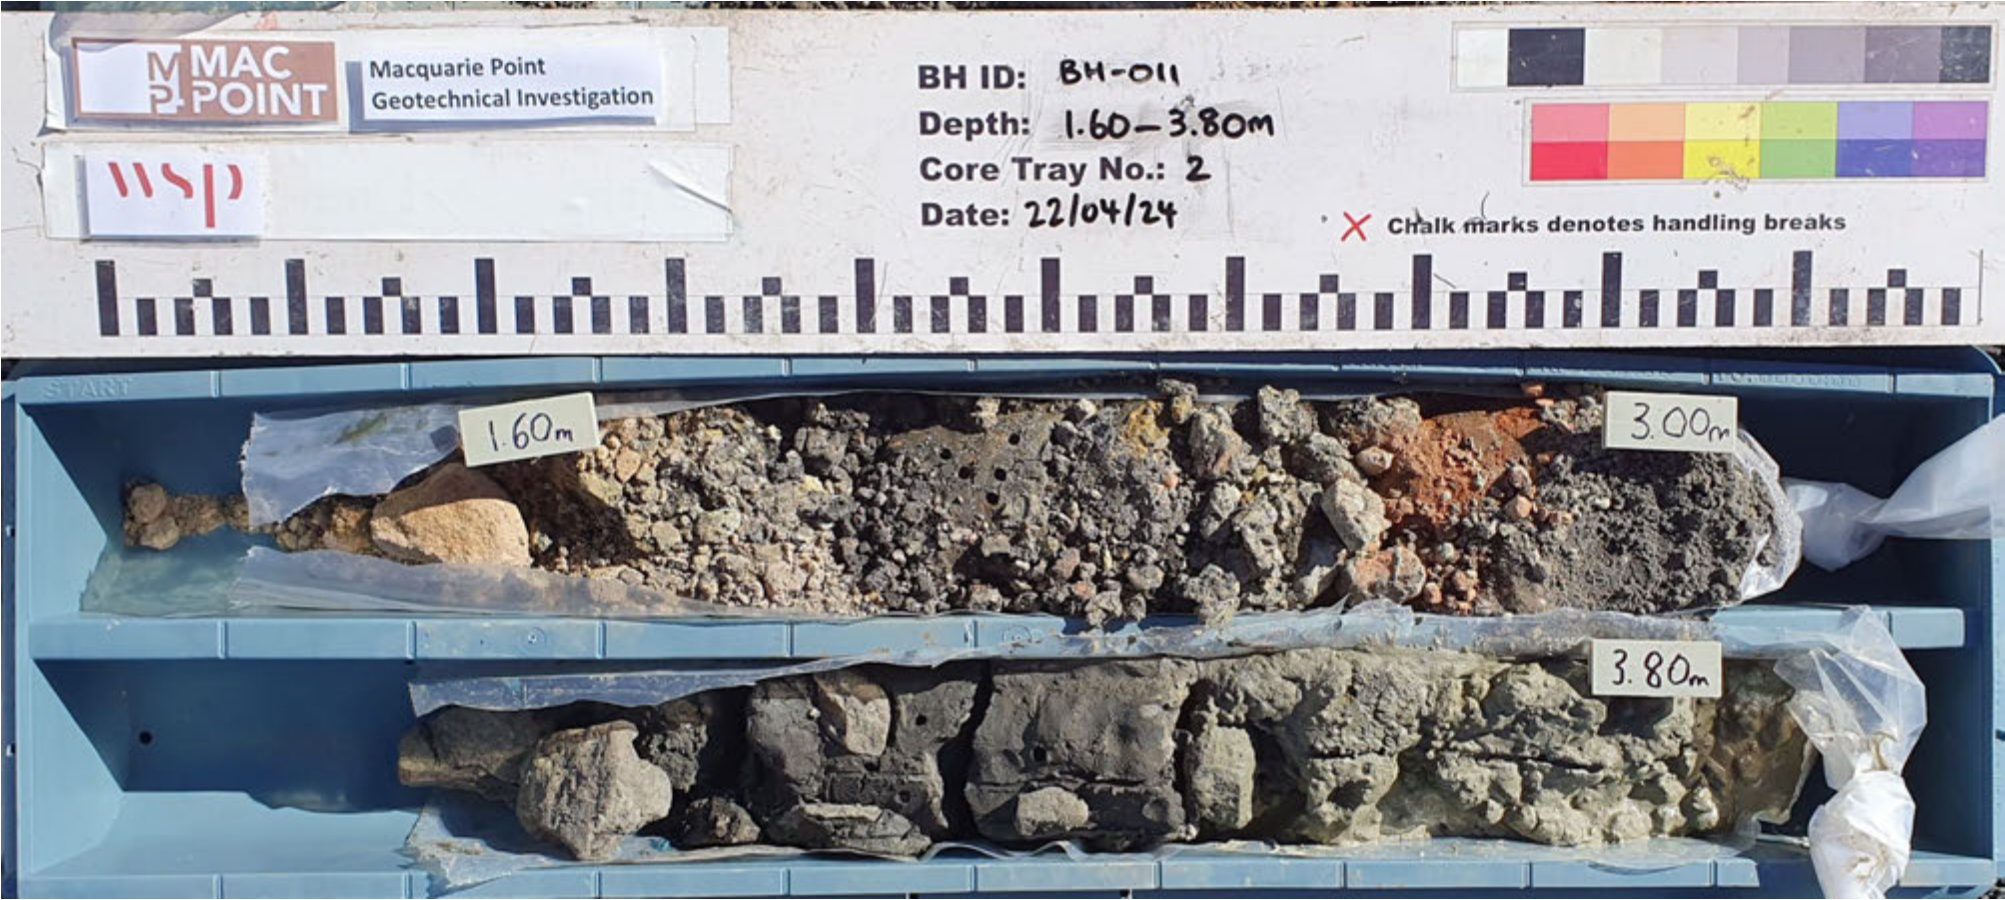
PointID : BH-011 Depth Range: 1.60 - 3.80 m

| | TITLE<br><br>MPDC<br>Macquarie Point<br>Macquarie Point GI<br>Core Photo - BH-011 | DRAWN | DATE<br>18/6/2024 |

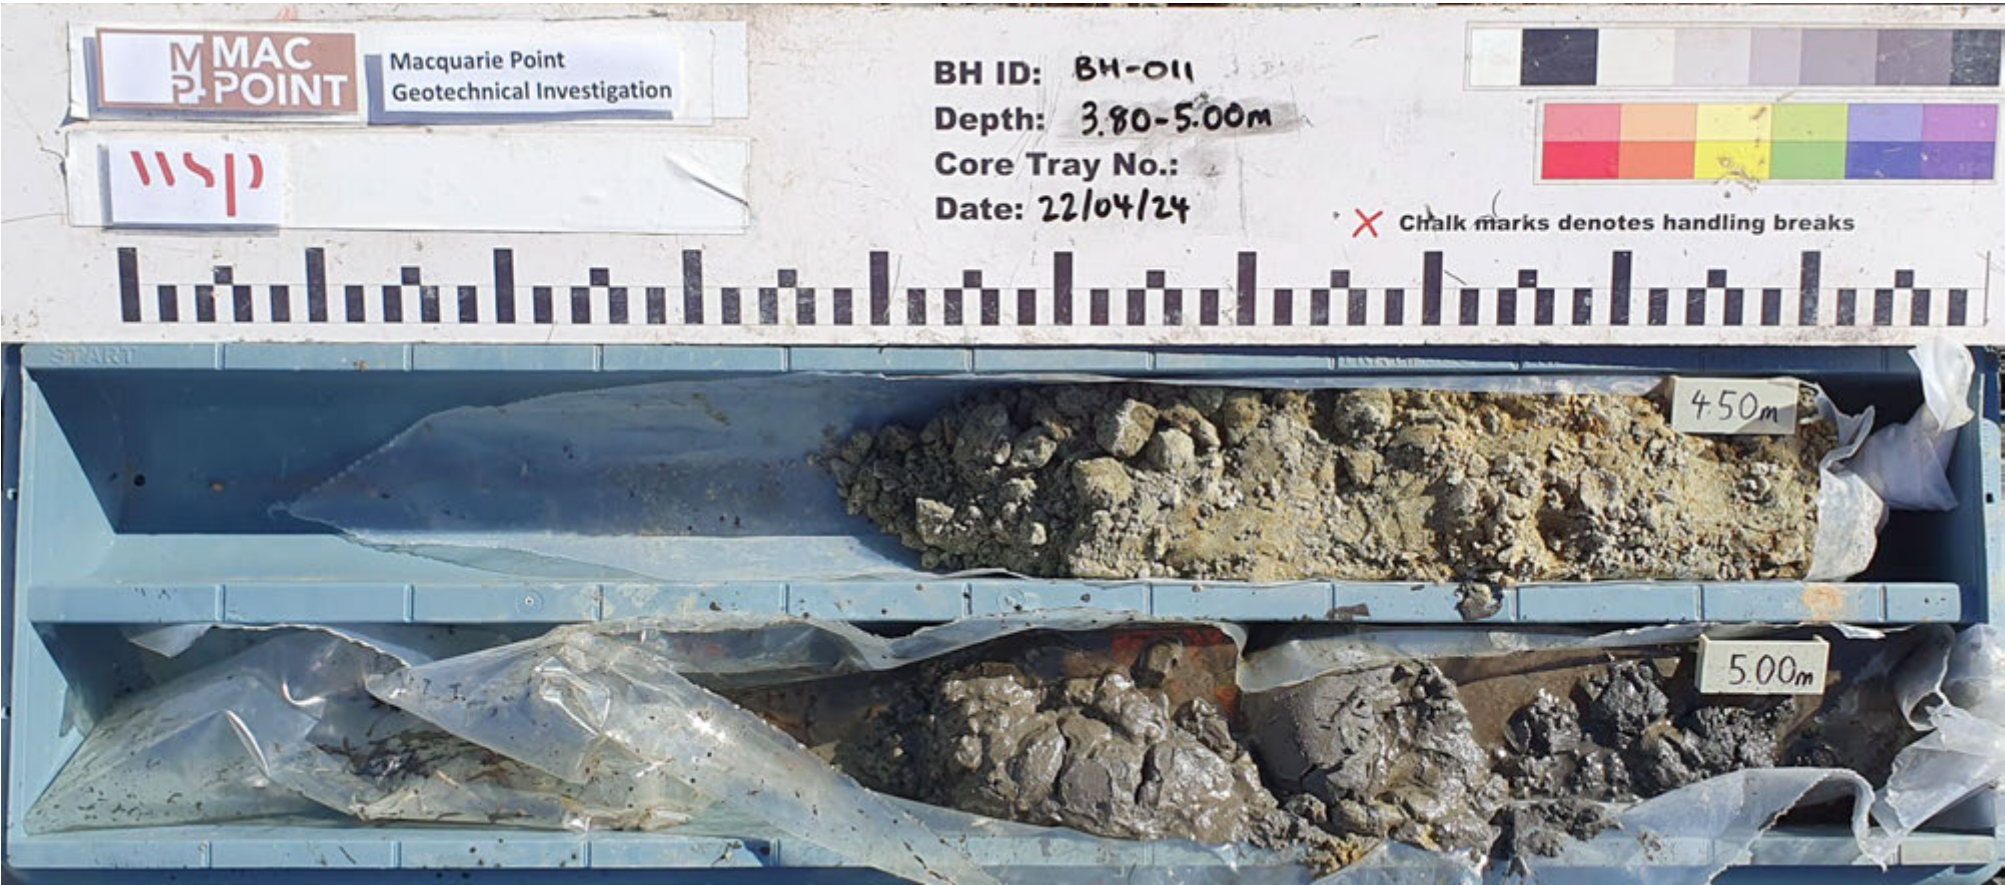
PointID : BH-011 Depth Range: 3.80 - 5.00 m

| | TITLE<br><br>MPDC<br>Macquarie Point<br>Macquarie Point GI<br>Core Photo - BH-011 | DRAWN | DATE<br>18/6/2024 |

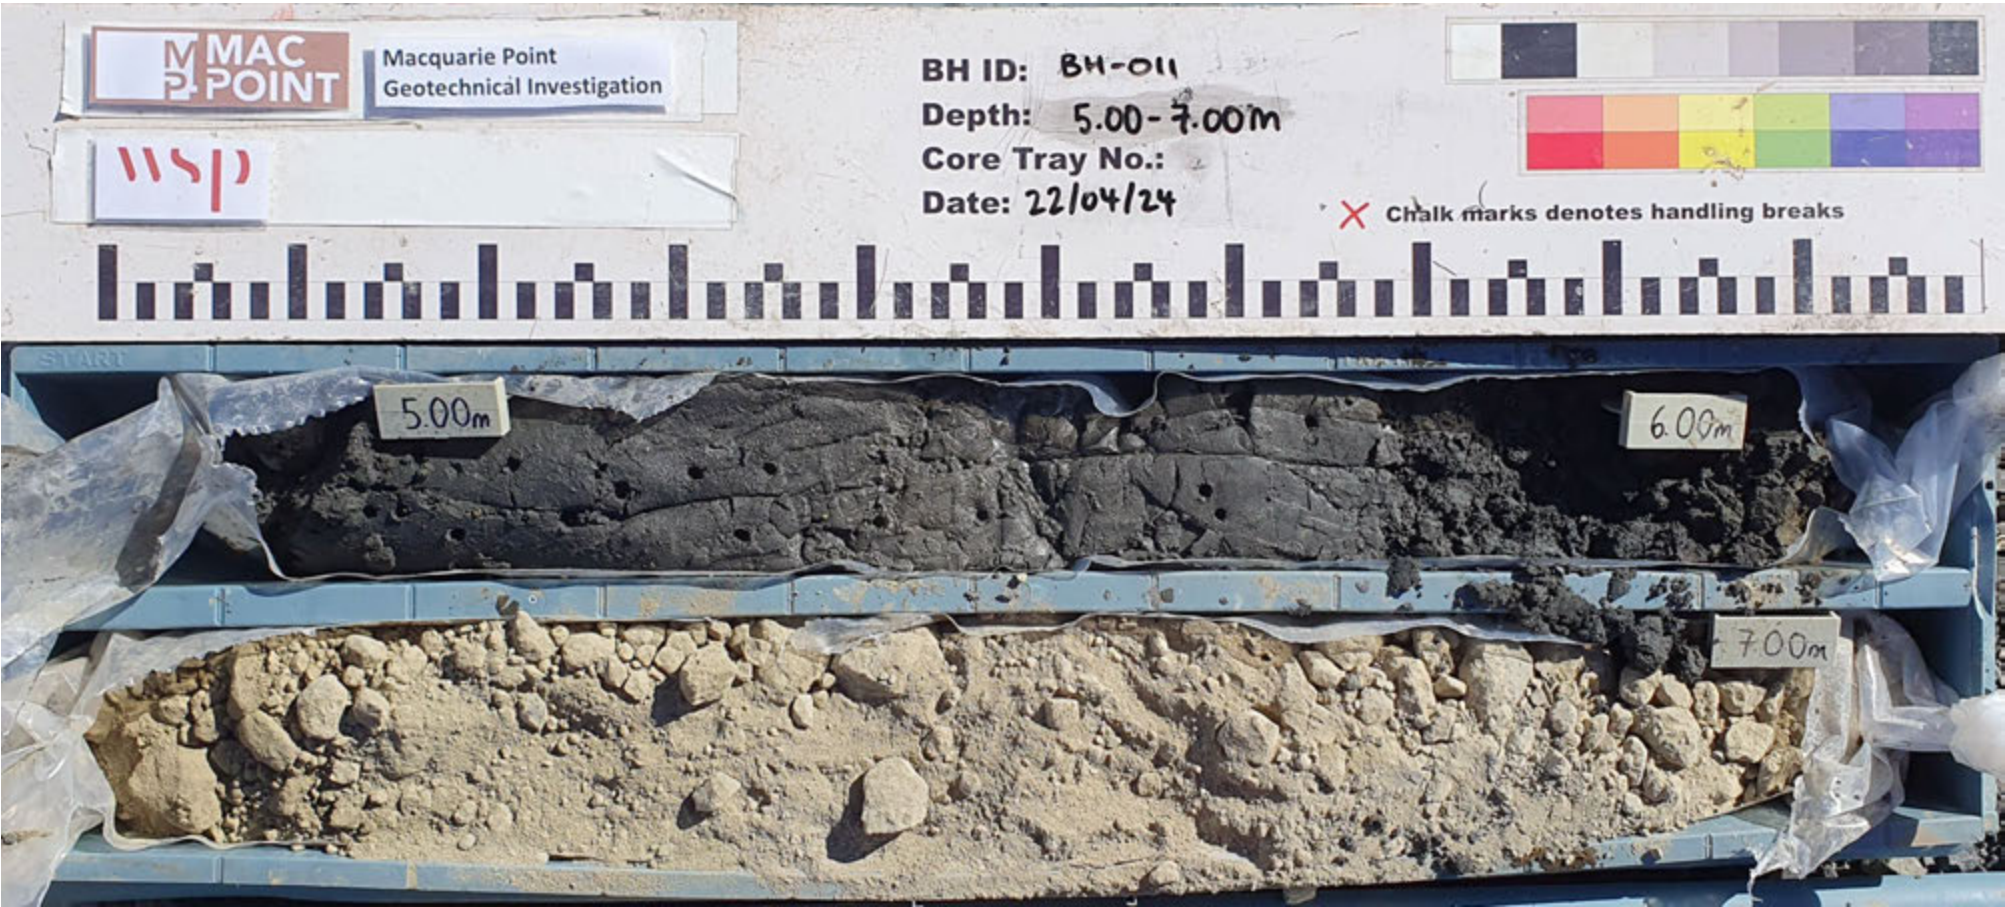
PointID : BH-011 Depth Range: 5.00 - 7.00 m

| | TITLE<br><br>MPDC<br>Macquarie Point<br>Macquarie Point GI<br>Core Photo - BH-011 | DRAWN | DATE<br>18/6/2024 |

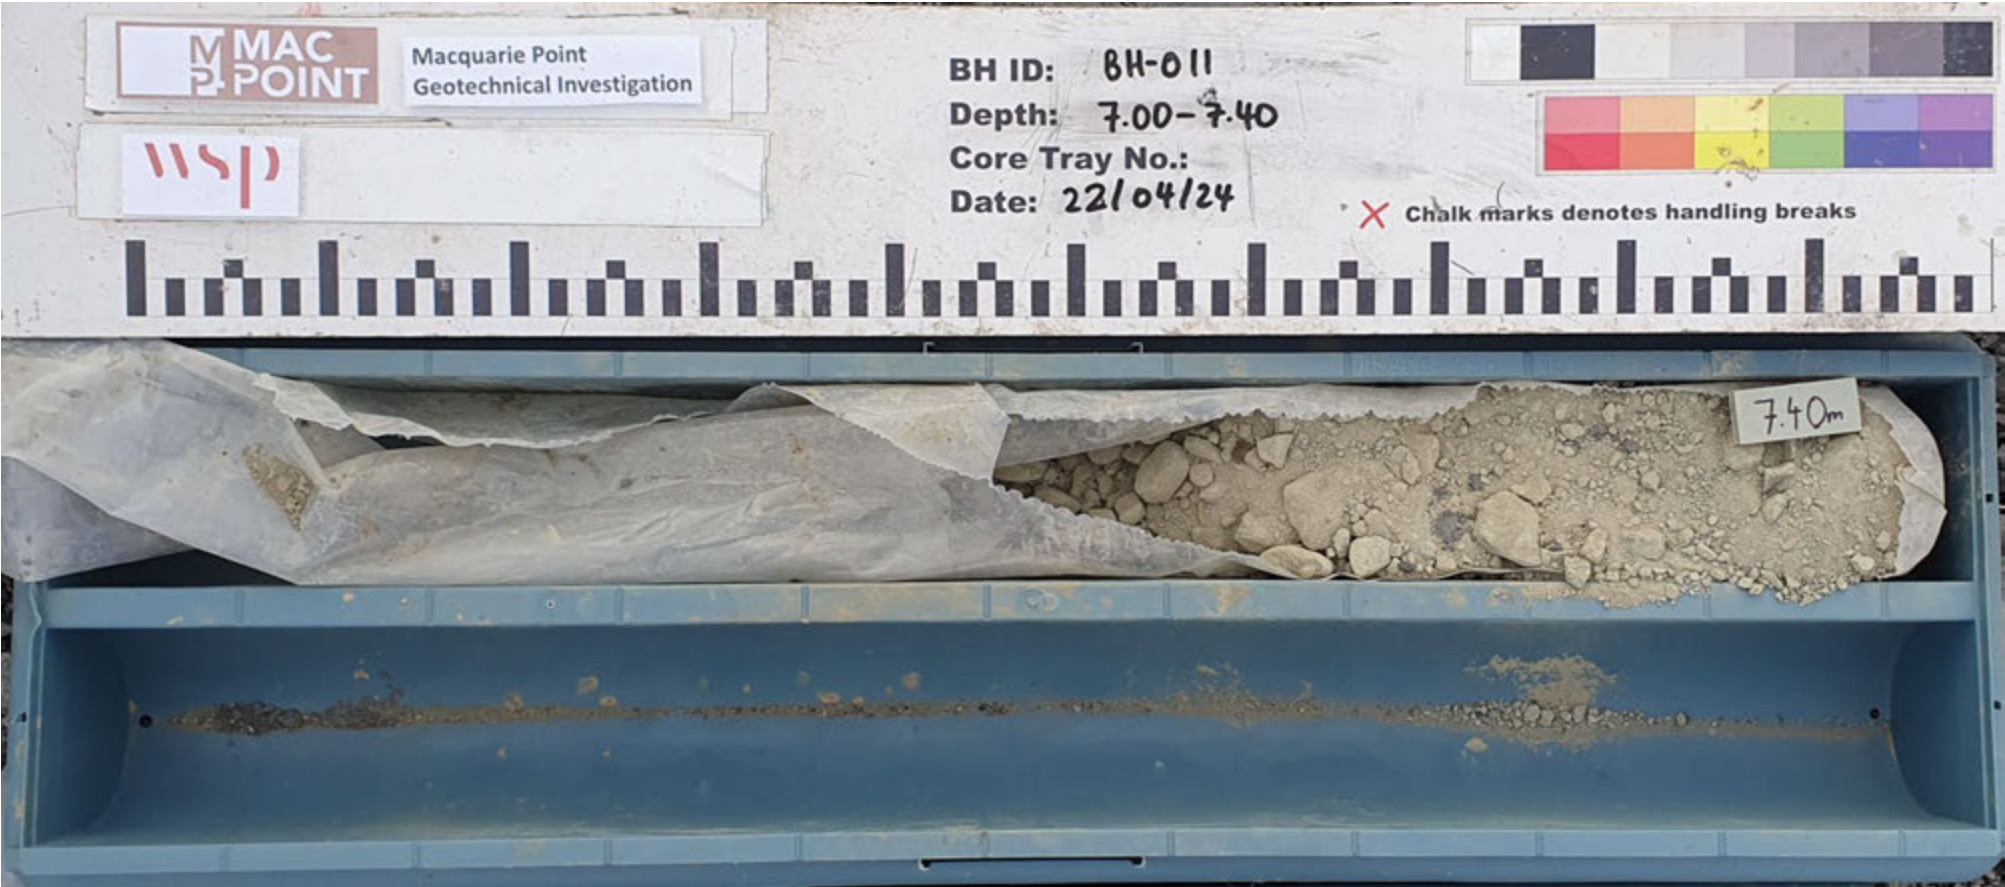
PointID : BH-011 Depth Range: 7.00 - 7.40 m

| | TITLE<br><br>MPDC<br>Macquarie Point<br>Macquarie Point GI<br>Core Photo - BH-011 | DRAWN | DATE<br>18/6/2024 |

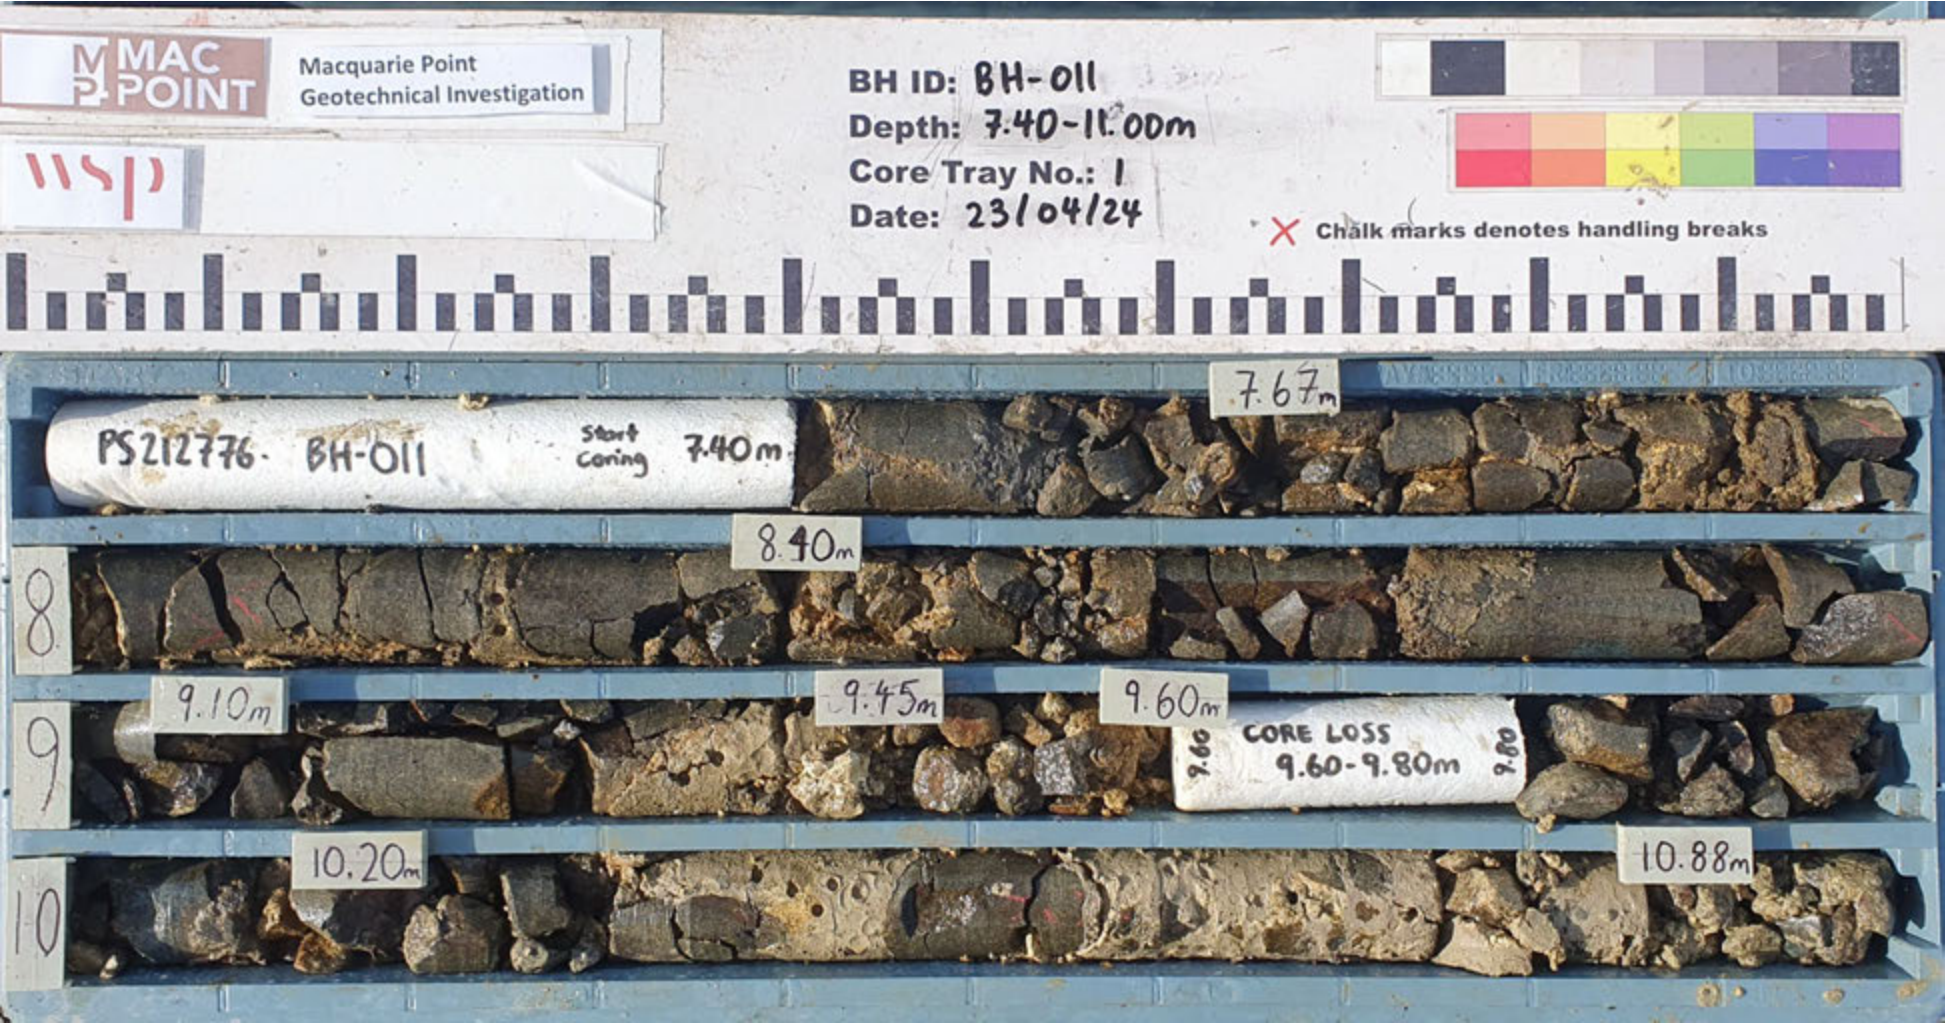
PointID : BH-011 Depth Range: 7.40 - 11.00 m

| | TITLE<br><br>MPDC<br>Macquarie Point<br>Macquarie Point GI<br>Core Photo - BH-011 | DRAWN | DATE<br>18/6/2024 |
