# Macquarie Point Stadium Development

## Geotechnical Factual Report

June 2024

## Macquarie Point Stadium Development Geotechnical Factual Report

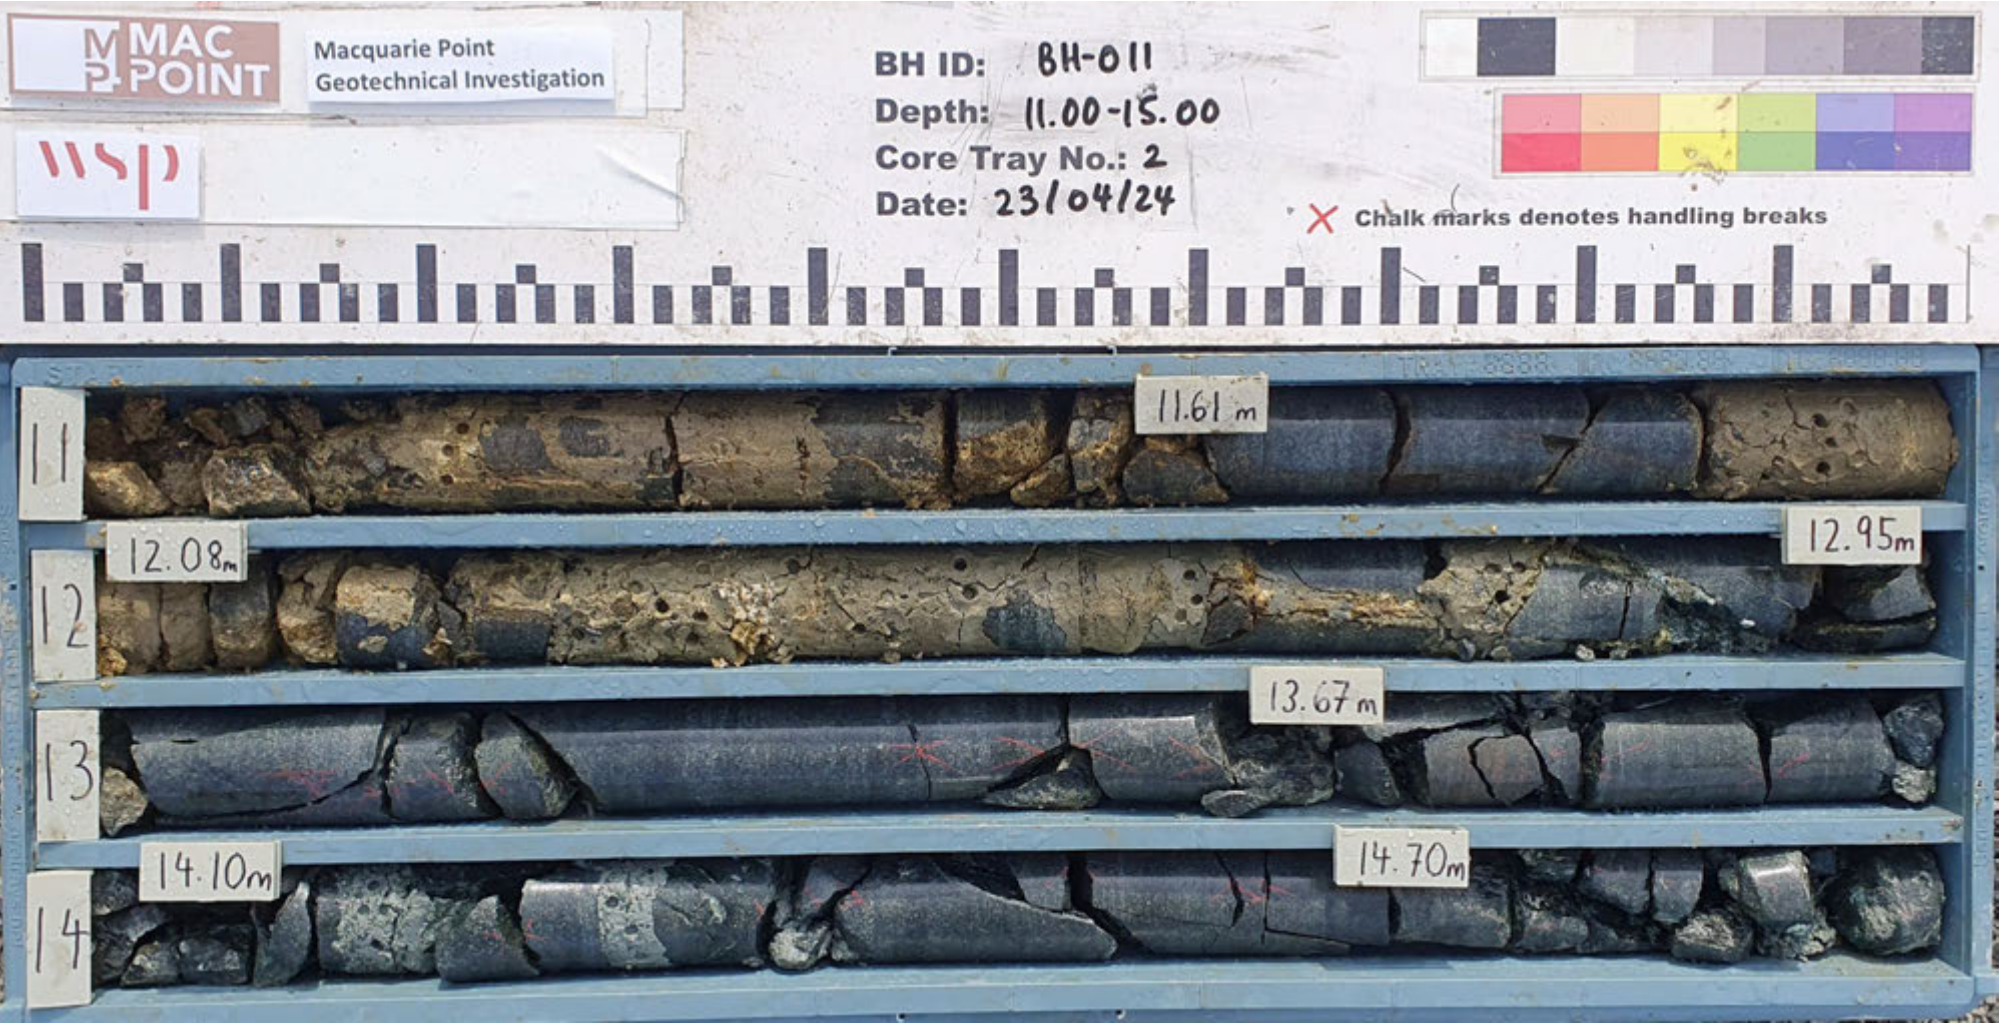
PointID : BH-011 Depth Range: 11.00 - 15.00 m

| | TITLE<br><br>MPDC<br>Macquarie Point<br>Macquarie Point GI<br>Core Photo - BH-011 | DRAWN | DATE<br>18/6/2024 |

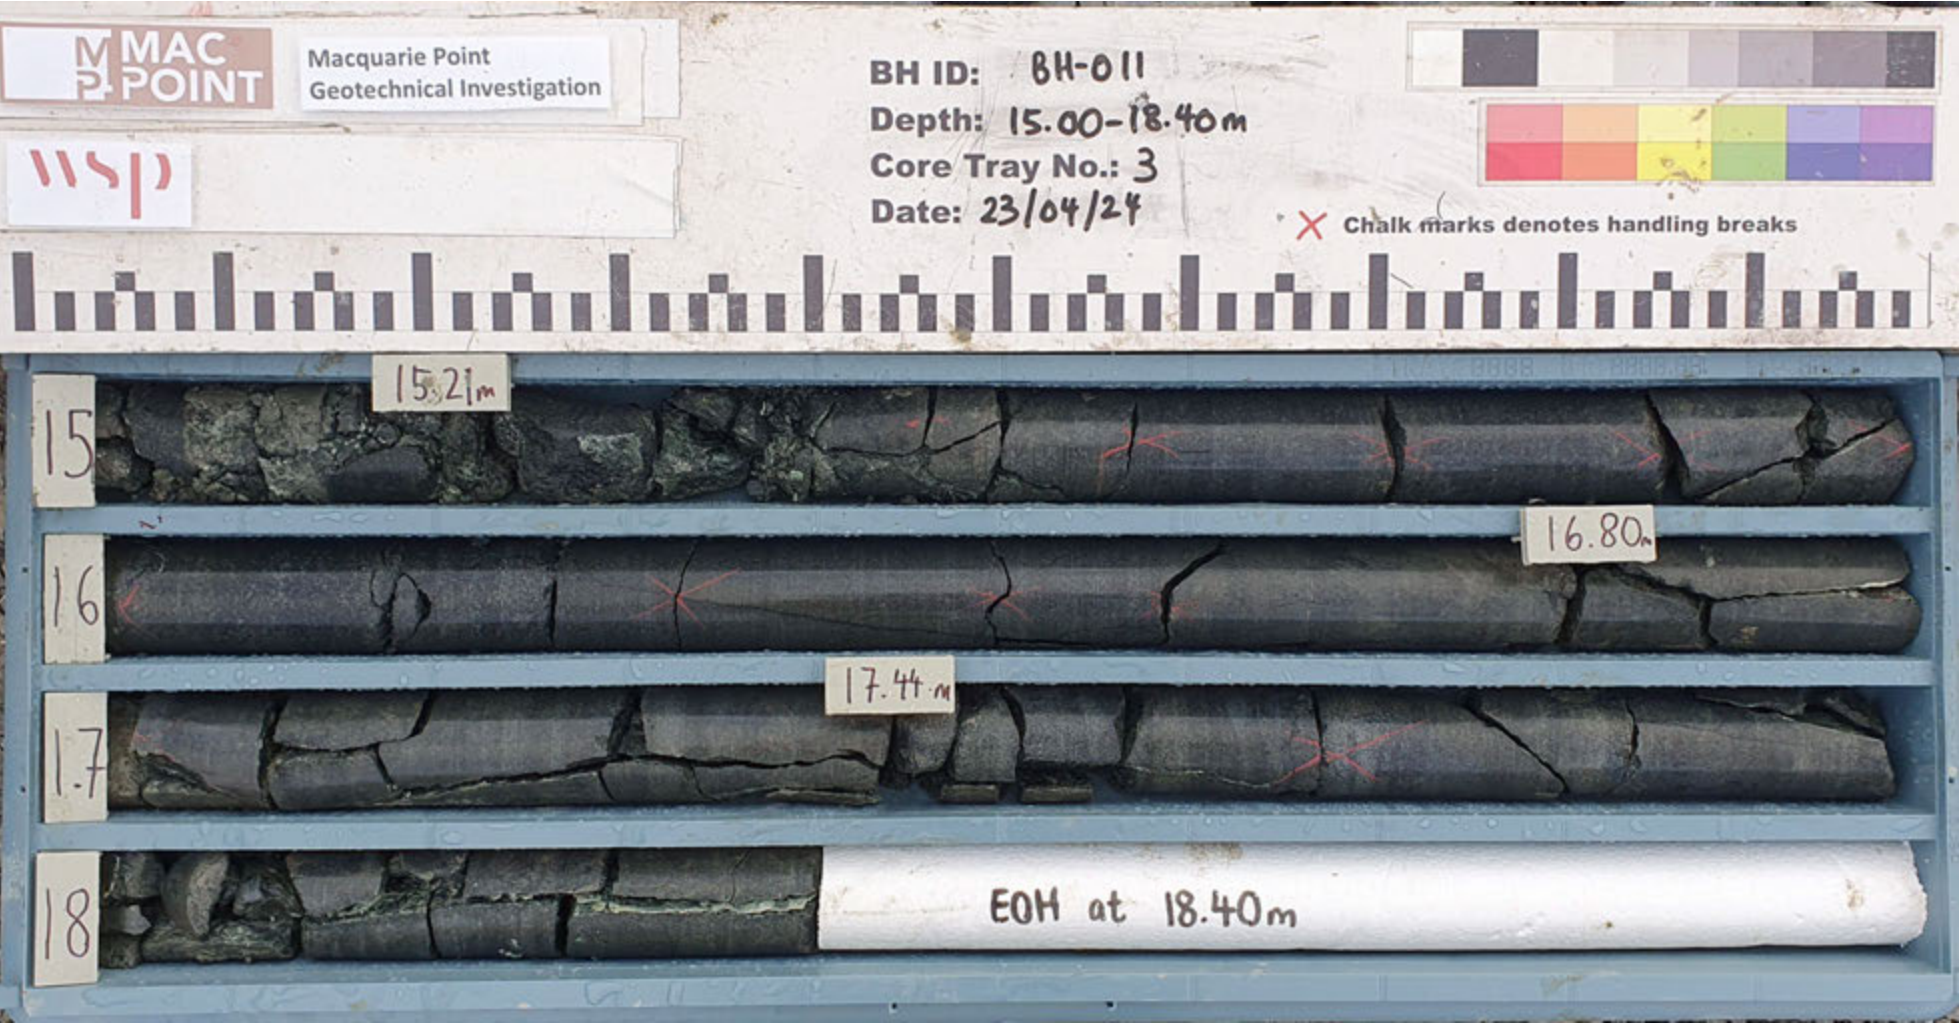
PointID : BH-011 Depth Range: 15.00 - 18.40 m

| | TITLE<br><br>MPDC<br>Macquarie Point<br>Macquarie Point GI<br>Core Photo - BH-011 | DRAWN | DATE<br>18/6/2024 |

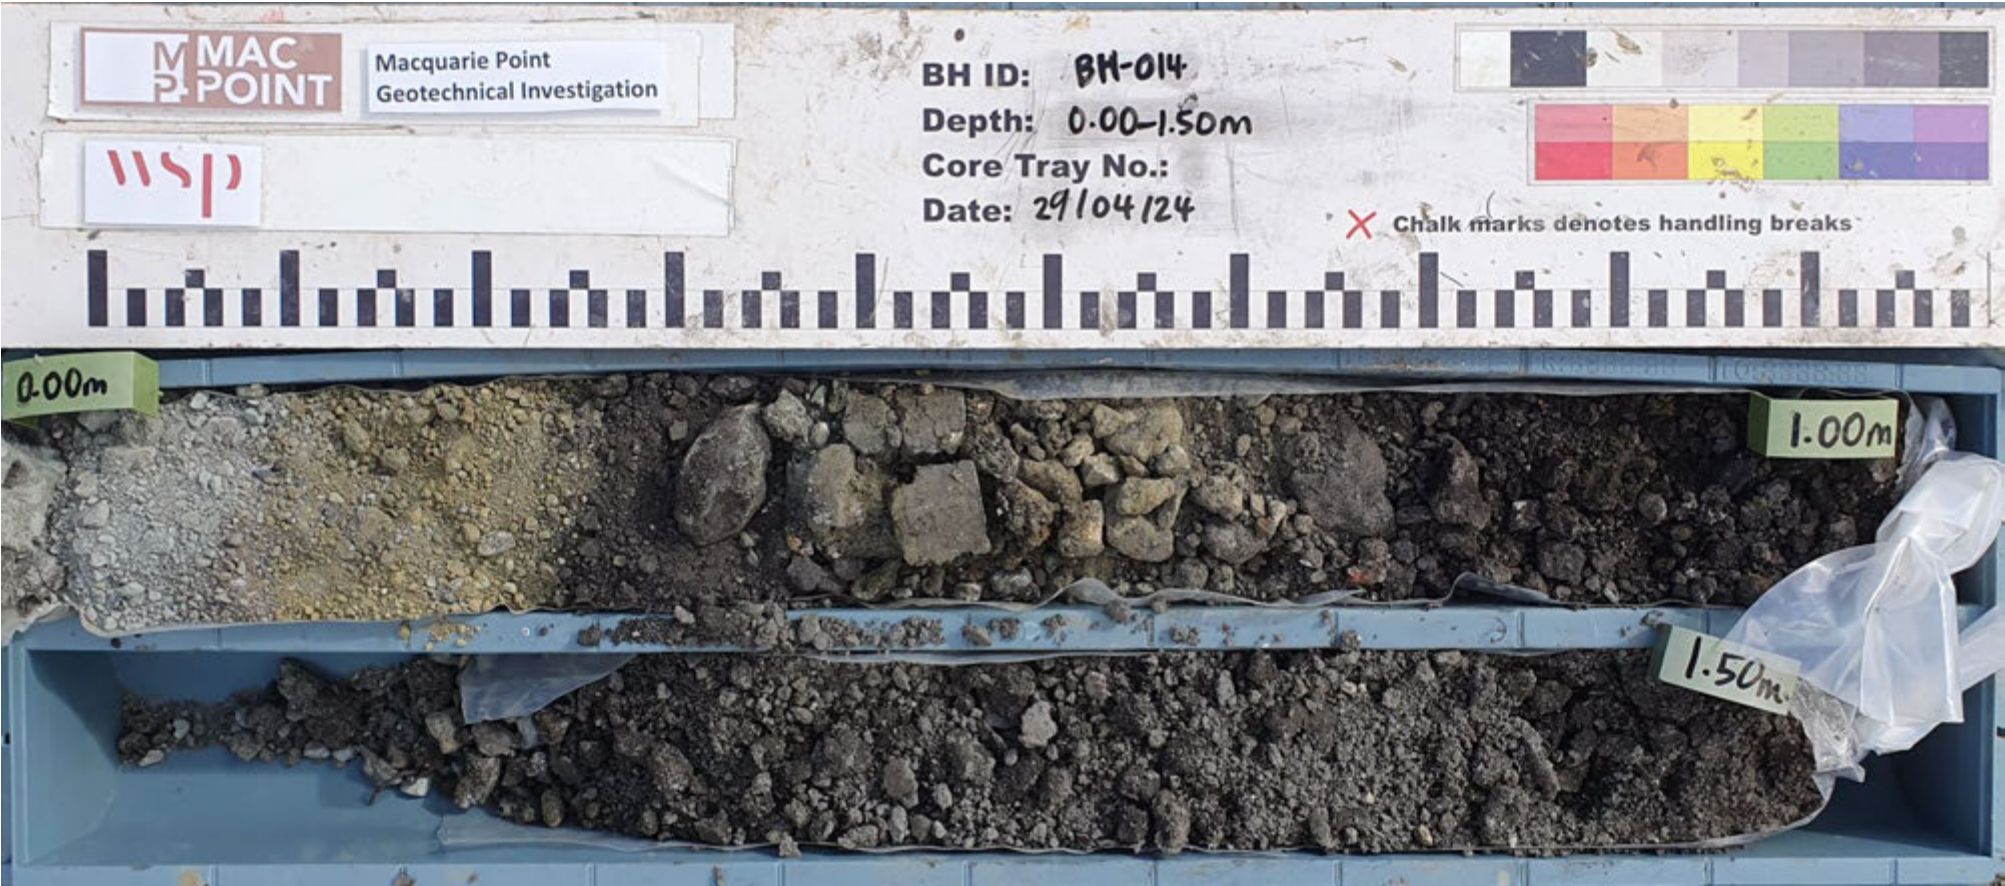
| | | PROJECT No<br>PS212776 | FIGURE No<br>1/8 |

PointID : BH-014 Depth Range: 0.00 - 1.50 m

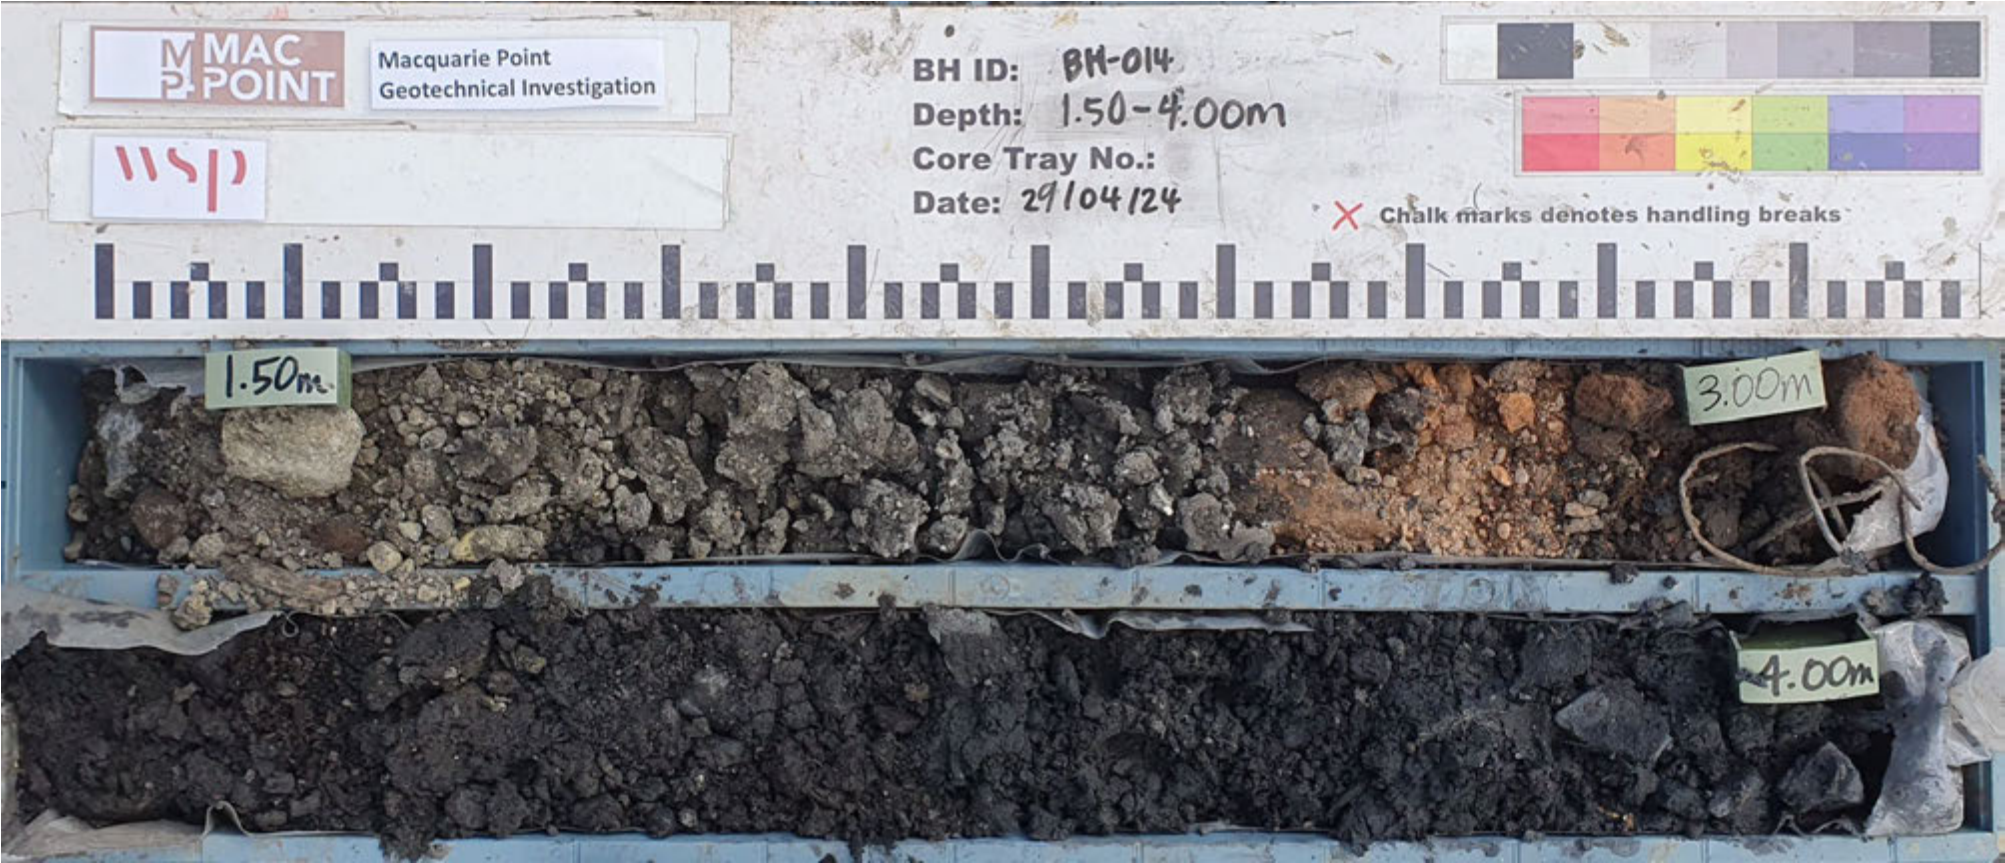
| | | PROJECT No<br>PS212776 | FIGURE No<br>2/8 |

PointID : BH-014 Depth Range: 1.50 - 4.00 m

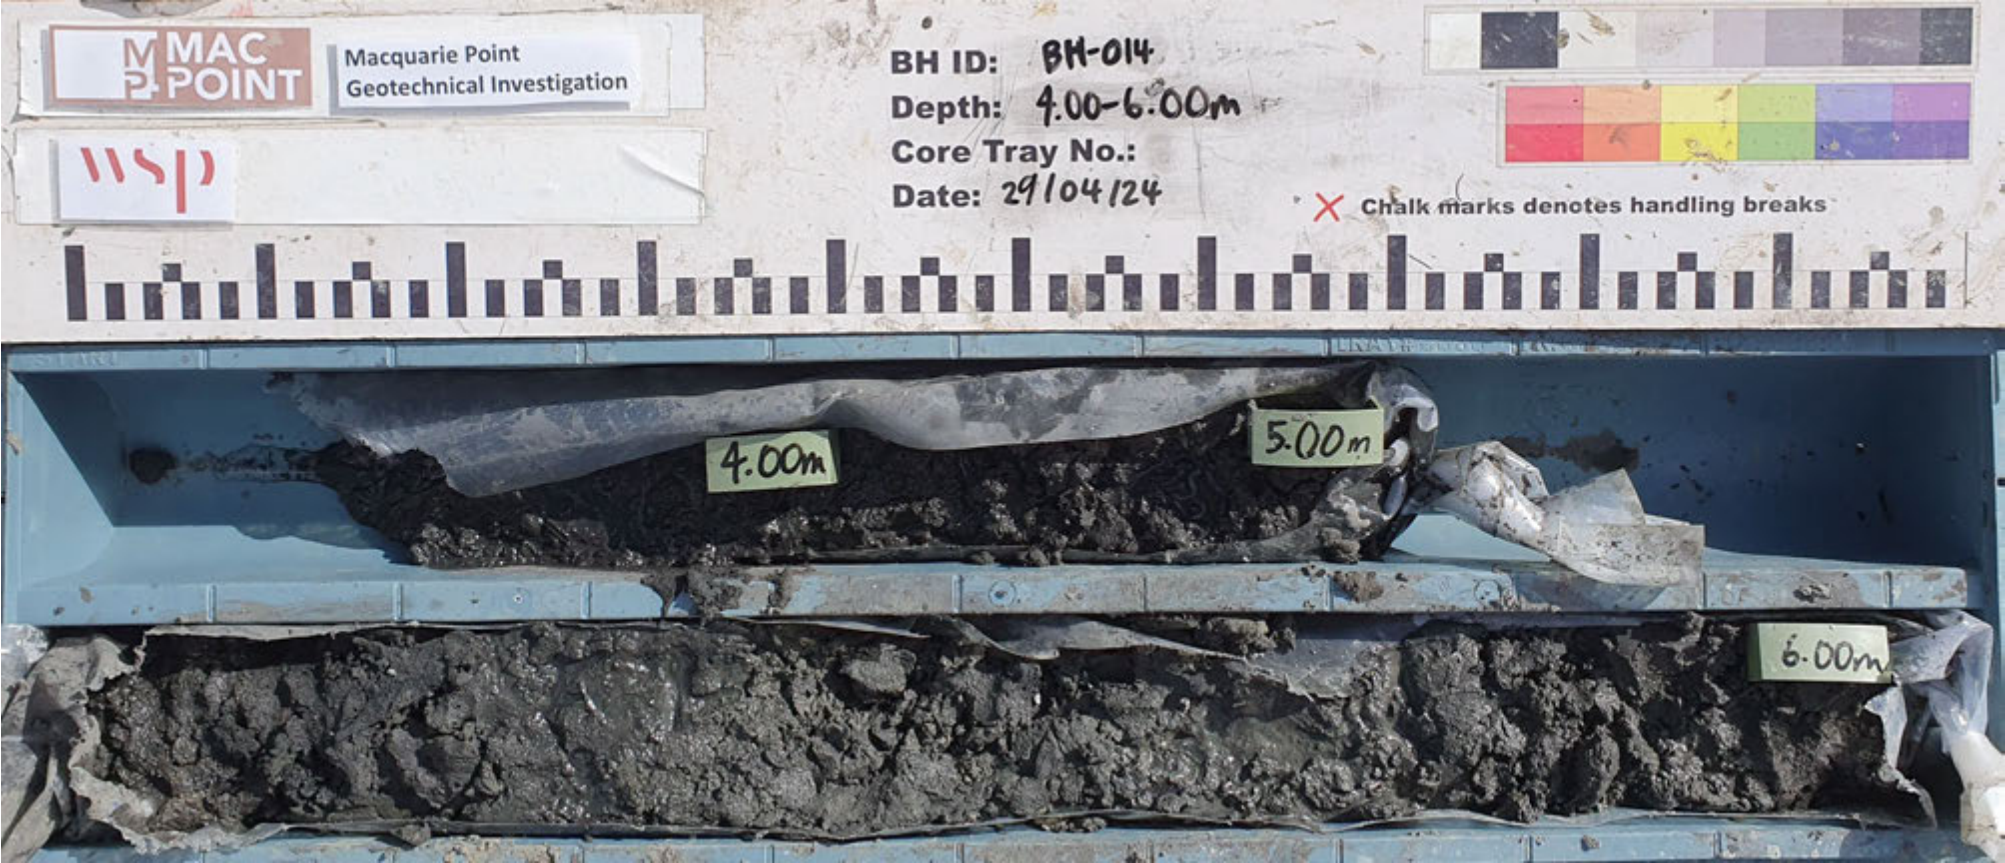
| | | PROJECT No<br>PS212776 | FIGURE No<br>3/8 |

PointID : BH-014 Depth Range: 4.00 - 6.00 m

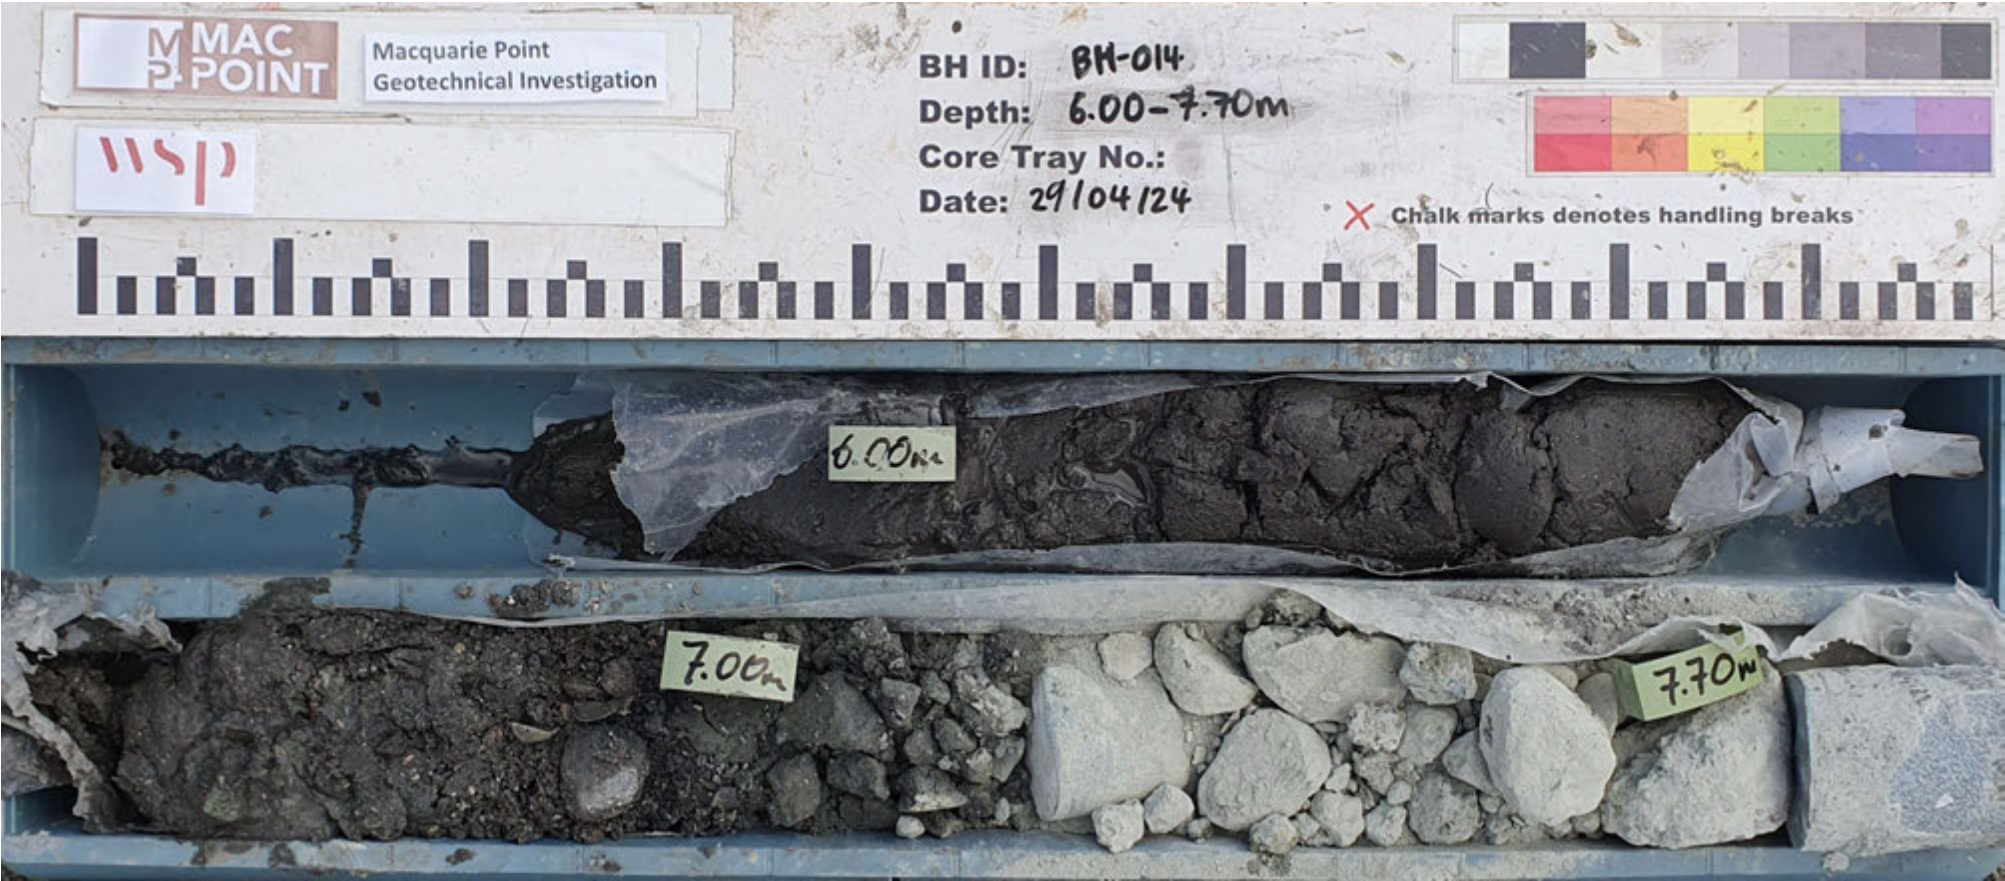
| | | PROJECT No<br>PS212776 | FIGURE No<br>4/8 |

PointID : BH-014 Depth Range: 6.00 - 7.70 m

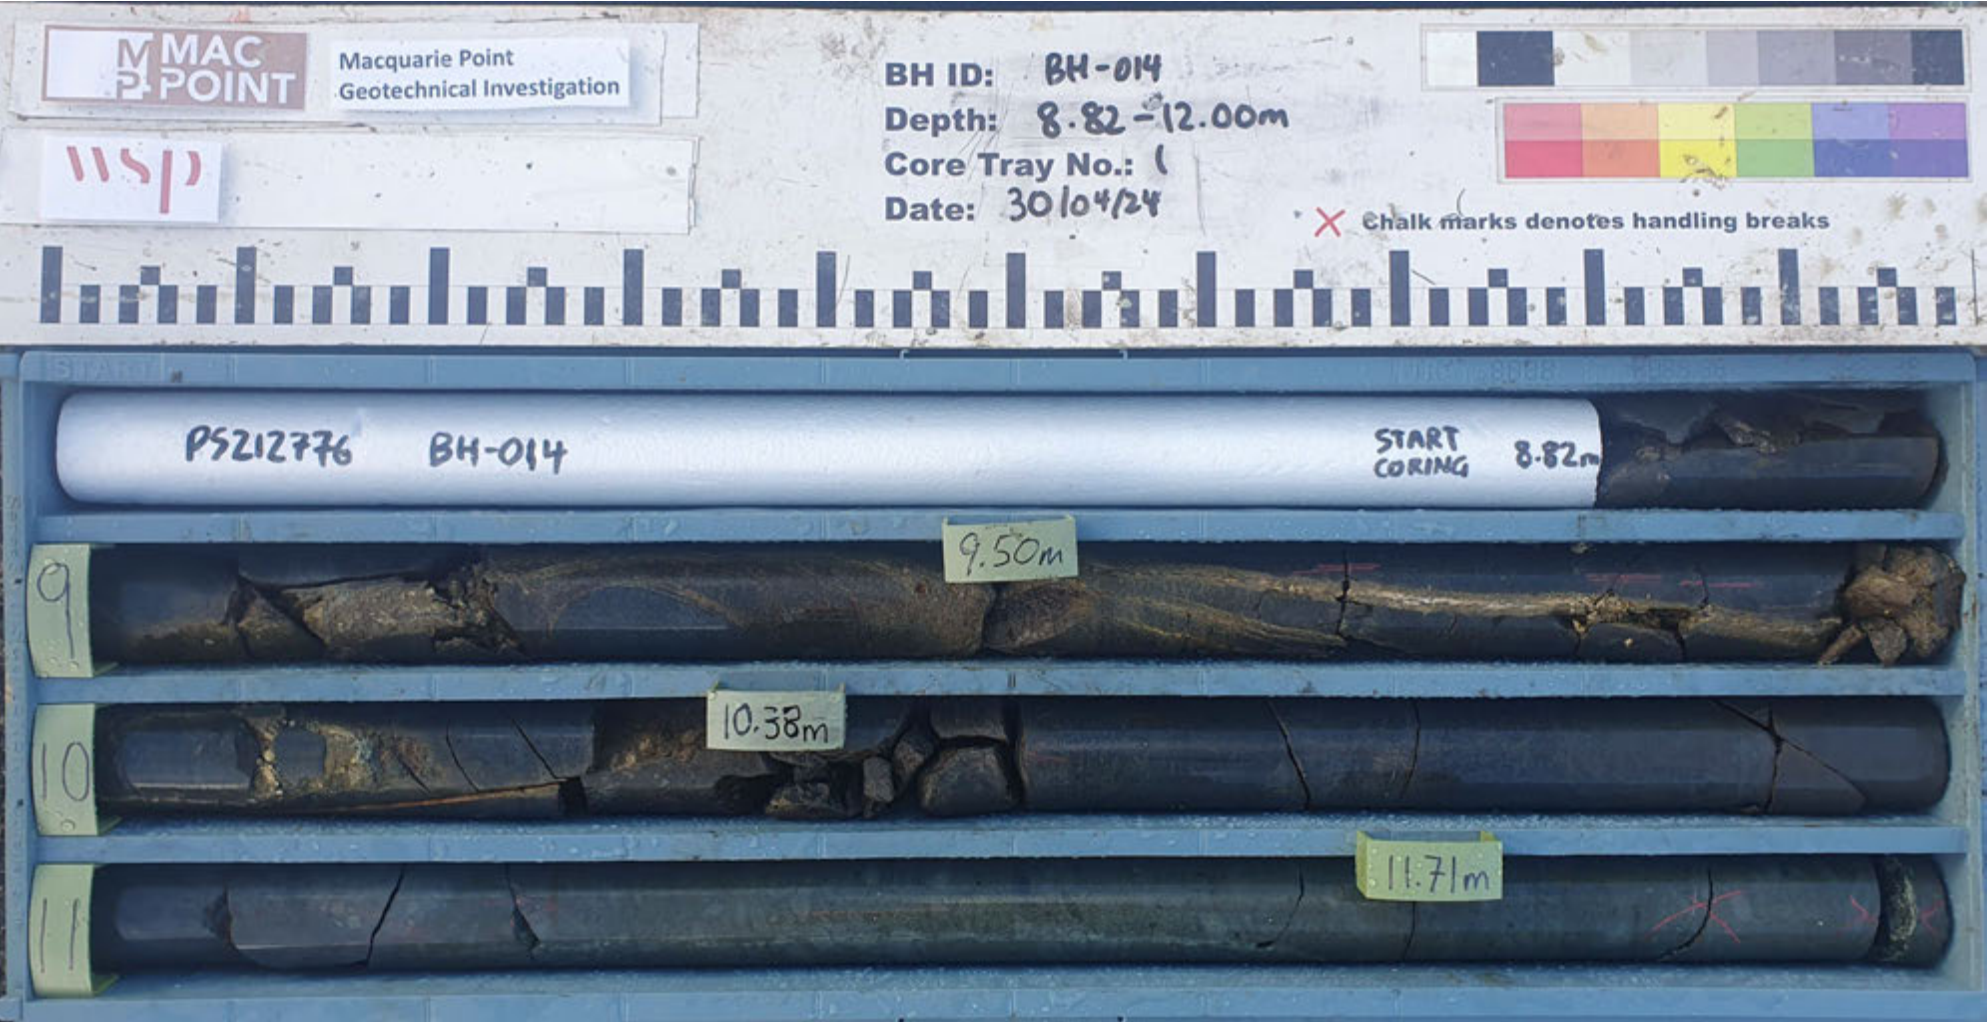
PointID : BH-014 Depth Range: 8.82 - 12.00 m

| | TITLE<br><br>MPDC<br>Macquarie Point<br>Macquarie Point GI<br>Core Photo - BH-014 | DRAWN | DATE<br>18/6/2024 |

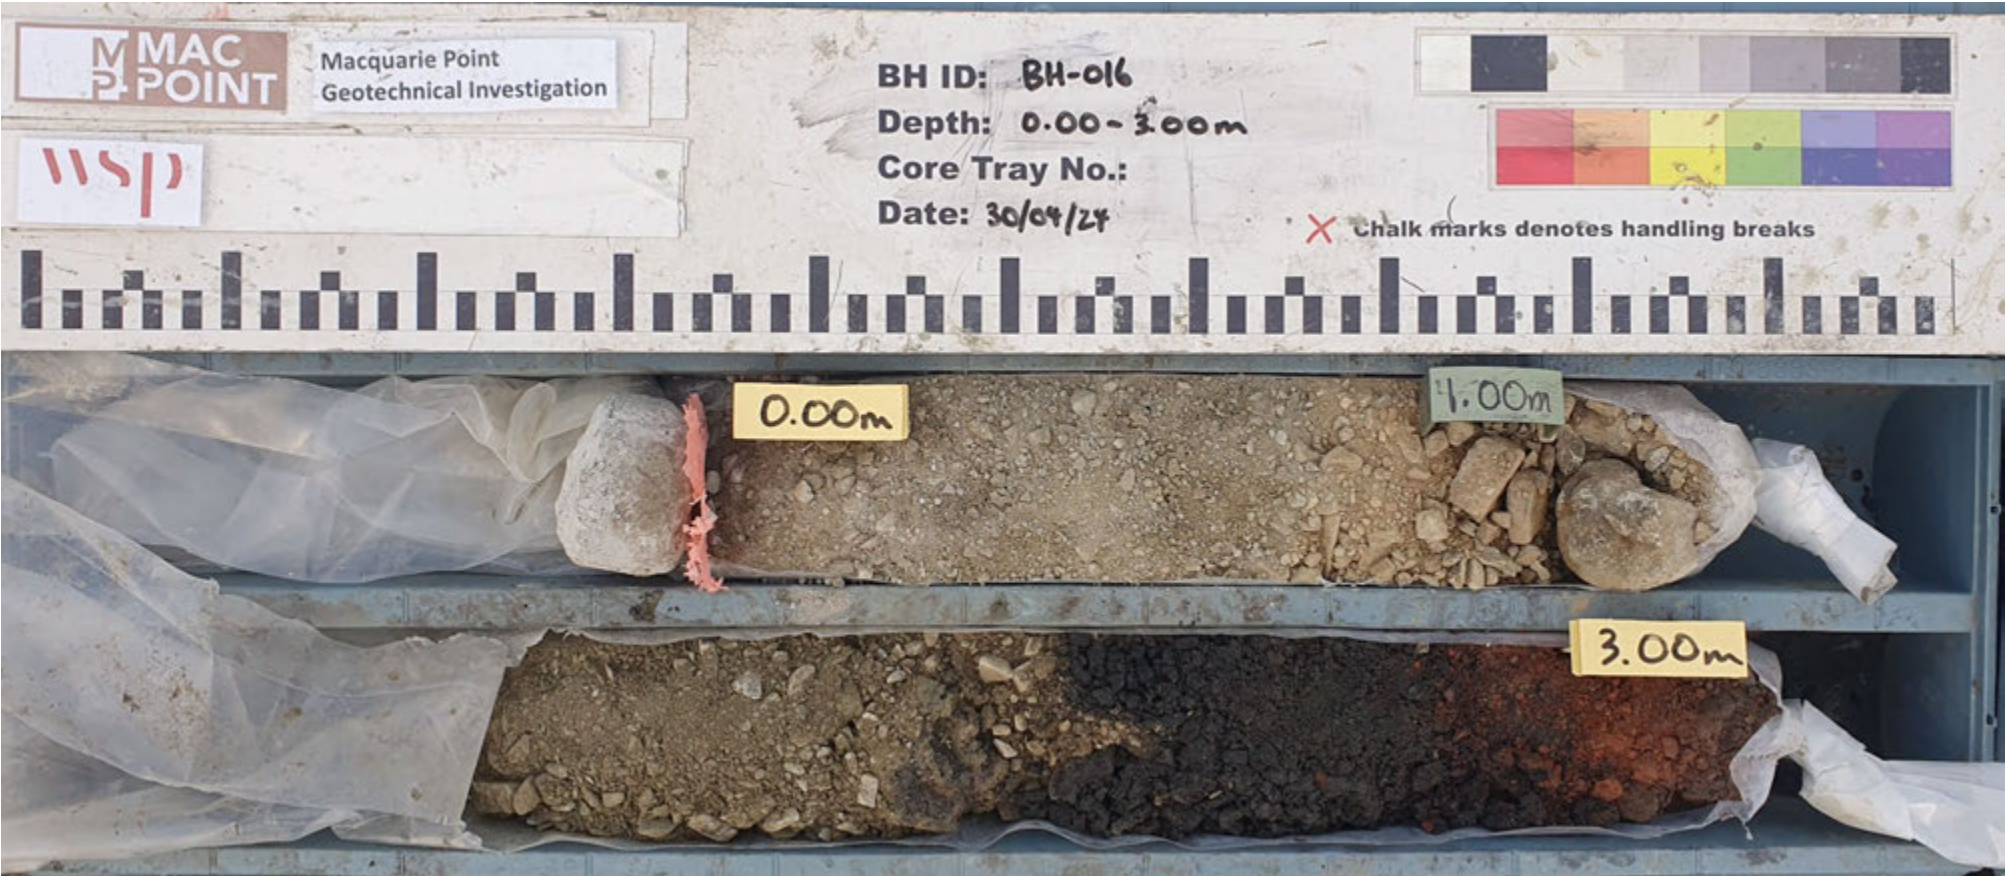
| | | PROJECT No<br>PS212776 | FIGURE No<br>1/11 |

PointID : BH-016 Depth Range: 0.00 - 3.00 m

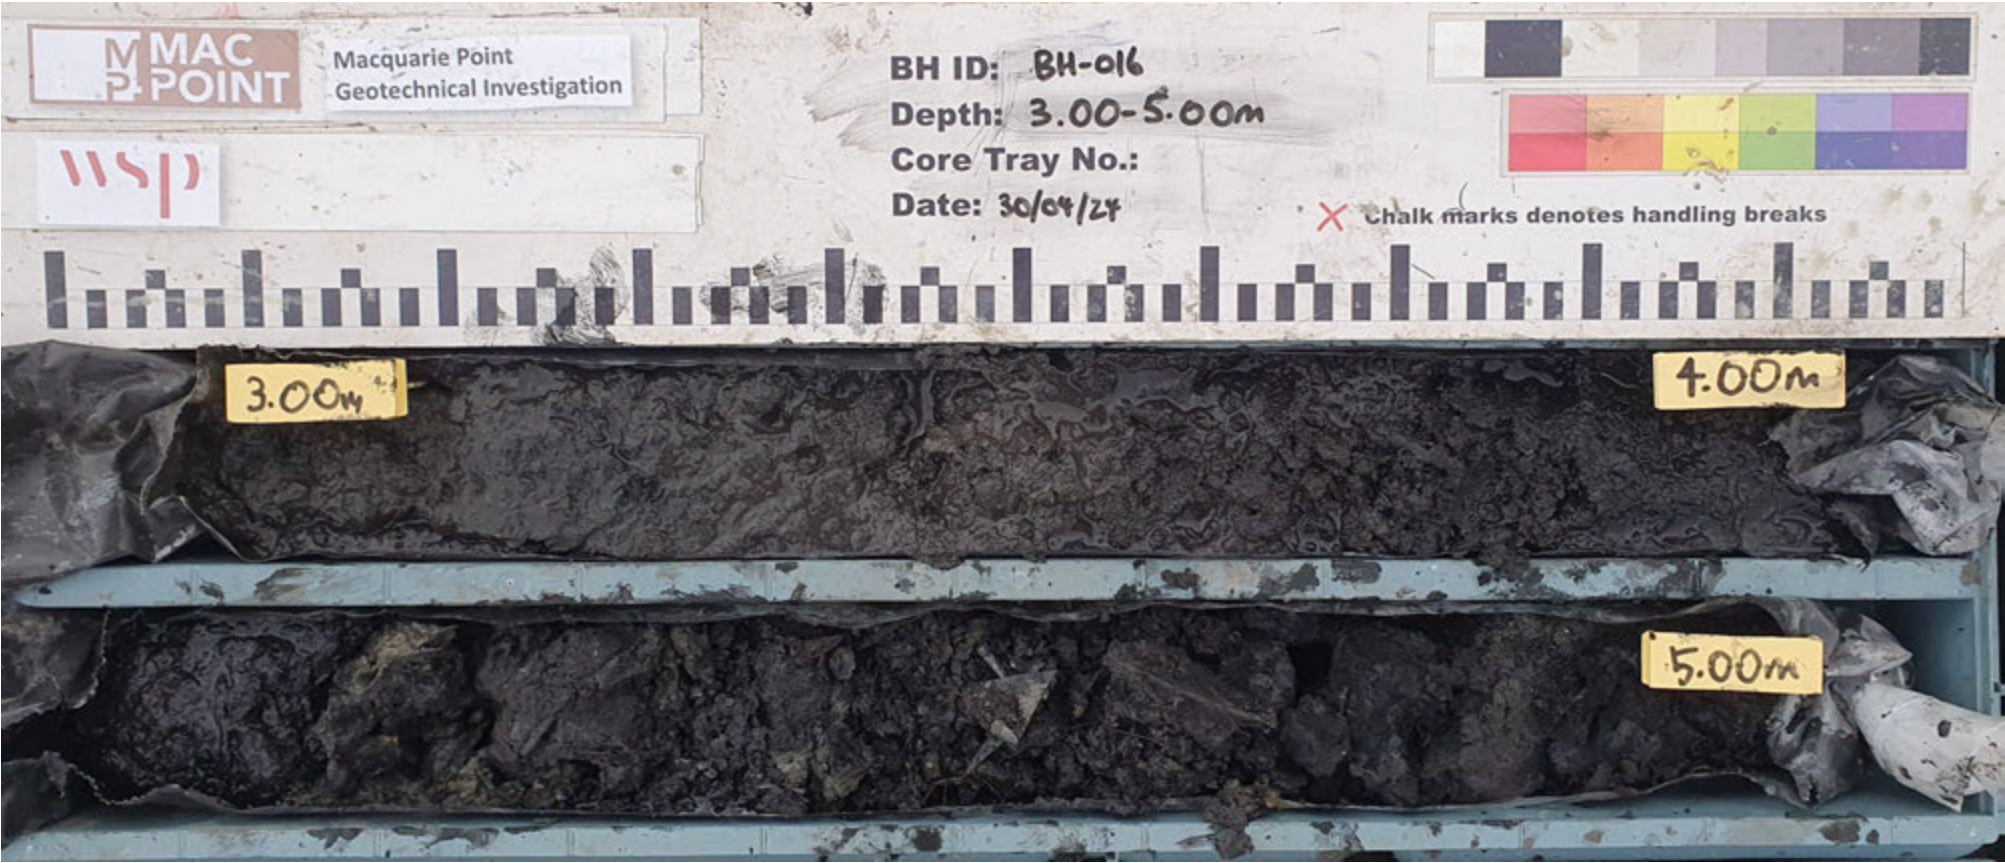
| | | PROJECT No<br>PS212776 | FIGURE No<br>2/11 |

PointID : BH-016 Depth Range: 3.00 - 5.00 m

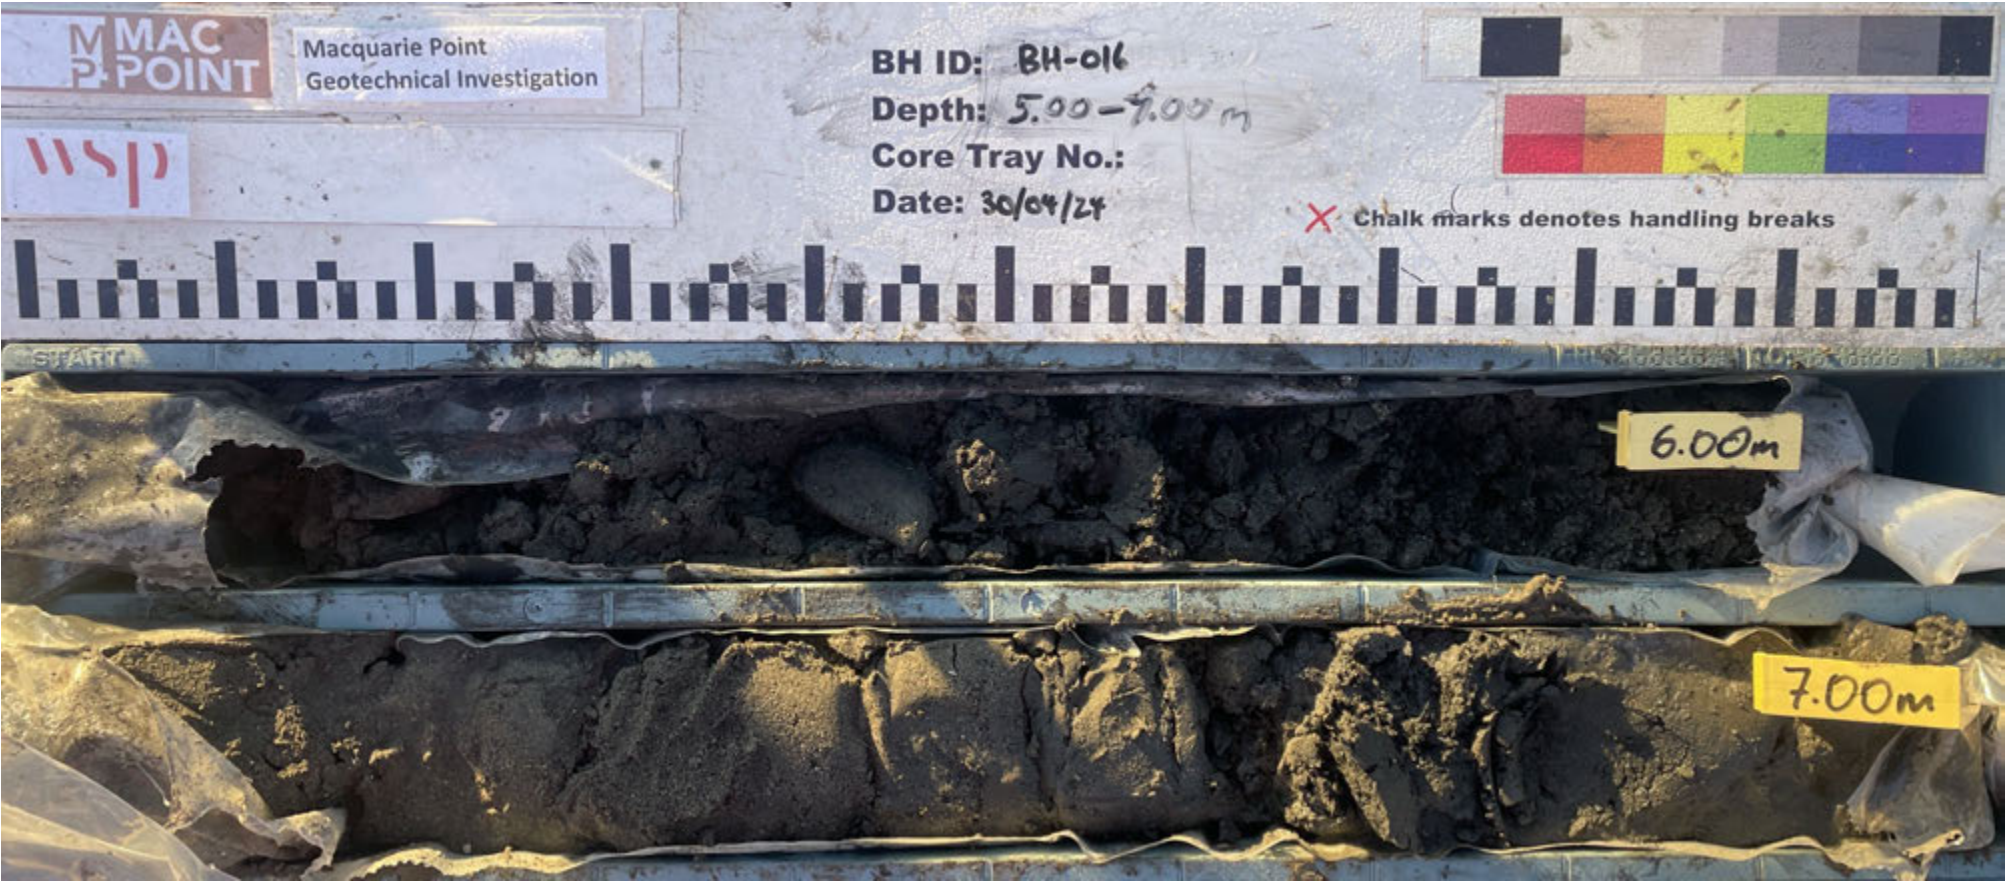
| | | PROJECT No<br>PS212776 | FIGURE No<br>3/11 |

PointID : BH-016 Depth Range: 5.00 - 7.00 m

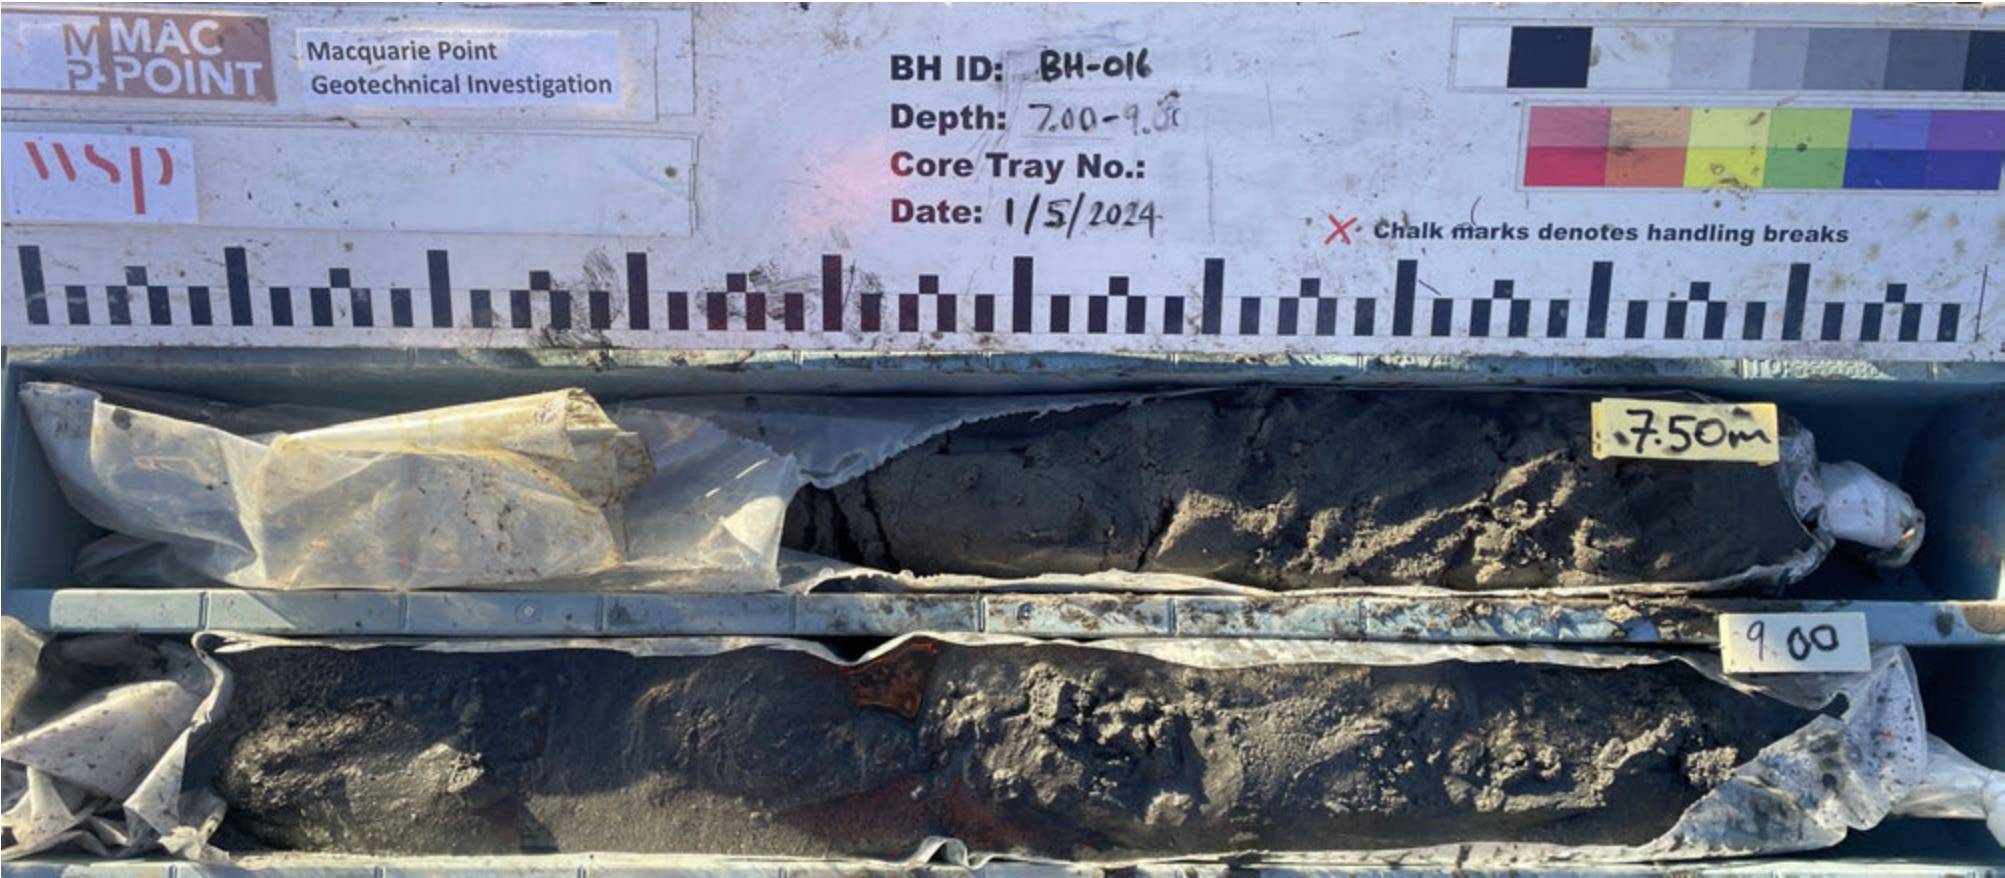
| | | PROJECT No<br>PS212776 | FIGURE No<br>4/11 |

PointID : BH-016 Depth Range: 7.00 - 9.00 m

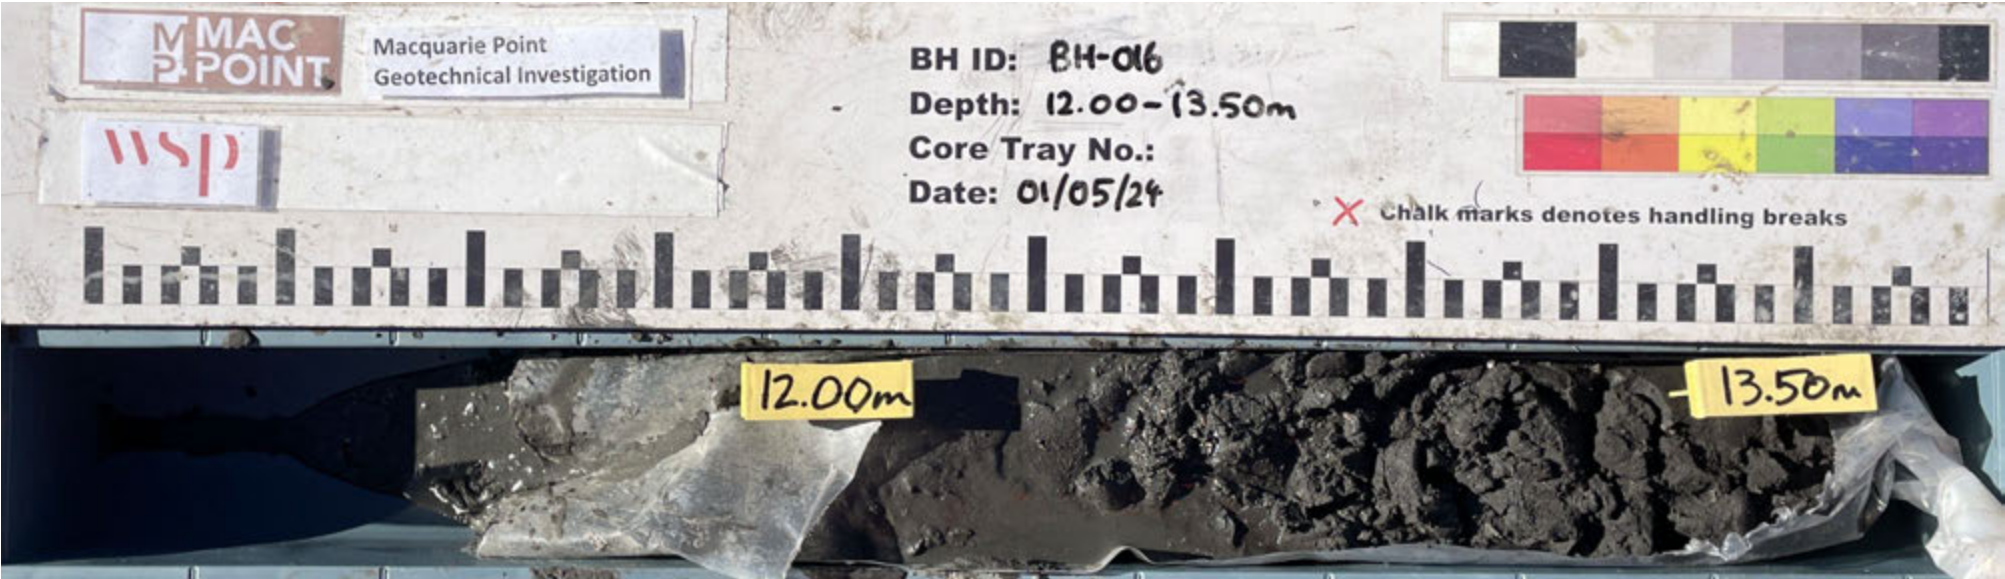
| | | PROJECT No<br>PS212776 | FIGURE No<br>5/11 |

PointID : BH-016 Depth Range: 12.00 - 13.50 m

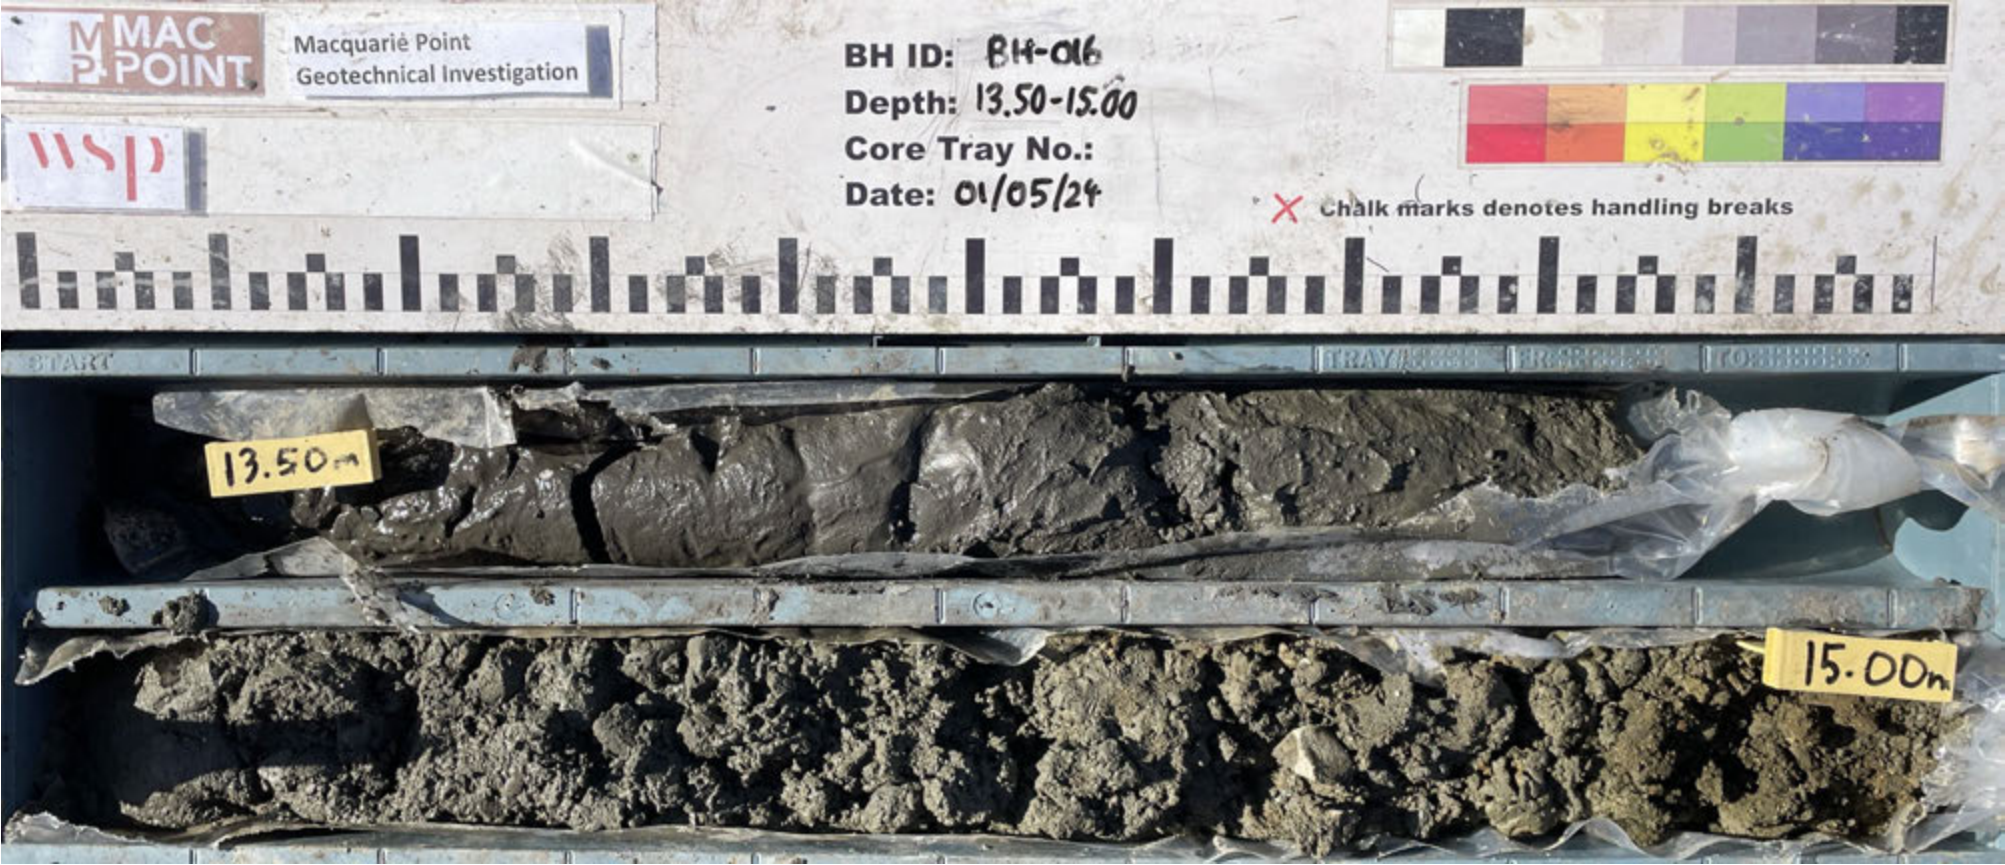
| | | PROJECT No<br>PS212776 | FIGURE No<br>6/11 |

PointID : BH-016 Depth Range: 13.50 - 15.00 m
