# Macquarie Point Stadium Development

## Geotechnical Factual Report

June 2024

## Macquarie Point Stadium Development Geotechnical Factual Report

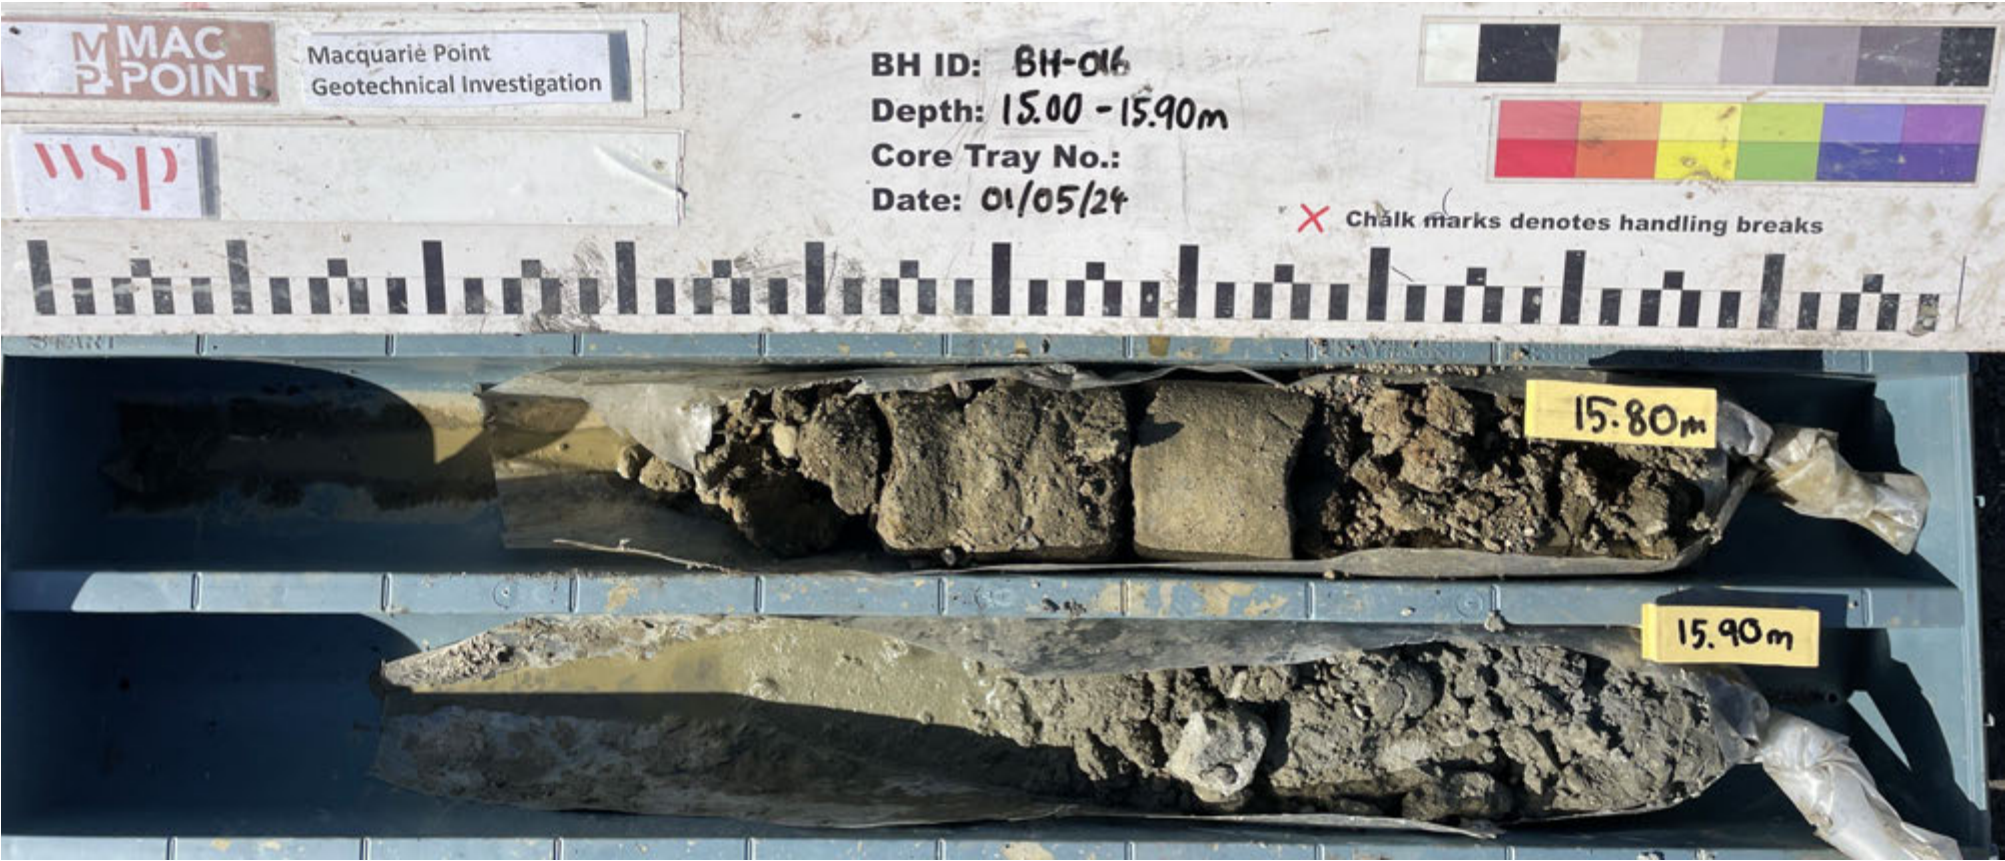
| | | PROJECT No<br>PS212776 | FIGURE No<br>7/11 |

PointID : BH-016 Depth Range: 15.00 - 15.90 m

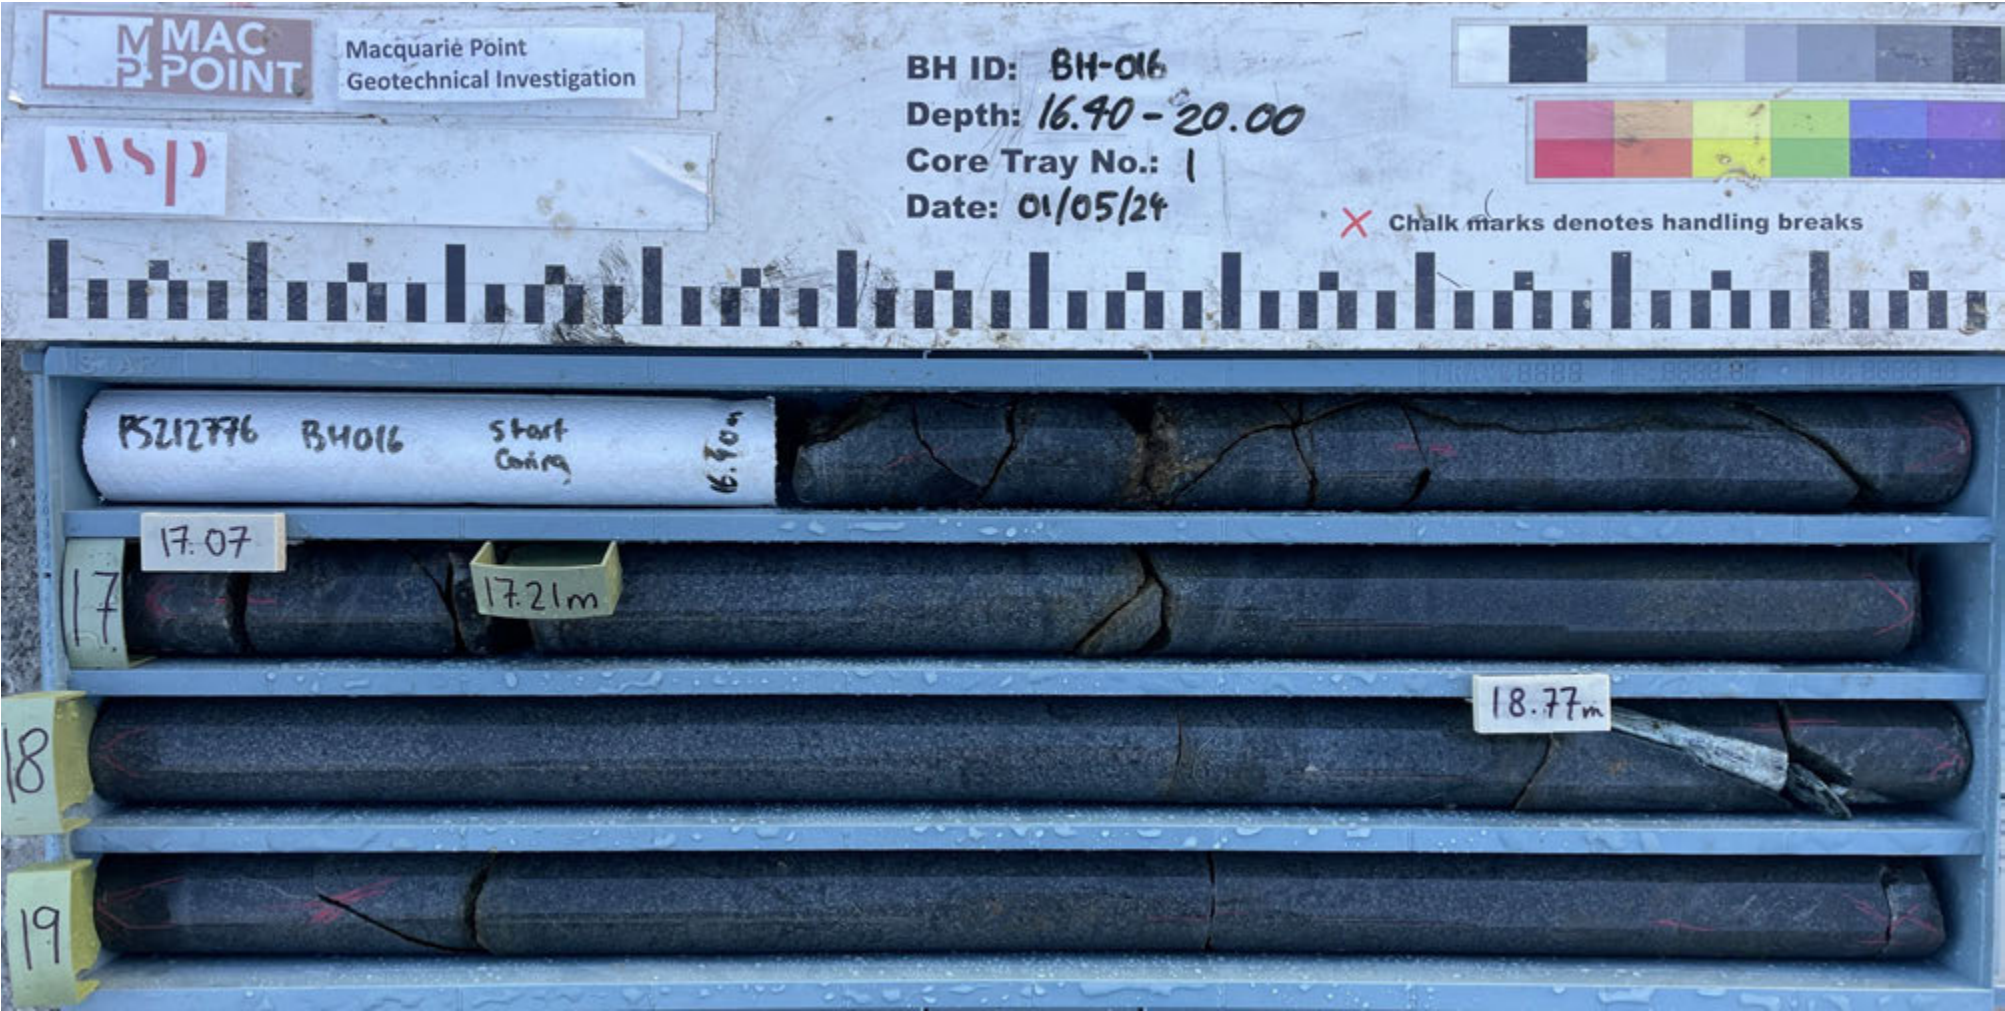
PointID : BH-016 Depth Range: 16.40 - 20.00 m

| | TITLE<br><br>MPDC<br>Macquarie Point<br>Macquarie Point GI<br>Core Photo - BH-016 | DRAWN | DATE<br>18/6/2024 |

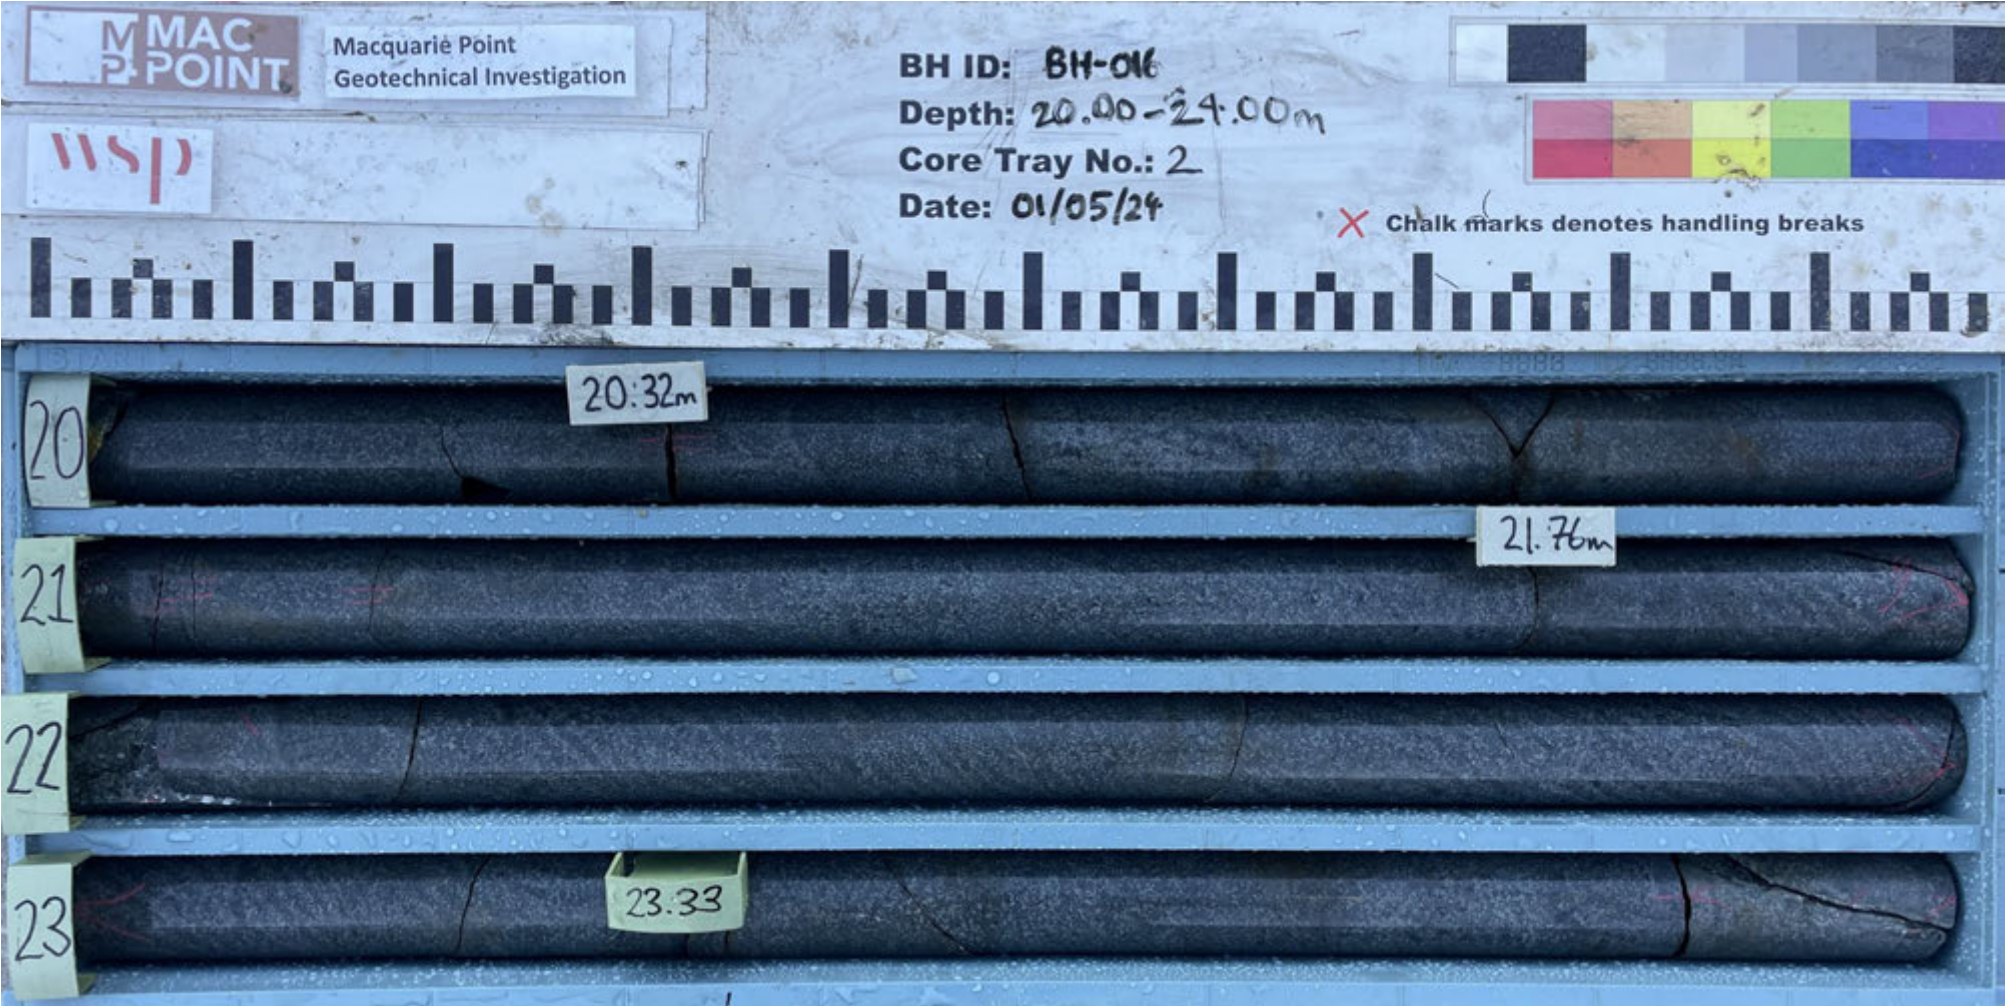
PointID : BH-016 Depth Range: 20.00 - 24.00 m

| | TITLE<br><br>MPDC<br>Macquarie Point<br>Macquarie Point GI<br>Core Photo - BH-016 | DRAWN | DATE<br>18/6/2024 |

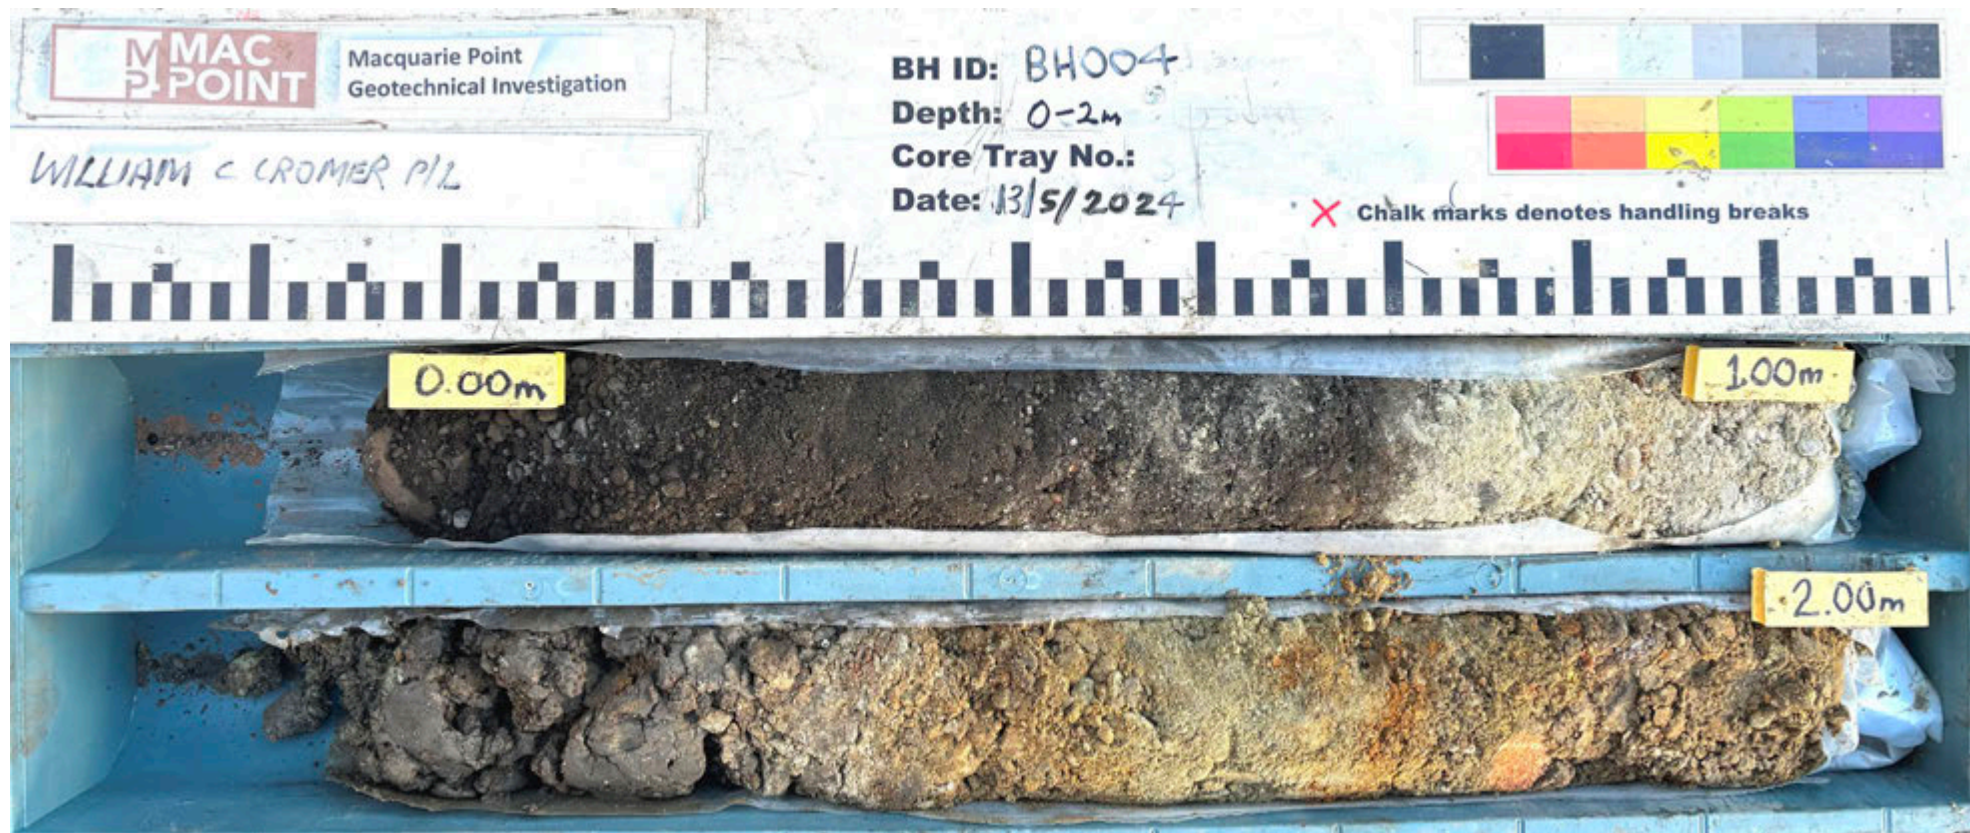
1/13

PointID: BH-004 Depth Range: 0.0 – 2.0 m

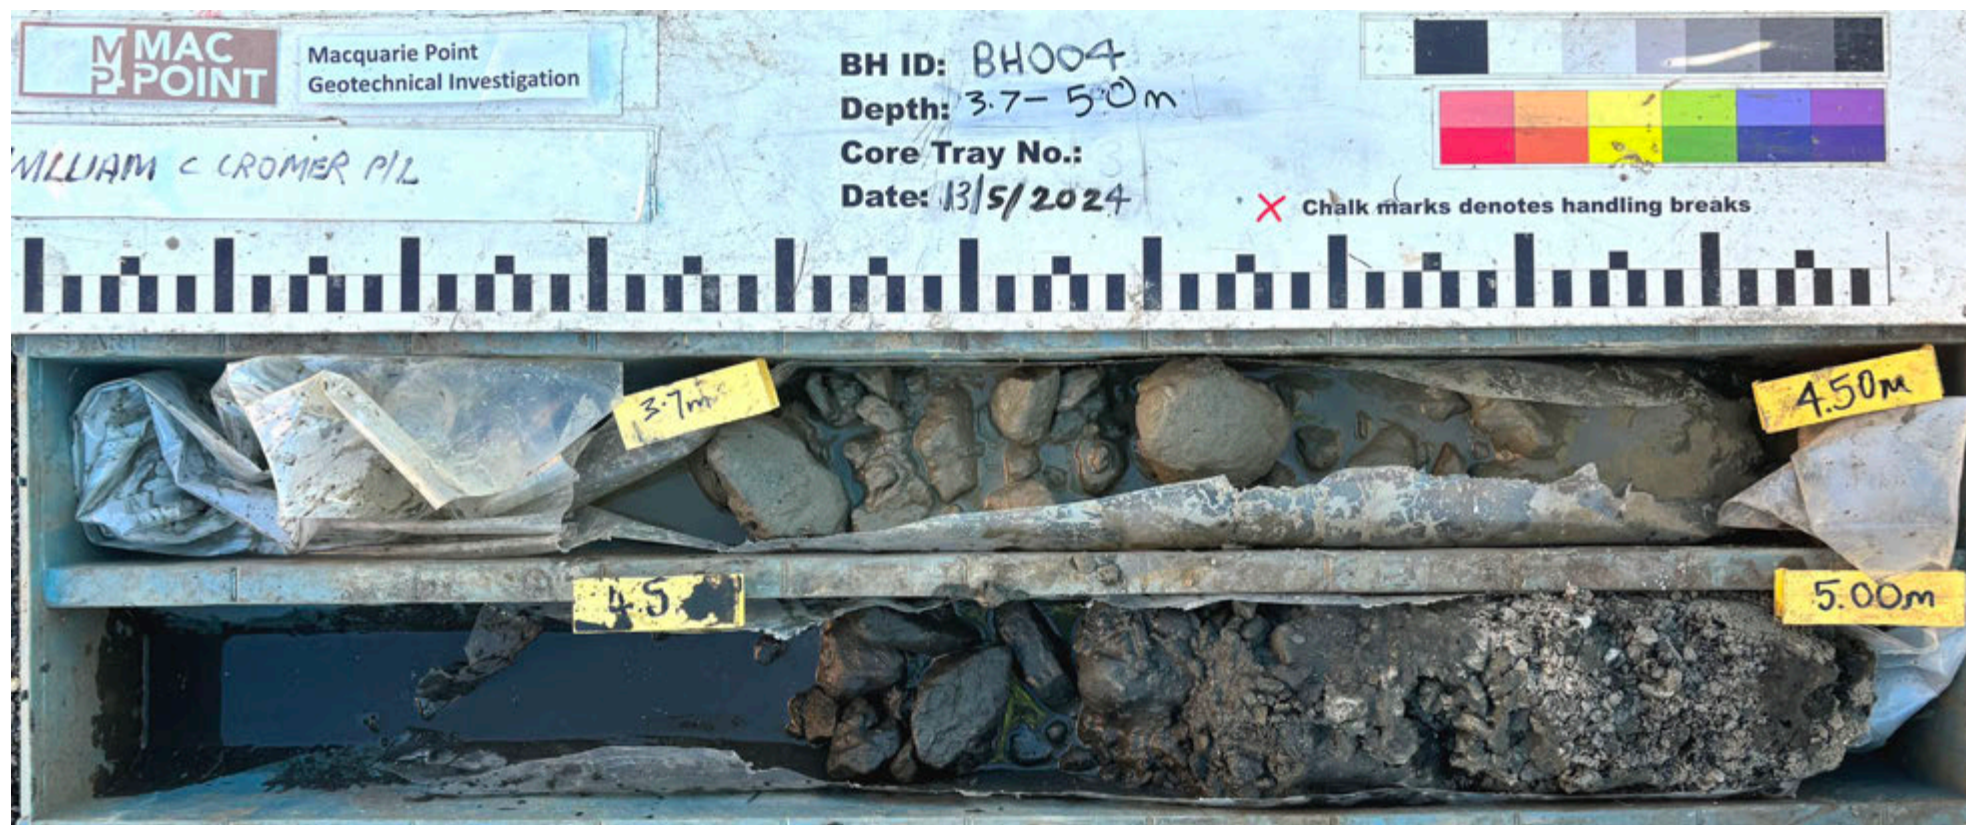
3/13

PointID: BH-004 Depth Range: 3.7 – 5.0 m

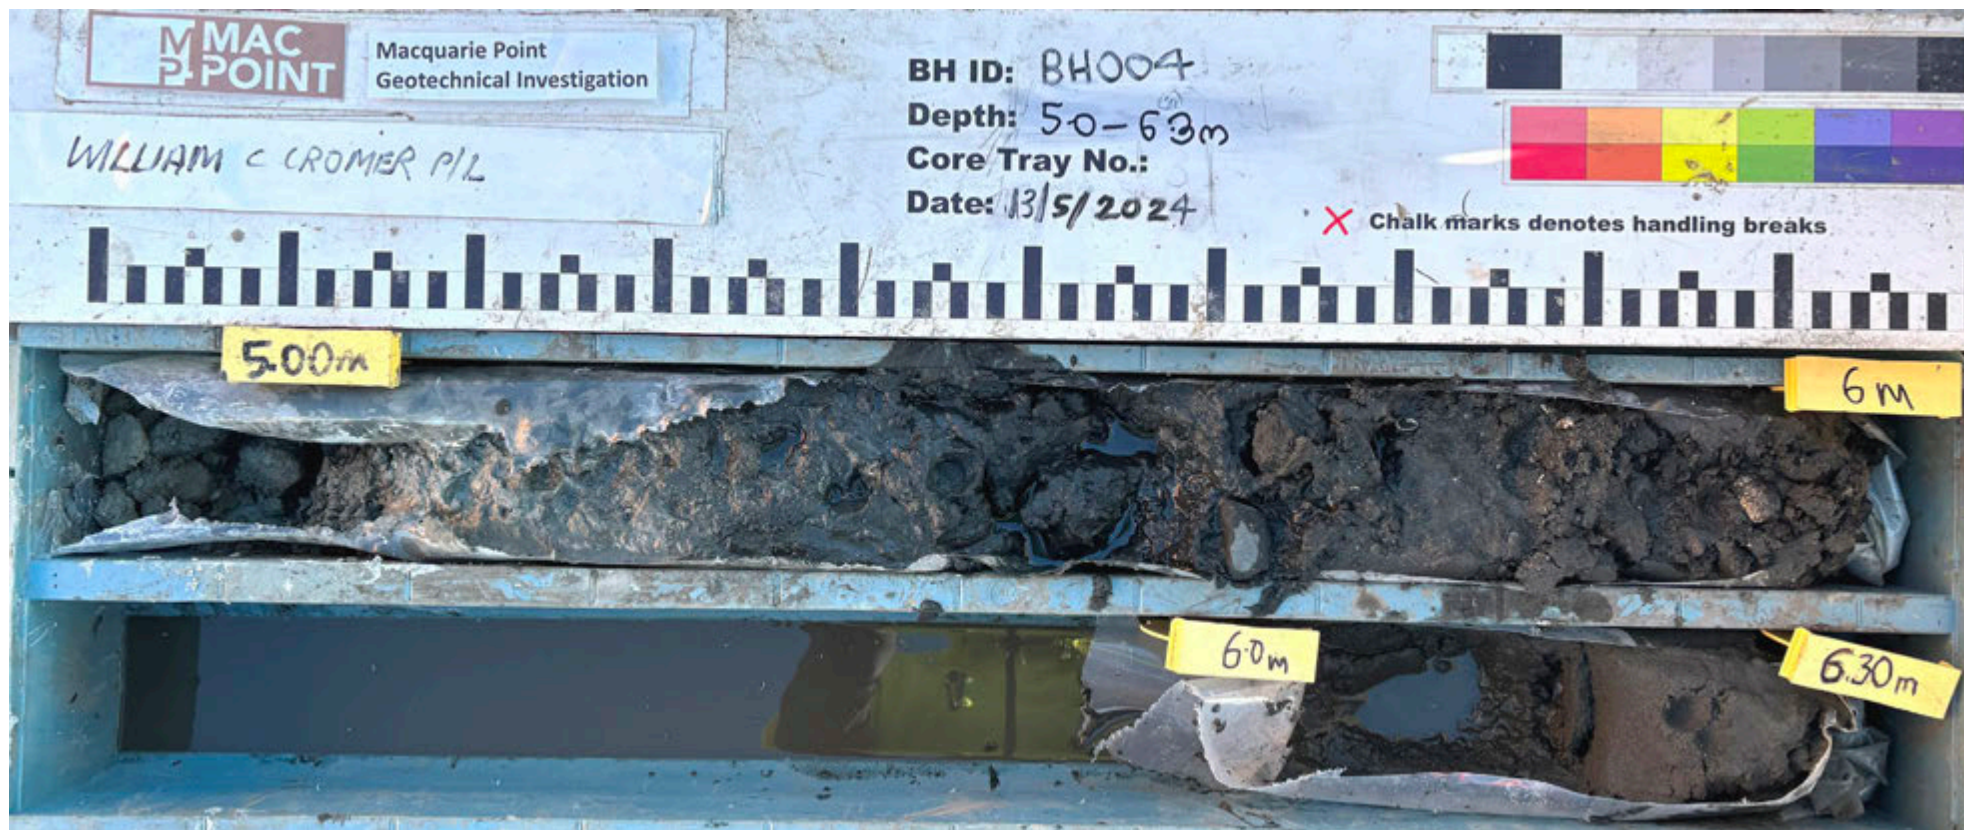
4/13

PointID: BH-004 Depth Range: 5.0 – 6.3 m

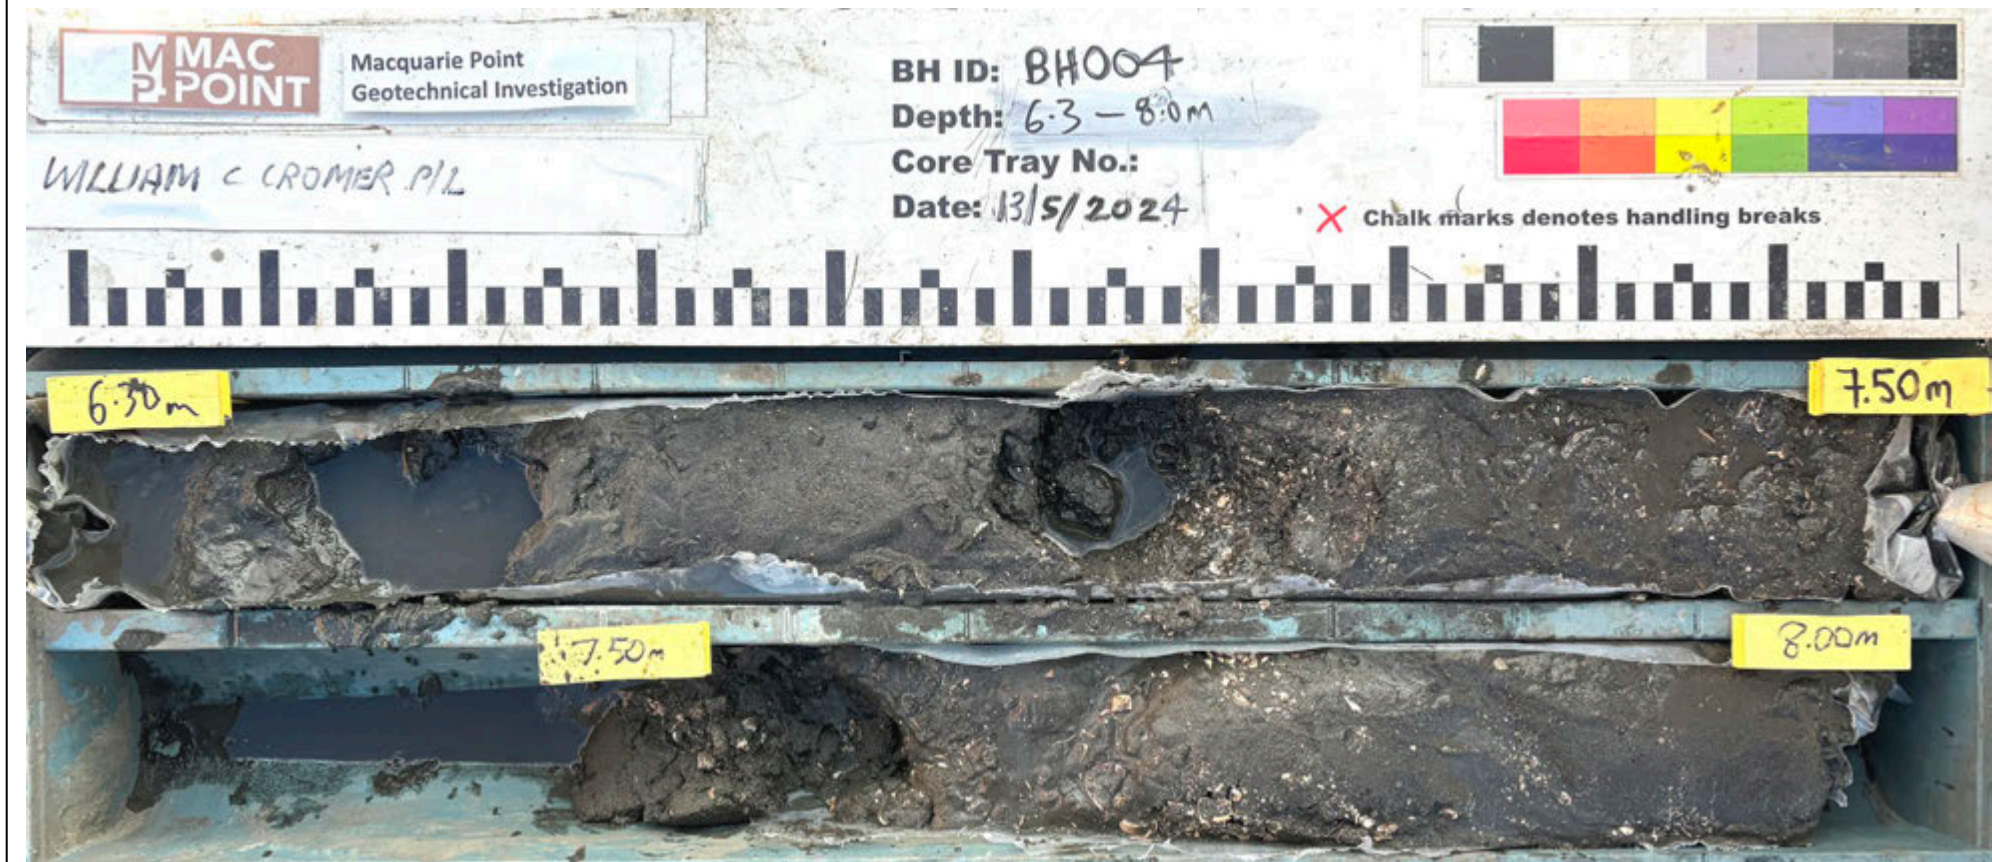
5/13

PointID: BH-004 Depth Range: 6.3 – 8.0 m

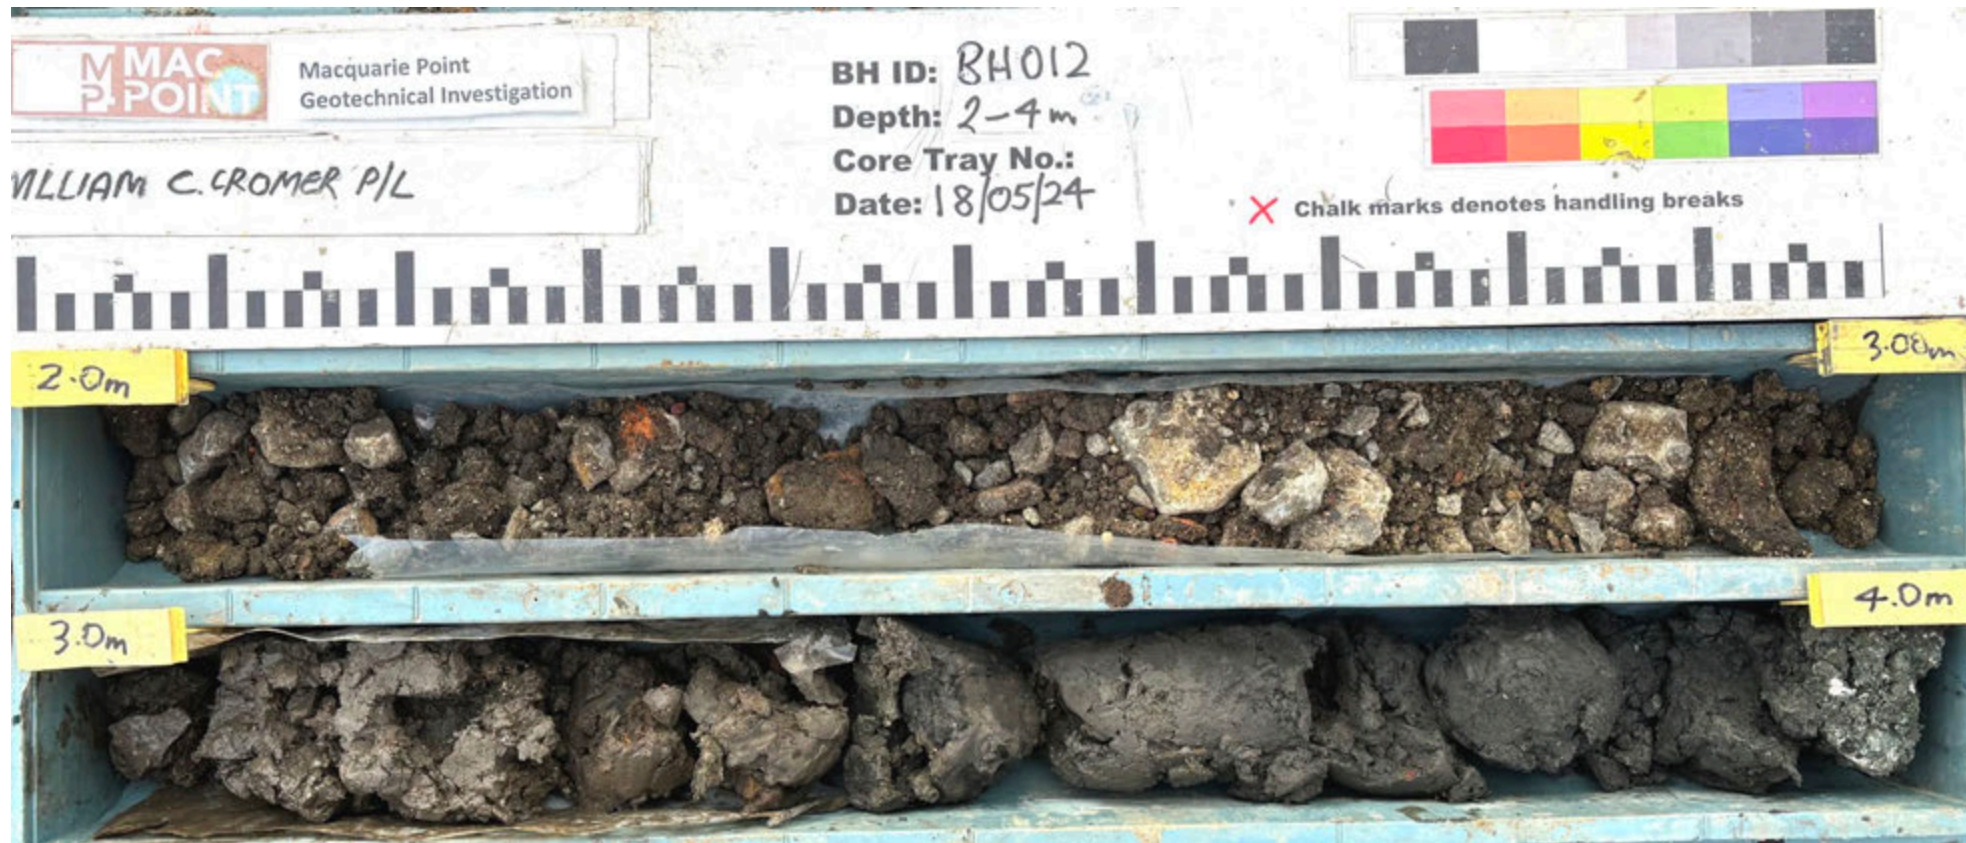
2/6

PointID: BH-012 Depth Range: 2.0 – 4.0 m

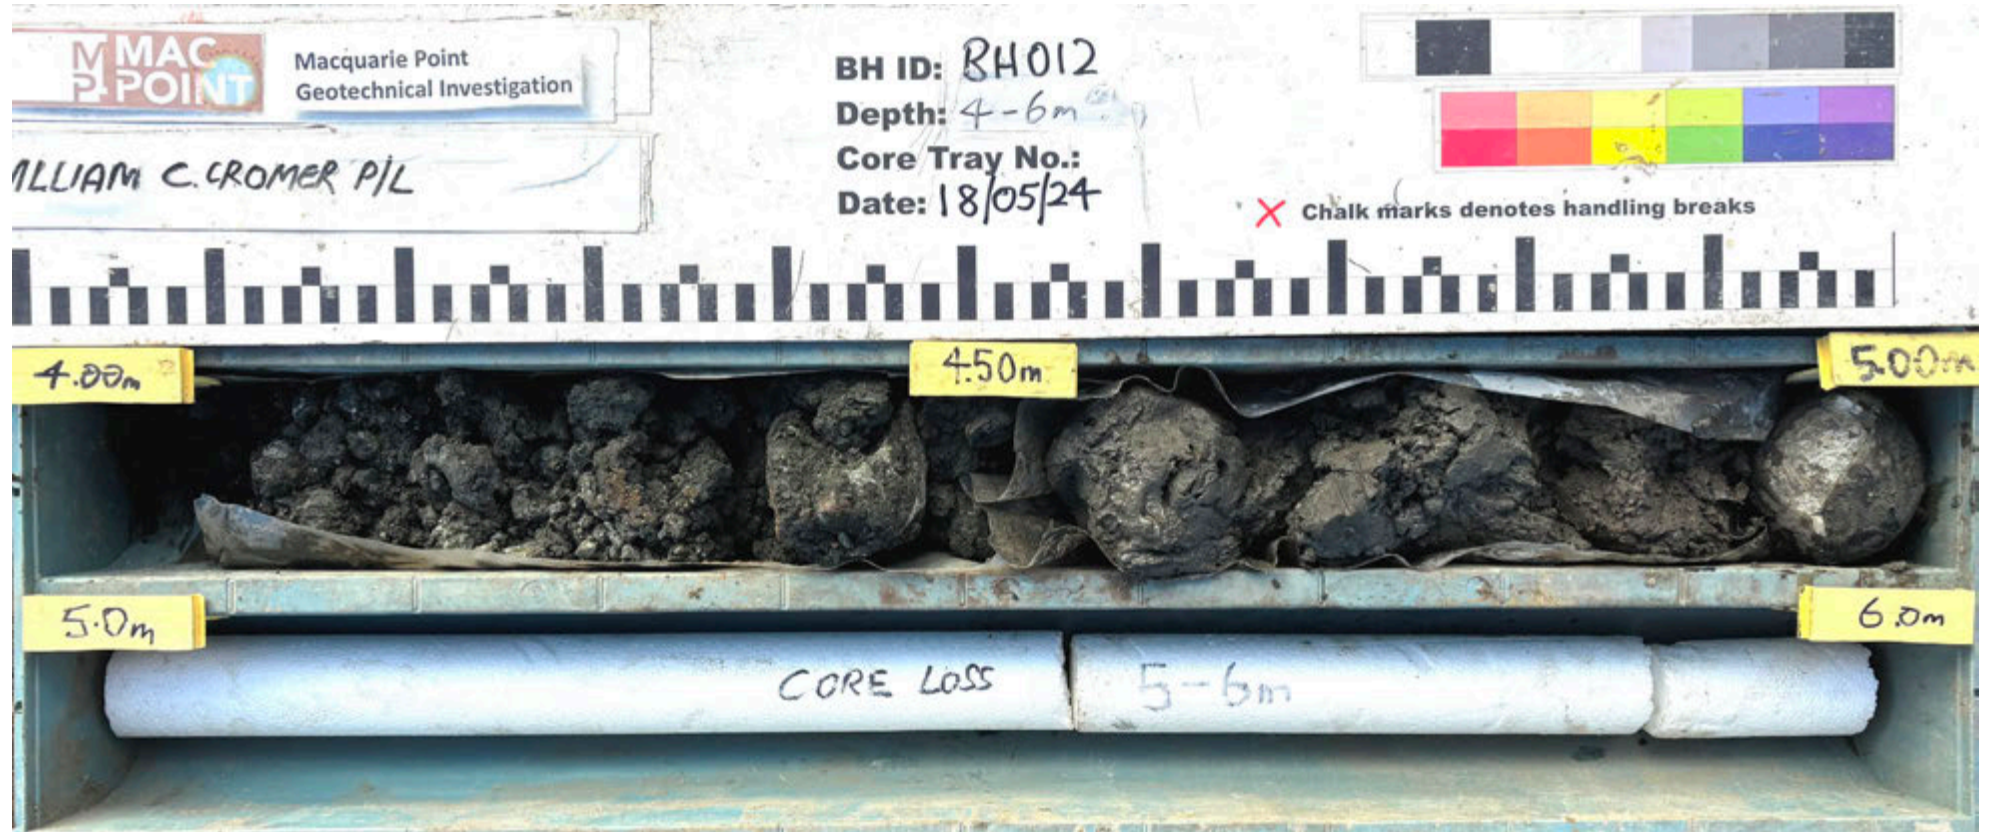
3/6

PointID: BH-012 Depth Range: 4.0 – 6.0 m

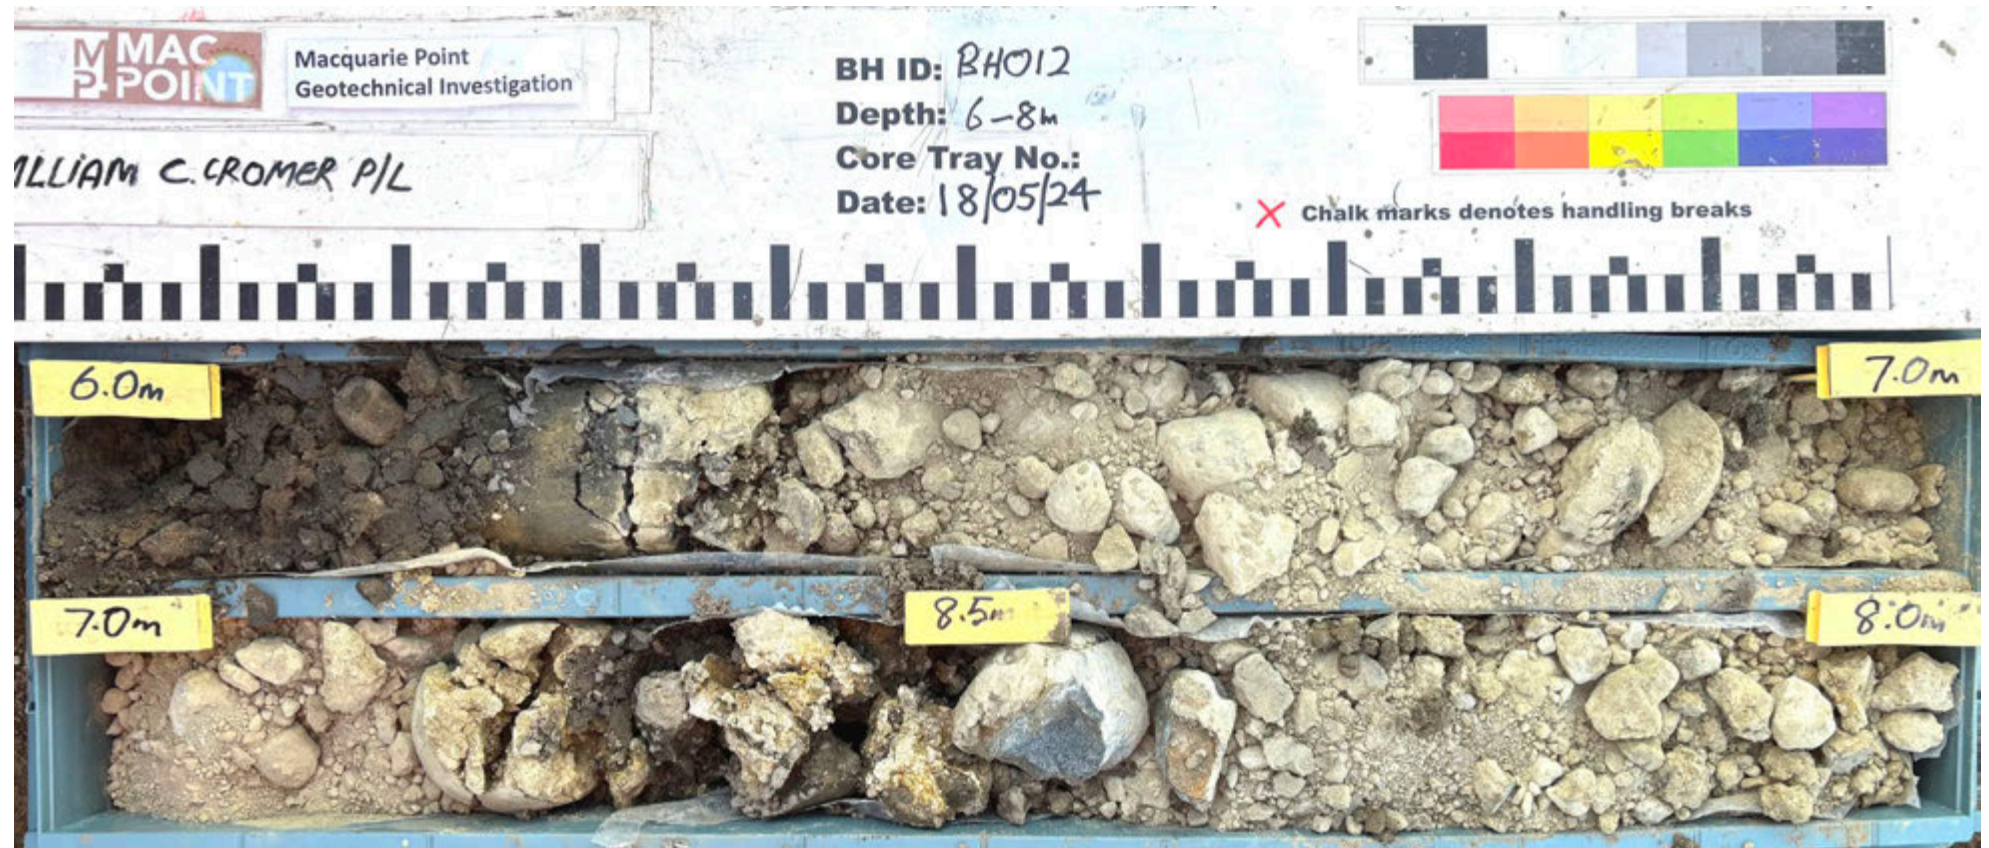
4/6

PointID: BH-012 Depth Range: 6.0 – 8.0 m

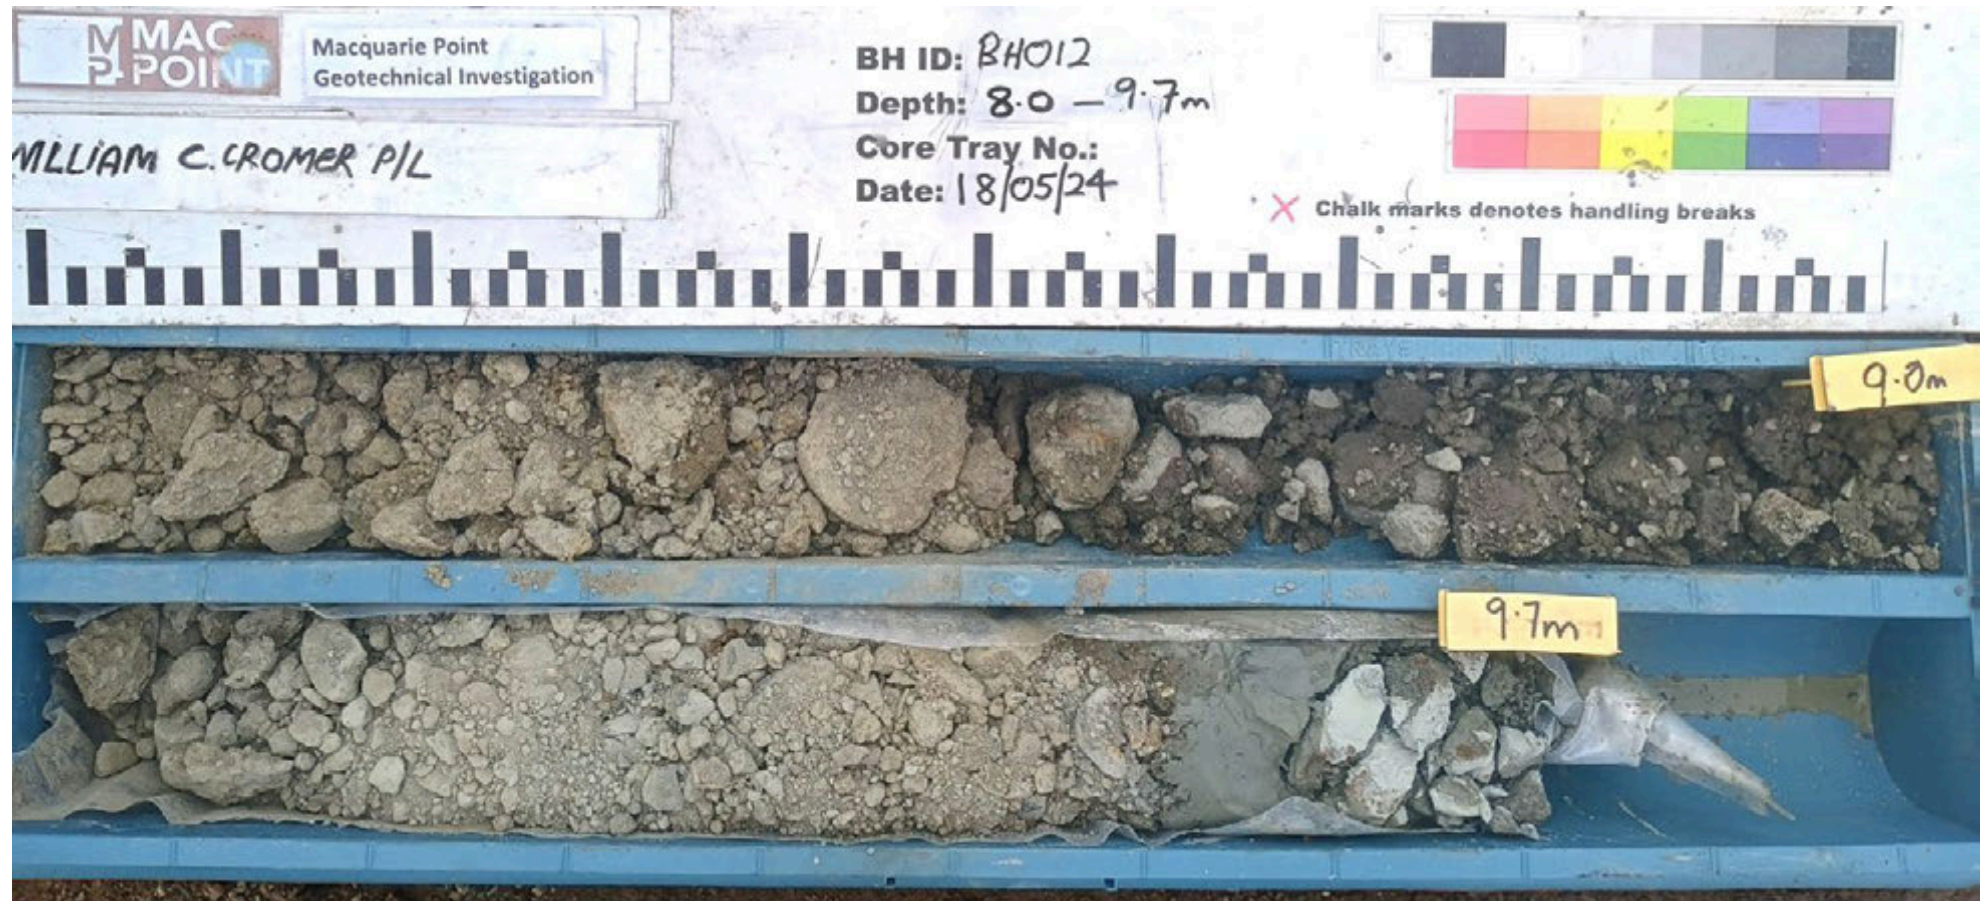
5/6

PointID: BH-012 Depth Range: 8.0 – 9.7 m

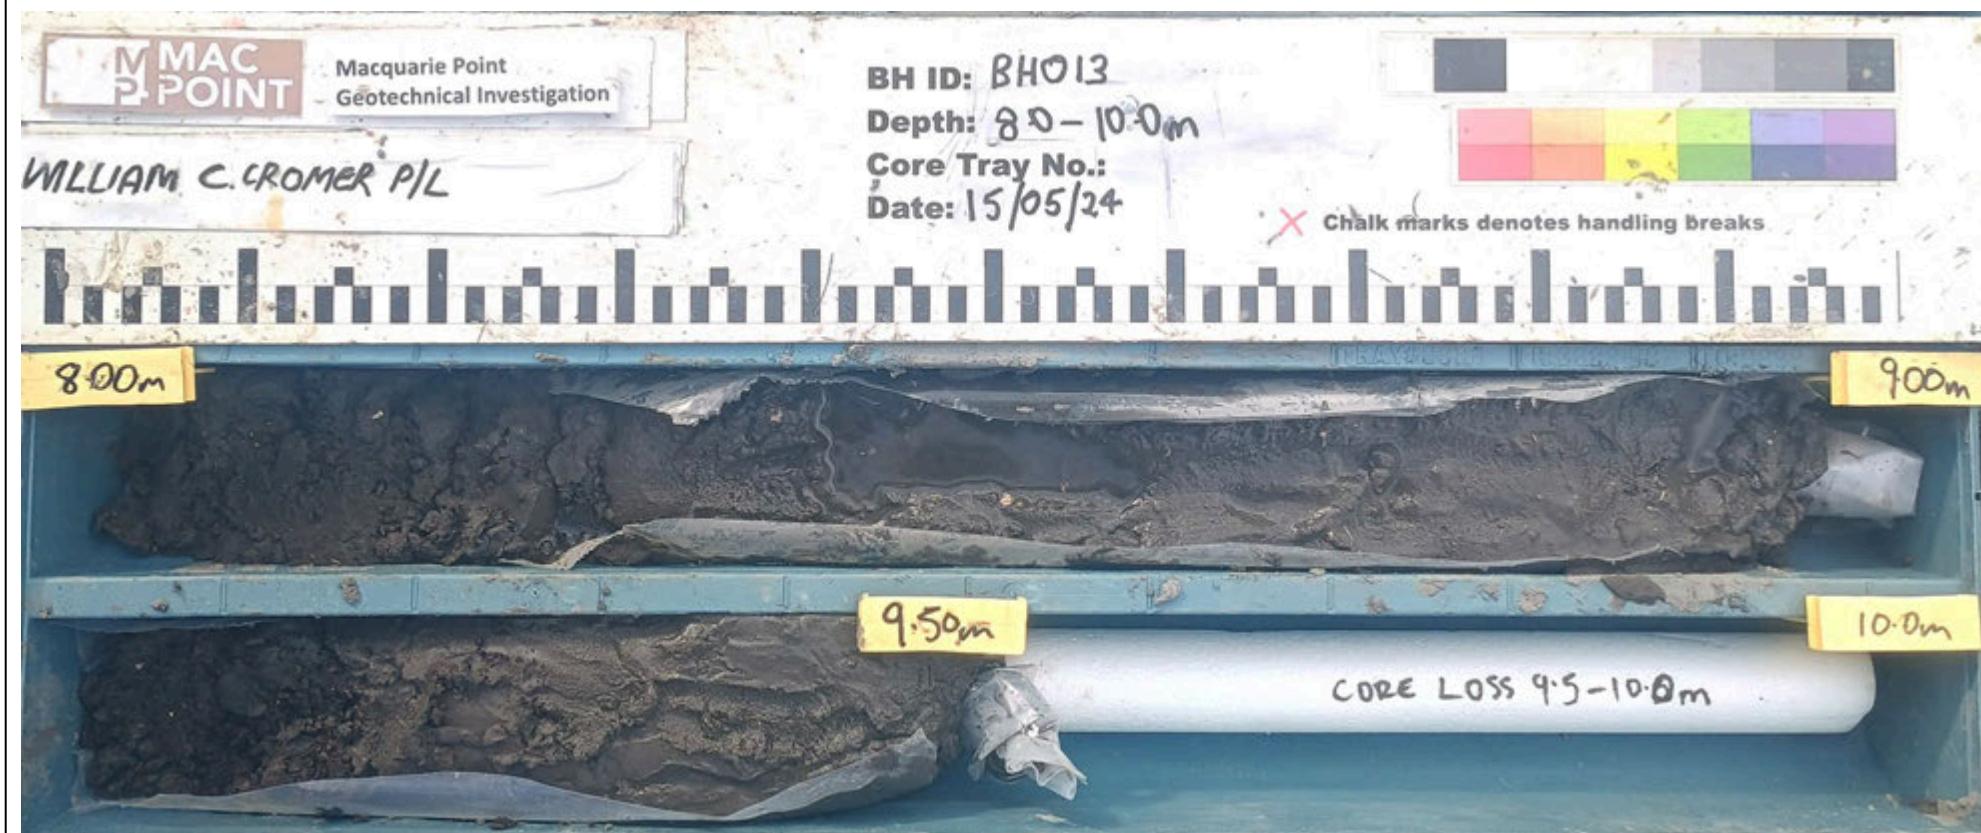
3/10

PointID: BH-013 Depth Range: 8.0 – 10.0 m

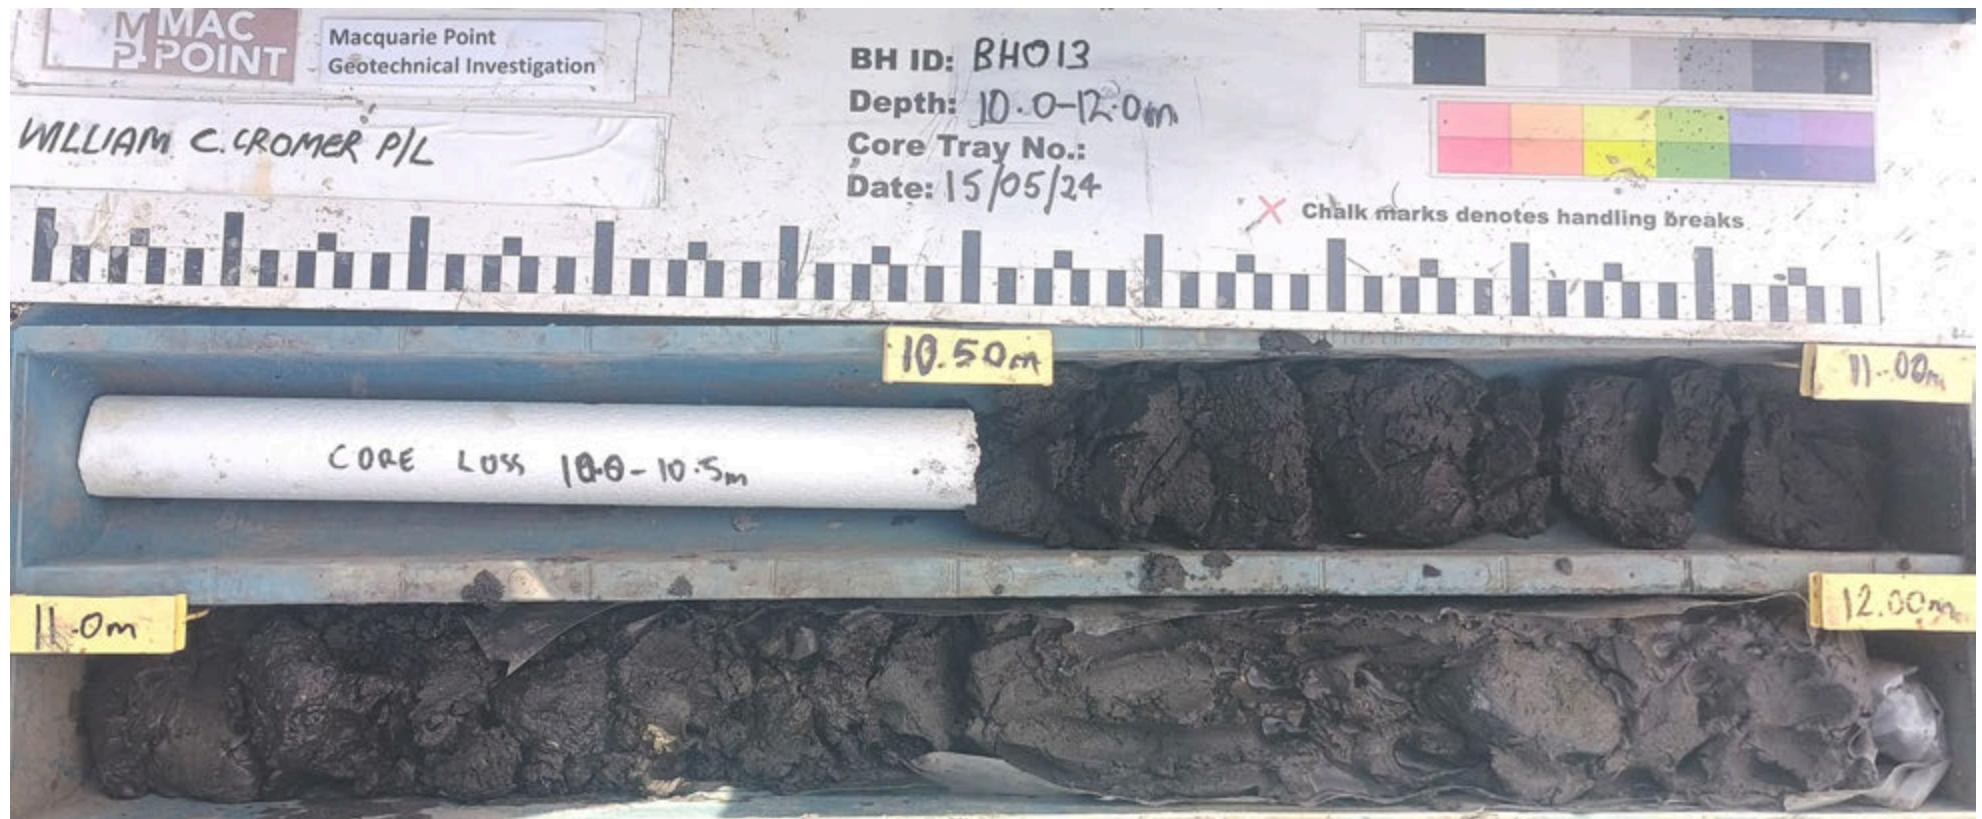
4/10

PointID: BH-013 Depth Range: 10.0 – 12.0 m
