# Macquarie Point Stadium Development

## Geotechnical Factual Report

June 2024

## Macquarie Point Stadium Development Geotechnical Factual Report

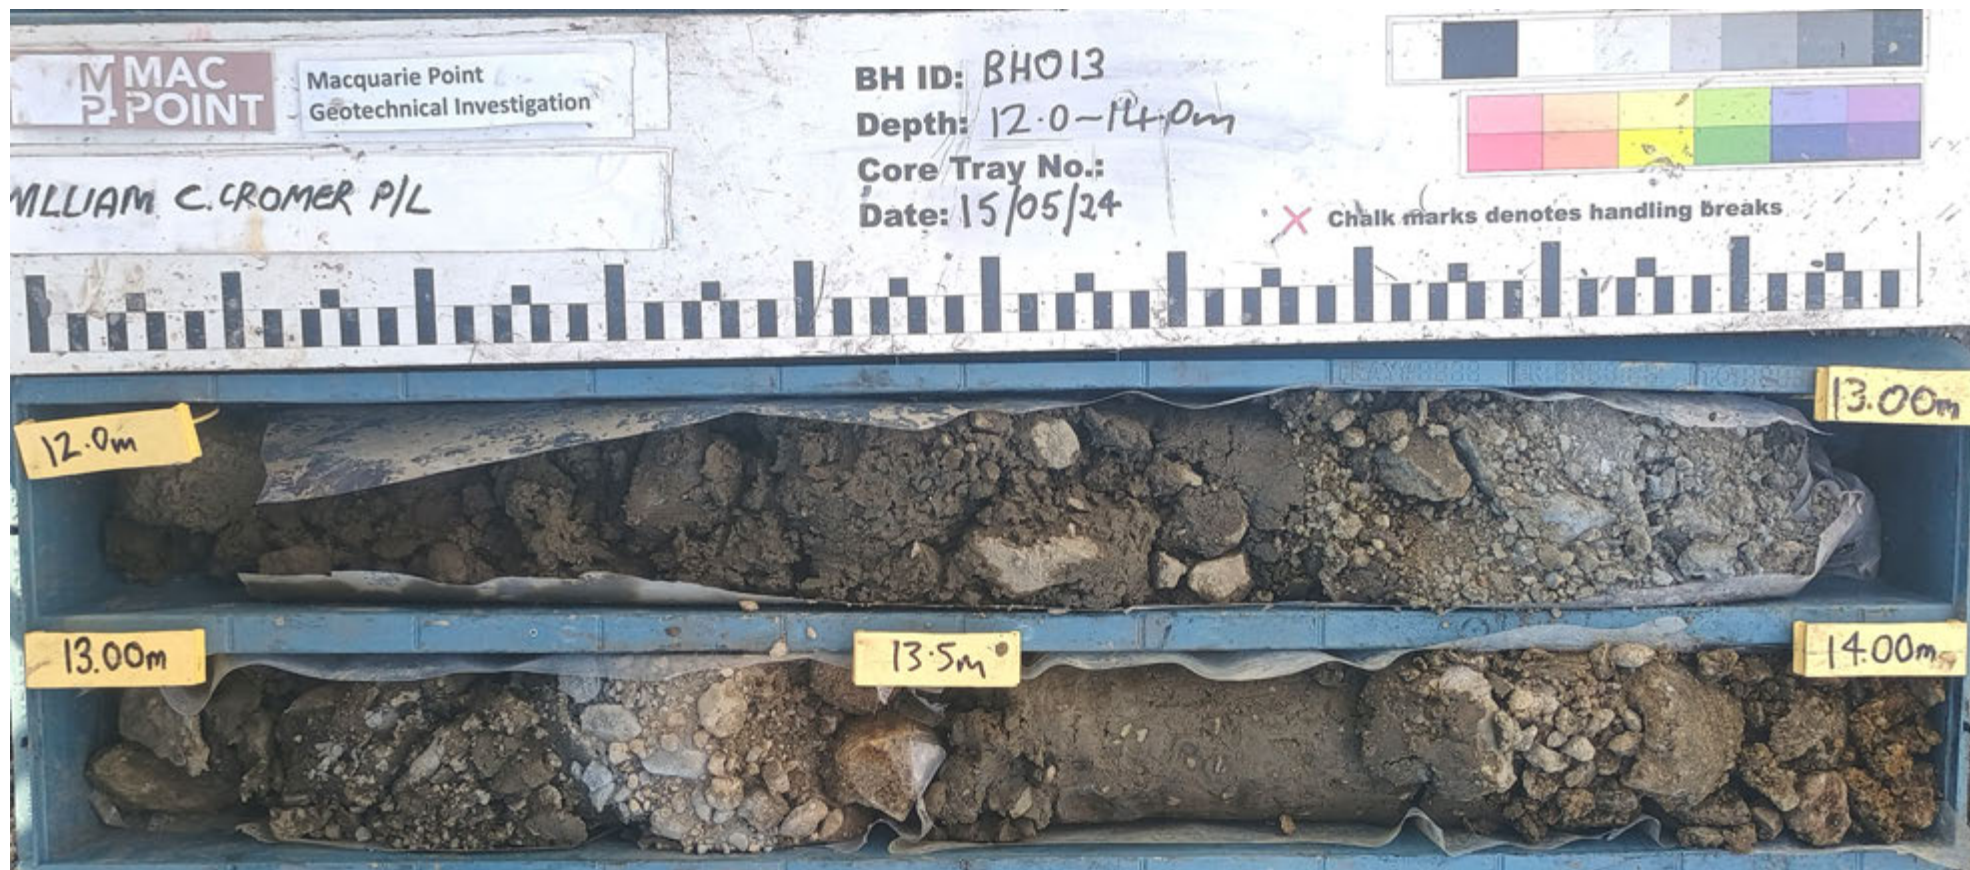
| PROJECT No.<br>PS212776 | FIGURE No.<br>5/10 |

PointID: BH-013 Depth Range: 12.0 – 14.0 m

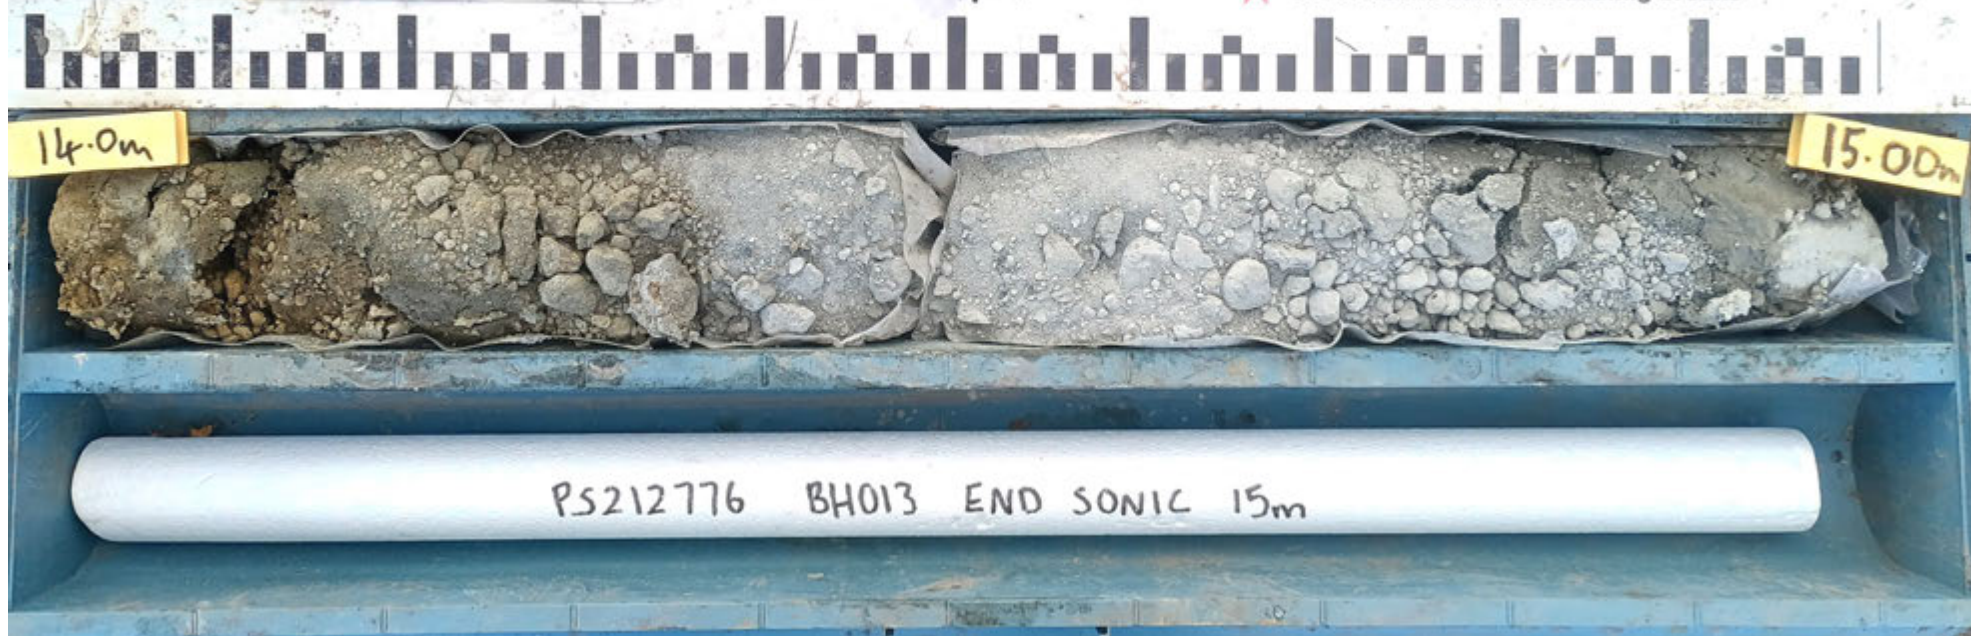
| | | | PROJECT No.<br>PS212776 | FIGURE No.<br>7/10 |

✗ Chalk marks denotes handling breaks

PointID: BH-013 Depth Range: 14.0 – 15.0 m

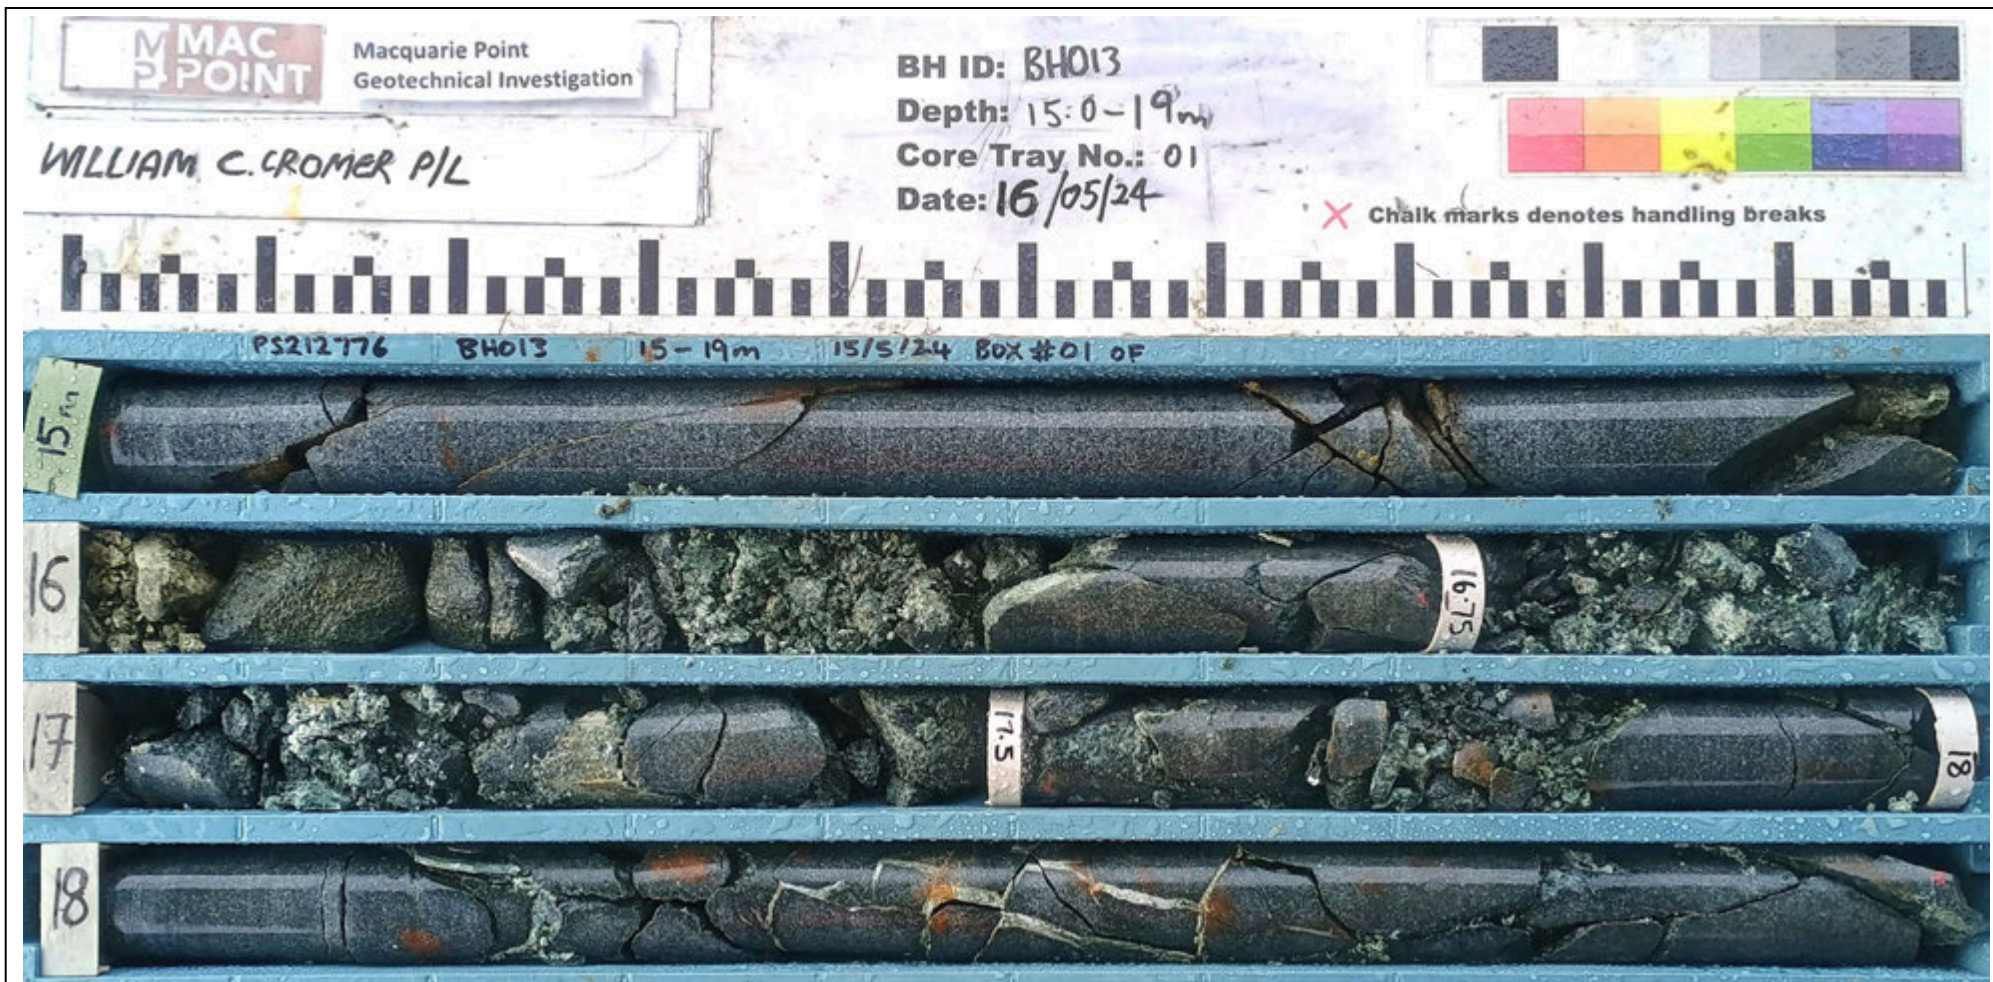
PointID: BH-013 Depth Range: 15.0 – 19.0 m

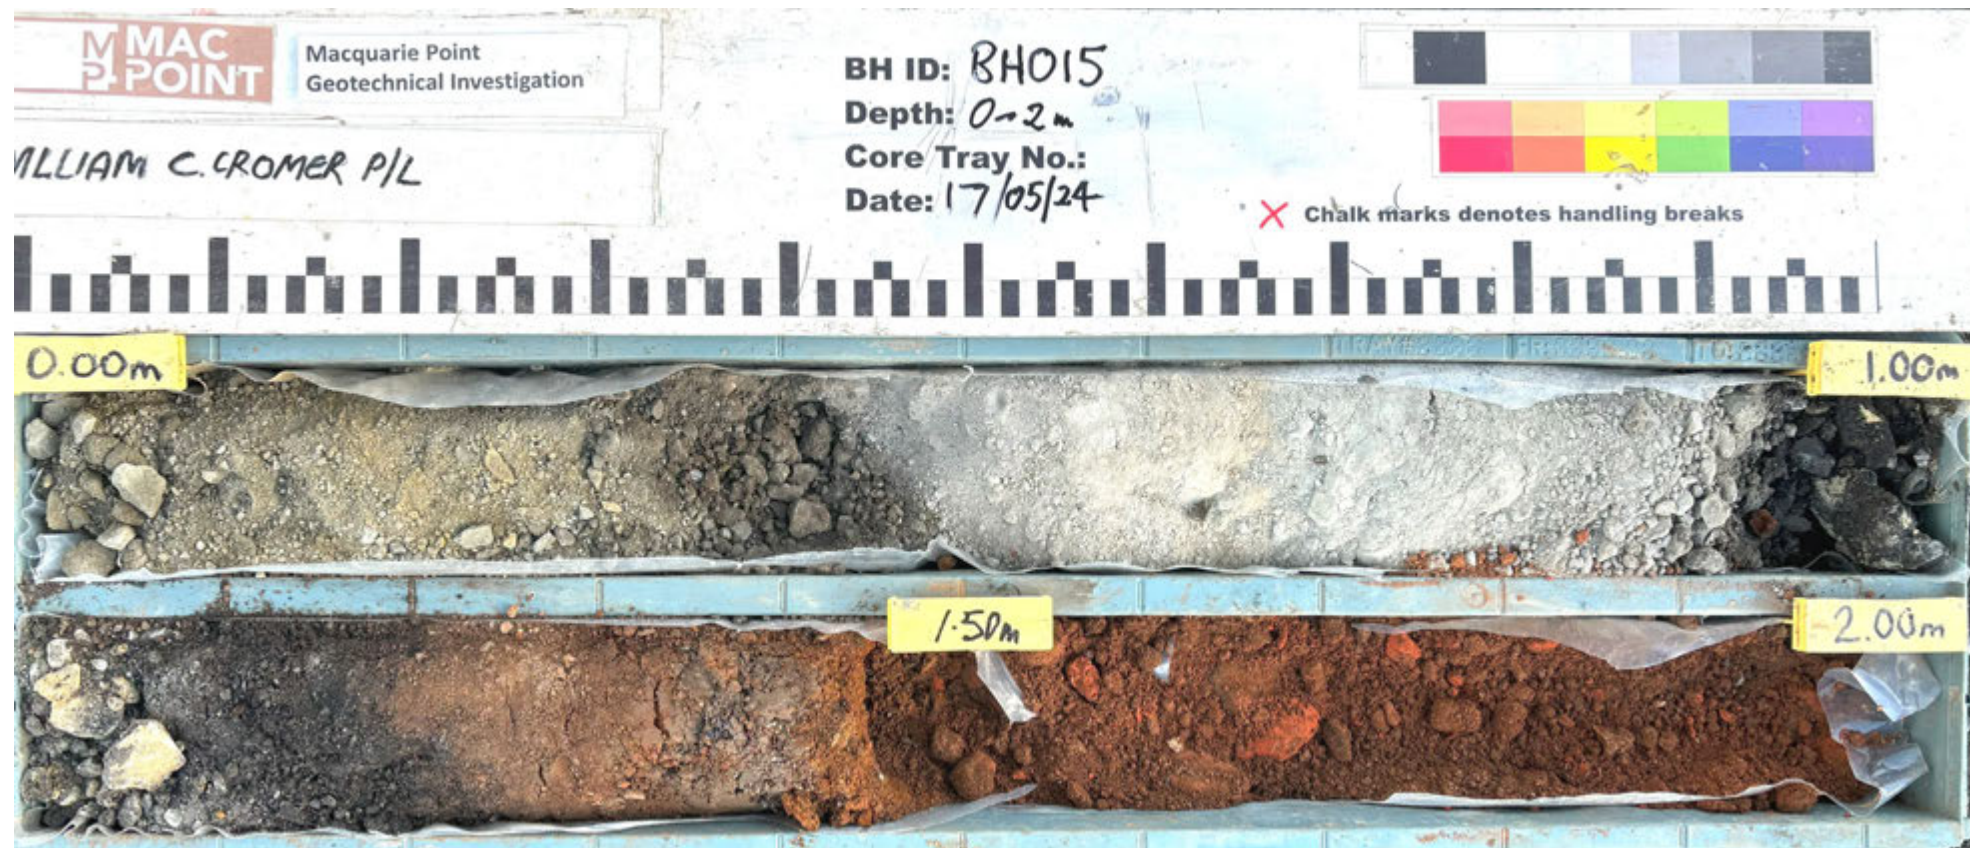
PointID: BH-015 Depth Range: 0.0 – 2.0 m

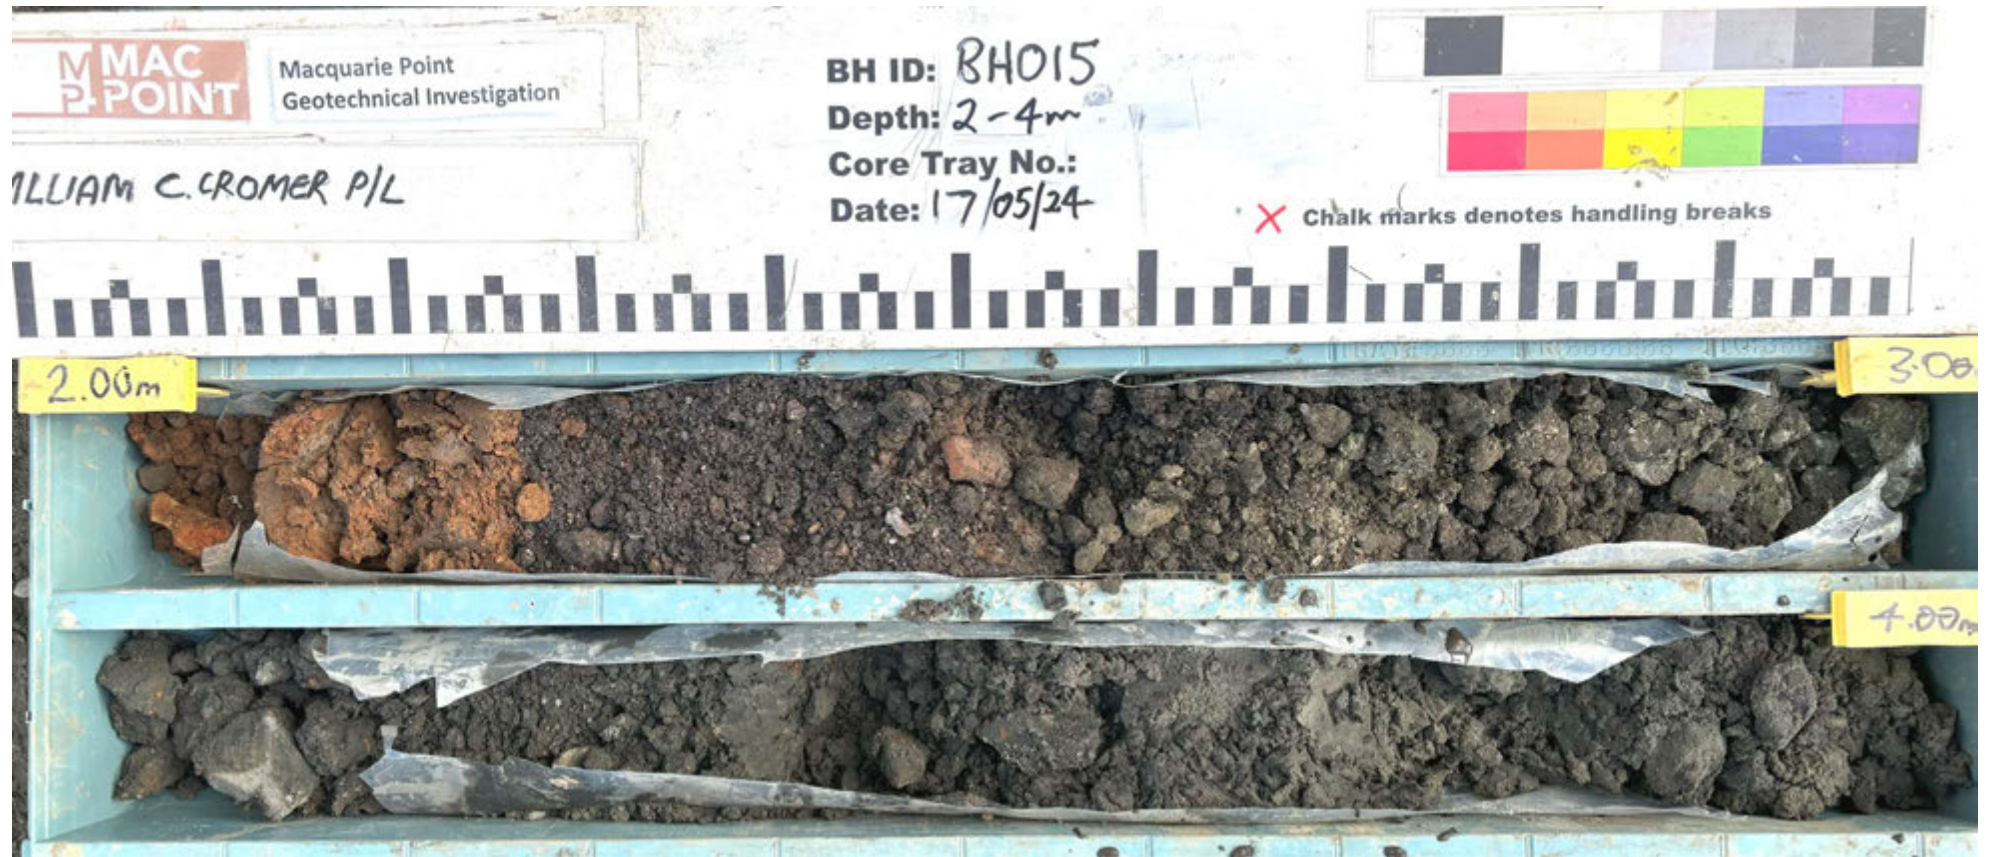
1/5

PointID: BH-015 Depth Range: 2.0 – 4.0 m

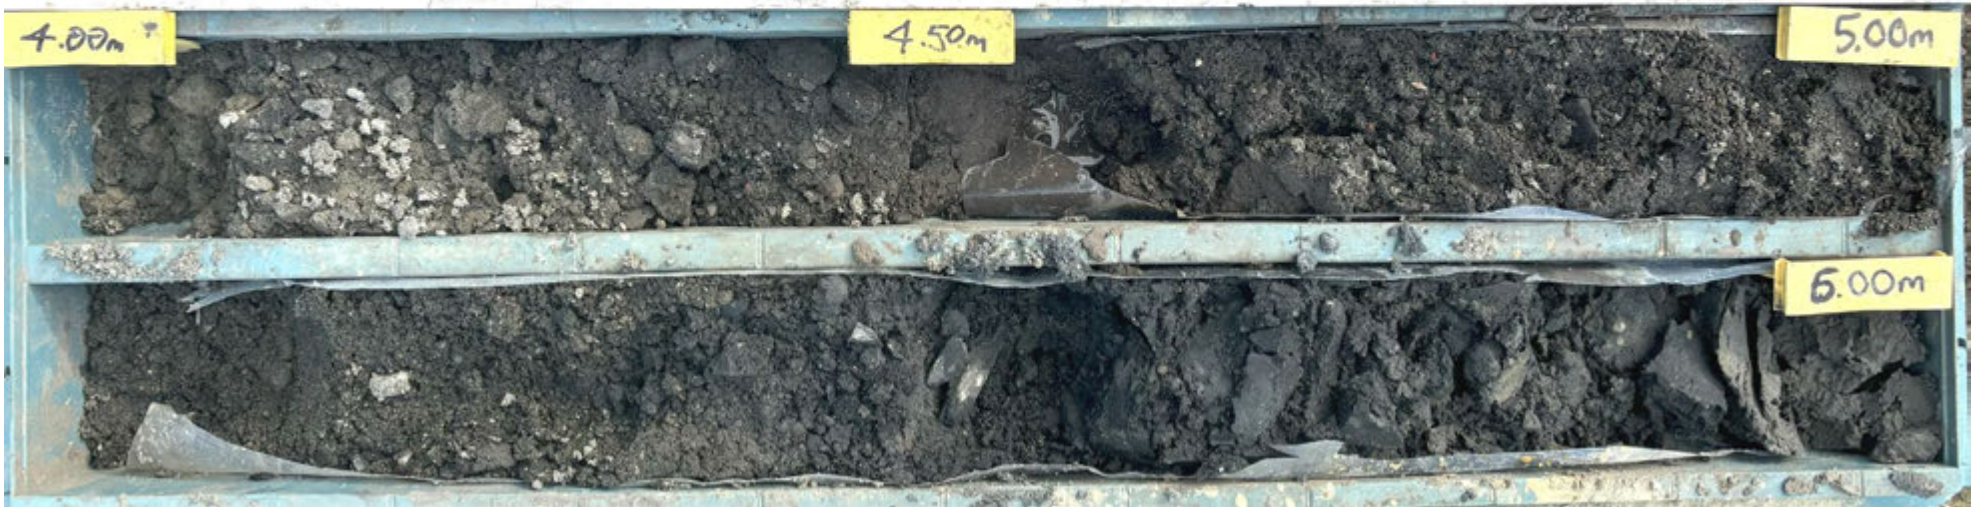
| | | PROJECT No.<br>PS212776 | | FIGURE No.<br>3/5 |

Chalk marks denotes handling breaks

PointID: BH-015 Depth Range: 4.0 – 6.0 m

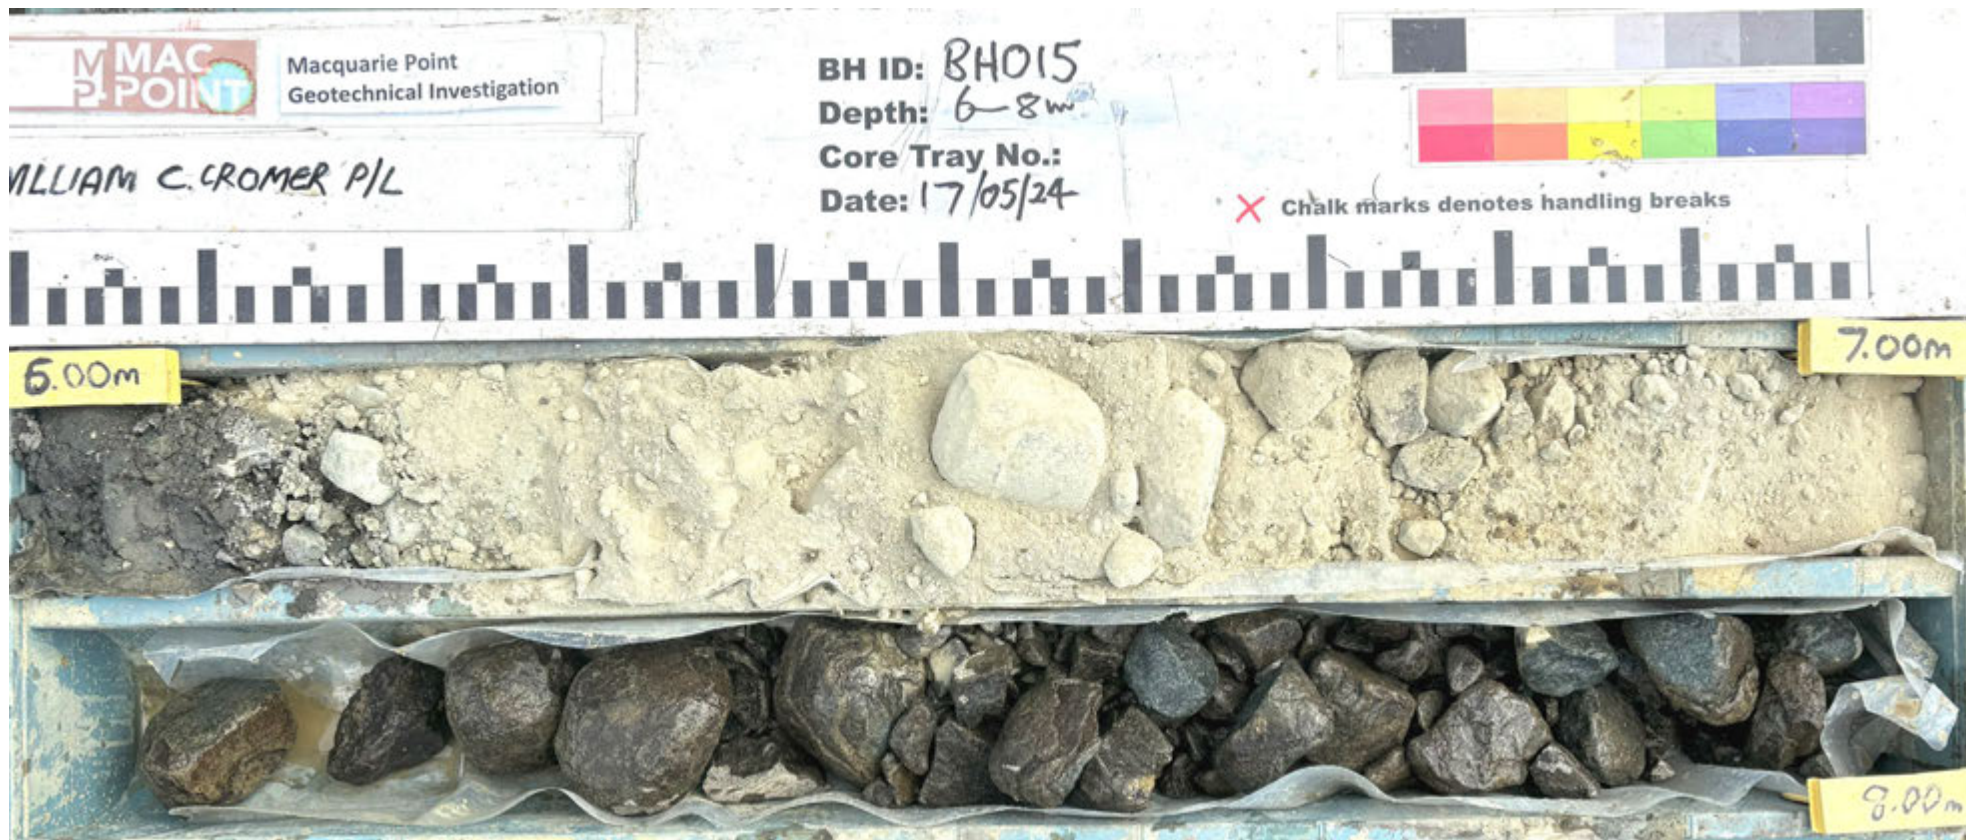
PointID: BH-015 Depth Range: 6.0 – 8.0 m

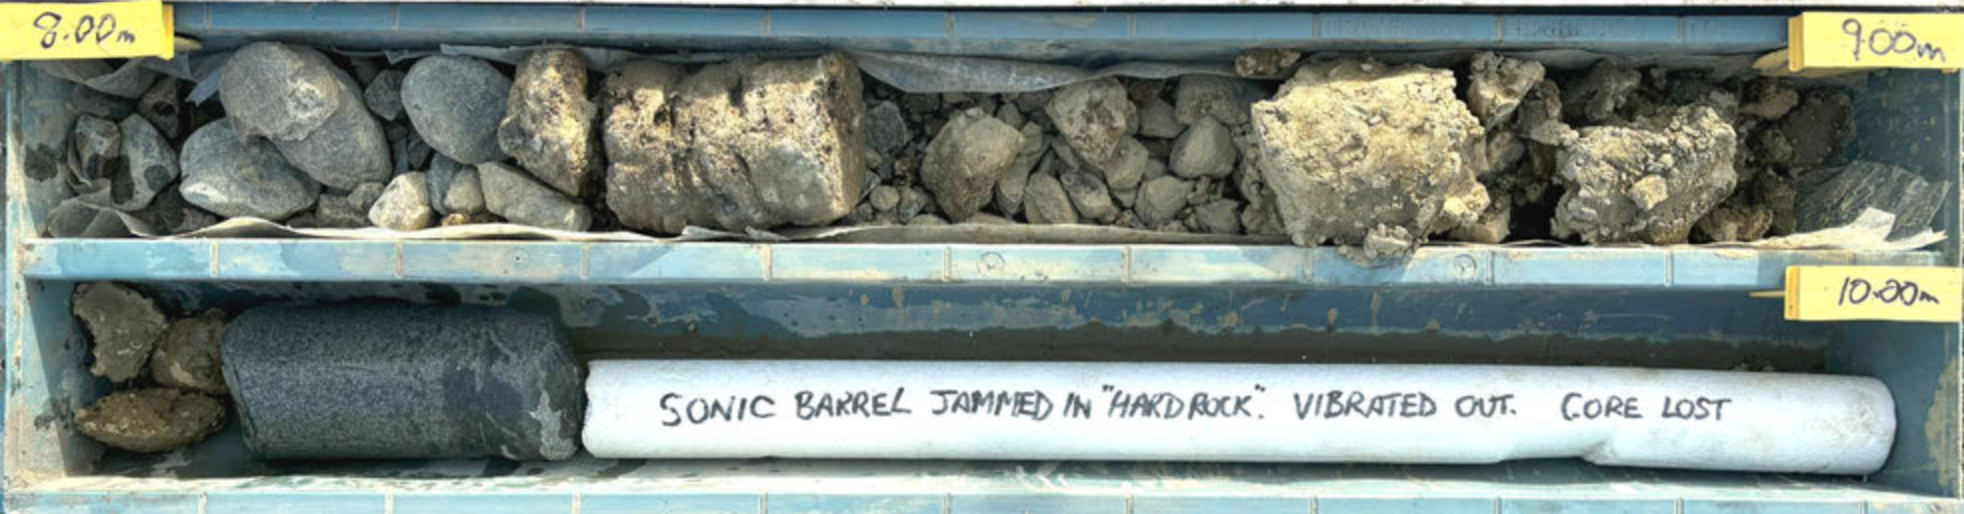
✗ Chalk marks denotes handling breaks

PointID: BH-015 Depth Range: 8.0 – 10.1 m EOH

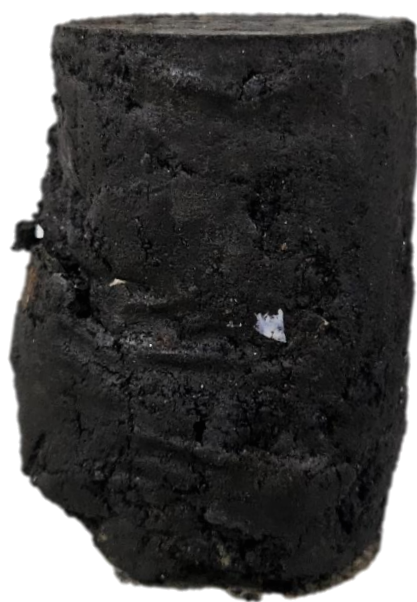
After Test Photo

| Failure Mode | Plastic |

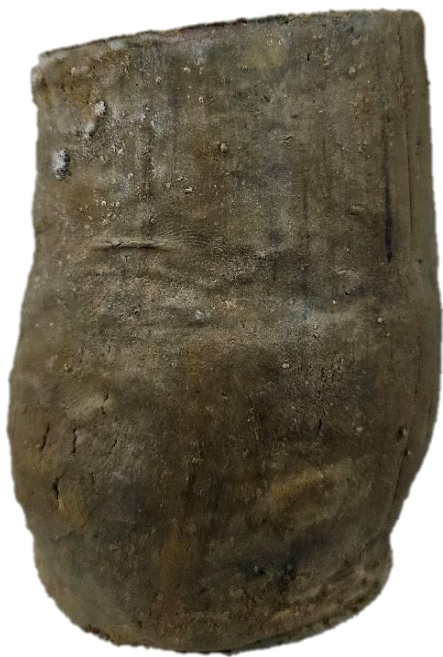
After Test Photo

| Failure Mode | Plastic |

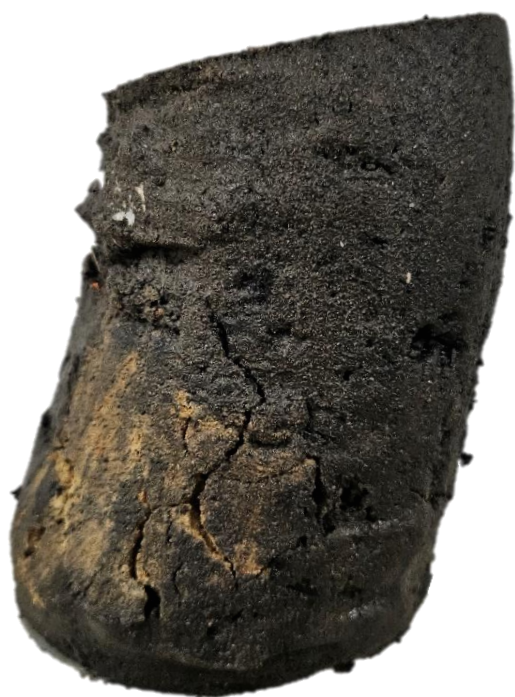
After Test Photo

| Failure Mode | Compound |

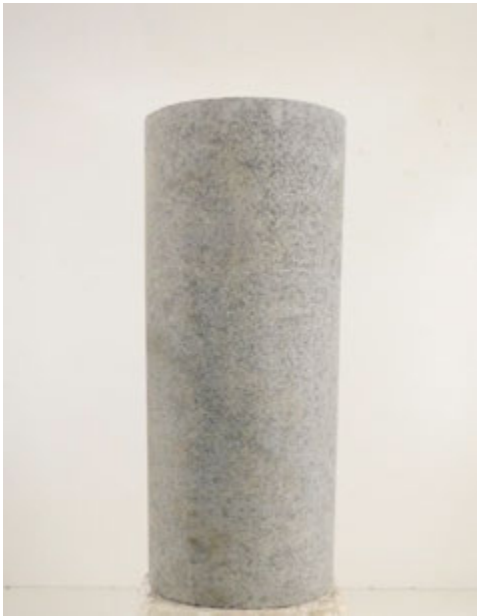
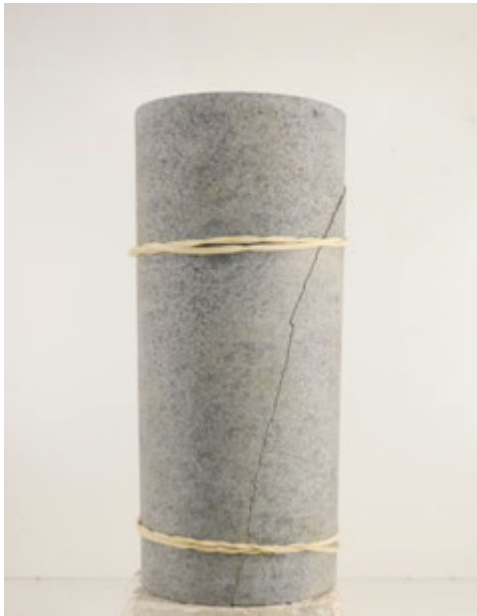
| Uniaxial Compressive Strength | | | |
|---|---|---|---|
| Sample Curing | - | Testing Machine | Matest 2000 kN Compression Machine |
| Uniaxial Compressive Strength | | 23 | MPa |

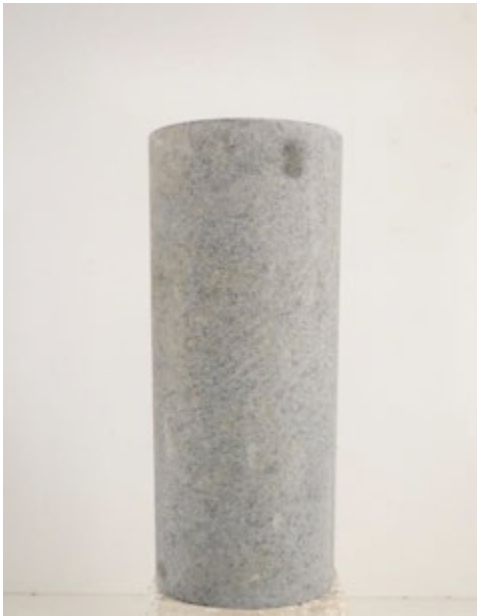
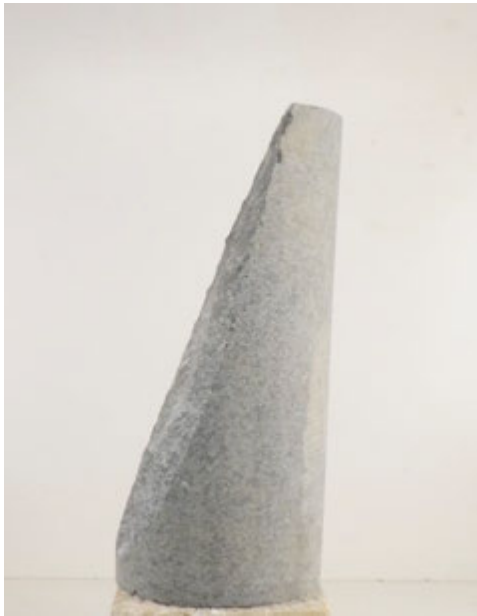
| Uniaxial Compressive Strength | | | |
|---|---|---|---|
| Uniaxial Compressive Strength | | 138 | MPa |

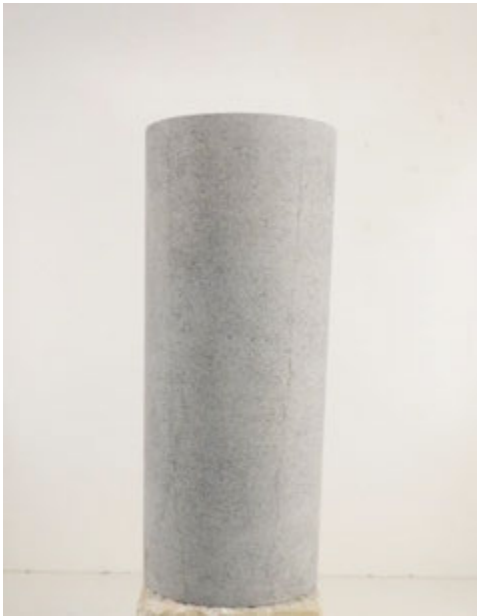
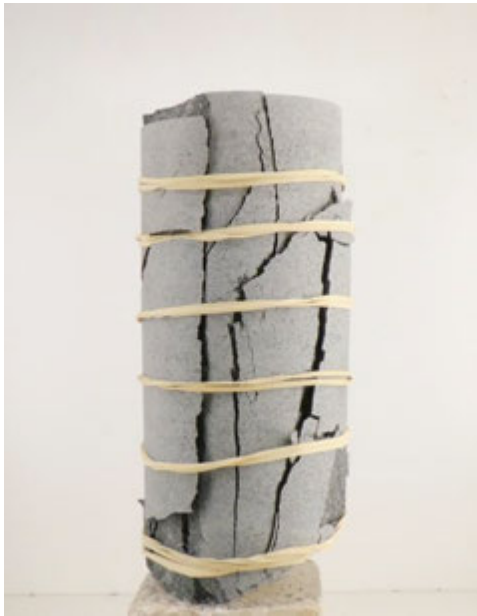
| Uniaxial Compressive Strength | | | |
|---|---|---|---|
| Sample Curing | - | Testing Machine | Matest 2000 kN Compression Machine |
| Uniaxial Compressive Strength | | 140 | MPa |

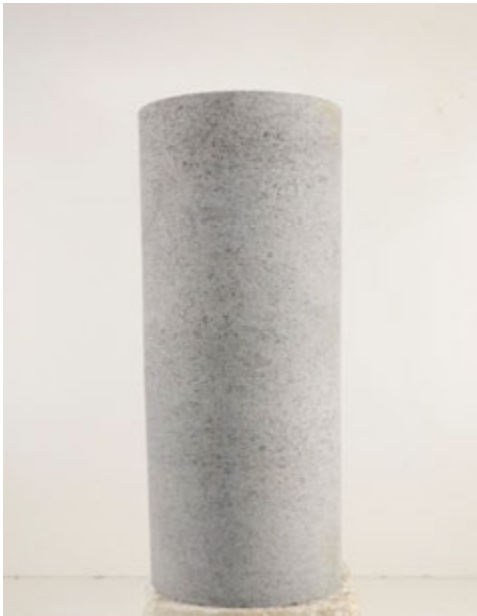
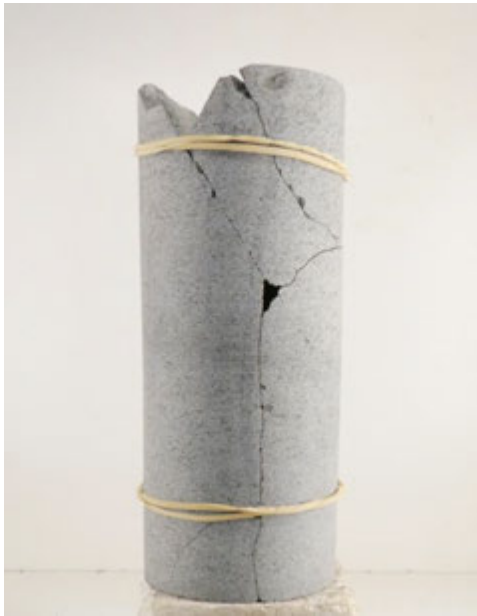
| Uniaxial Compressive Strength | | | |
|---|---|---|---|
| Sample Curing | - | Testing Machine | Matest 2000 kN Compression Machine |
| Uniaxial Compressive Strength      100      MPa | | | |

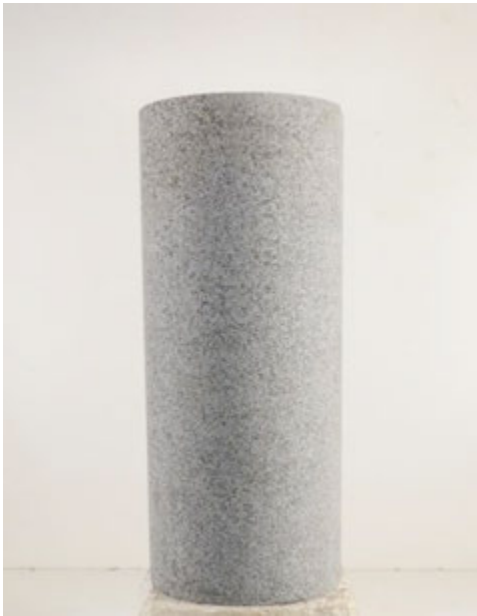
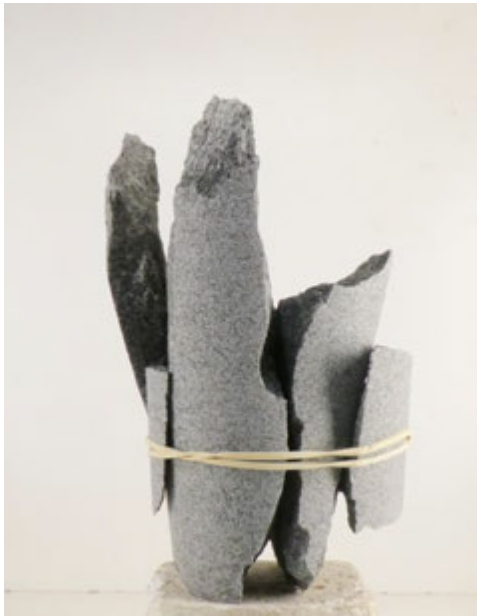
| Uniaxial Compressive Strength | | | |
|---|---|---|---|
| Sample Curing | - | Testing Machine | Matest 2000 kN Compression Machine |
| Uniaxial Compressive Strength | | 172 | MPa |

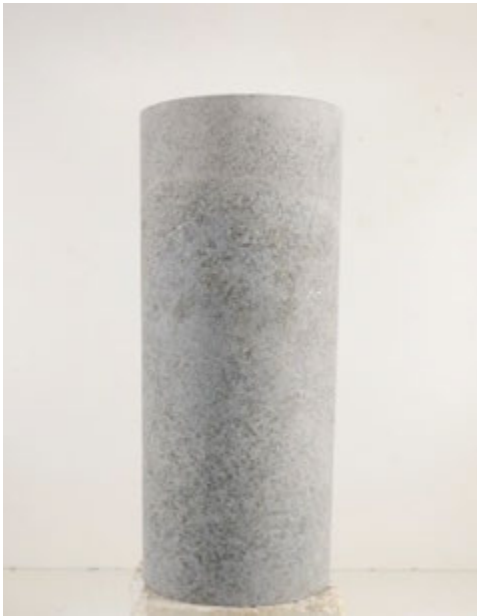
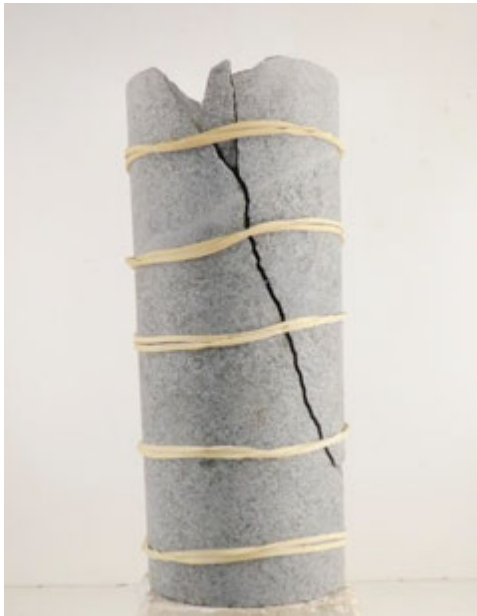
| Uniaxial Compressive Strength | | | |
|---|---|---|---|
| Sample Curing | - | Testing Machine | Matest 2000 kN Compression Machine |
| Uniaxial Compressive Strength | | 46 | MPa |

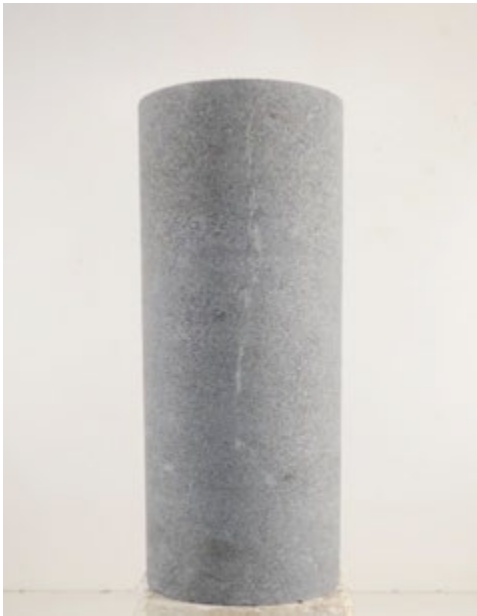
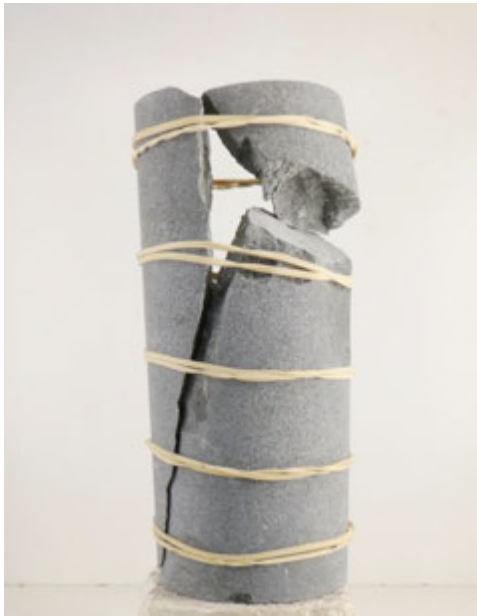
| Uniaxial Compressive Strength | | | |
|---|---|---|---|
| Sample Curing | - | Testing Machine | Matest 2000 kN Compression Machine |
| Uniaxial Compressive Strength | | 98.6 | MPa |

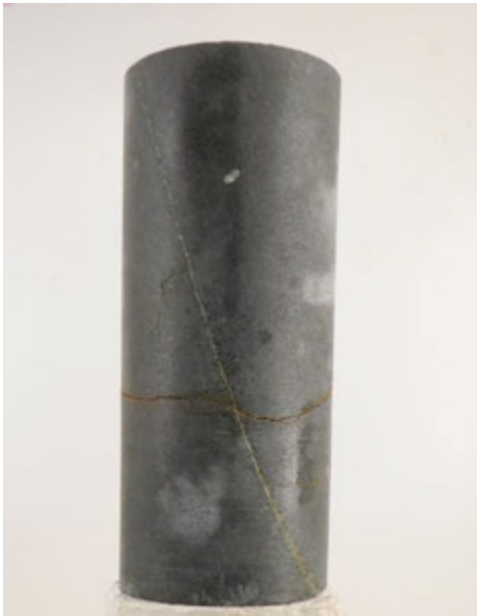
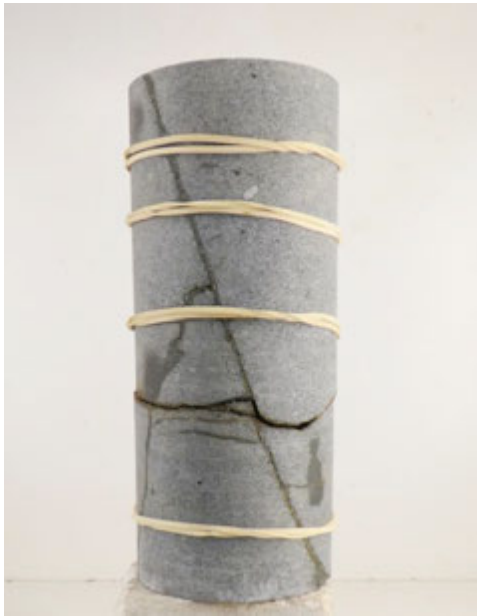
| Uniaxial Compressive Strength | | | |
|---|---|---|---|
| Sample Curing | - | Testing Machine | Matest 2000 kN Compression Machine |
| Uniaxial Compressive Strength | | 1.1 | MPa |

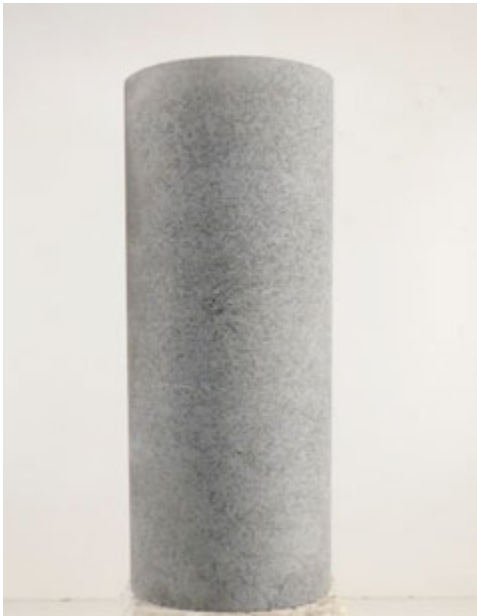
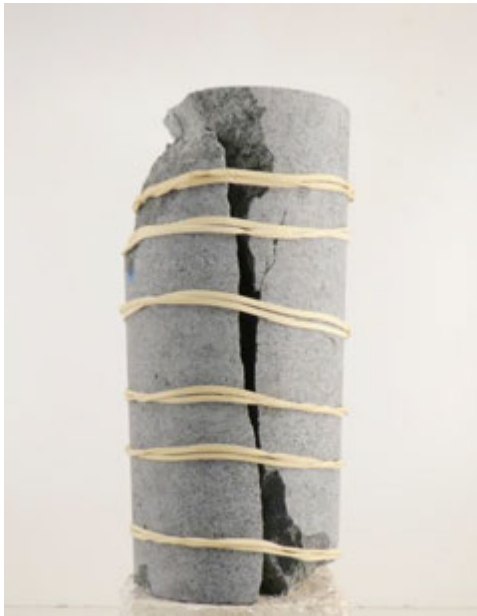
| Uniaxial Compressive Strength | | | |
|---|---|---|---|
| Sample Curing | - | Testing Machine | Matest 2000 kN Compression Machine |
| Uniaxial Compressive Strength | | 153 | MPa |

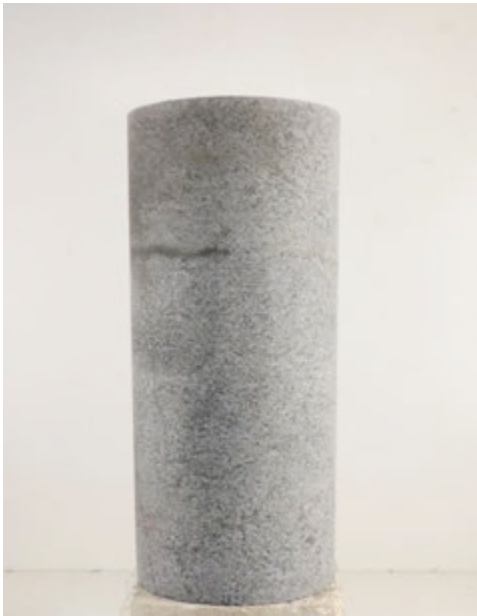
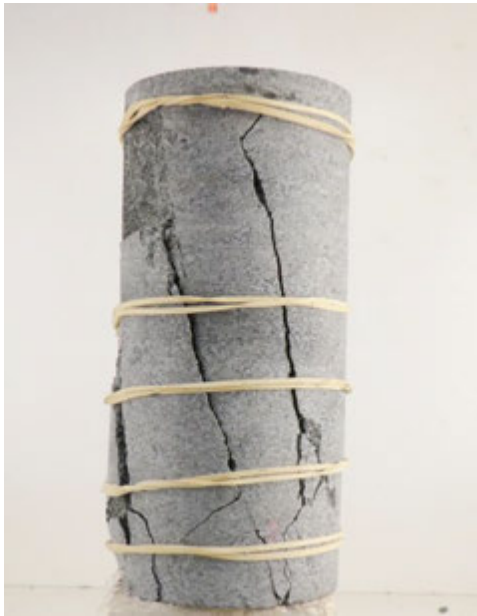
| Uniaxial Compressive Strength | | | |
|---|---|---|---|
| Sample Curing | - | Testing Machine | Matest 2000 kN Compression Machine |
| Uniaxial Compressive Strength | | 89.7 | MPa |

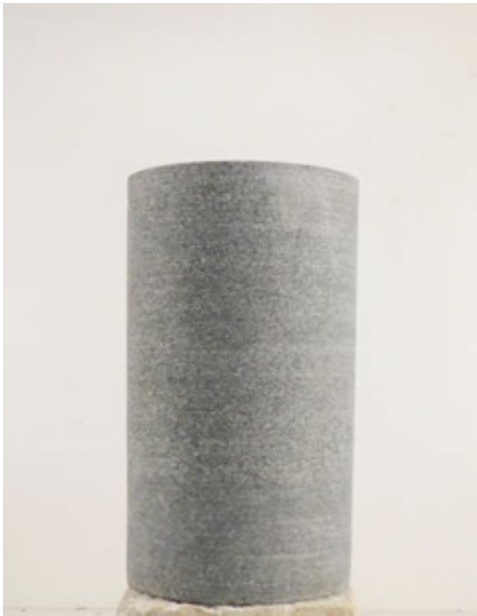
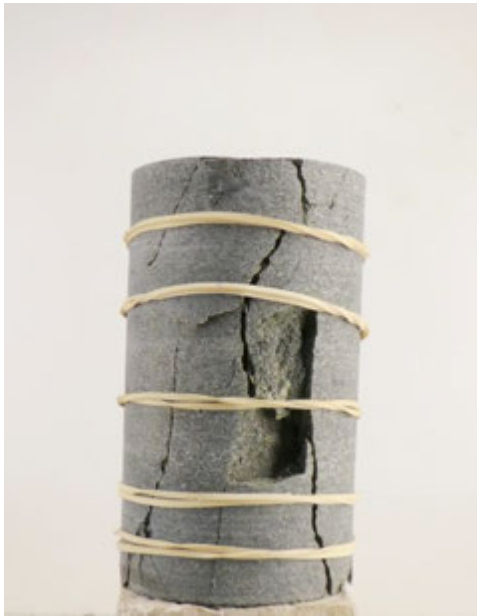
| Uniaxial Compressive Strength | | | |
|---|---|---|---|
| Sample Curing | - | Testing Machine | Matest 2000 kN Compression Machine |
| Uniaxial Compressive Strength | | 96 | MPa |

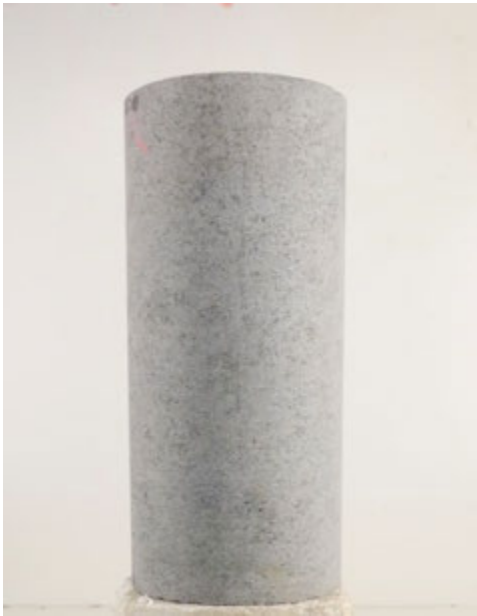
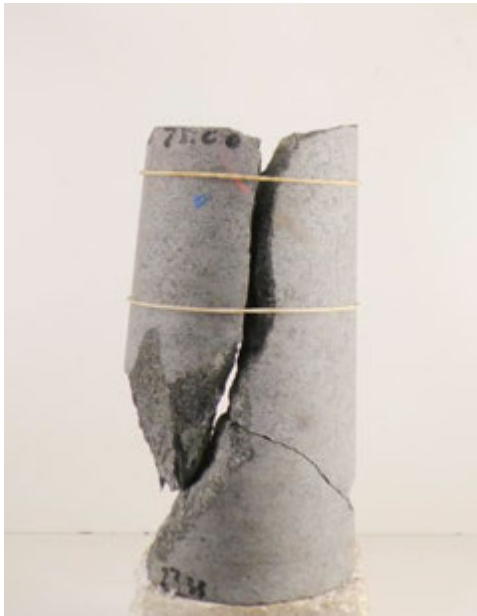
| Uniaxial Compressive Strength | | | |
|---|---|---|---|
| Sample Curing | - | Testing Machine | Matest 2000 kN Compression Machine |
| Uniaxial Compressive Strength | | 229 | MPa |

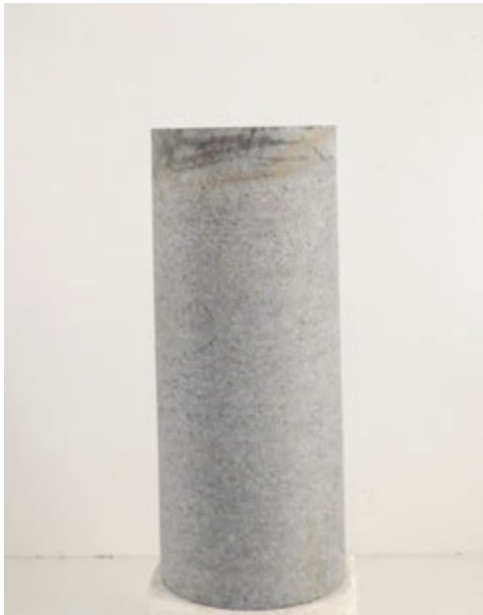
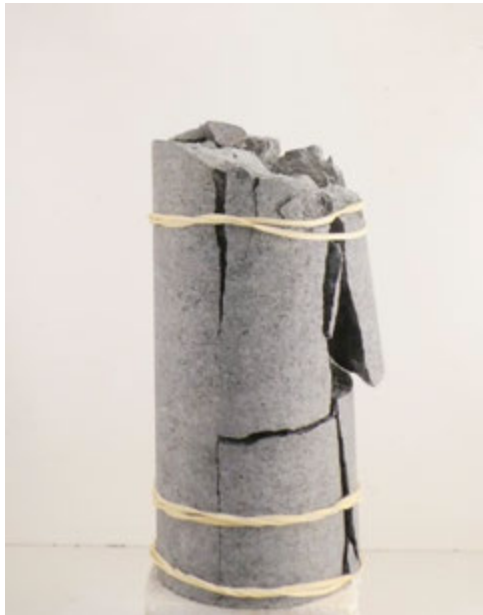
| Deformability of Rock Materials in Uniaxial Compression | | | |
|---|---|---|---|
| <b>Mode of Failure</b> | Mixed mode | <b>Test Apparatus</b> | Matest Compression Machine with Axial and<br>Circumferential Extensometers. |
| <b>Uniaxial Compressive Strength</b> | | <b>114</b> | <b>MPa</b> |

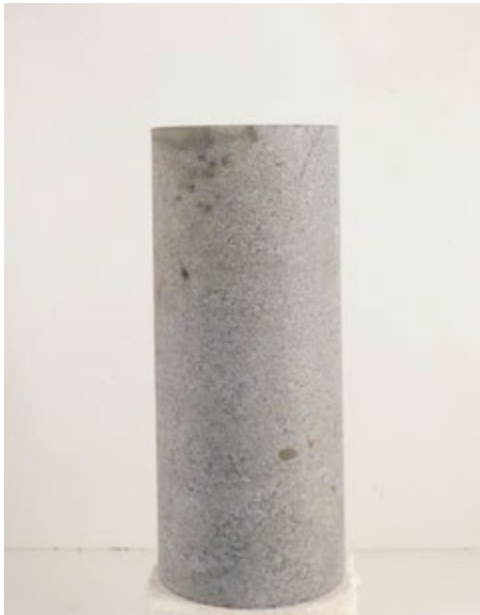
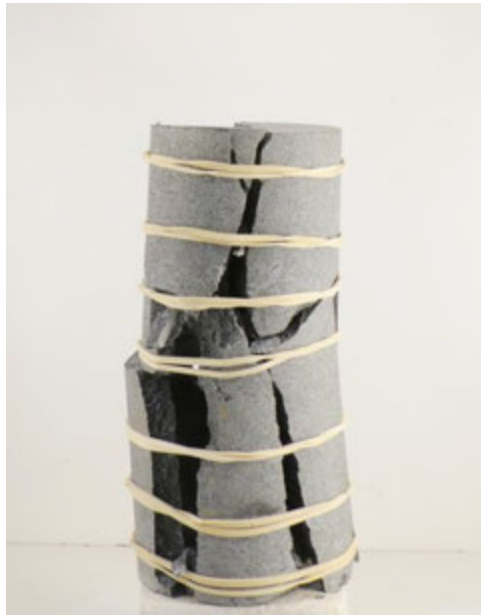
| Deformability of Rock Materials in Uniaxial Compression | | | |
|---|---|---|---|
| Tensile dominated | | Matest Compression Machine with Axial and Circumferential Extensometers. | |
| Uniaxial Compressive Strength | | 128 MPa | |
