BRIDGEWATER CROSSING DERWENT RIVER, BRIDGEWATER ARCHIVAL RECORD

PREPARED FOR DEPARTMENT OF STATE GROWTH

18 August 2021 02 FINAL ISSUE TO CLIENT

ARCHIVAL RECORD

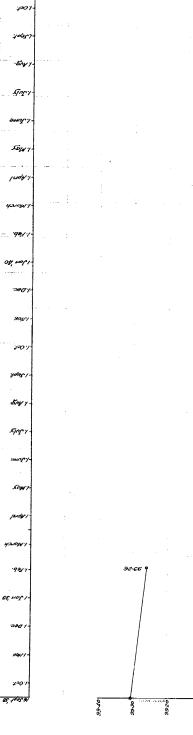
CHIEFÉNGINEER OERMENT RIVER BRIDGE AT BRIDGENATER Prepared Checked 1507 -32 DEPARTMENT OF PUBLIC WORKS - TAS. SETTLEMENT OF SOUTH ABUTMENT as observed on N.W. seating bolt Scale: -Drawing Tracing Dasign Supervision Settle . . .

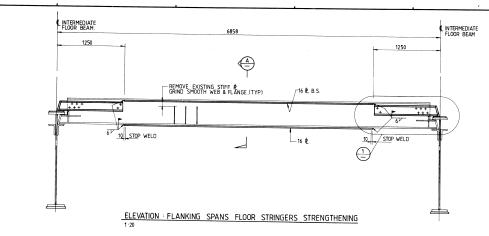
SECTION

ALL CONTACT SURFACES TO BE FASTENED WITH FRICTION GRIP BOLTS TO BE PREPARED AS DETAILED IN THE SPECIFICATION.

Maunsell & Partners Pty Ltd CONSULTING ENGINEER'S & PLANNERS
	1	REFERENCE DRAWINGS	SCALES	LOADING	T						MAUNSELL DRAWING No. 17687—1006
			JUNCES	T44	DESIGN	DRAWING			CONTRACT NUMBER	DEPARTMENT OF MAIN	I ROADS, TASMANIA
				PREPARED	Reverthalland	RRaneer 1973	BRIDGEWAT RECOMMENDED	ACCEPTED	-	DERWENT RIVER BRI	
AMENDMENTS	APPROVED	3		SUPERVISED	PSelfort	4	S Neuron 6/6/1		R	STRINGERS DETAILS OF STREN	IGTHENING 19

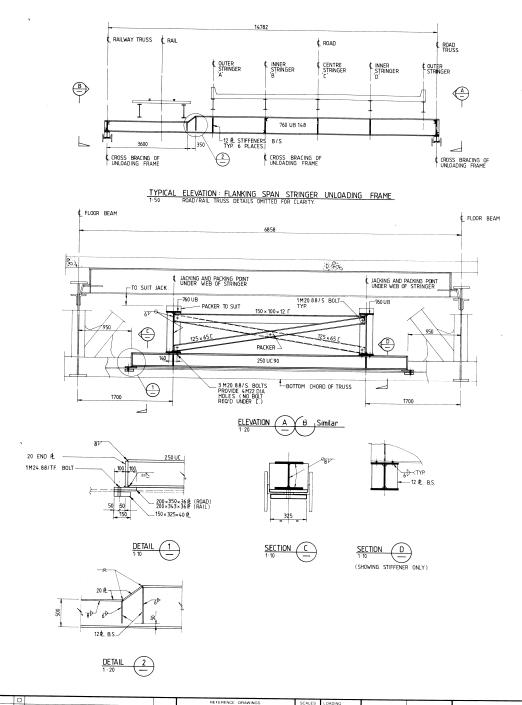
NOTES

Э.	JACKS SHALL BE SYNCHRONISED TO ENSURE EQUAL LOADING DURING JACKING OPERATIONS BY HYDRAULIC LINKING OR OTHER APPROVED METHOD.
4.	LOAD PER JACK PRIOR TO PACKING SHALL BE AS FOLLOWS.

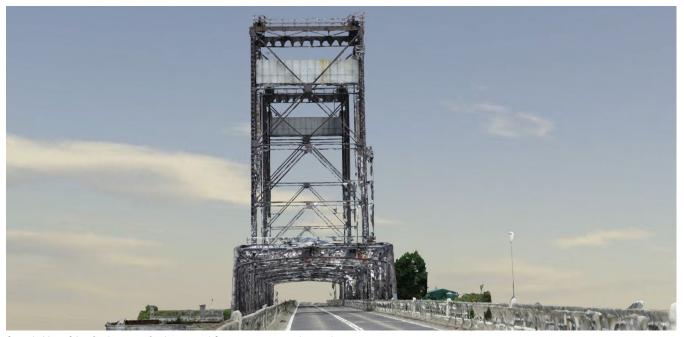
Sample View 05 – Perspective view of Bridgewater Bridge, looking north.

Sample View 06 - Bridgewater Bridge viewed from causeway to the north.
