SLR Ref No.: 620.041093\_L1\_v1\_20250131.docx

**RE: Mac Point Proposed Stadium  
Response to Request for Information**

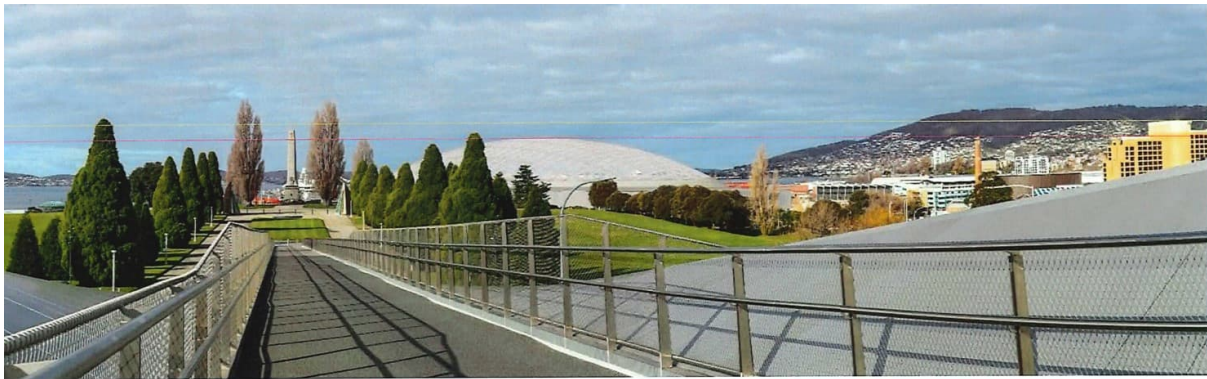
**Figure 1 – VP2 panoramic image.**

Having regard to the query around the height of the Grand Chancellor Hotel appearing to higher than the Stadium (**Figure 2**), I consider this is a result of distortion of the image at the edges.

The panoramic image in VP2 was used to provide a wider contextual view of the Stadium including natural elements and other built form. The nature of the panorama relies on 'stitching' a number of consecutive photographs/ images together. In the process, distortion of the overall image can occur which is caused by the camera lens, the nature or overlap of the consecutive images or the way the photographs are taken.

While the photographs were taken using a 50mm focal point, prime lens, the process of stitching these together has resulted in some minor distortion to the field of view at the extremities of the panorama. This is most evident around the position of the Grand Chancellor Hotel.

**Figure 38** Viewpoint 2 (VP2) – View of proposed stadium

Following the request for further information from the Tasmanian Planning Commission (TPC) on the 19 November 2024, and in particular the reference to the comparative height of the proposed Stadium in relation to the existing Grand Chancellor Hotel as shown in Viewpoint 2 (VP2), Figure 38.
