## Planning Submission

### **Baudin Road (northern end), Carlton River CT 119311-1 and CT 169070-1 (Approx. 41ha)**

To rezone from Rural Resource Zone to Rural Living Zone  
and concurrently subdivide into 9 1ha lots

To rezone the balance land from Rural Resource Zone to Rural Living Zone – Area B  
and concurrently subdivide into 3 10ha lots

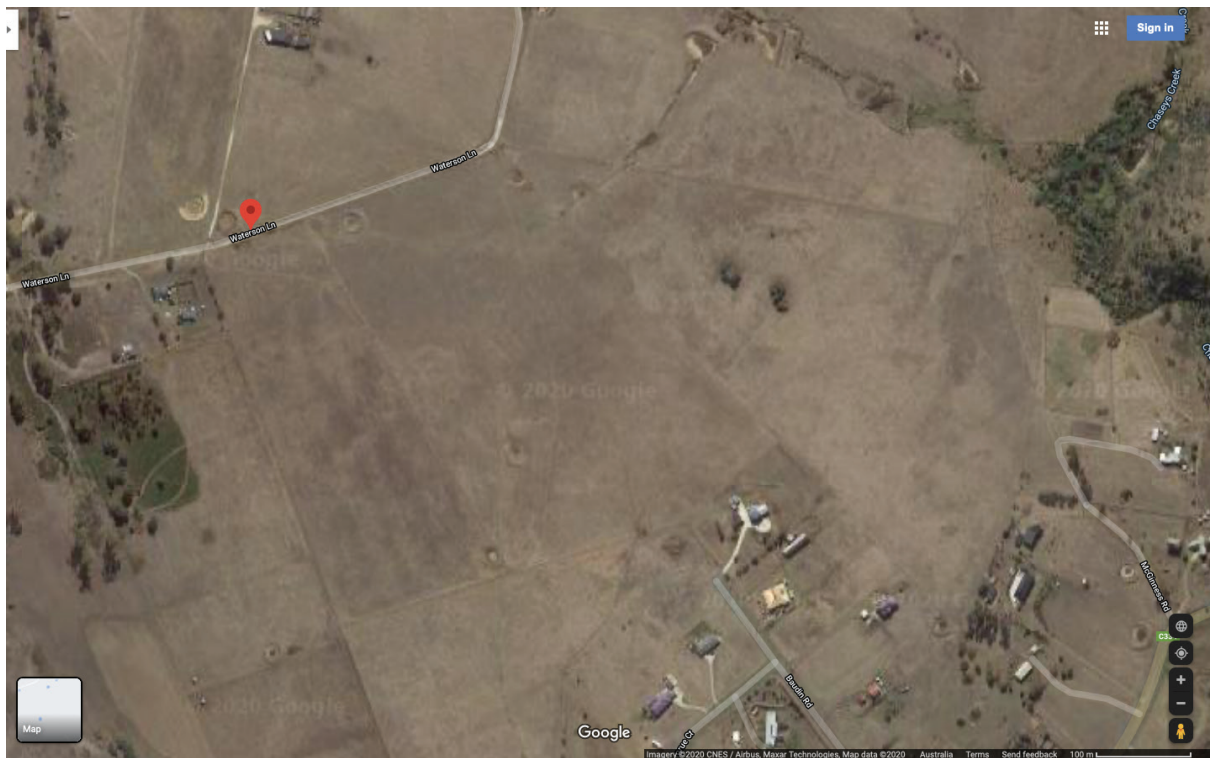
Figure 3 Satellite Image showing dry conditions in early 2020 (source Google maps 2020)

Figure 3 below is a Google map satellite image from early 2020 showing the impact of the dry period prior to April 2020 on the vegetation cover in the area of the subject property. The dry waterholes are evident in the image.

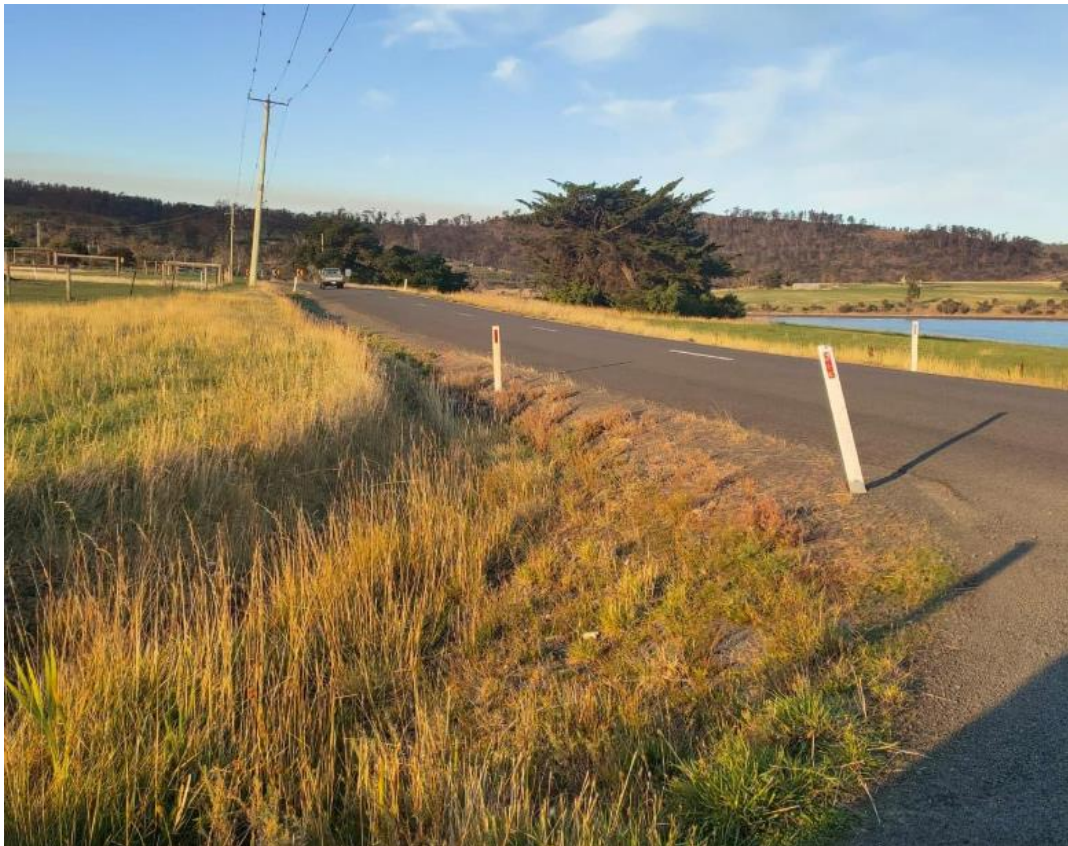
**Figure 4 Looking east from the Baudin Road intersection**

Figure 4 and Figure 5 show the sight distance looking from the Baudin Road / Carlton River Road intersection.

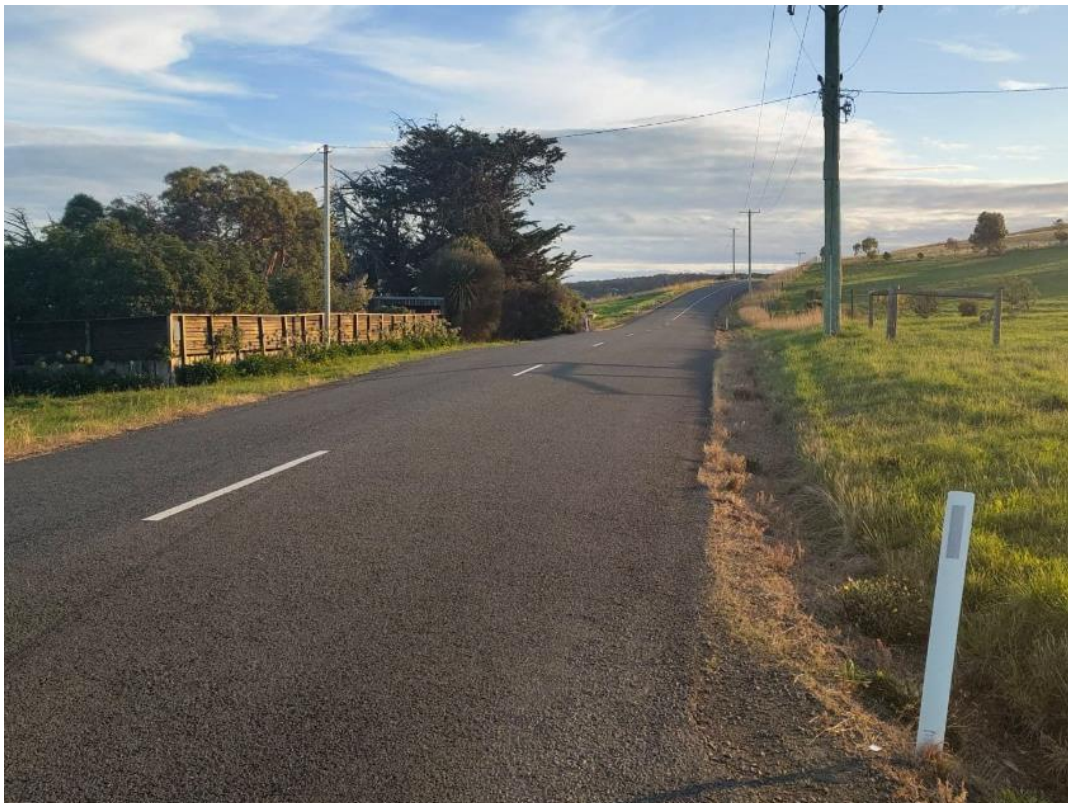
**Figure 5 Looking west from the Baudin Road intersection**

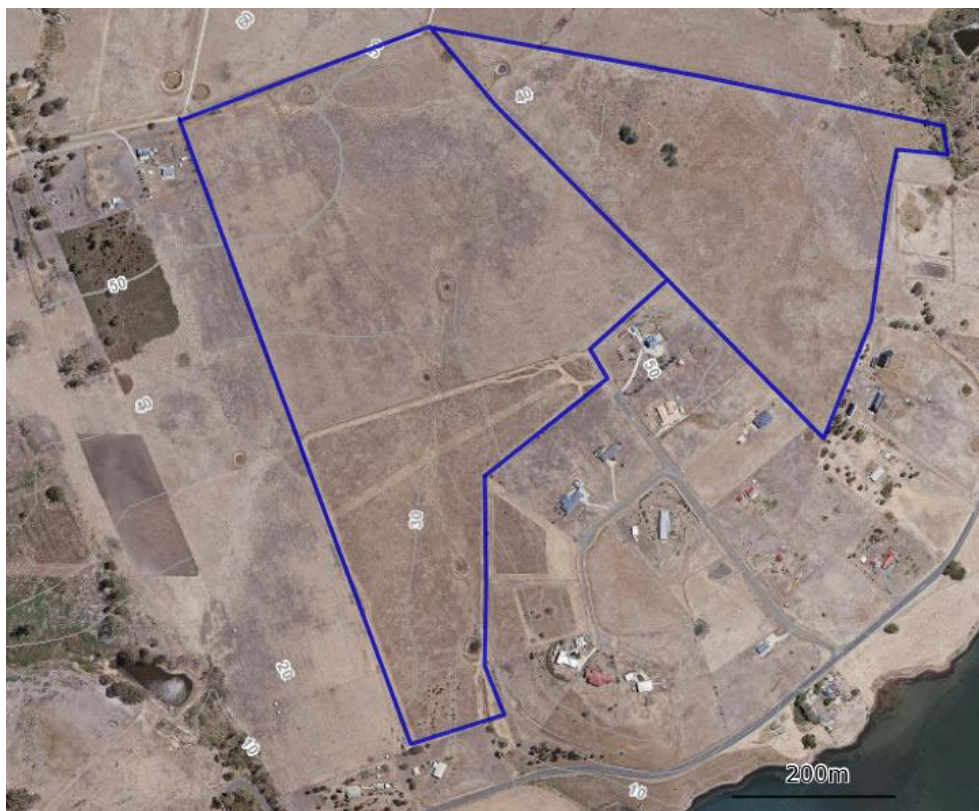
Figure 2 Topography of the property (contours in meters) (source the LIST)

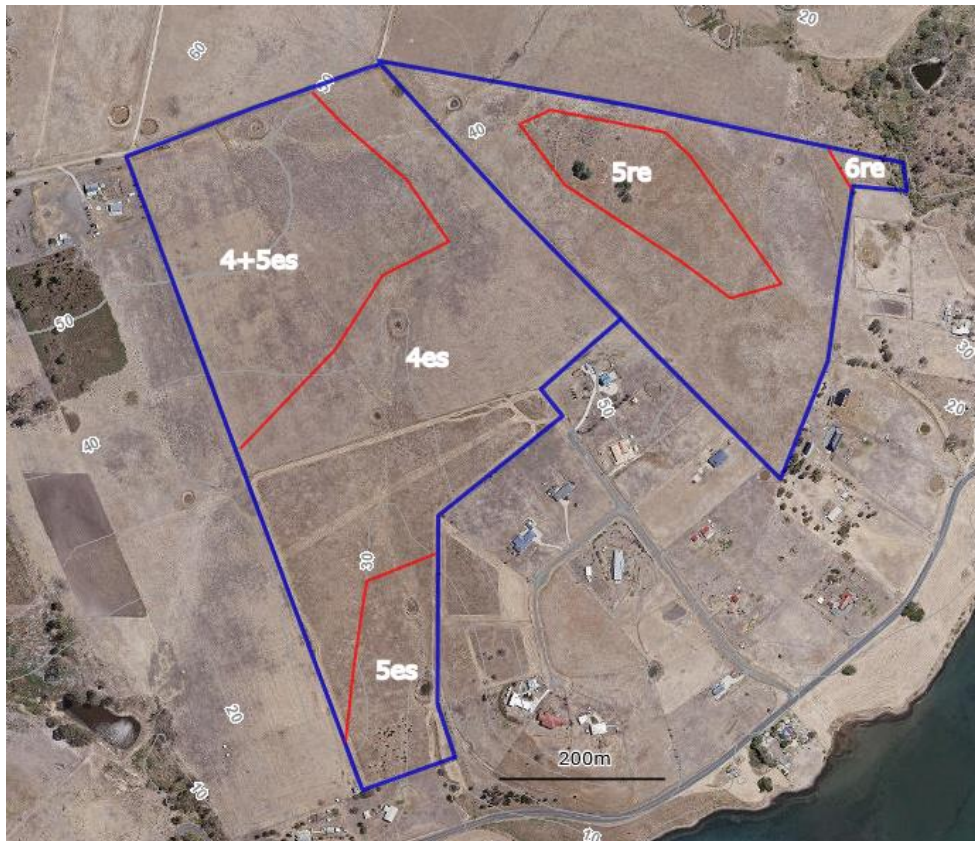
**Figure 5 Land capability areas on the properties in question**

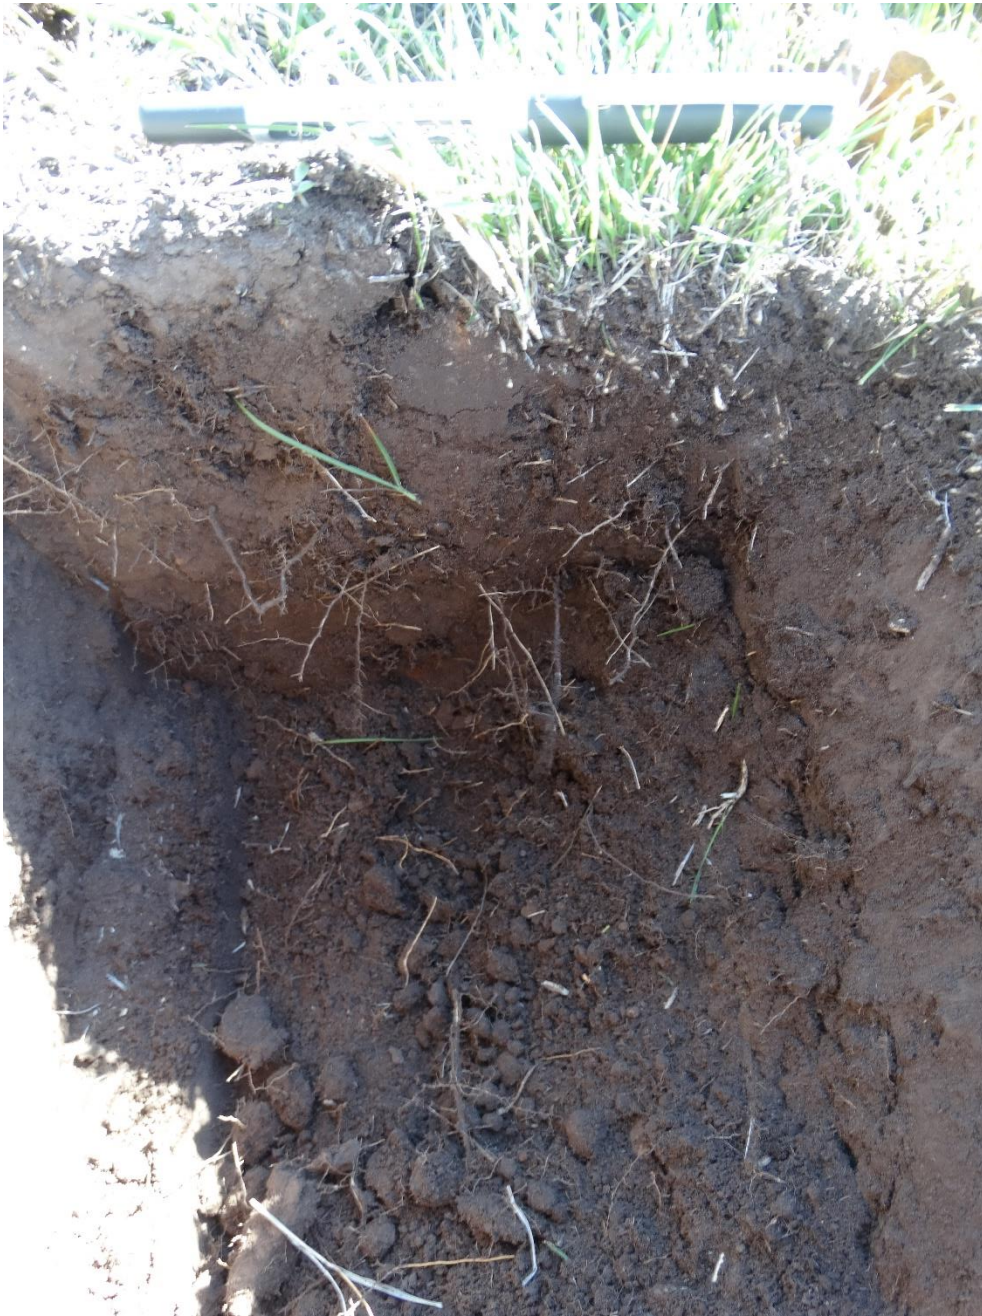
**Figure 6 Top soil profile of the dominant dermosol soil present in the class 4es area of the properties**

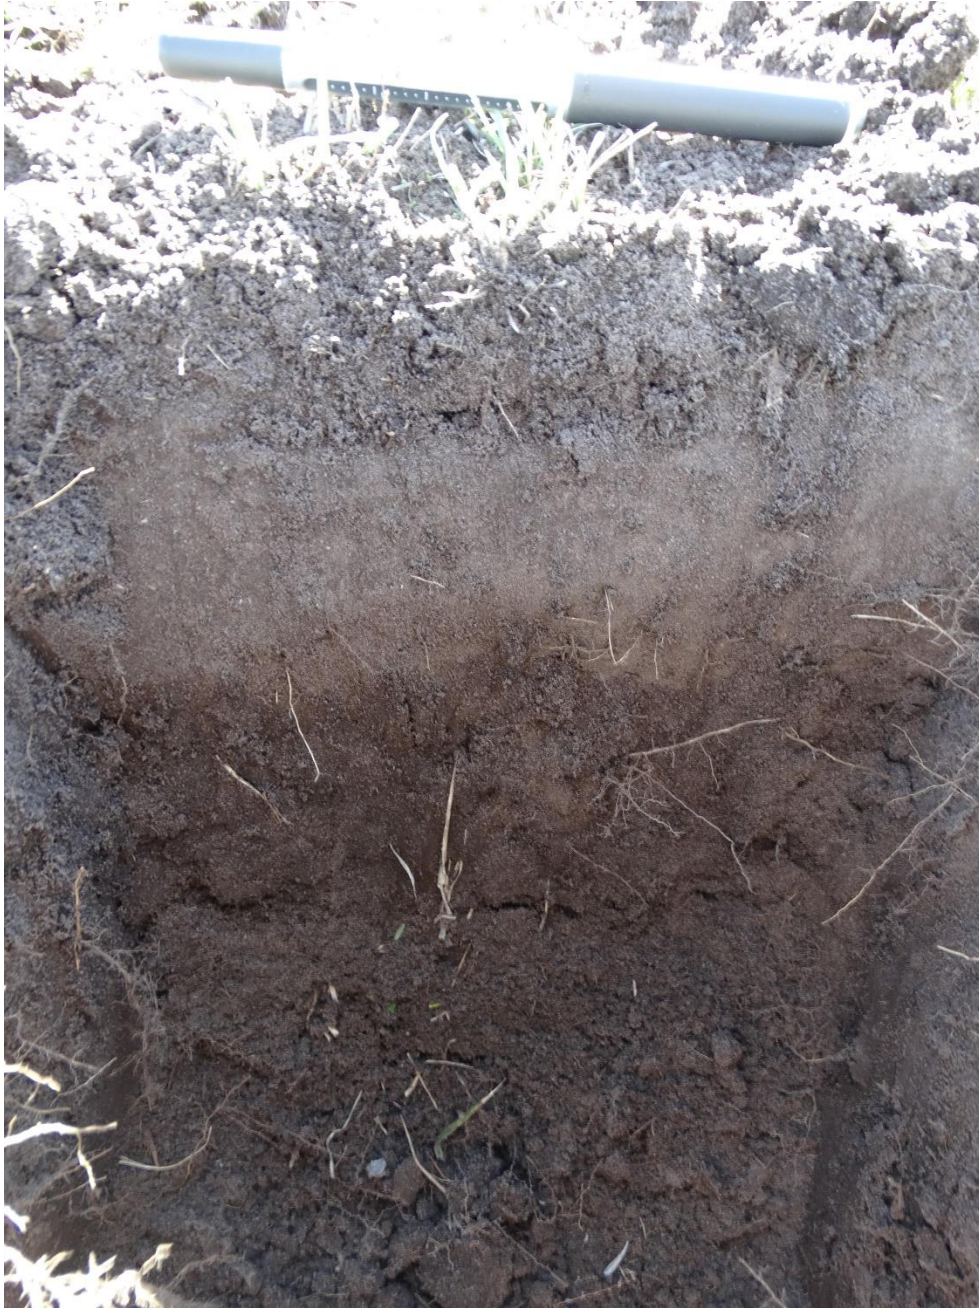
**Figure 7 Sandy loam soils present on the northern areas of the class 5es land**

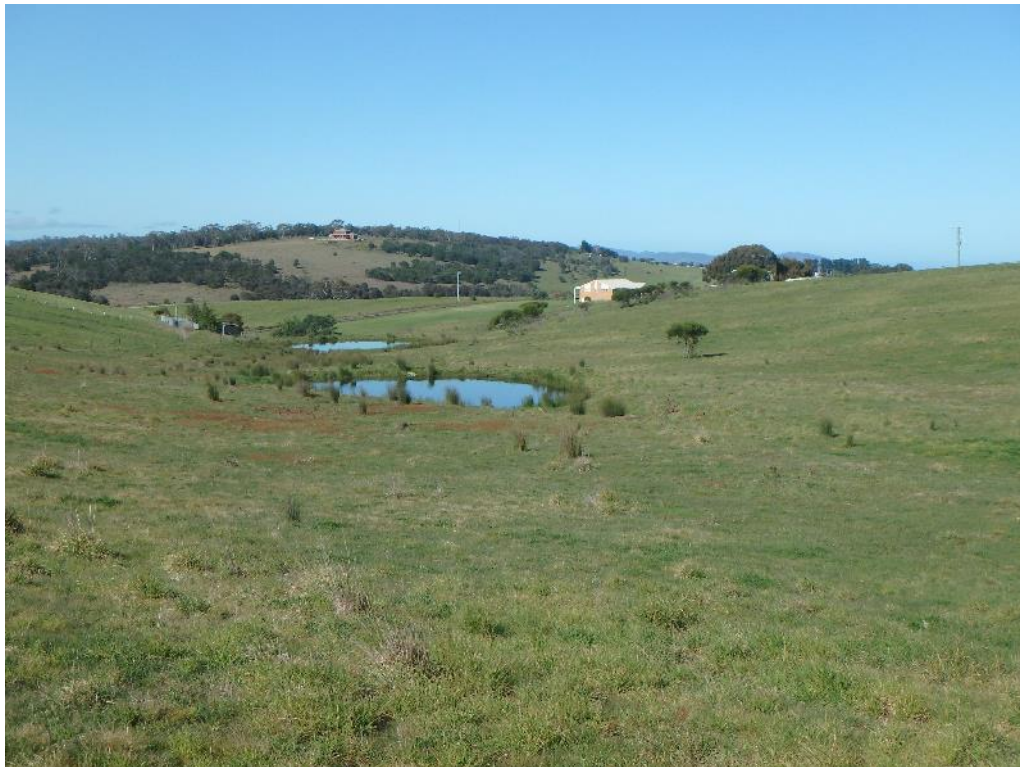
Plate 4: View south at the unnamed ephemeral drainage line that runs through the study area, with a series of small dams constructed along its course

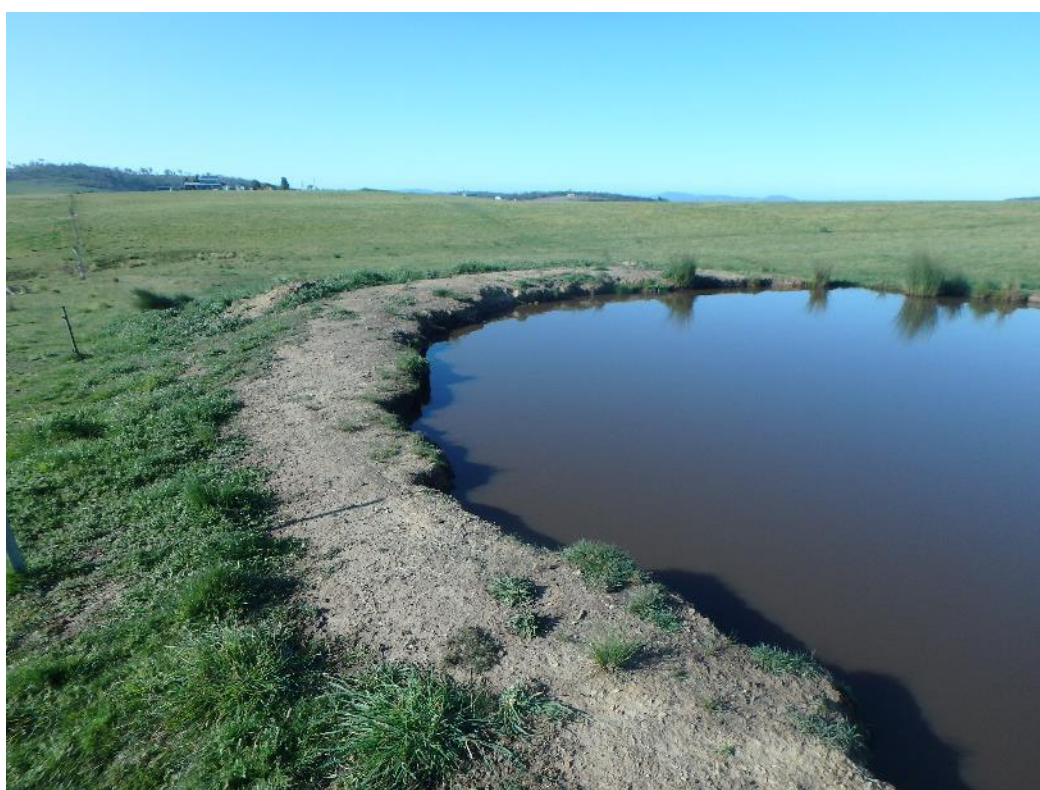
Plate 9: View west at erosion scalds around a farm dam within the study area

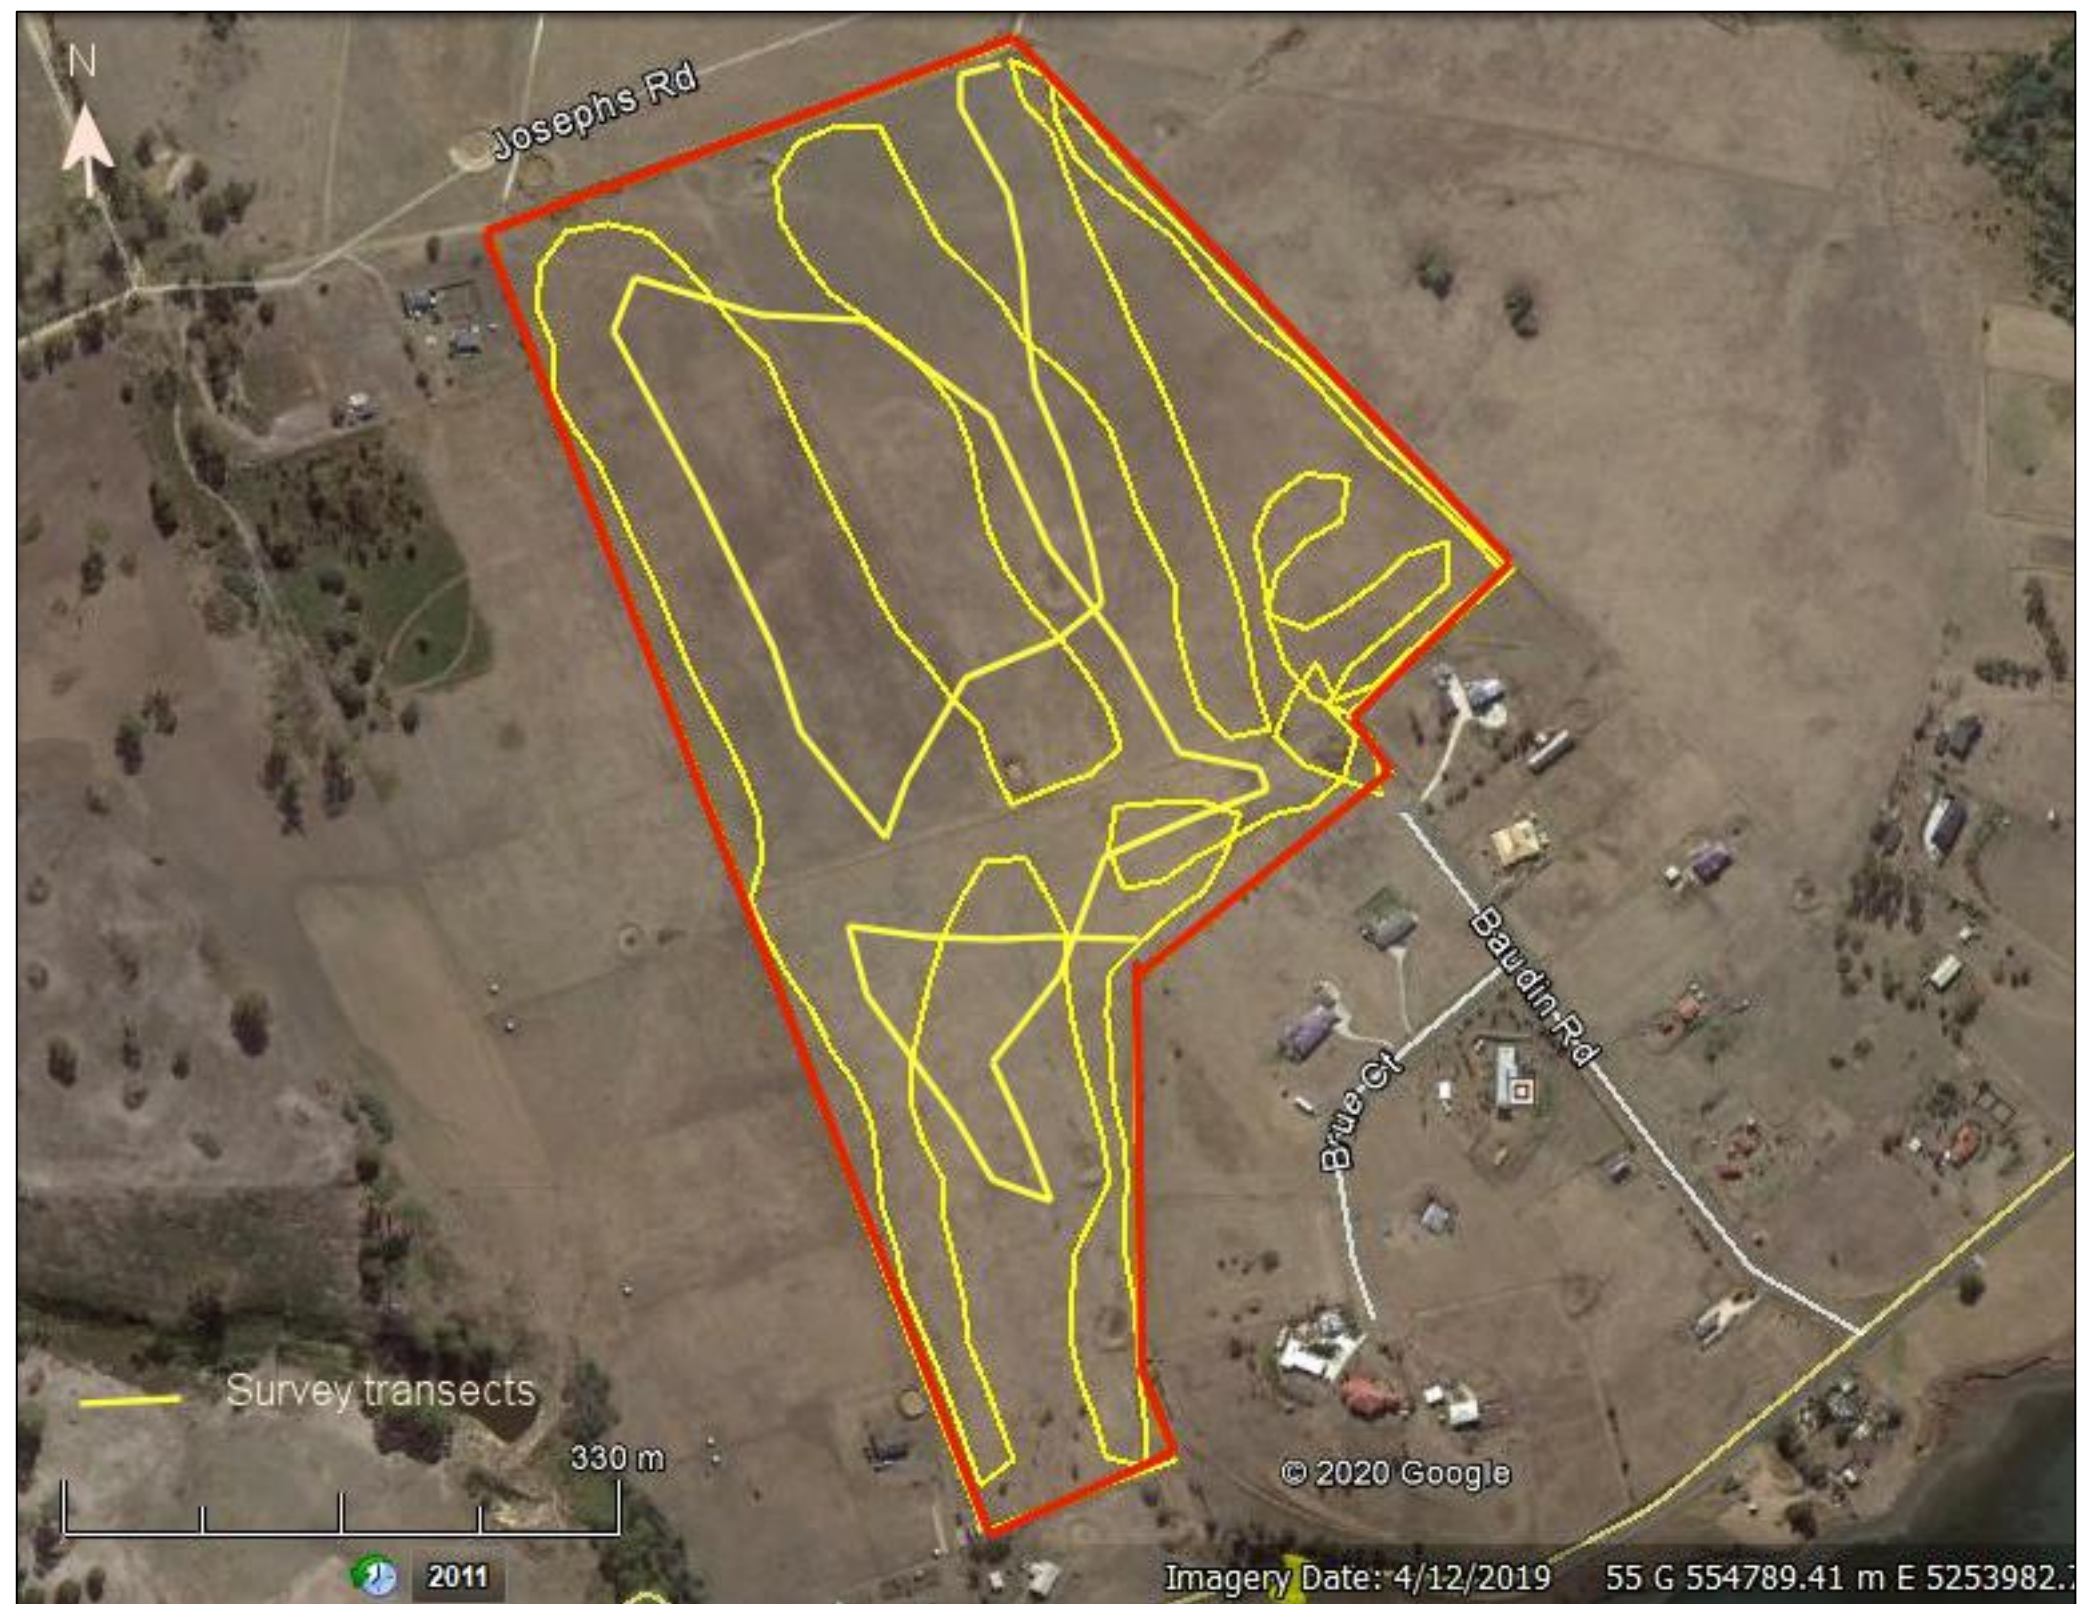
Figure 9: Survey transects walked by the field team within the study area at Waterson Lane, Carlton River
