## BREAK O'DAY COASTAL LAGOON ASSESSMENT

December 2009

For NRM North & Break O'Day Council

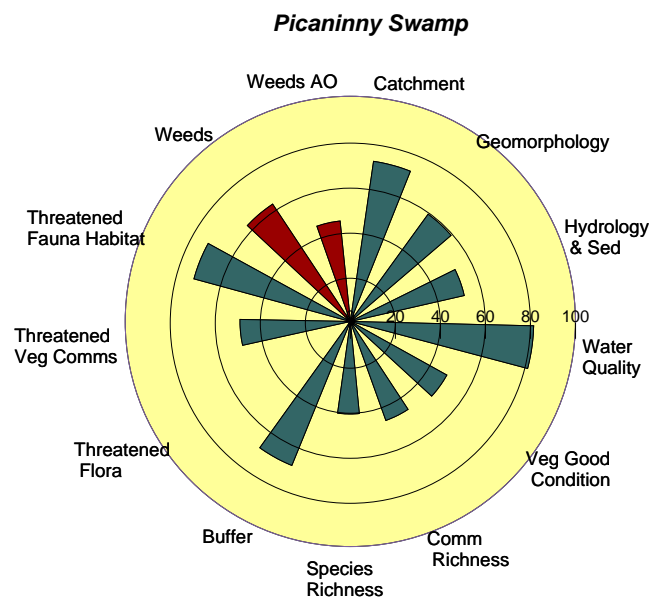
**Figure 2 - Example of wetland condition rose**

An example of a wetland condition rose is shown below in Figure 2. Variables represented in green are considered to be “goods”, where a high value or longer radial line, is considered to be a positive for the wetland, in other words, the higher the better. Variables represented in red are considered to be “bads”, where a high value or longer radial line, is considered to be a negative for the wetland, in other words, the lower the better.

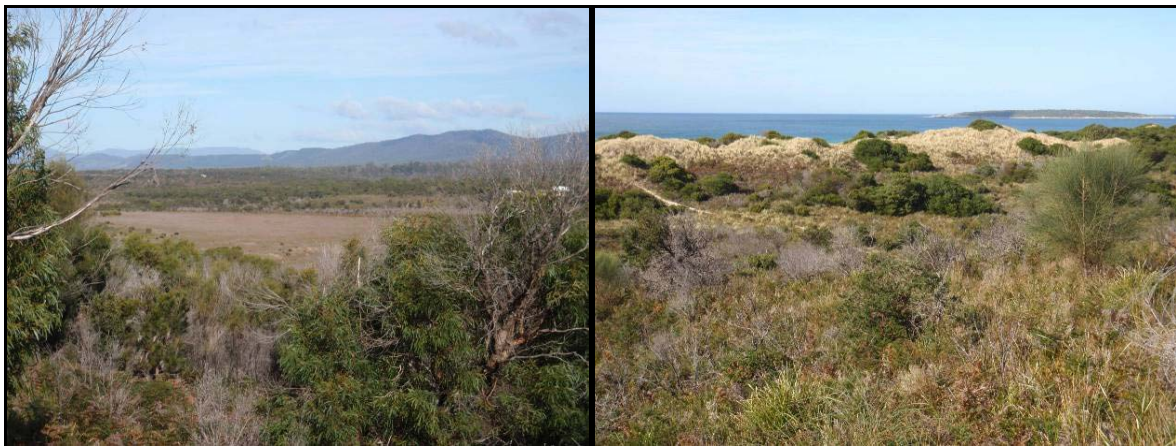
**Photo 3.2. Left -Moriarty Lagoon south from dunes on eastern margin looking southwest. Note ridge forming eastern boundary of lagoonal basin.**

**Photo 3.3. Right - Vegetated stable dunes (including abundant marram grass) on eastern side of Moriarty & Windmill lagoons.**

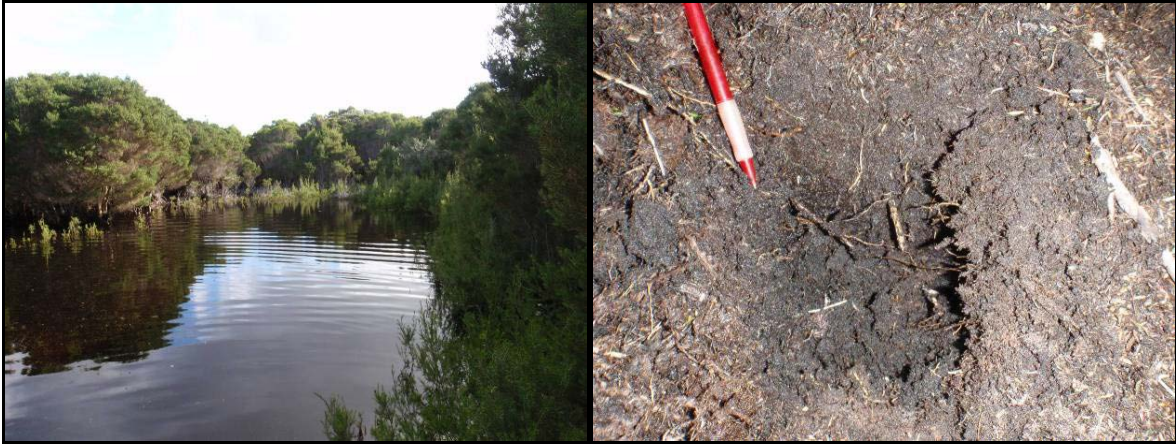
**Photo 3.4 Left - Moriarty Lagoon north showing small area of prolonged inundation.**

**Photo 3.5. Right - Sandy organic rich soils characteristic of Moriarty Lagoon north.**

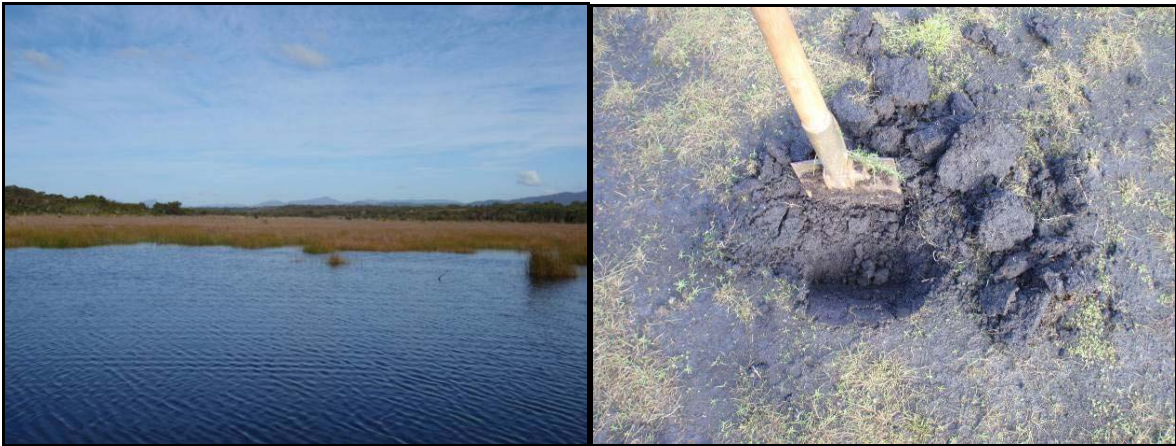
**Photo 3.6. Left -Northern section of Moriarty Lagoon south showing area of extended inundation.**

**Photo 3.7. Right - Organic rich soils characteristic of Moriarty Lagoon south and Windmill Lagoons.**

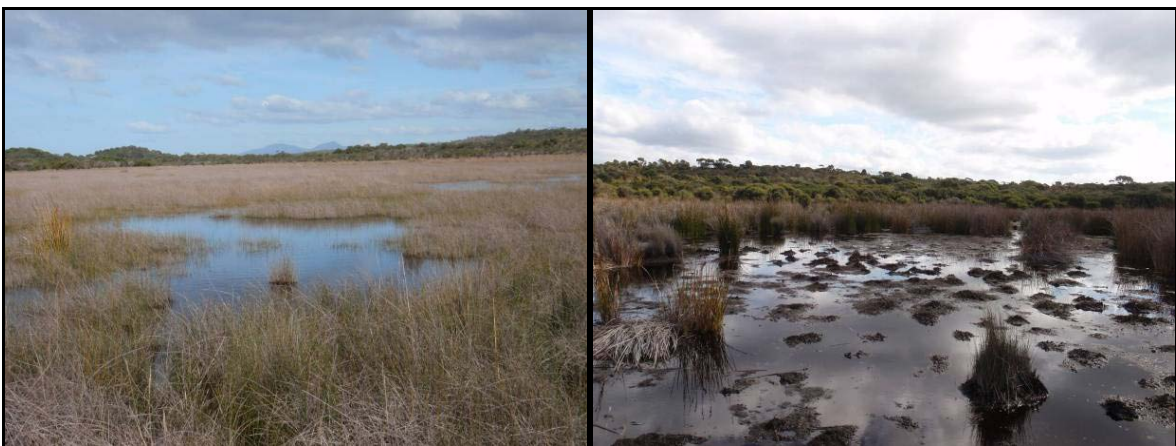
**Photo 3.8 & 3.9. Typical hydrologic pattern in Moriarty South (Left) and Windmill North (Right). Note lack of defined channels.**

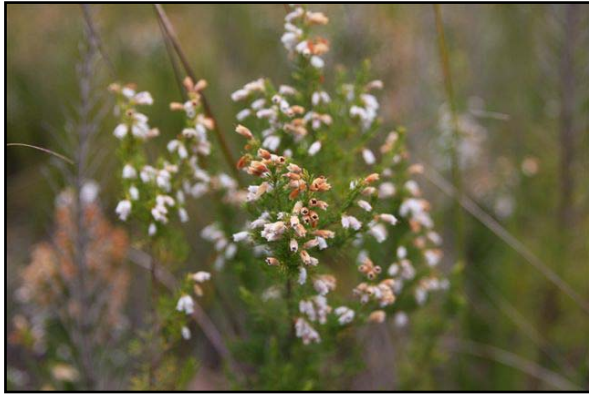
**Photo 3.16. Left - Spanish heath (*Erica lusitanica*) close-up view.**

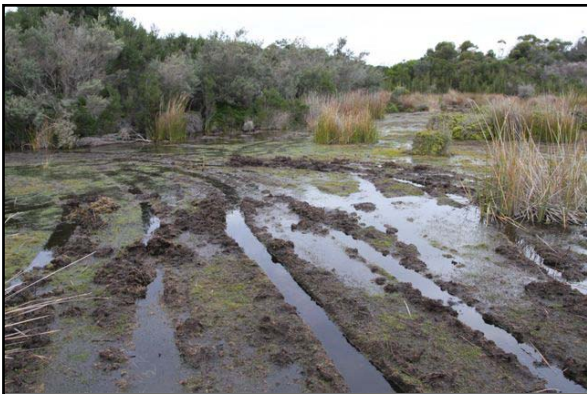
- **Off road vehicle access – Moderate Threat.** Evidence of off road vehicles accessing the wetland flats of the Windmill South lagoon were observed, with deep tracks being cut into the wetland surface (see photo 3.16). This type of activity damages surface vegetation, potentially changes surface water flows and hydrology, as well as potentially disturbing fauna species and perhaps limiting breeding success. It is currently considered an occasional moderate threat that could be reduced by fencing off the crown land area and thereby restricting access. If off road vehicle access increases this will become a major threat to the wetlands natural values.

Photo 3.16. Left - Off road vehicle damage in Windmill South lagoon.

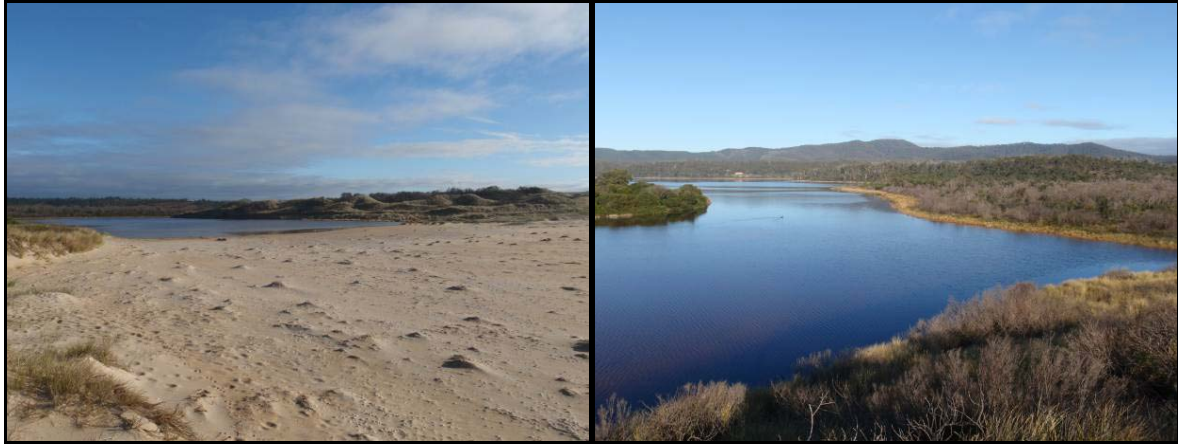
**Photo 4.3. Left - Mouth of lagoon showing well vegetated dunes separating Diana's Basin from Little Diana's Basin.**

**Photo 4.4. Right - Little Diana's Basin with Scamander Tier in background.**

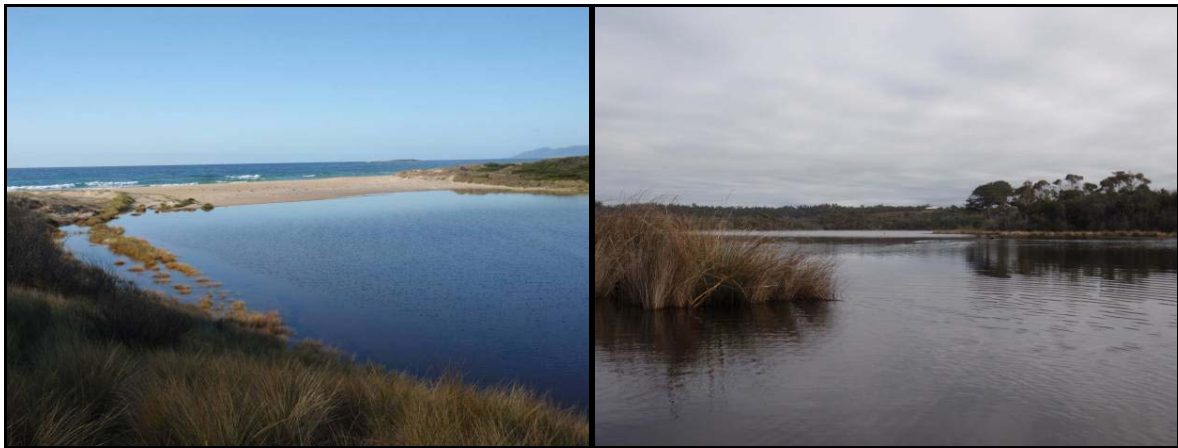
**Photo 4.5. Left - Shows wide mouth of lagoon and relationship with ocean.**

**Photo 4.6. Right - Entrance to Little Diana's Basin from Diana's Basin.**

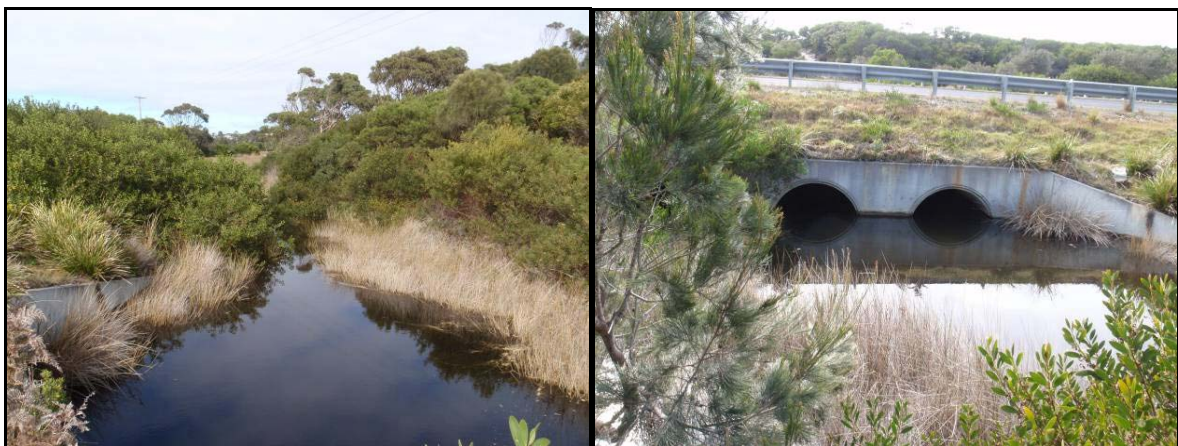
**Photo 4.7. Left - Vegetation choked outflow of Crockers Arm.**

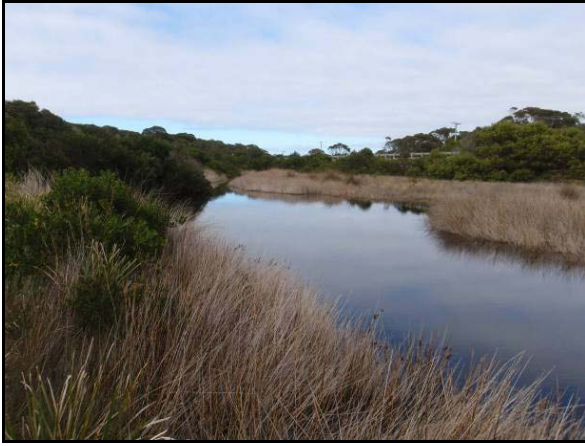
Photo 4.9. Deposition where culverts enter Diana's has resulted in fringing reeds.

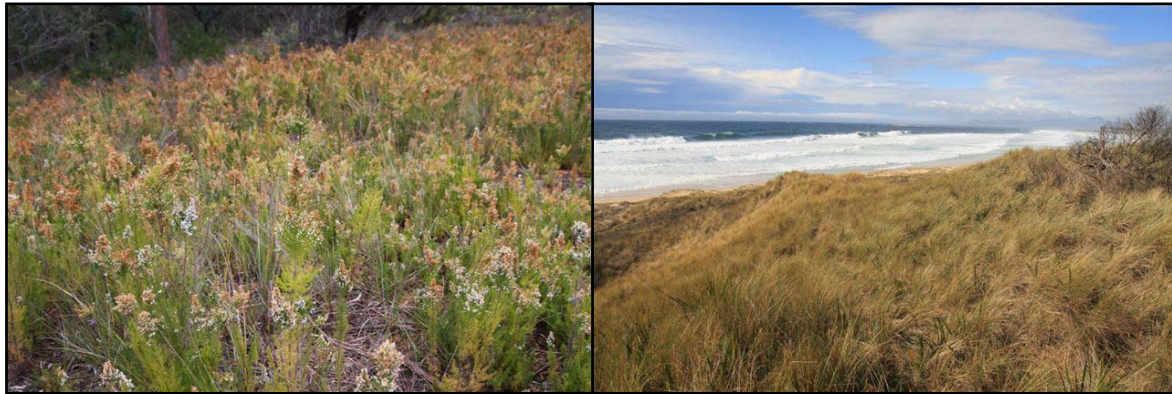
**Photo 4.14. Left - Extensive spanish heath infestation at Crockers Arm.**

**Photo 4.15. Right - Extensive marram grass infestation at Diana's Basin in coastal dunes.**

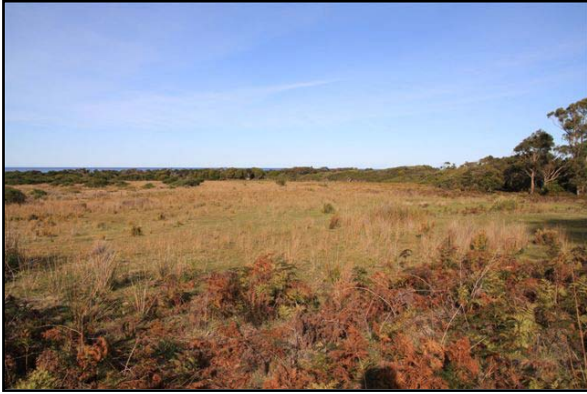
then they will continue to spread, with a consequent displacement and loss of flora species, and decline in fauna abundance as food plants and habitat values are decreased. Increased colonisation of marram grass could also lead to an additional restriction of water outflow.

Photo 5.7. Extensive spanish heath (*Erica lusitanica*) infestation.

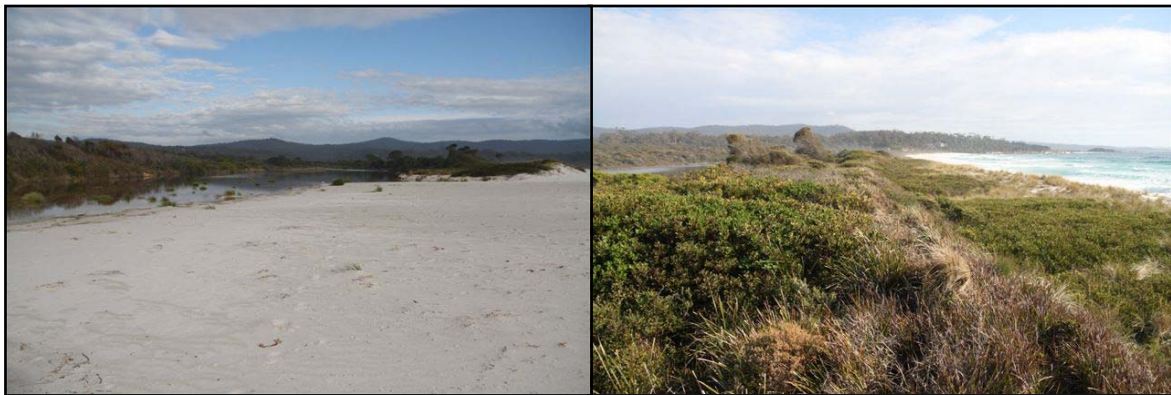
**Photo 6.3. Left - Closed off mouth of Grants Lagoon.**

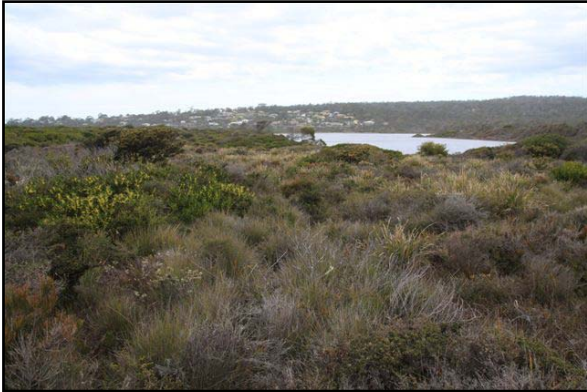
edge of the lagoon. Further development is also occurring around the lagoon area. It is important that the crown land areas that surround this wetland be maintained as natural areas, and not be allowed to be developed for residential, industrial or agricultural purposes. Restrictions on what type and scale of future development should be put in place within a buffer around Grants Lagoon, to help protect the remaining habitat, the water quality and other natural values of the area. A total of 69 cadastral properties occur within the Grants Lagoon study area, which is considered to be high and indicative of the potential impact of development within the area.

Photo 6.5. Urban development of Binalong Bay on the southern edge of Grants Lagoon.

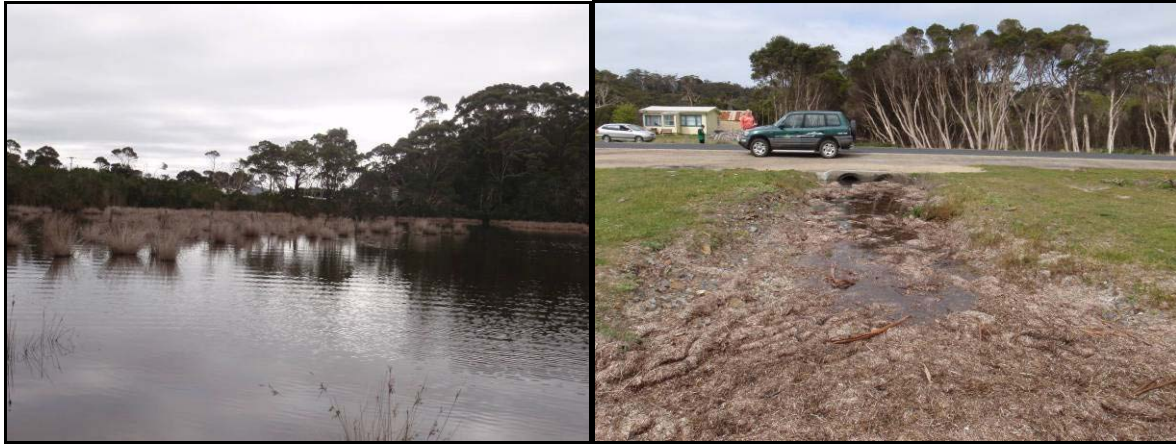
Parkside Lagoon has been highly altered compared to its 'natural' state, primarily due to alterations in the hydrology associated with the road and culverts. The ratings shown on the

condition rose are considerably lower for hydrology & sediment and geomorphology as compared to CFEV ratings which do not take alterations to the outflow into account. In spite of the alterations to the hydrology of the system, present water quality appears good (although it was observed following an extended high rain-fall period).

Figure 7.3. Left - Parkside Lagoon at upstream end.

Figure 7.4. Right - Outflow of Parkside Lagoon from beach side of culverts showing restriction of flow. Trees in background are in southern end of Parkside Lagoon.

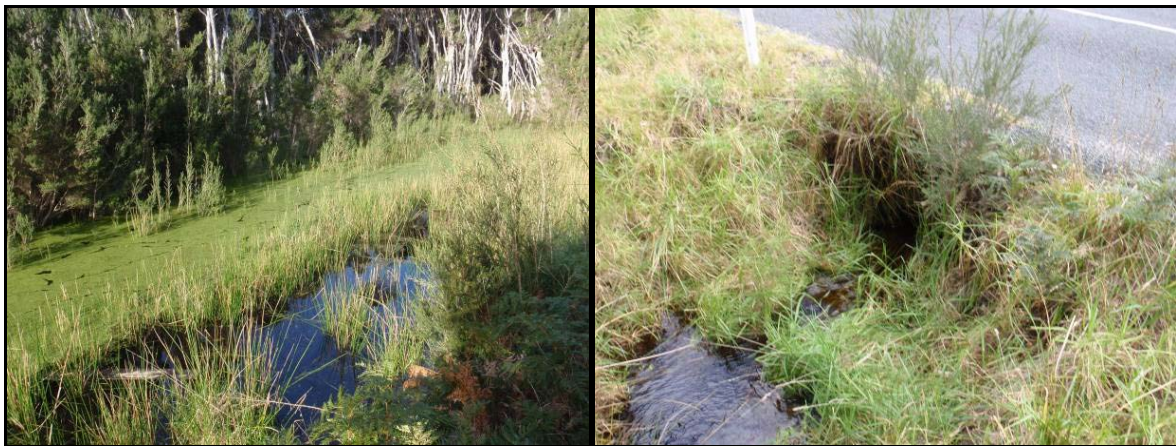
**Photo 8.3. Left - Stagnant water near outlet of Chimney Lagoon showing algal growth**

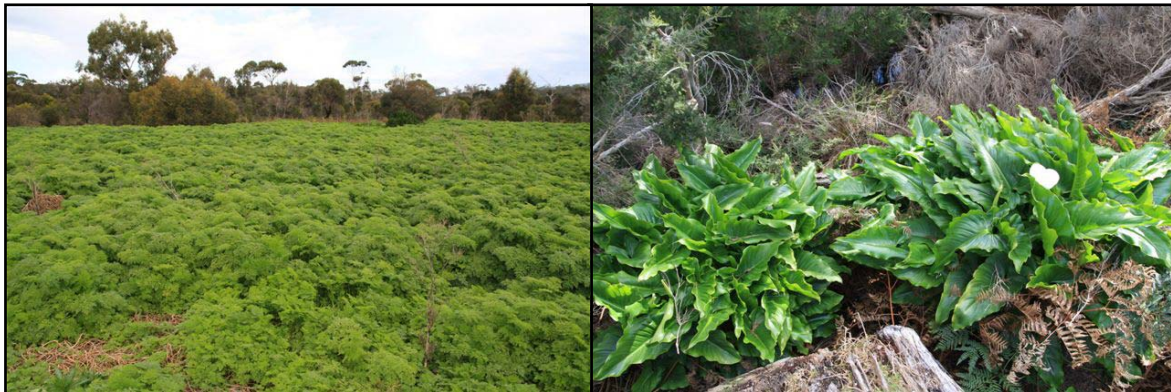
**Photo 8.6. Left - Extensive hemlock (*Conium maculatum*) infestation just outside of the study area in degraded land.**

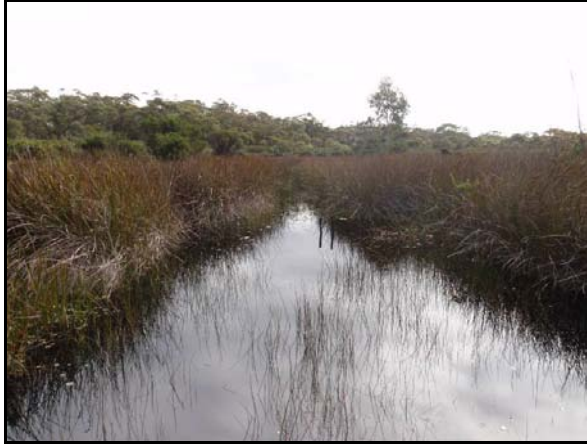
Figure 9.3. Oceana Wetland under high water level conditions.

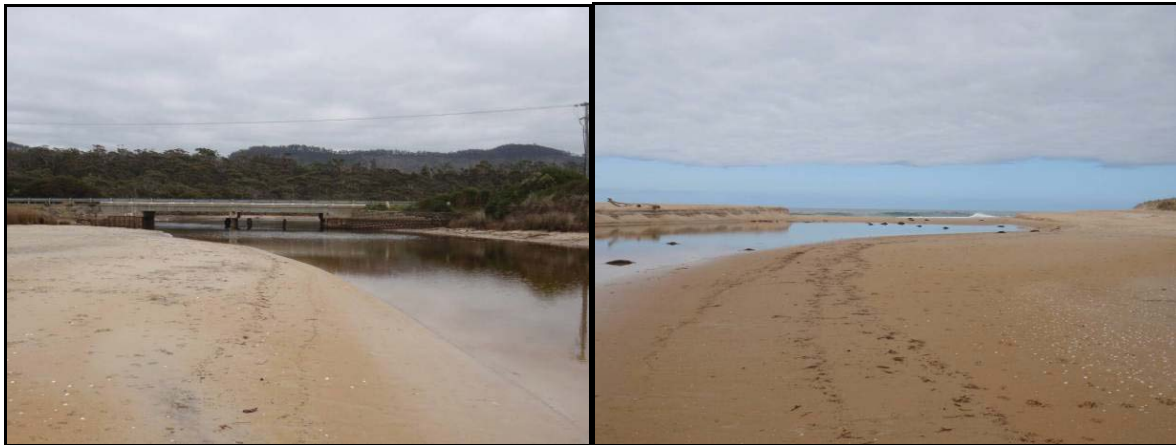
**Figure 10.3.** Left - Bridge at mouth of lagoon from ocean side.

**Figure 10.4.** Right - Connection of lagoon with the sea.

The moderate scores on the condition rose reflect the large extent of clearing in the catchment and the potential impact this could have on the lagoon, significant modification of the hydrology of the lagoon outflow, and the presence of algal growth in the lagoon.

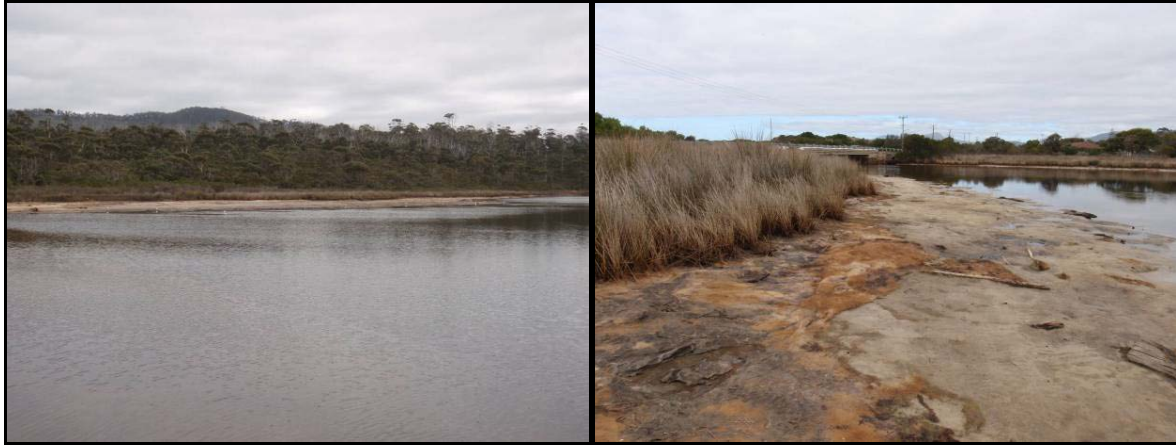
Figure 10.5. Left - General view of Wrinklers Lagoon.

Figure 10.6. Right - Fringing reeds and algal mats on exposed banks of Wrinklers Lagoon.

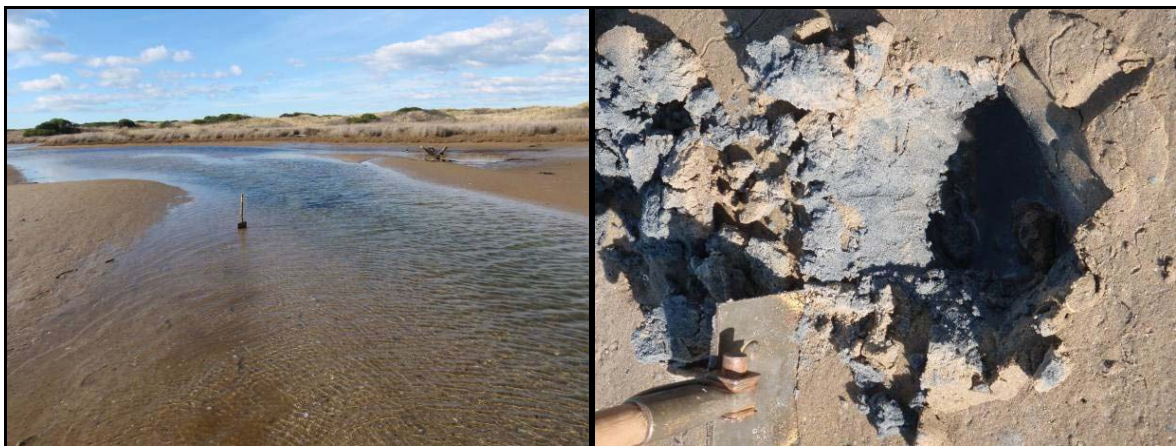
**Figure 111.3. Left - Tidal channel entering embayment.**

**Figure 111.4. Right - Sulphide rich sediments below the low tide level.**

The presence of sulphide rich sediments in the embayment and surrounding coastal vegetation is consistent with the acid sulphide soil maps of Tasmania which identify the Scamander area as having a high risk of potentially acid sulphate soils (Gurung, 2001). These sediments do not pose a water quality risk as long as they are maintained saturated and not disturbed. Minor sediment disturbances are unlikely to result in environmental damage due to the neutralising capacity of sea water, but large scale exposure through disturbance or draining could lead to sulphide oxidation and acid generation.

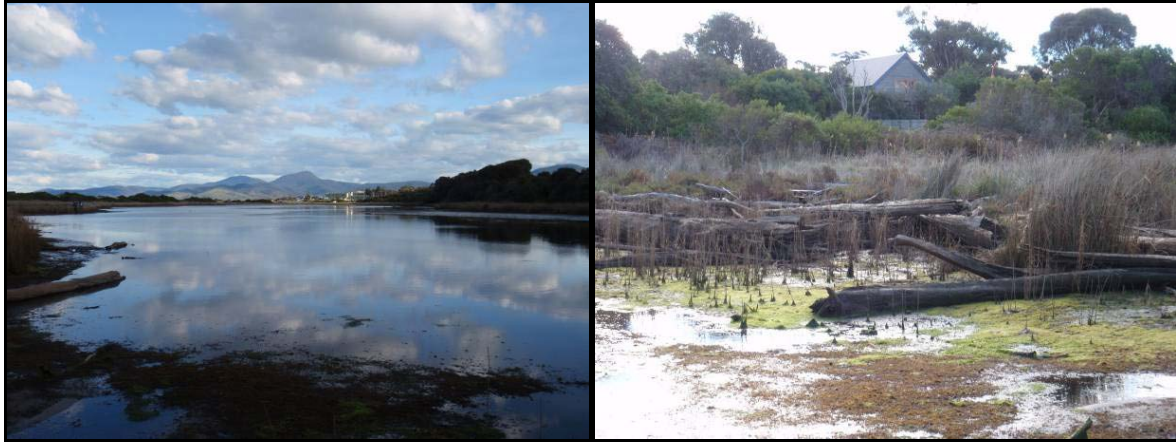
Figure 11.5. Left - View of Scamander River mouth embayment from upstream end looking towards mouth.

Figure 11.6. Right - Storm debris trapped at upstream end of embayment.

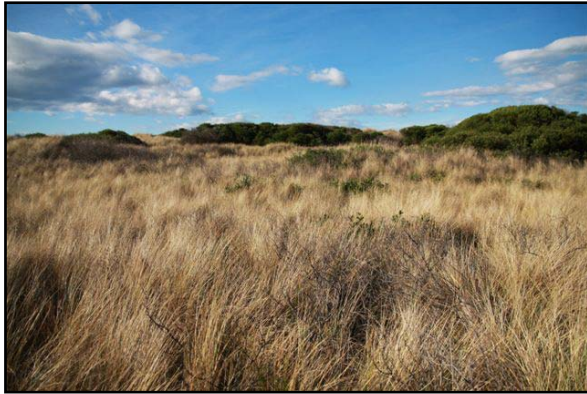
**Figure 11.8. Marram grass (*Ammophila arenaria*) infestation in coastal dunes.**

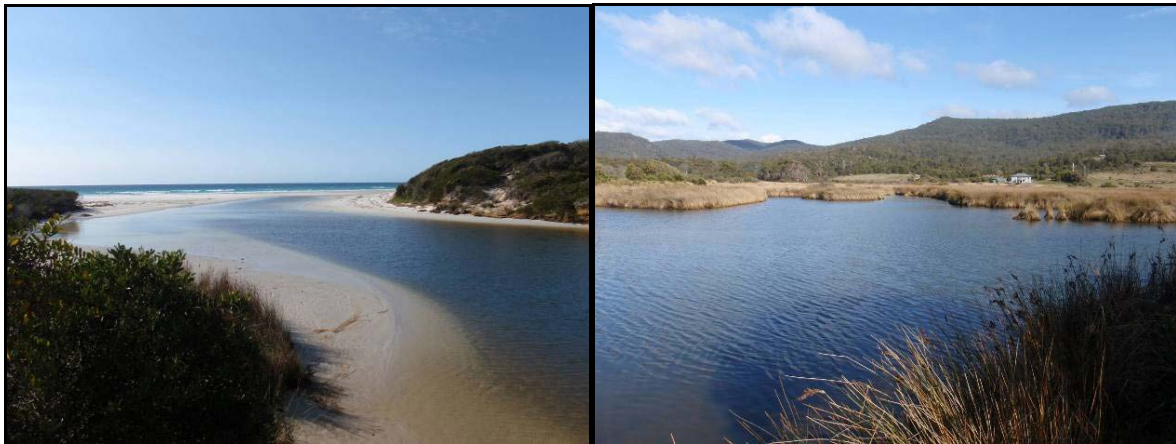
**Figure 122.3. Left - Mouth of lagoon flowing between vegetated dunes and outcrop of indurated sediments forming low bluff.**

**Figure 122.4. Right - Reed mats near entrance to Doctors Creek.**

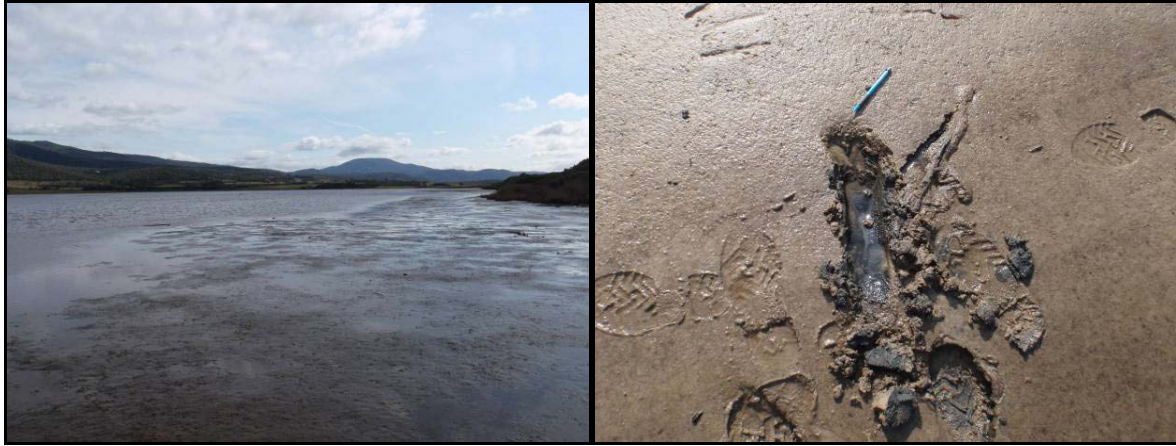
Figure 122.5. Left - Main body of Templestowe Lagoon.

Figure 122.6. Right - Sulphide rich sediments below beach sands.

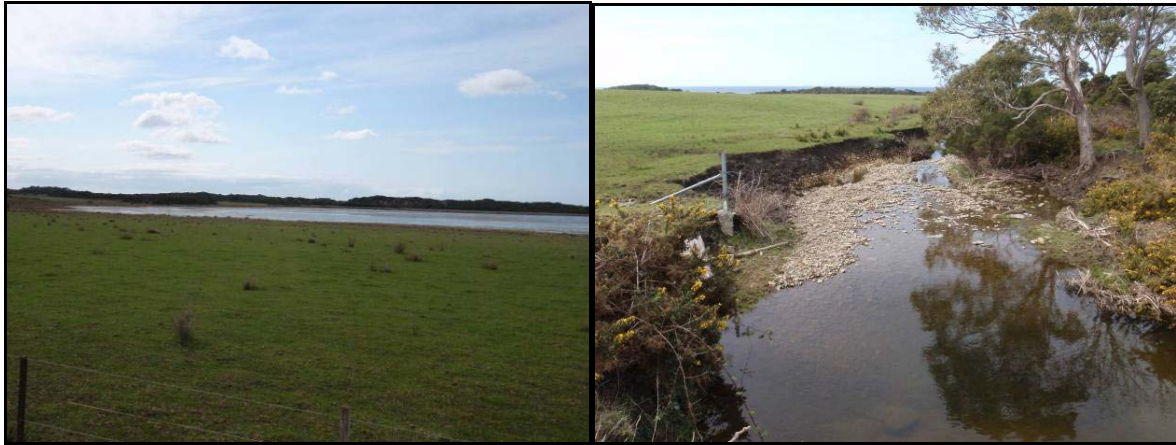
Figure 122.7. Left - Cleared margin of lagoon.

Figure 122.8. Right - Bank erosion in Doctors Creek downstream of road crossing.

The condition rose reflects the highly modified nature of the land adjacent to Templestowe Lagoon, channelized creeks and lack of riparian vegetation. Although the hydrology and sediment rating is relatively low due to the poor condition of the catchment, the unmodified nature of the mouth of Templestowe Lagoon is a relatively unique attribute which should be recognised.

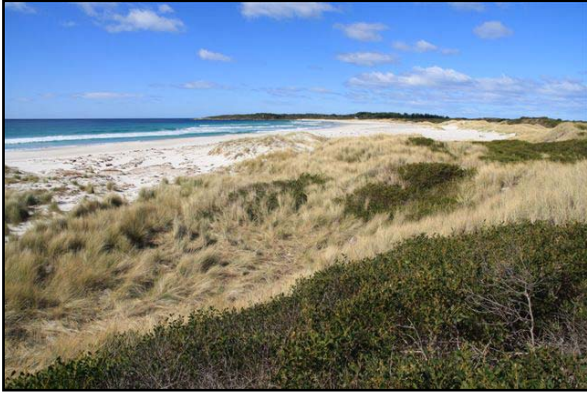
Figure 122.11. Marram grass invading coastal dunes.

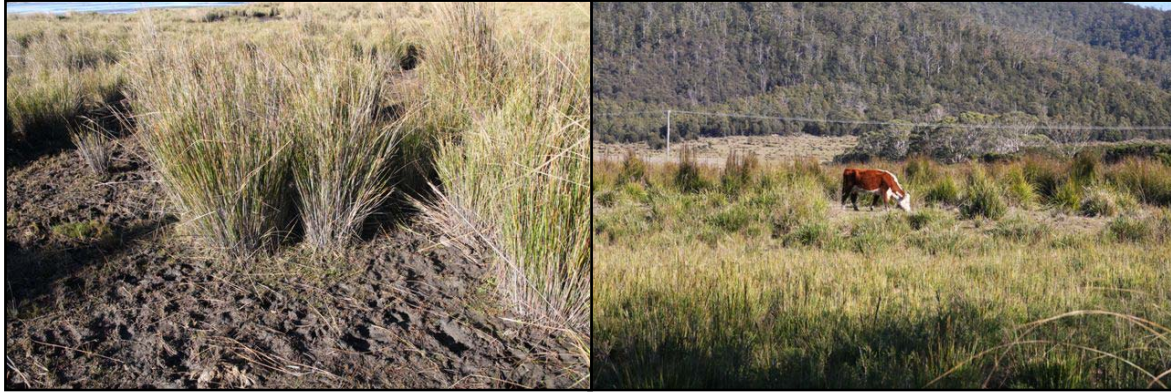
Figure 122.12. Left - Soil pugging in saline sedgeland/grassland (ARS).

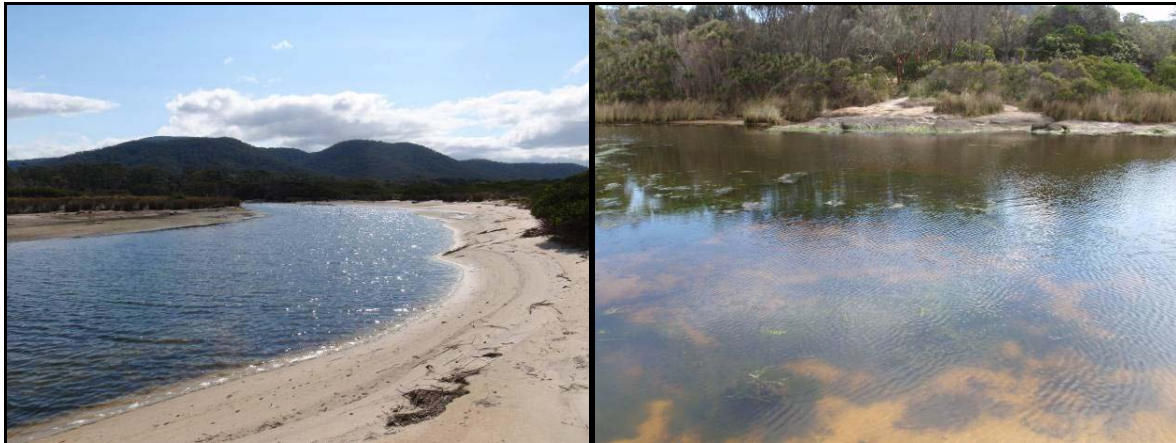
**Figure 133.3. Left - Mouth of Lower Marshes Lagoon at northern end of Lagoons Beach**

**Figure 133.4. Right - Granitic bedrock outcrop in Lower Marsh Lagoon which controls the geomorphology of the mouth of the lagoon.**

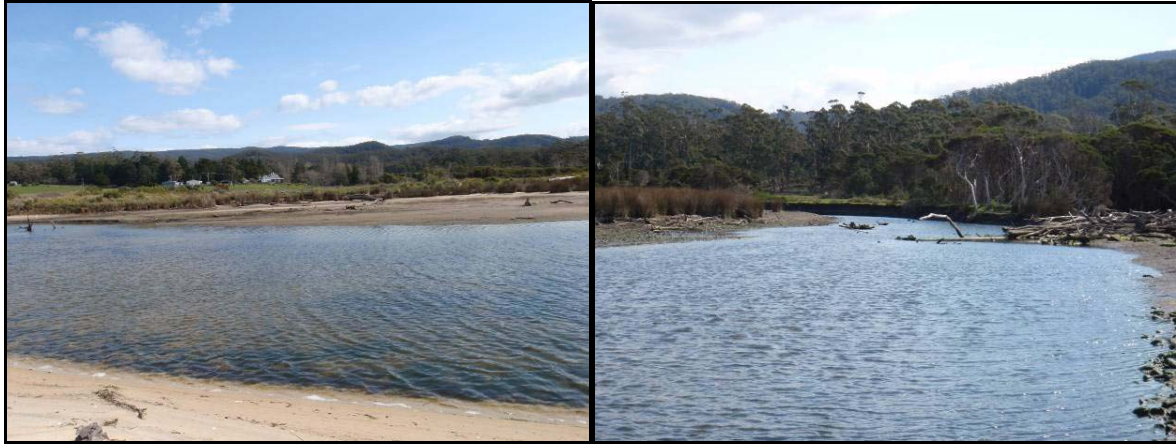
Figure 133.5. Left - Chain of Lagoons showing reed mats.

Figure 133.6. Right - Bank erosion in Chain of Lagoons.

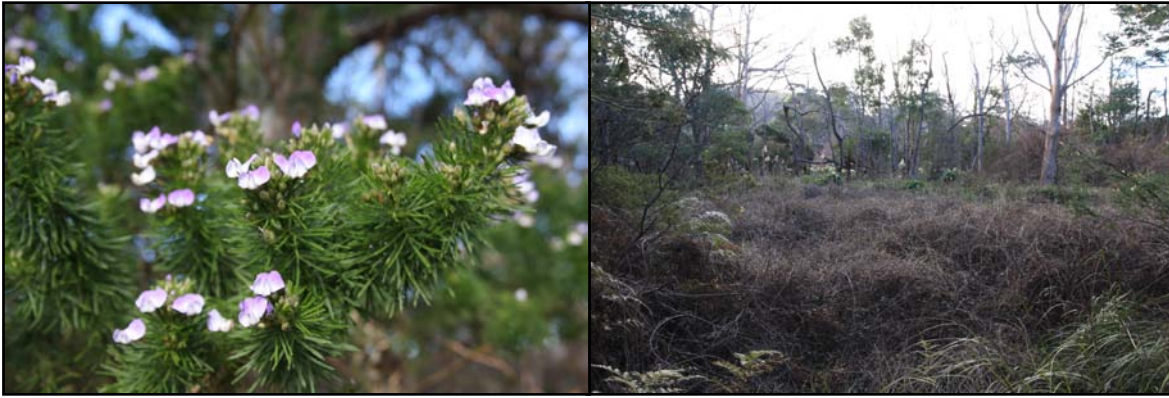
Figure 133.9. Left - Blue psoralea (*Psoralea pinnata*).

Figure 133.10. Right - Blackberry (*Rubus fruticosus*) and arum lily (*Zantedeschia aethiopica*) infestation.

- **Weeds – High Threat.** A large area of weed infestation occurs near the centre of the study area adjacent to the Tasman Highway. This area is dominated by weeds, particularly a large deciduous exotic tree species, blackberry and arum lilies. Blackberry also occurs in scattered infestations throughout the study area, while african boxthorn occurs in large patches adjacent to and in the agricultural land at the southern end of the study area. A single small patch of blue psoralea was also located in the southern half of the study area. Marram grass was found in some large patches particularly along the front edge of the coastal dunes which are dominated by *Acacia longifolia* coastal scrub (SAC). Increased marram grass could also lead to a restriction of lagoon outflow.

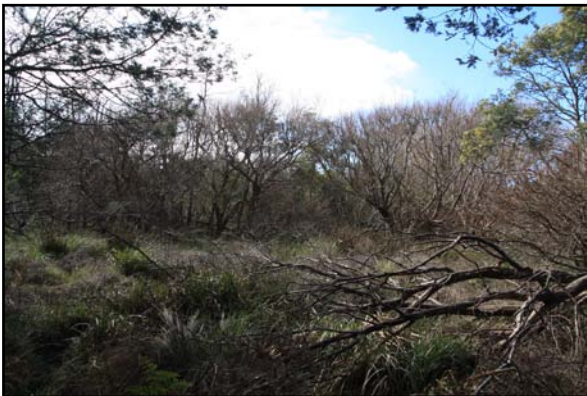
Figure 133.11. Left - Deciduous exotic tree species (species unknown) infestation.

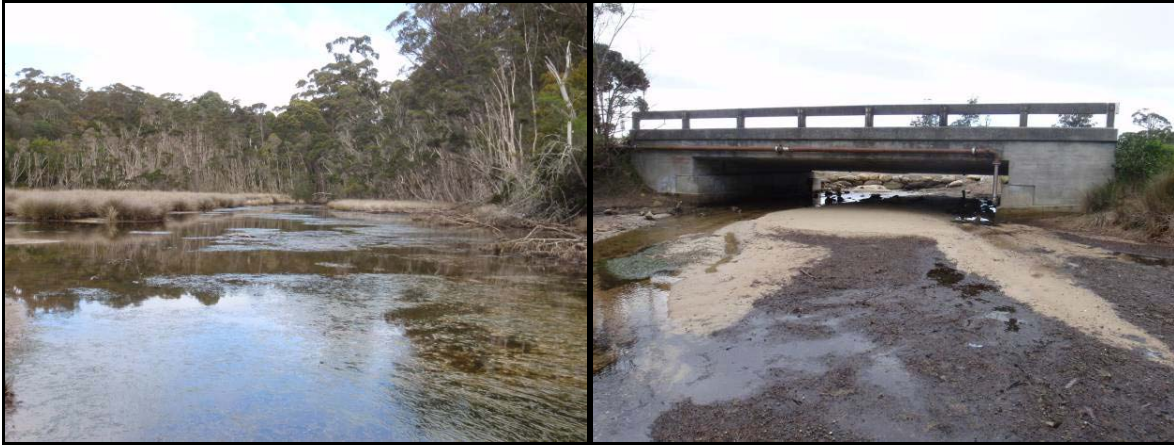
Figure 144.3. Left - View of downstream end of wetland showing channel

Figure 144.4. Right - Sedimentation upstream of bridge.

The upstream wetland in Boggy Creek is in good physical condition. The salt marsh in the lower catchment is in moderate to poor conditions compared to natural due to the major modifications to the hydrology of the outflow.

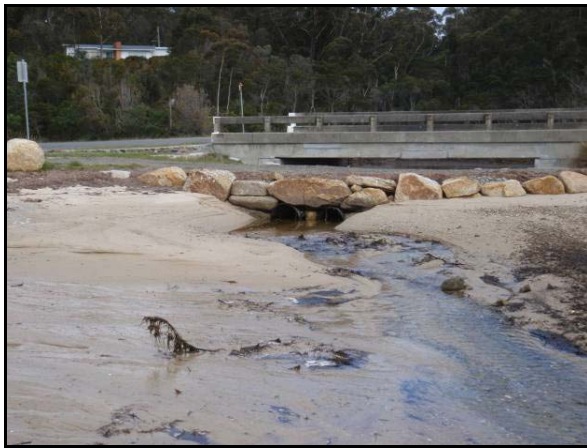
Figure 144.4. Restricted flow through pedestrian walkway.

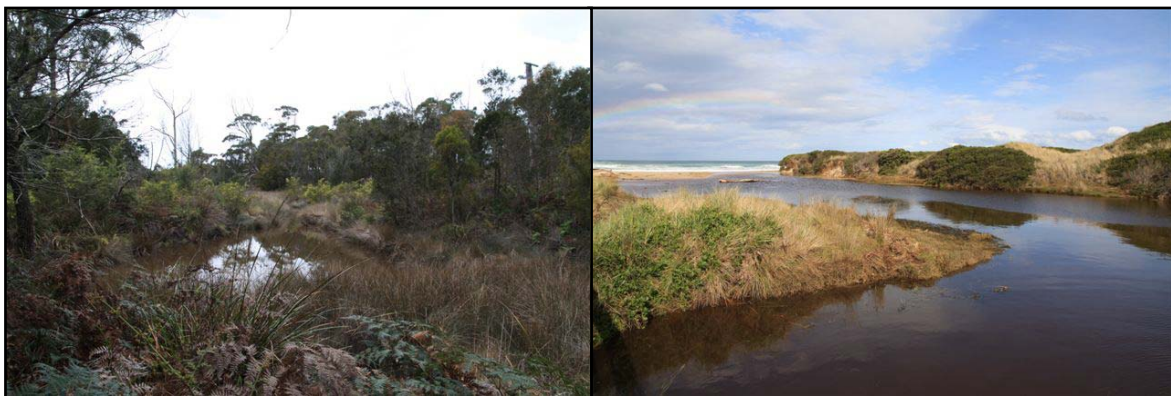
**Figure 15.3. Left - Upper end of Yarmouth Creek wetland.**

**Figure 155.4. Right - Mouth of Yarmouth Creek cutting through coastal dunes.**

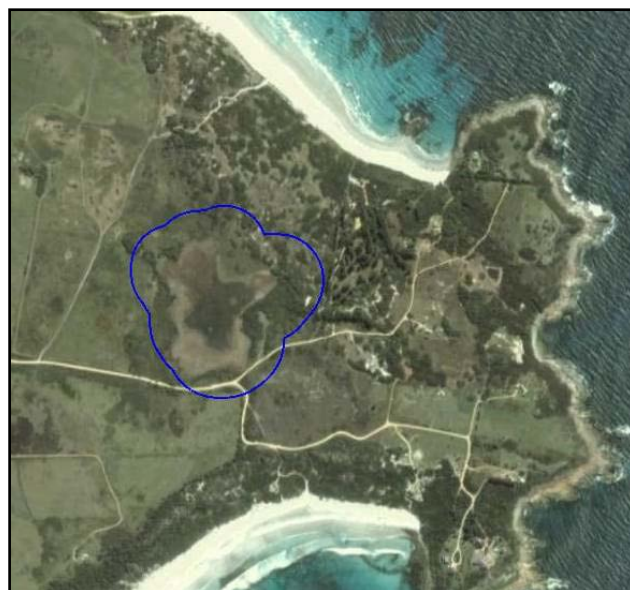
Photo 16.2. Google Earth aerial photo of Seymour Swamp study area.

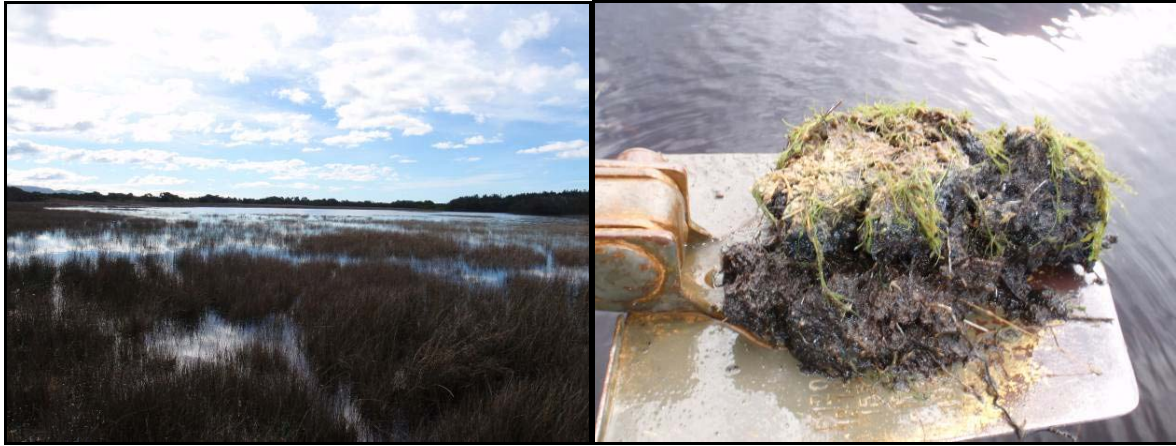
The condition of Seymour Swamp compared to natural is poor due to the artificial nature of the geomorphology and hydrology of the swamp. It is also located within a larger catchment which has poor condition due to extensive agricultural development. If the highly modified nature of Seymour Swamp is accepted as the baseline, then the condition of Seymour Swamp is good as its processes are similar to natural lagoons operating in similar settings. The condition rose is based on accepting the modified nature of the swamp and not applying the CFEV results except for Catchment condition. The geomorphology, hydrology and water quality criteria are based on comparing the swamp with other natural small natural lagoons, such as Windmill.

Figure 16.3. Left - General view of swamp.

Figure 16.4. Right - Organic rich sediments.

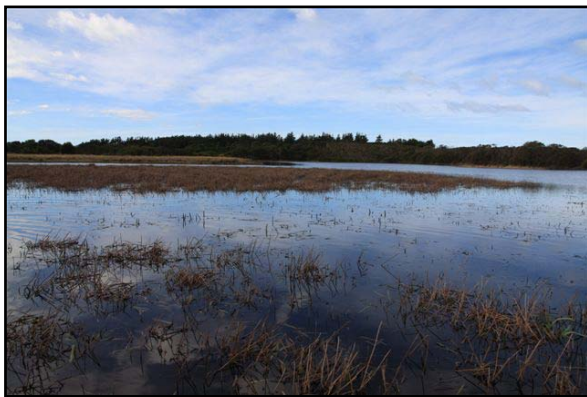
Figure 16.5. Fresh water aquatic sedgeland and rushland (ASF) and Water, sea (OAQ).

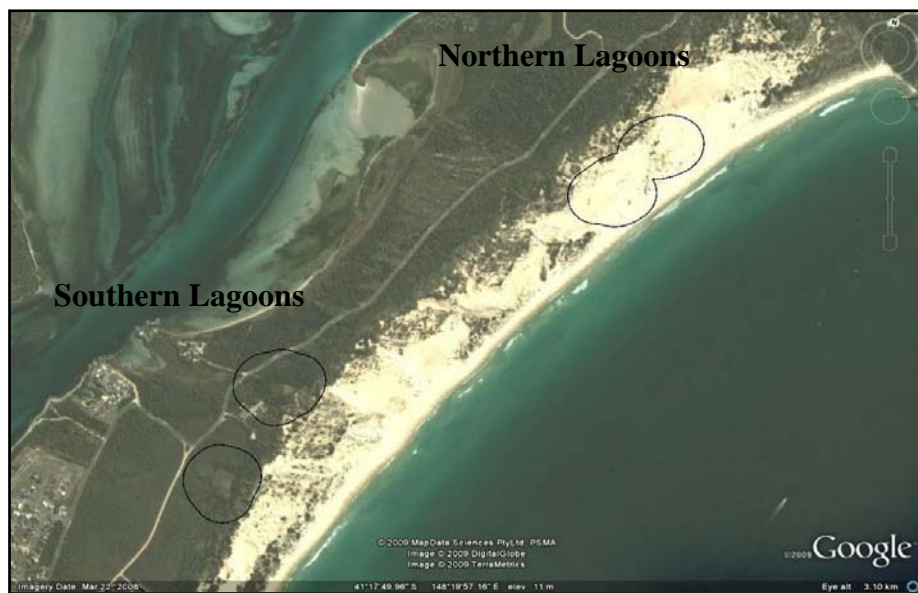
**Photo 17.1. Google Earth aerial photo of St Helens Point study area showing the northern and southern**

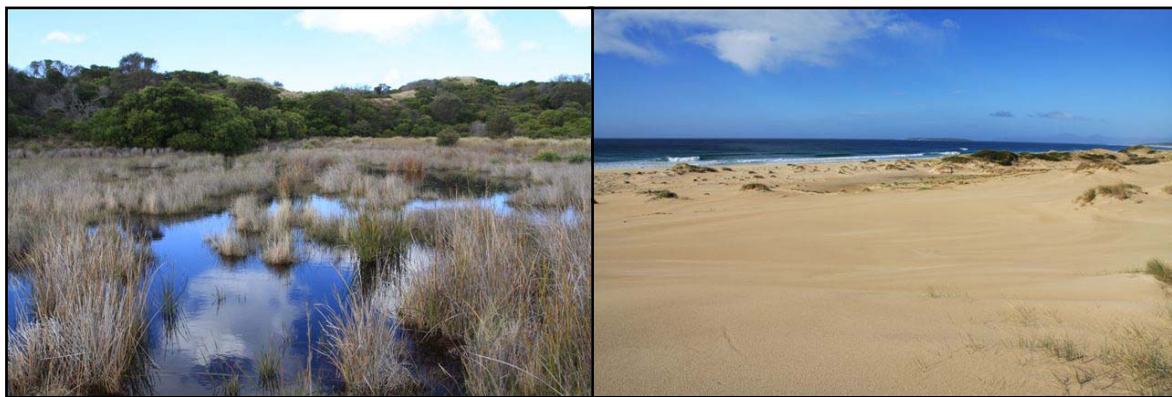
**Photo 17.2. Left - St Helens Point North. Photo 17.3. Right - St Helens Point South.**

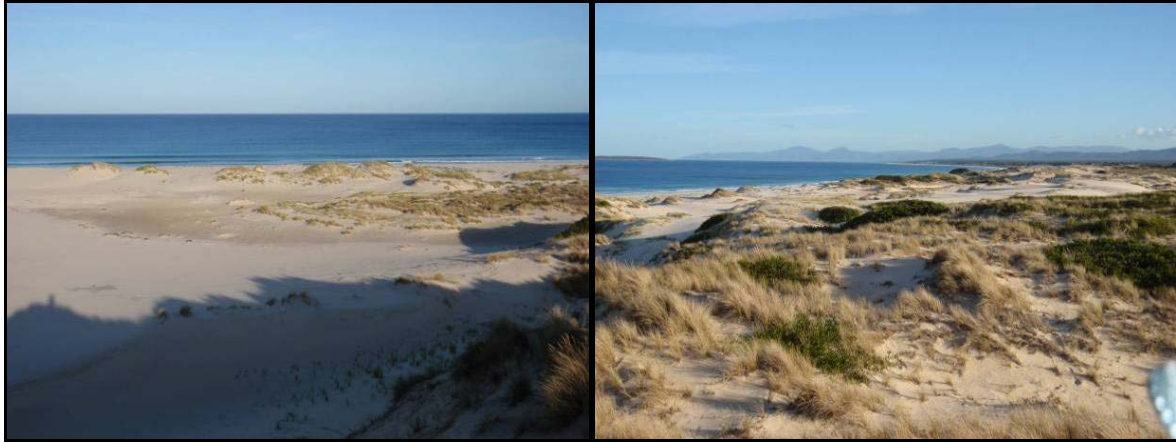
The northern lagoons are considered to be in near natural condition, with the presence of marram grass the only modification to the system. The southern lagoons are slightly more modified (assuming the channels entering and exiting the lagoon are not natural) but overall still in very good condition.

Photo 22. Left - Northern most lagoon occupies damp area at base of vegetated dune.

Photo 23. Right - Coastal dune setting of northern lagoons.

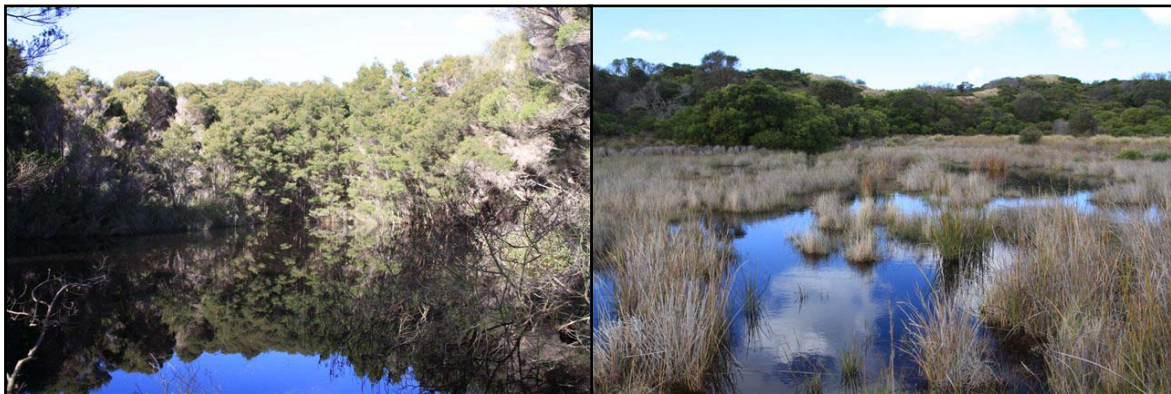
Photo 245. Left - St Helens Point southern lagoons (northern lagoon).

Photo 256. Right - St Helens Point southern lagoons (southern lagoon).

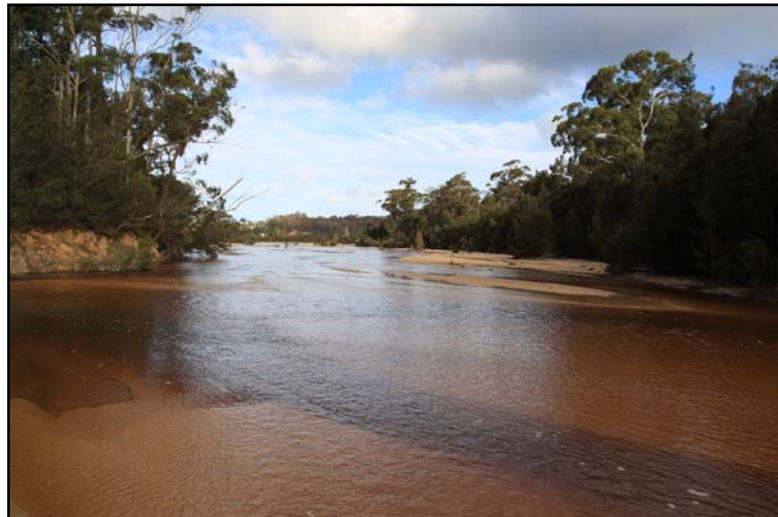
**Photo 18.2.** Google Earth aerial photo of Upper Medeas Cove Marshes study area.

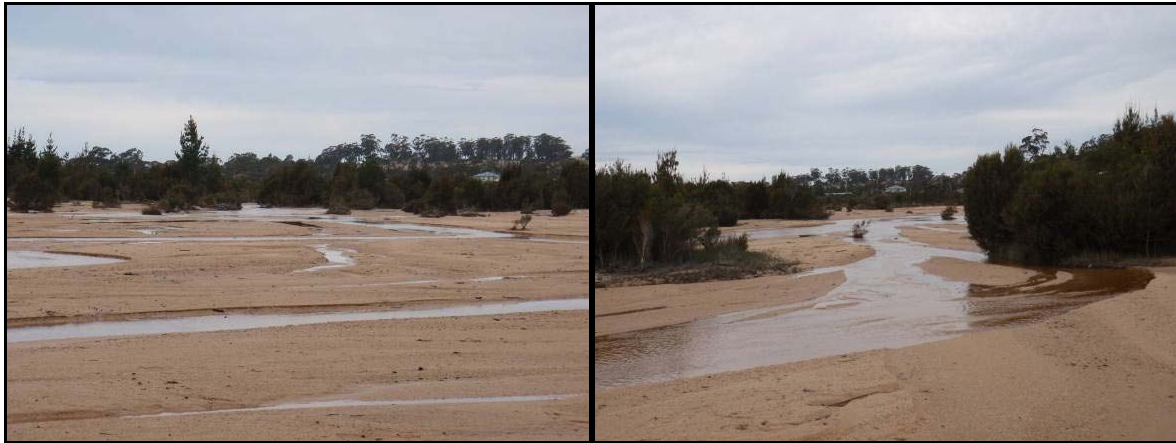
Photo 18.3. Left - Upstream end of Upper Medeas Cove with graded stream reworking historic mining sediments.
