## BREAK O'DAY COASTAL LAGOON ASSESSMENT

December 2009

For NRM North & Break O'Day Council

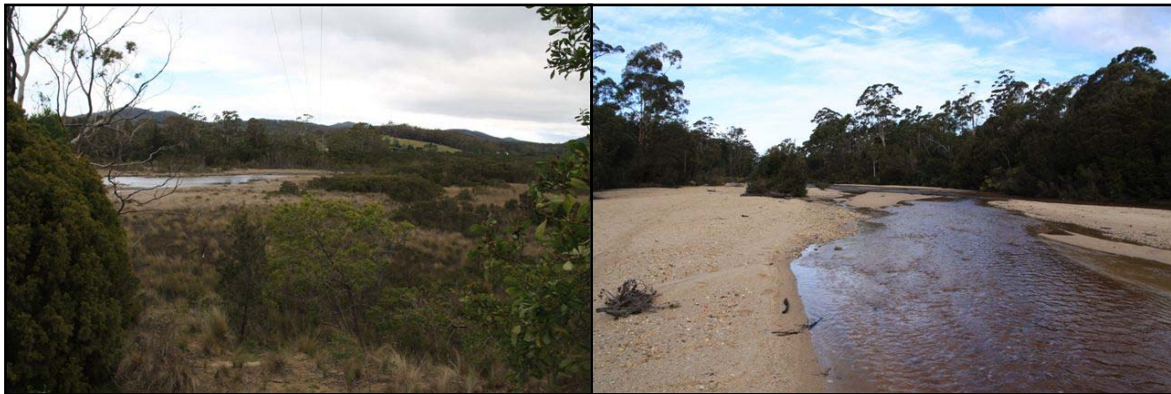
Photo 18.3. Left - Saline sedgeland/rushland (ARS).

Photo 18.4 Right - Golden Fleece Rivulet sandy channel bounded by forest and woodland communities.

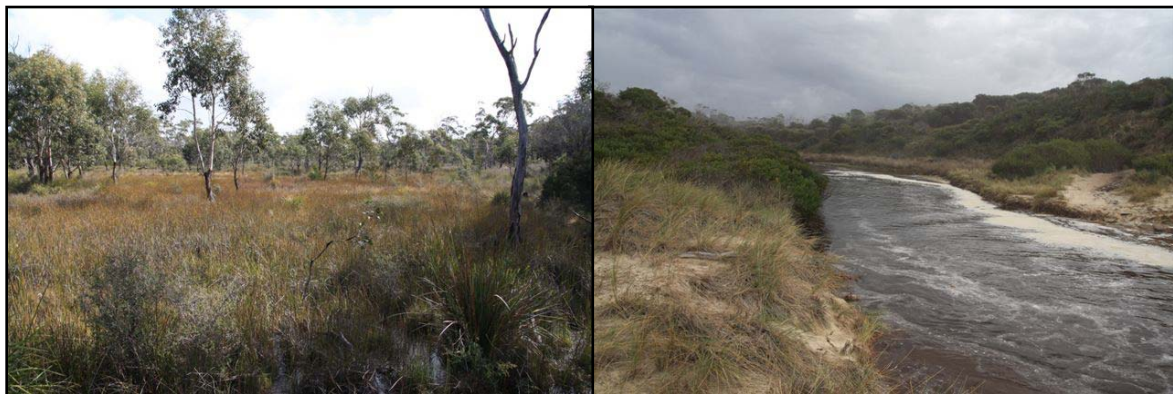
Photo 19.3. Left - Onion Creek. Photo 19.4 Right - St Helens Point (other) wetland mouth.

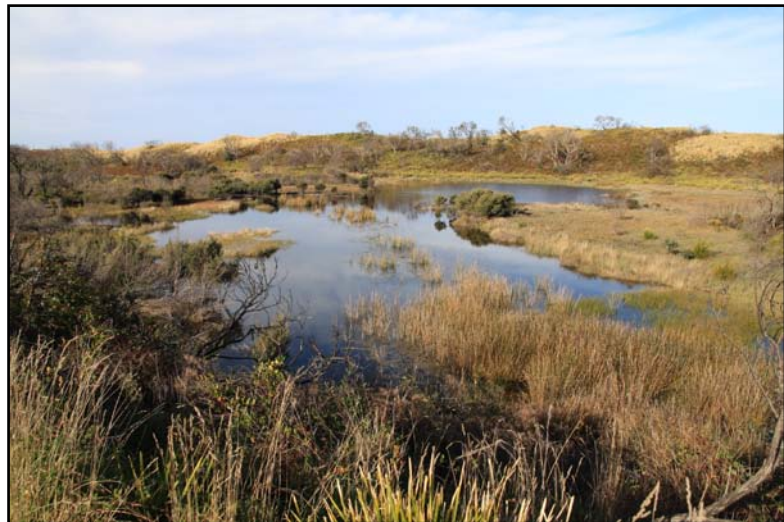
**Photo 20.2.** Google Earth aerial photo of Dark Hollow Creek study area.

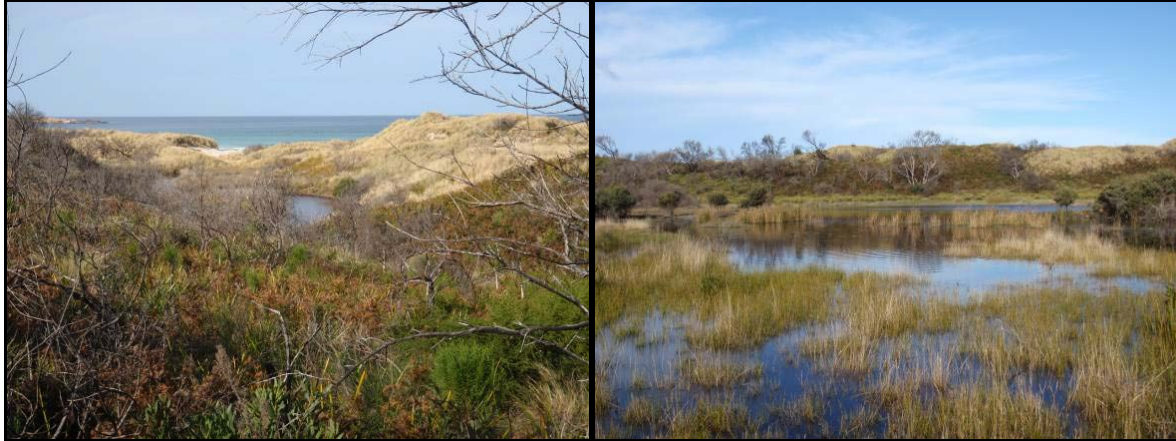
**Photo 20.3 Left - Downstream view of lower 'pool' in Dark Hollow Lagoon. Note widespread presence of marram grass and other vegetation on dunes and in lagoon basin.**

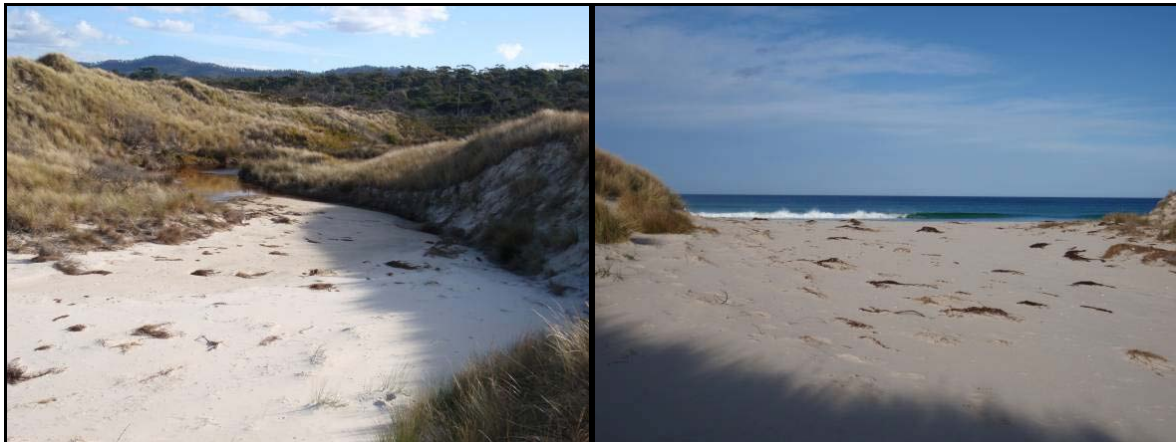
**Photo 20.5. Mouth of Dark Hollow Lagoon from beach showing seaweed deposition indicative of recent breakout.**

**Photo 20.6. Right - Mouth of Dark Hollow Lagoon looking towards sea. Note marram grass on both sides of opening.**

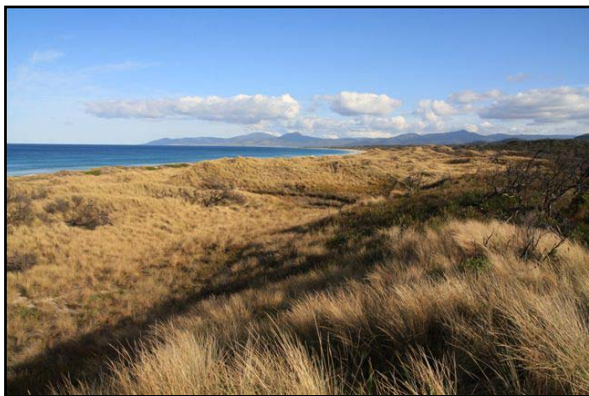
Weeds are common along the edge of the Tasman Highway, and marram grass was abundant in the coastal dunes. Four declared or environmental weed species were recorded within the study area. “Declared” weed species are listed on the schedules of the *Tasmanian Weed Management Act 1999*. All declared and environmental weed species recorded within the study area are listed below:

Photo 20.7. Extensive marram grass in coastal dunes.

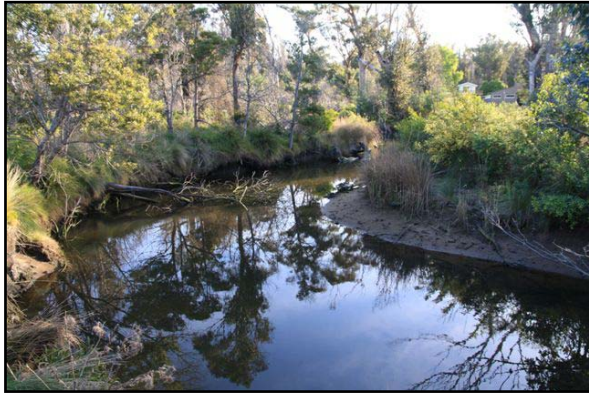
Figure 221.3. Off main channel section of Four Mile Creek.

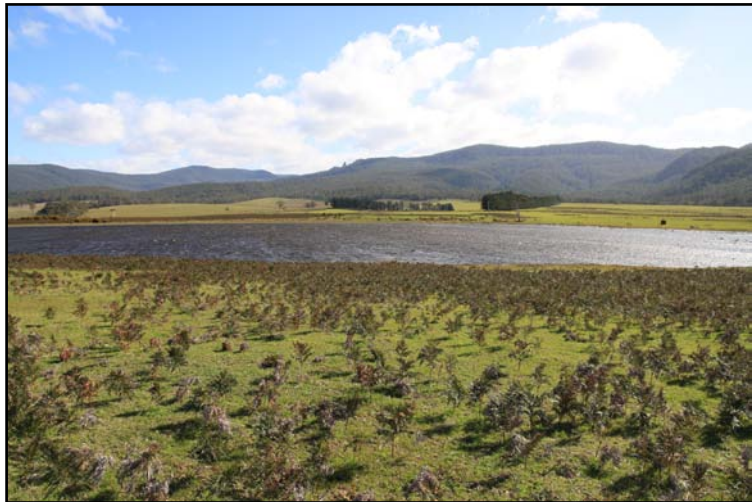
Photo 22.2. Google Earth aerial photo of Blind Creek study area.

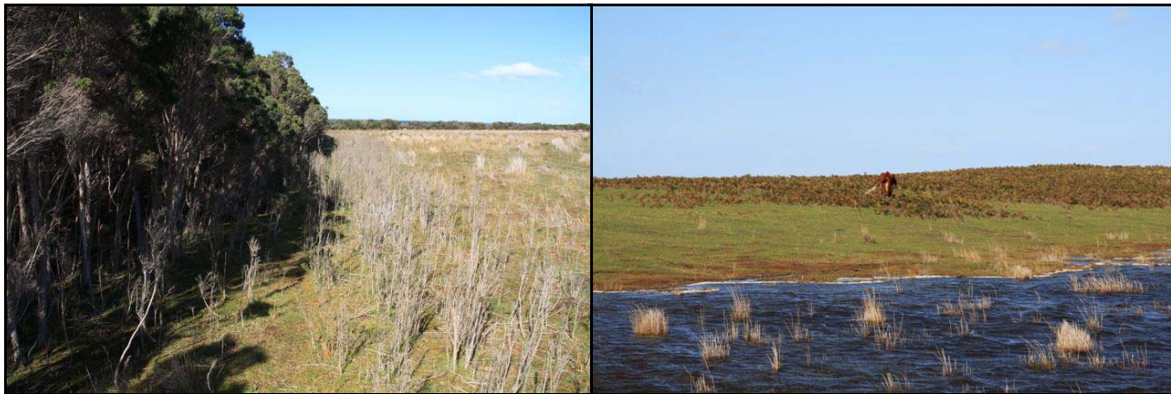
Figure 22.3. Left - Damage caused by cattle grazing to *Melaleuca ericifolia* swamp forest (NME).

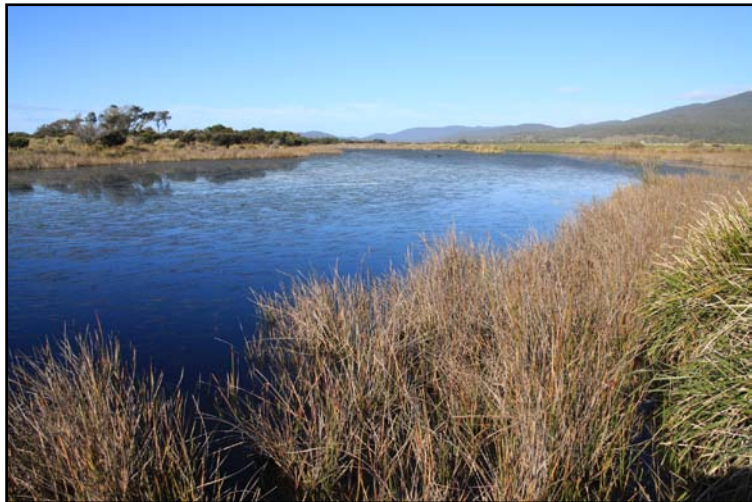
**Photo 23.2. Google Earth aerial photo of Douglas North Wetland study area.**

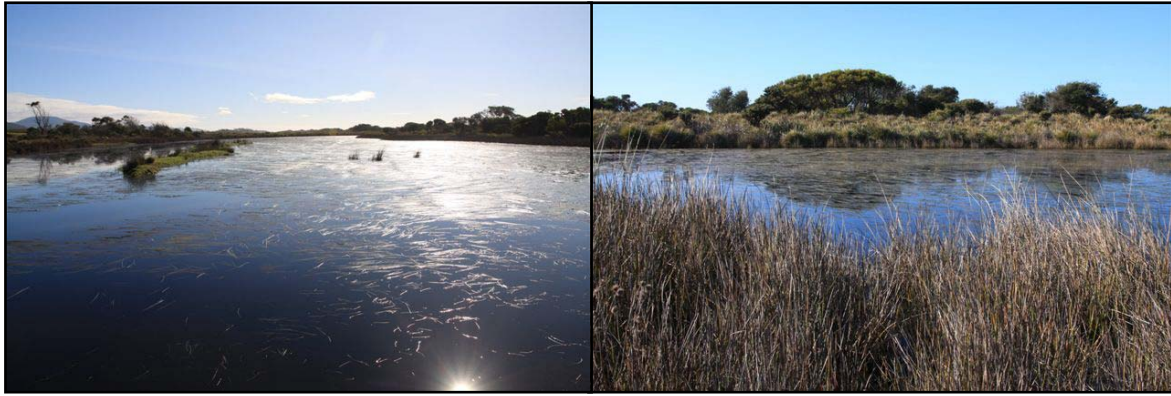
Figure 23.3. Left - Fresh water aquatic herbland (AHF).

Figure 23.3. Right - Fresh water aquatic sedgeland and rushland (ASF), Fresh water aquatic herbland (AHF) and Coastal scrub (SSC).

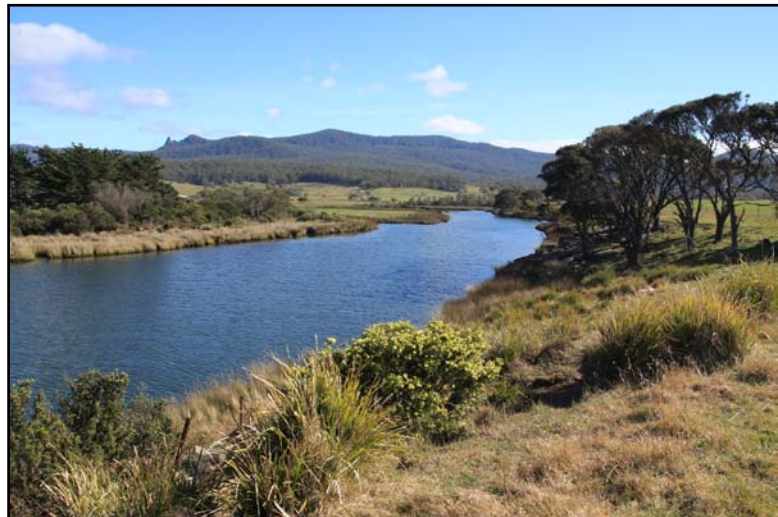
**Photo 24.2.** Google Earth aerial photo of Douglas River Wetland study area.

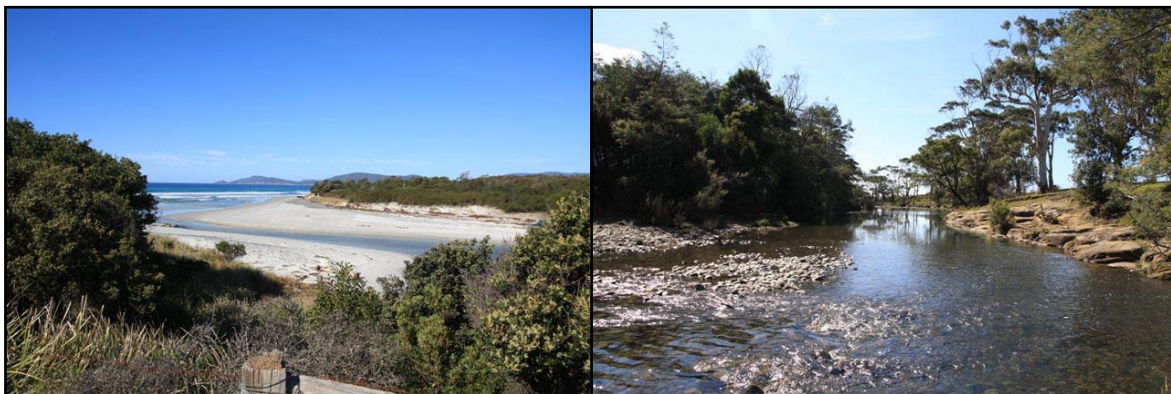
**Figure 24.3. Left - Douglas River mouth and coastal scrub.**

**Figure 24.4. Right - Douglas River inland section.**
