REPRESENTATIONS TO TASMANIA STATE PLANNING PROVISIONS (TSPP):

Request to rezone the Property from new proposed Agriculture Zone to Rural Zone

GEO-ENVIRONMENTAL ASSESSMENT

Lot 4 Mountain River Rd

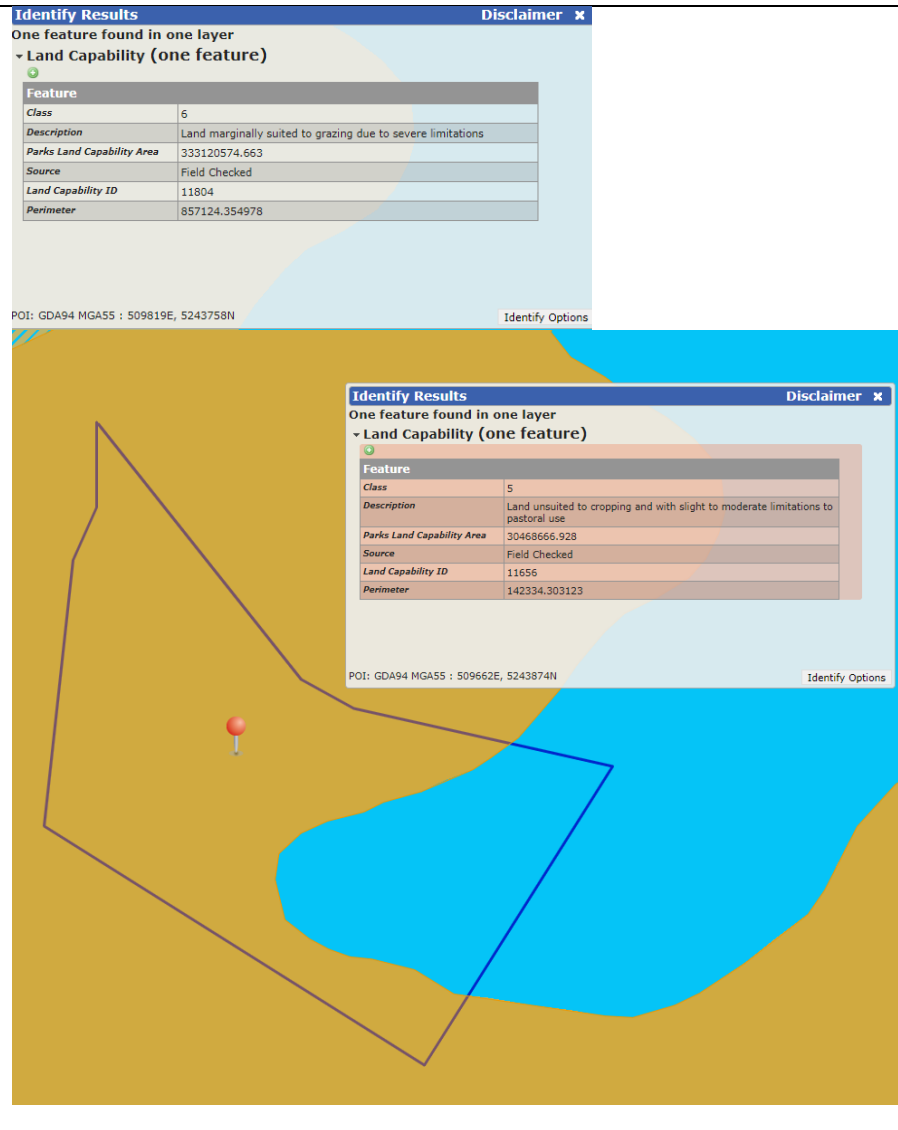
Land Capability Factor more than 60% of the Property is classified as “unsuited to Cropping and with slight to moderate limitations to pastoral use” the remaining of the land is classified as “land marginally suited to grazing due to severe limitations”.

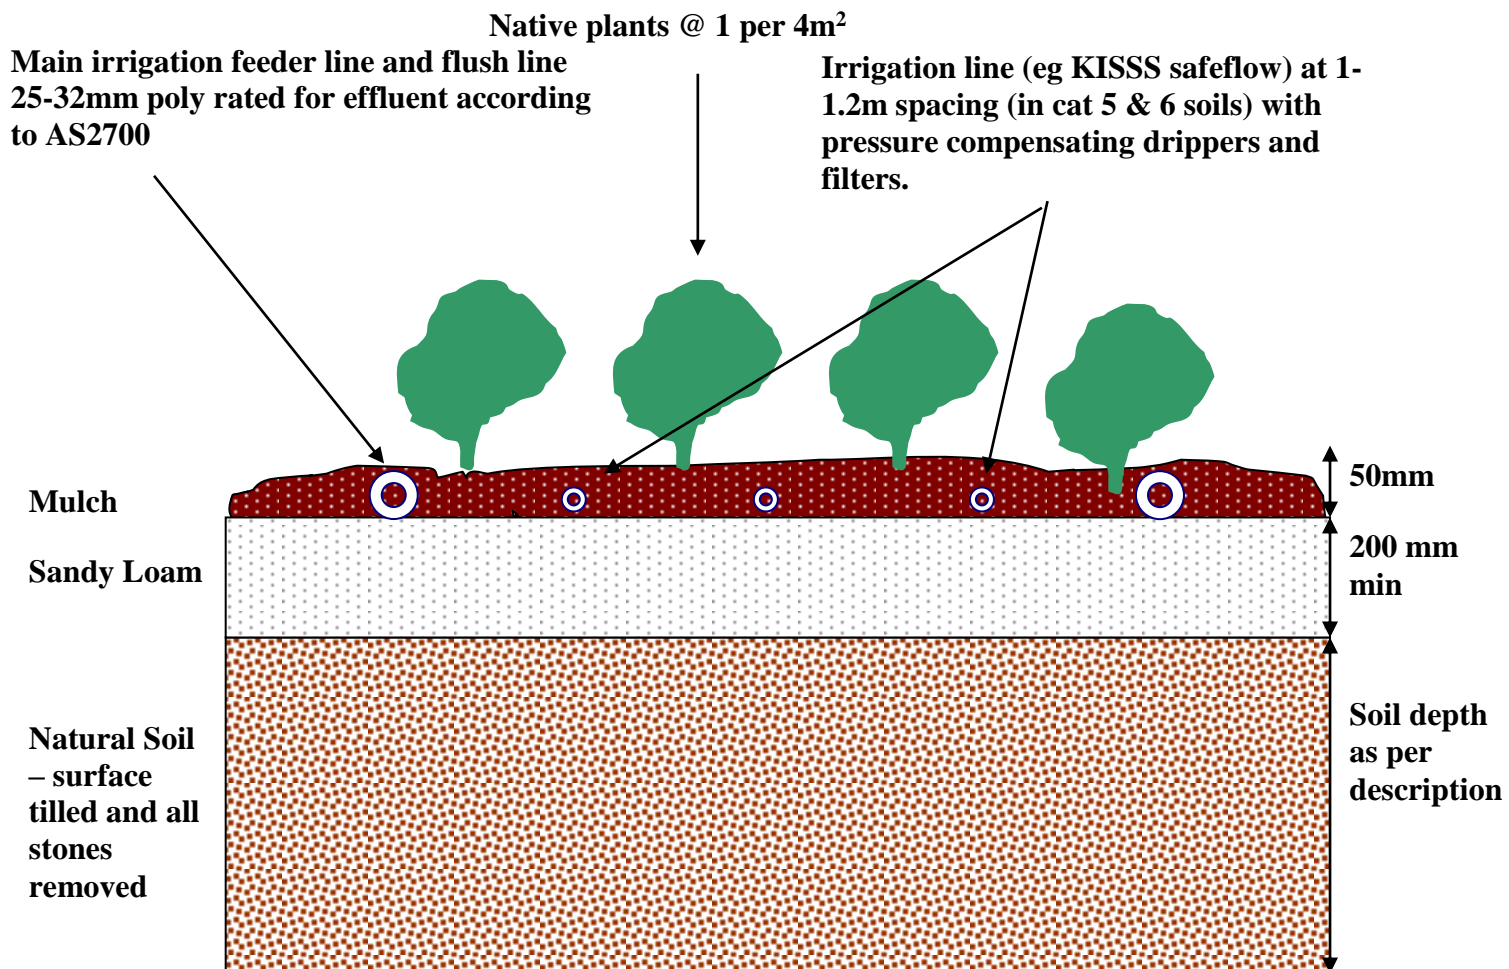
Irrigation Area Cross Section

- The existing surface of the site should be tilled to a depth of 100mm with a conventional plough, discs or spring tines to break down the turf matt and any large soil clods
- A minimum of 200mm of loam should be added to the site to aid installation—the loam should be mixed into the exiting subsoil with another pass of the cultivating tines or similar

To be used in conjunction with site evaluation report for construction of irrigation areas for use with aerated wastewater treatment systems (AWTS) on shallow, duplex, or clay soils. On dispersive soils gypsum should be added to tilled natural soil at 1Kg/5m². For irrigation areas larger than 500m² the irrigation area should be split into multiples of at least 100m² with flow automatically switched between each area by a kraine valve.

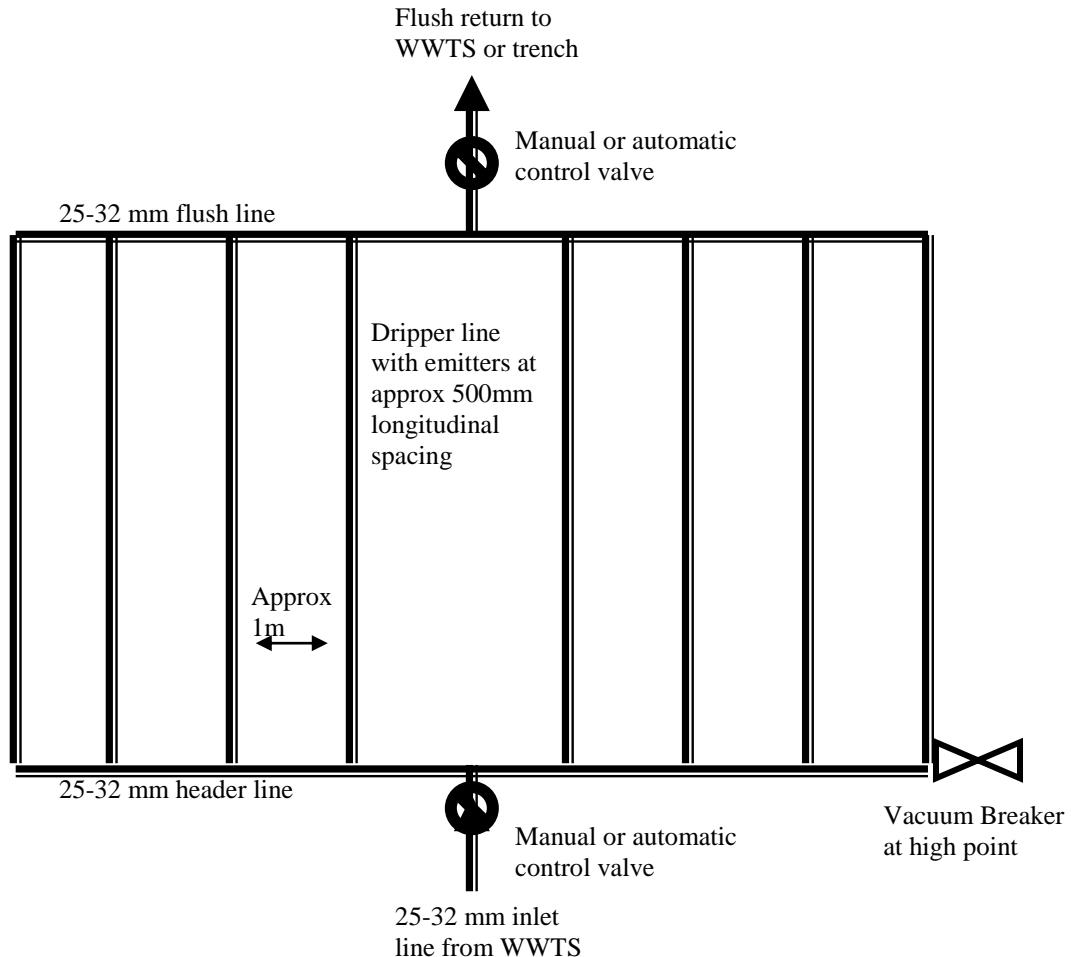
Irrigation Area Plan View

Design specifications:

1. Manufacturer's recommendations for spacing of lateral irrigation lines should be followed (either Techline brand, Geoflow or KISSS) with commonly used with spacing of 0.3m (0.6m KISSS) in highly permeable soils and 0.6m (1.0-1.2m KISSS) in less permeable loams and clays.

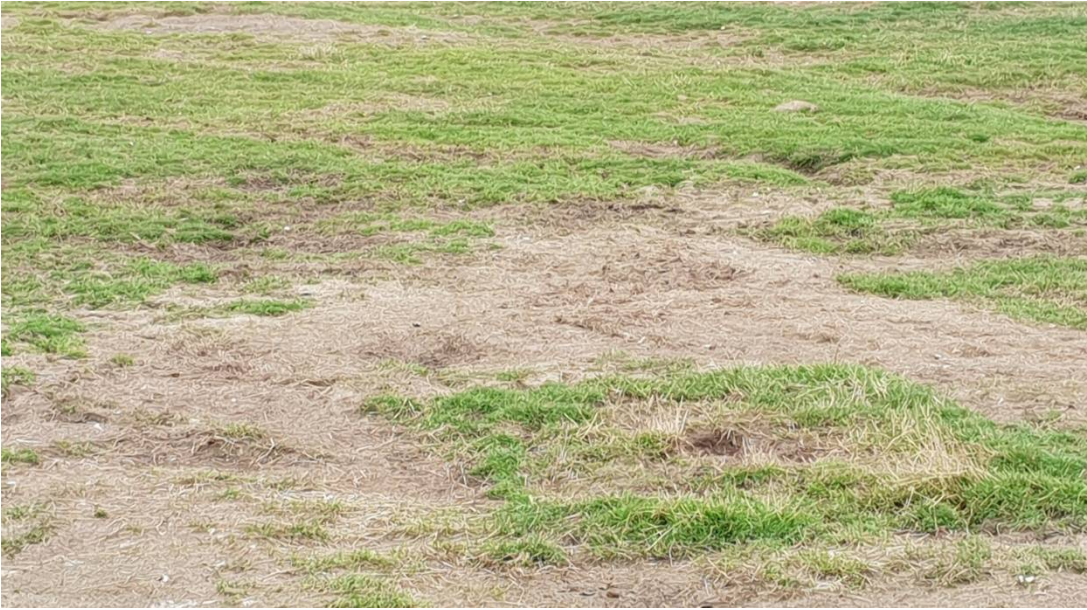
Image 3: One week after chicken enclosure placement

- Create a 30- metre use exclusion zone around the waterway
- Move enclosures more regularly during high rainfall / inundation periods.
- 50 per cent ground cover should be maintained (if this is challenged enclosure relocation will need to occur more often; more imported feed given to reduce pasture pressure or stocking rates / chicken numbers may need to be decreased)

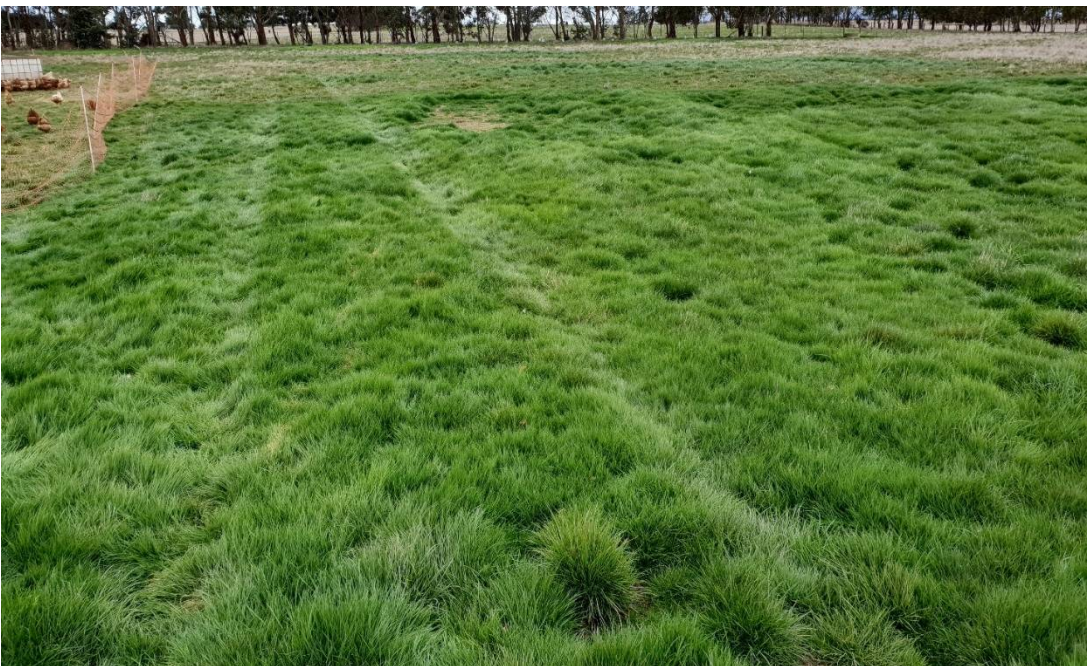
Image 4: Eight Weeks after enclosure placement

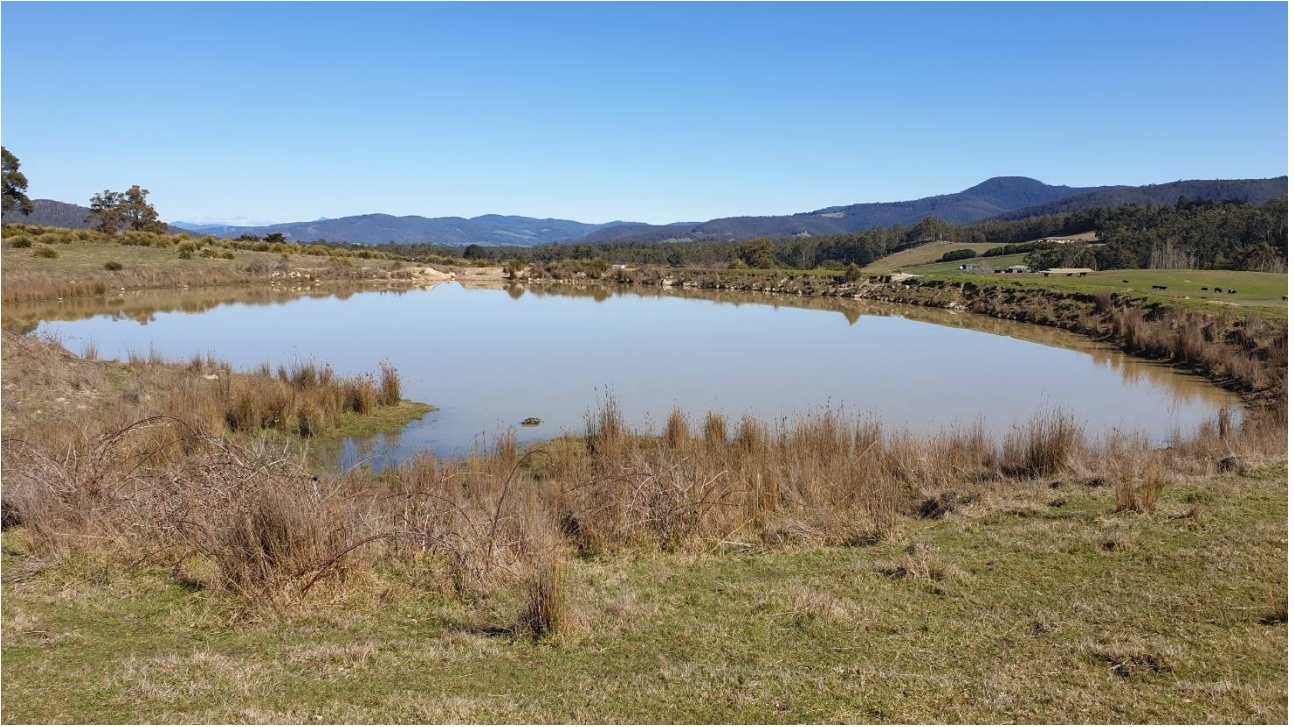
Image 9: Existing water dam

The property has a significant storage dam of over 3 megalitres and a water spring and a dam at the east. Neighbours report this a reliable source of water. The proposed dwelling and shed will have water tanks attached, and these will provide suitable drinking water for the chickens. Those buildings are expected to generate over 600 000 litres of captured water per year. Allowing 0.5 of a litre per chicken per day the entire requirement for the egg production will be 275 000 litres per year for drinking water. Having double this allowance is recommended for spillages, blockages and periods of higher temperatures.

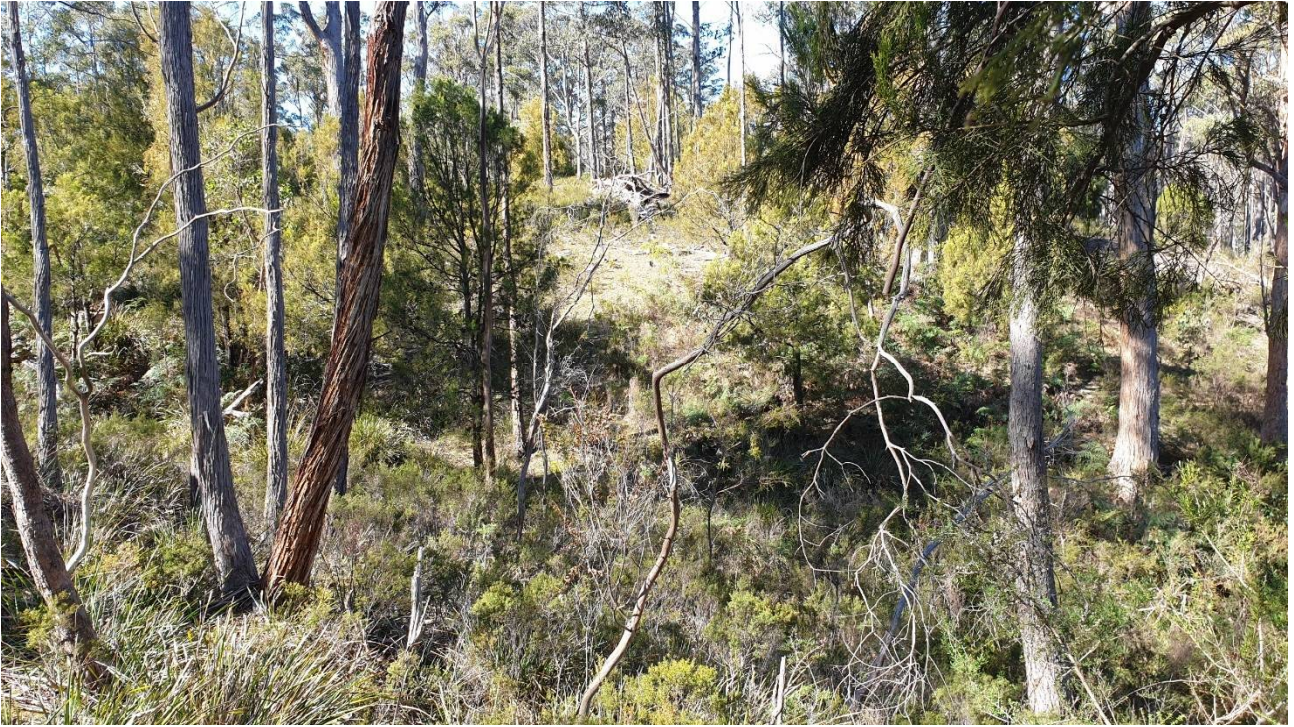
Image 11: Gully contained in Landslide Hazard Area.

There are 3 designated landslide hazard areas. These areas are not within the farmed areas and are well vegetated with large trees and ground cover, and this will not change. They are not slipping, and it is a little difficult to understand why they have been included. Nonetheless they will not be altered in any way.
