**From:** [REDACTED]  
**To:** [TPC Enquiry](#)  
**Subject:** Direction 20 zoning  
**Date:** Thursday, 29 February 2024 12:38:14 PM  
**Attachments:** [REDACTED]

Please find attached further documentation in regards to proposed split zoning on my block at [REDACTED], Crabtree TAS 7109

Please also find attached a letter which I employed Amy Robertson through her capacity as a Forestry Practises Officer to produce for me to help guide my planned and current forestry practises and private timber use on my land.

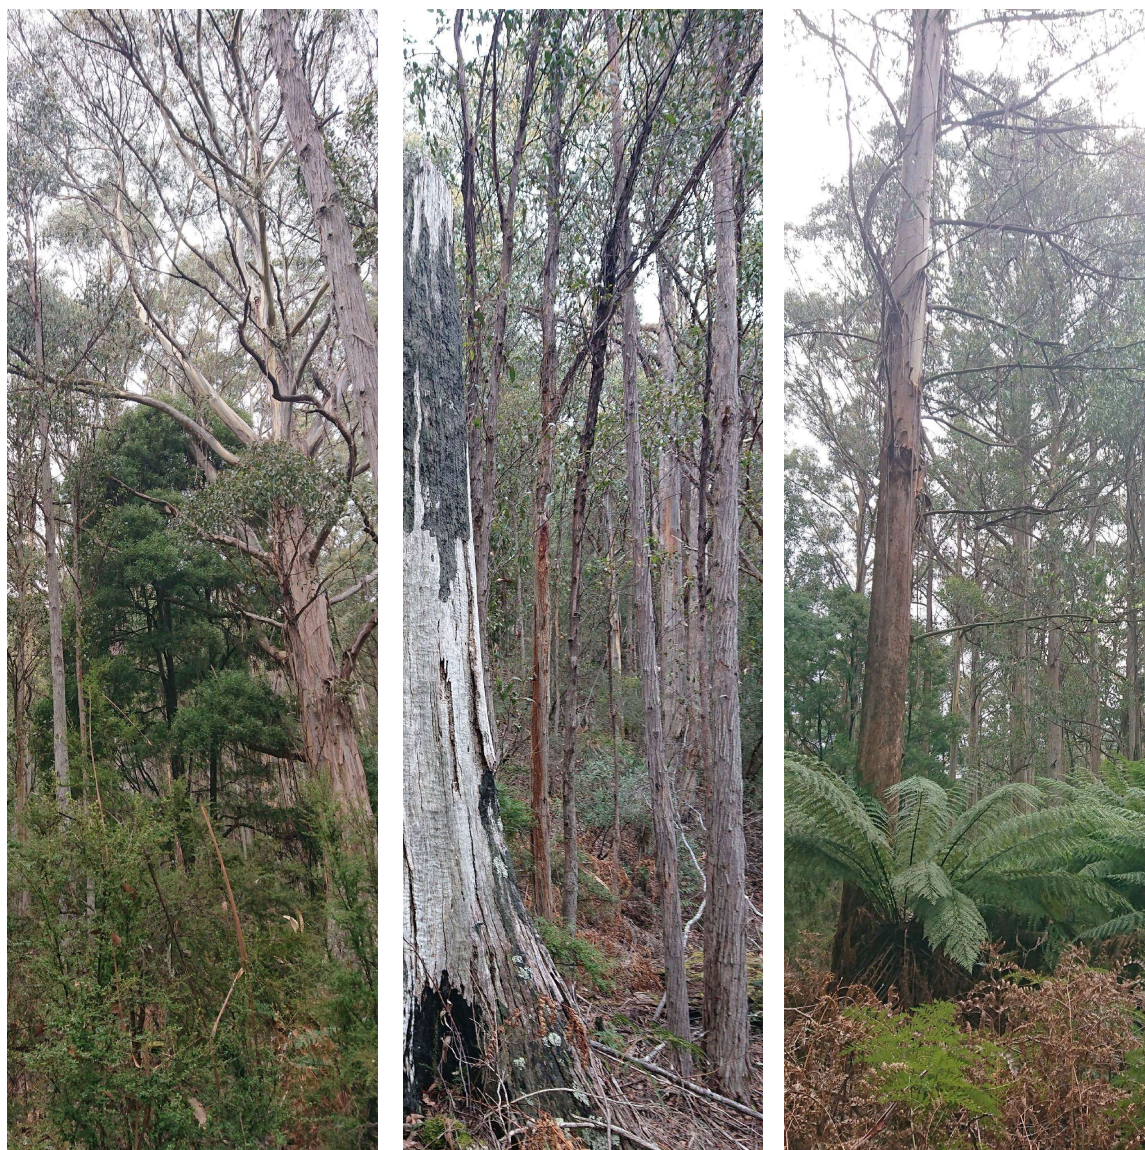
Tree size varied widely with site characteristics, but some individuals exceeded 1m diameter. Few trees contained hollows, and most showed an excellent regrowth stem form without signs of previous fire scarring. This area is not mapped as having been impacted by the broadscale 1967 fire event, but with little coarse woody debris evident across the site it is possible that this forest has regenerated from a fire 60-100 years ago.

- Dry Eucalyptus obliqua forest (DRY-shOB/O code) on the solid spurline near your SW boundary, possibly with some Peppermint and Blue Gums.
- Wet Eucalyptus obliqua forest (WET-OB0110/OT code) across the middle flats with occasional individuals or patches of E. globulus (Blue Gum), Acacia dealbata (Silver Wattle), Acacia melanoxylon (Blackwood) and Eucalyptus regnans (Swamp Gum).

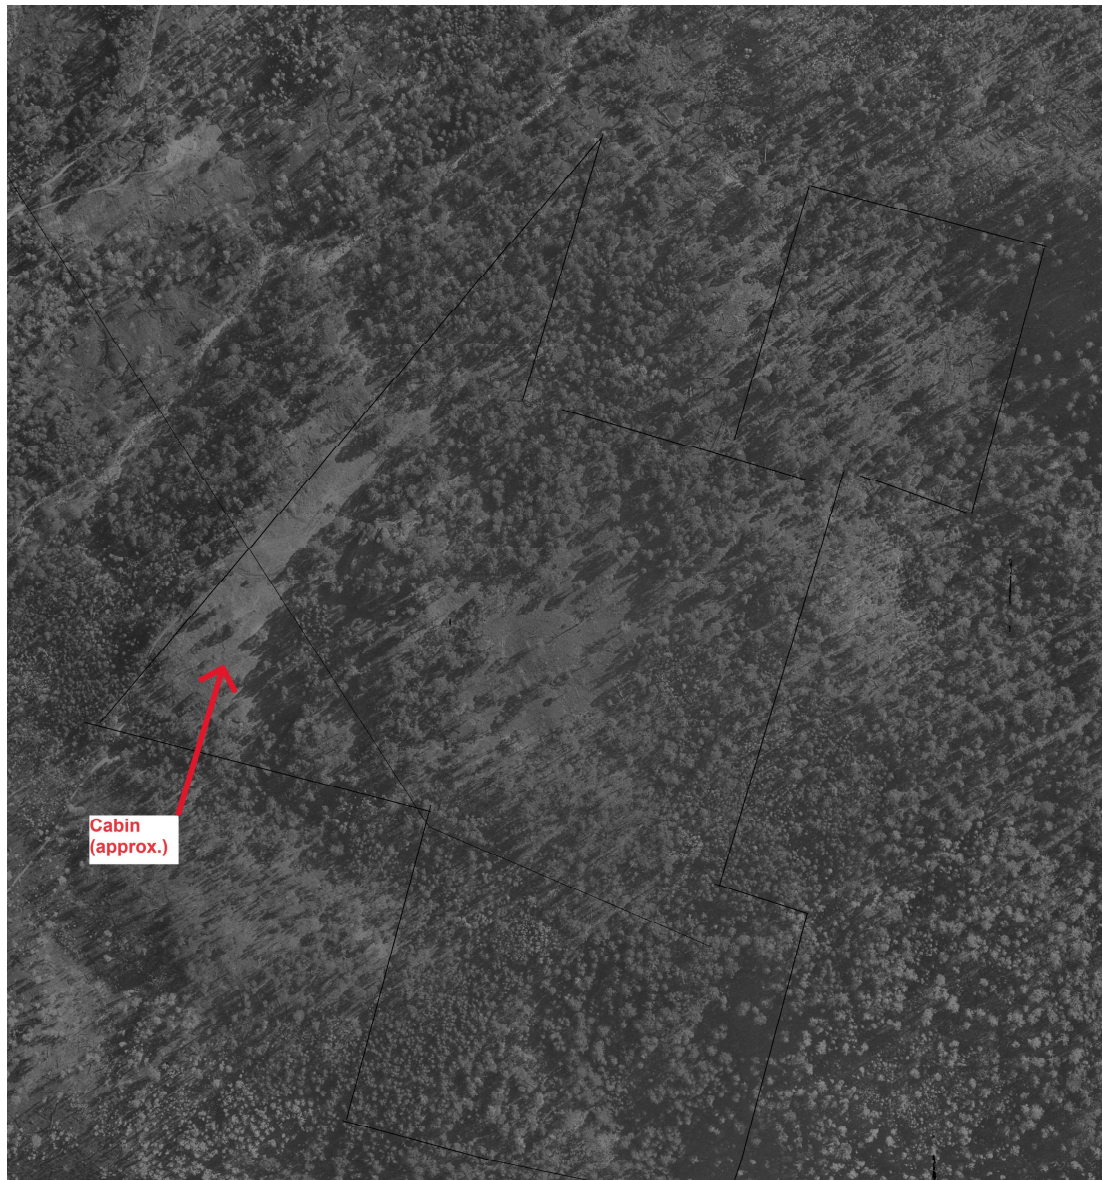
An aerial photo from 1967 indicates some areas of the property being cleared with most debris removed, consistent with on-ground observations of sparse coarse woody debris and less treed areas. Smaller crowns may indicate a younger forest or a shorter (eg. dry) forest type. It's useful to zoom in on a digital copy of this aerial photo to explore where old tracks or clearings may have occurred.

*\* boundary lines are rough estimates only*

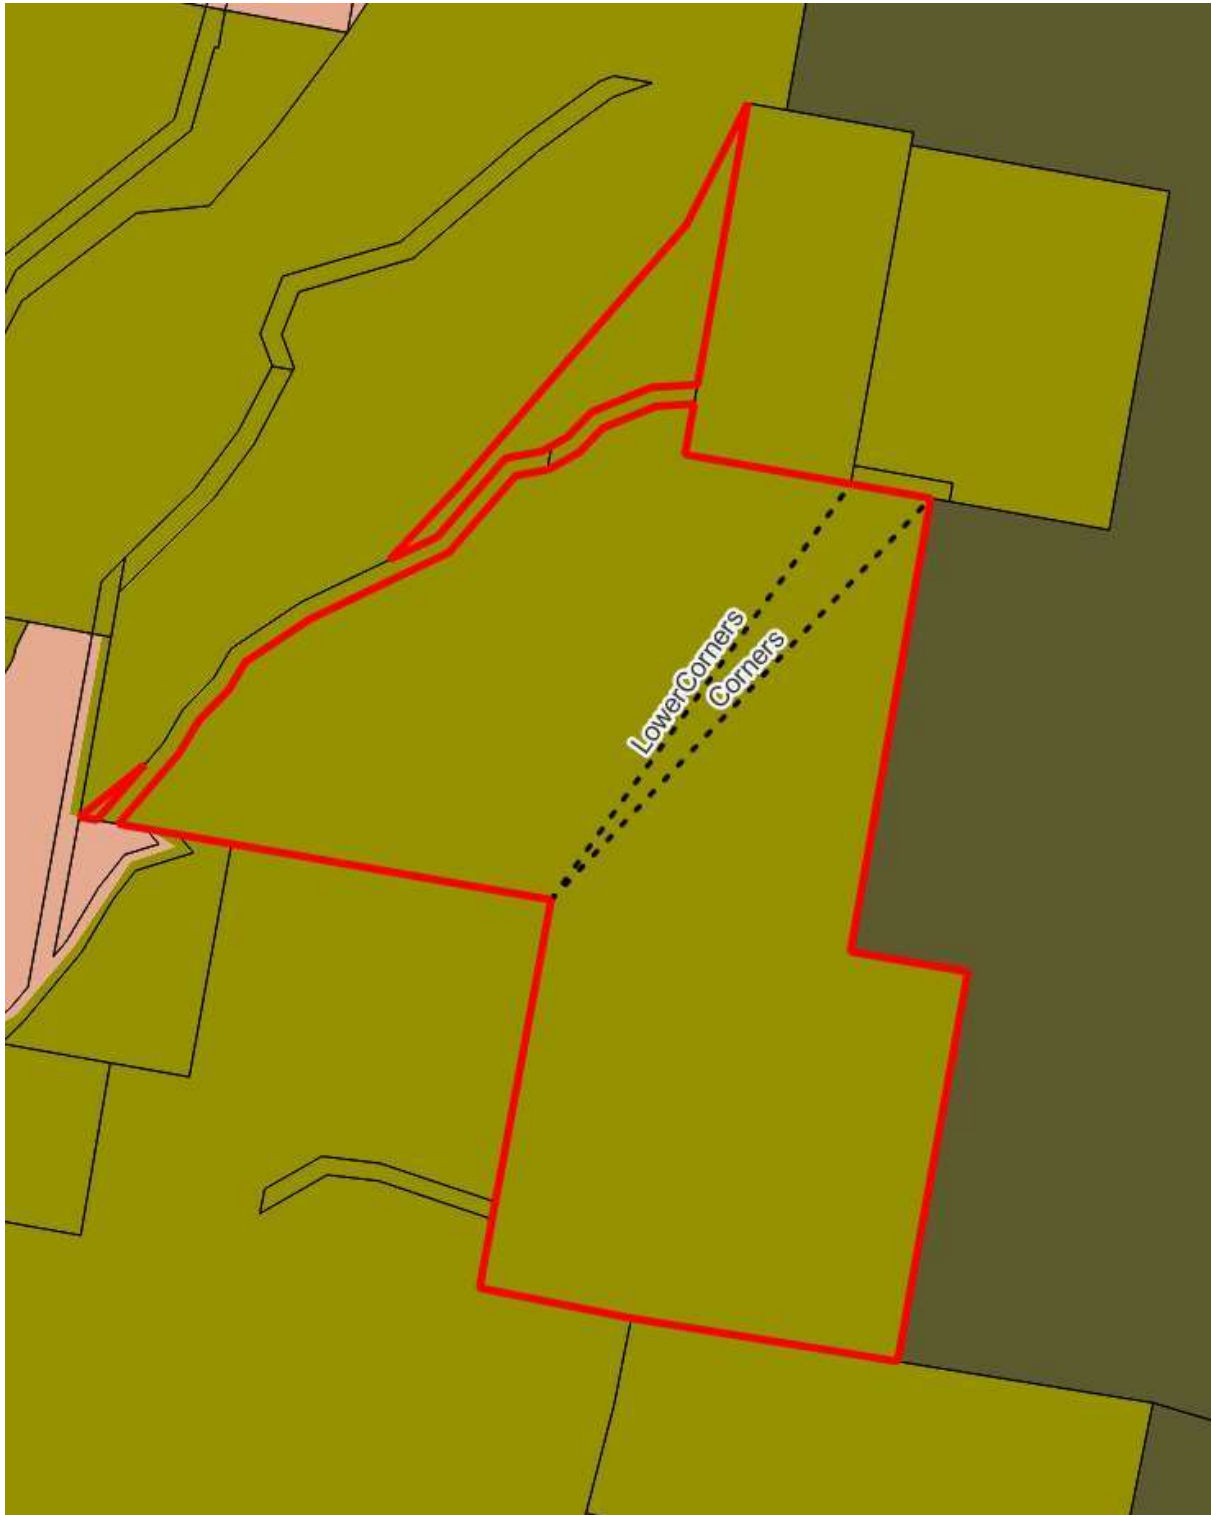
GIS data submitted by the landowner showing split zone boundary options for [REDACTED]  
Crabtree (folio of the Register [REDACTED])
