# Site Environment Management Plan

Macquarie Point Development Project

22-Oct-2021

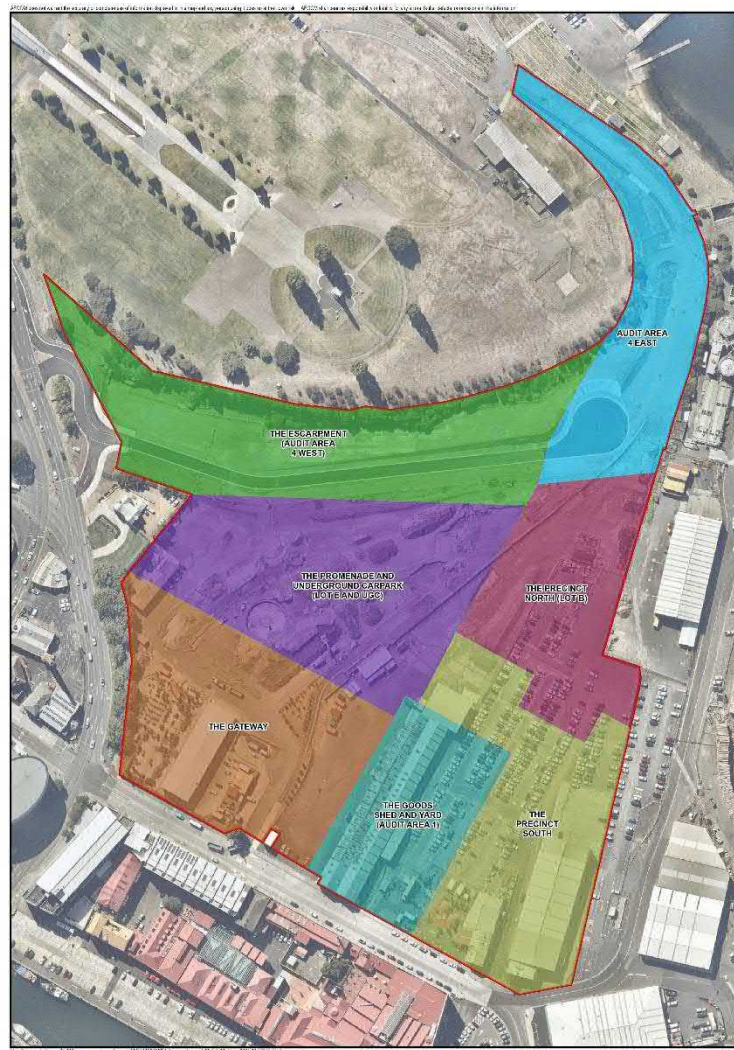
**Figure 1 Site Areas**

For the purpose of assessment and completion of the Environmental Audit, the Site has been divided into seven sub-areas for assessment based on the nature of identified contamination, historic activity, and the intended future uses of each area. Each area may have specific development controls or work requirements, which are discussed in **Section 4.0**. The sub-areas of the Site are shown on **Figure 1** below.

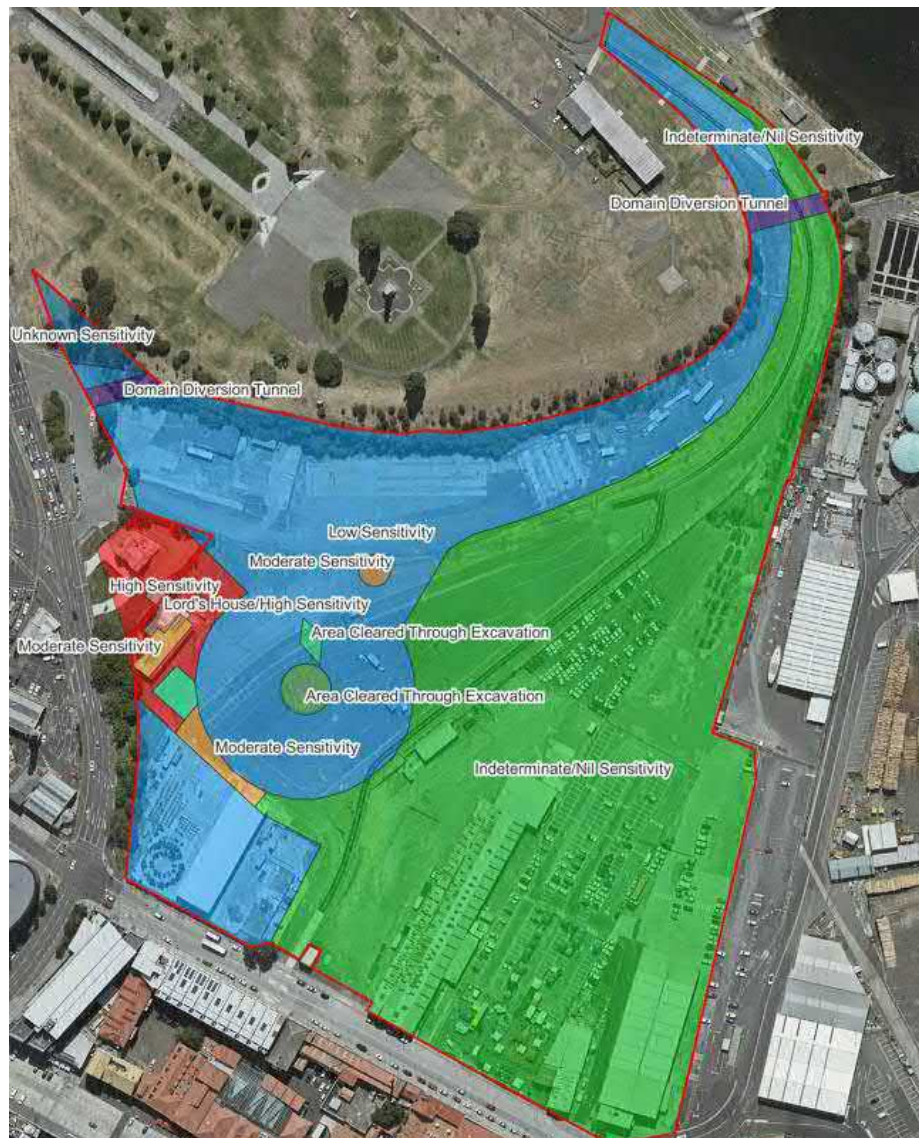
**Figure 2** Areas of Inferred Archaeological Sensitivity

**Figure 2** shows the inferred areas archaeological sensitivity of the Site based on works completed to date.

However, it is highly likely that unanticipated archaeology will be encountered during excavation works because of the diversity and widespread nature of past development on the site and the limited insights available from historical research and excavations.

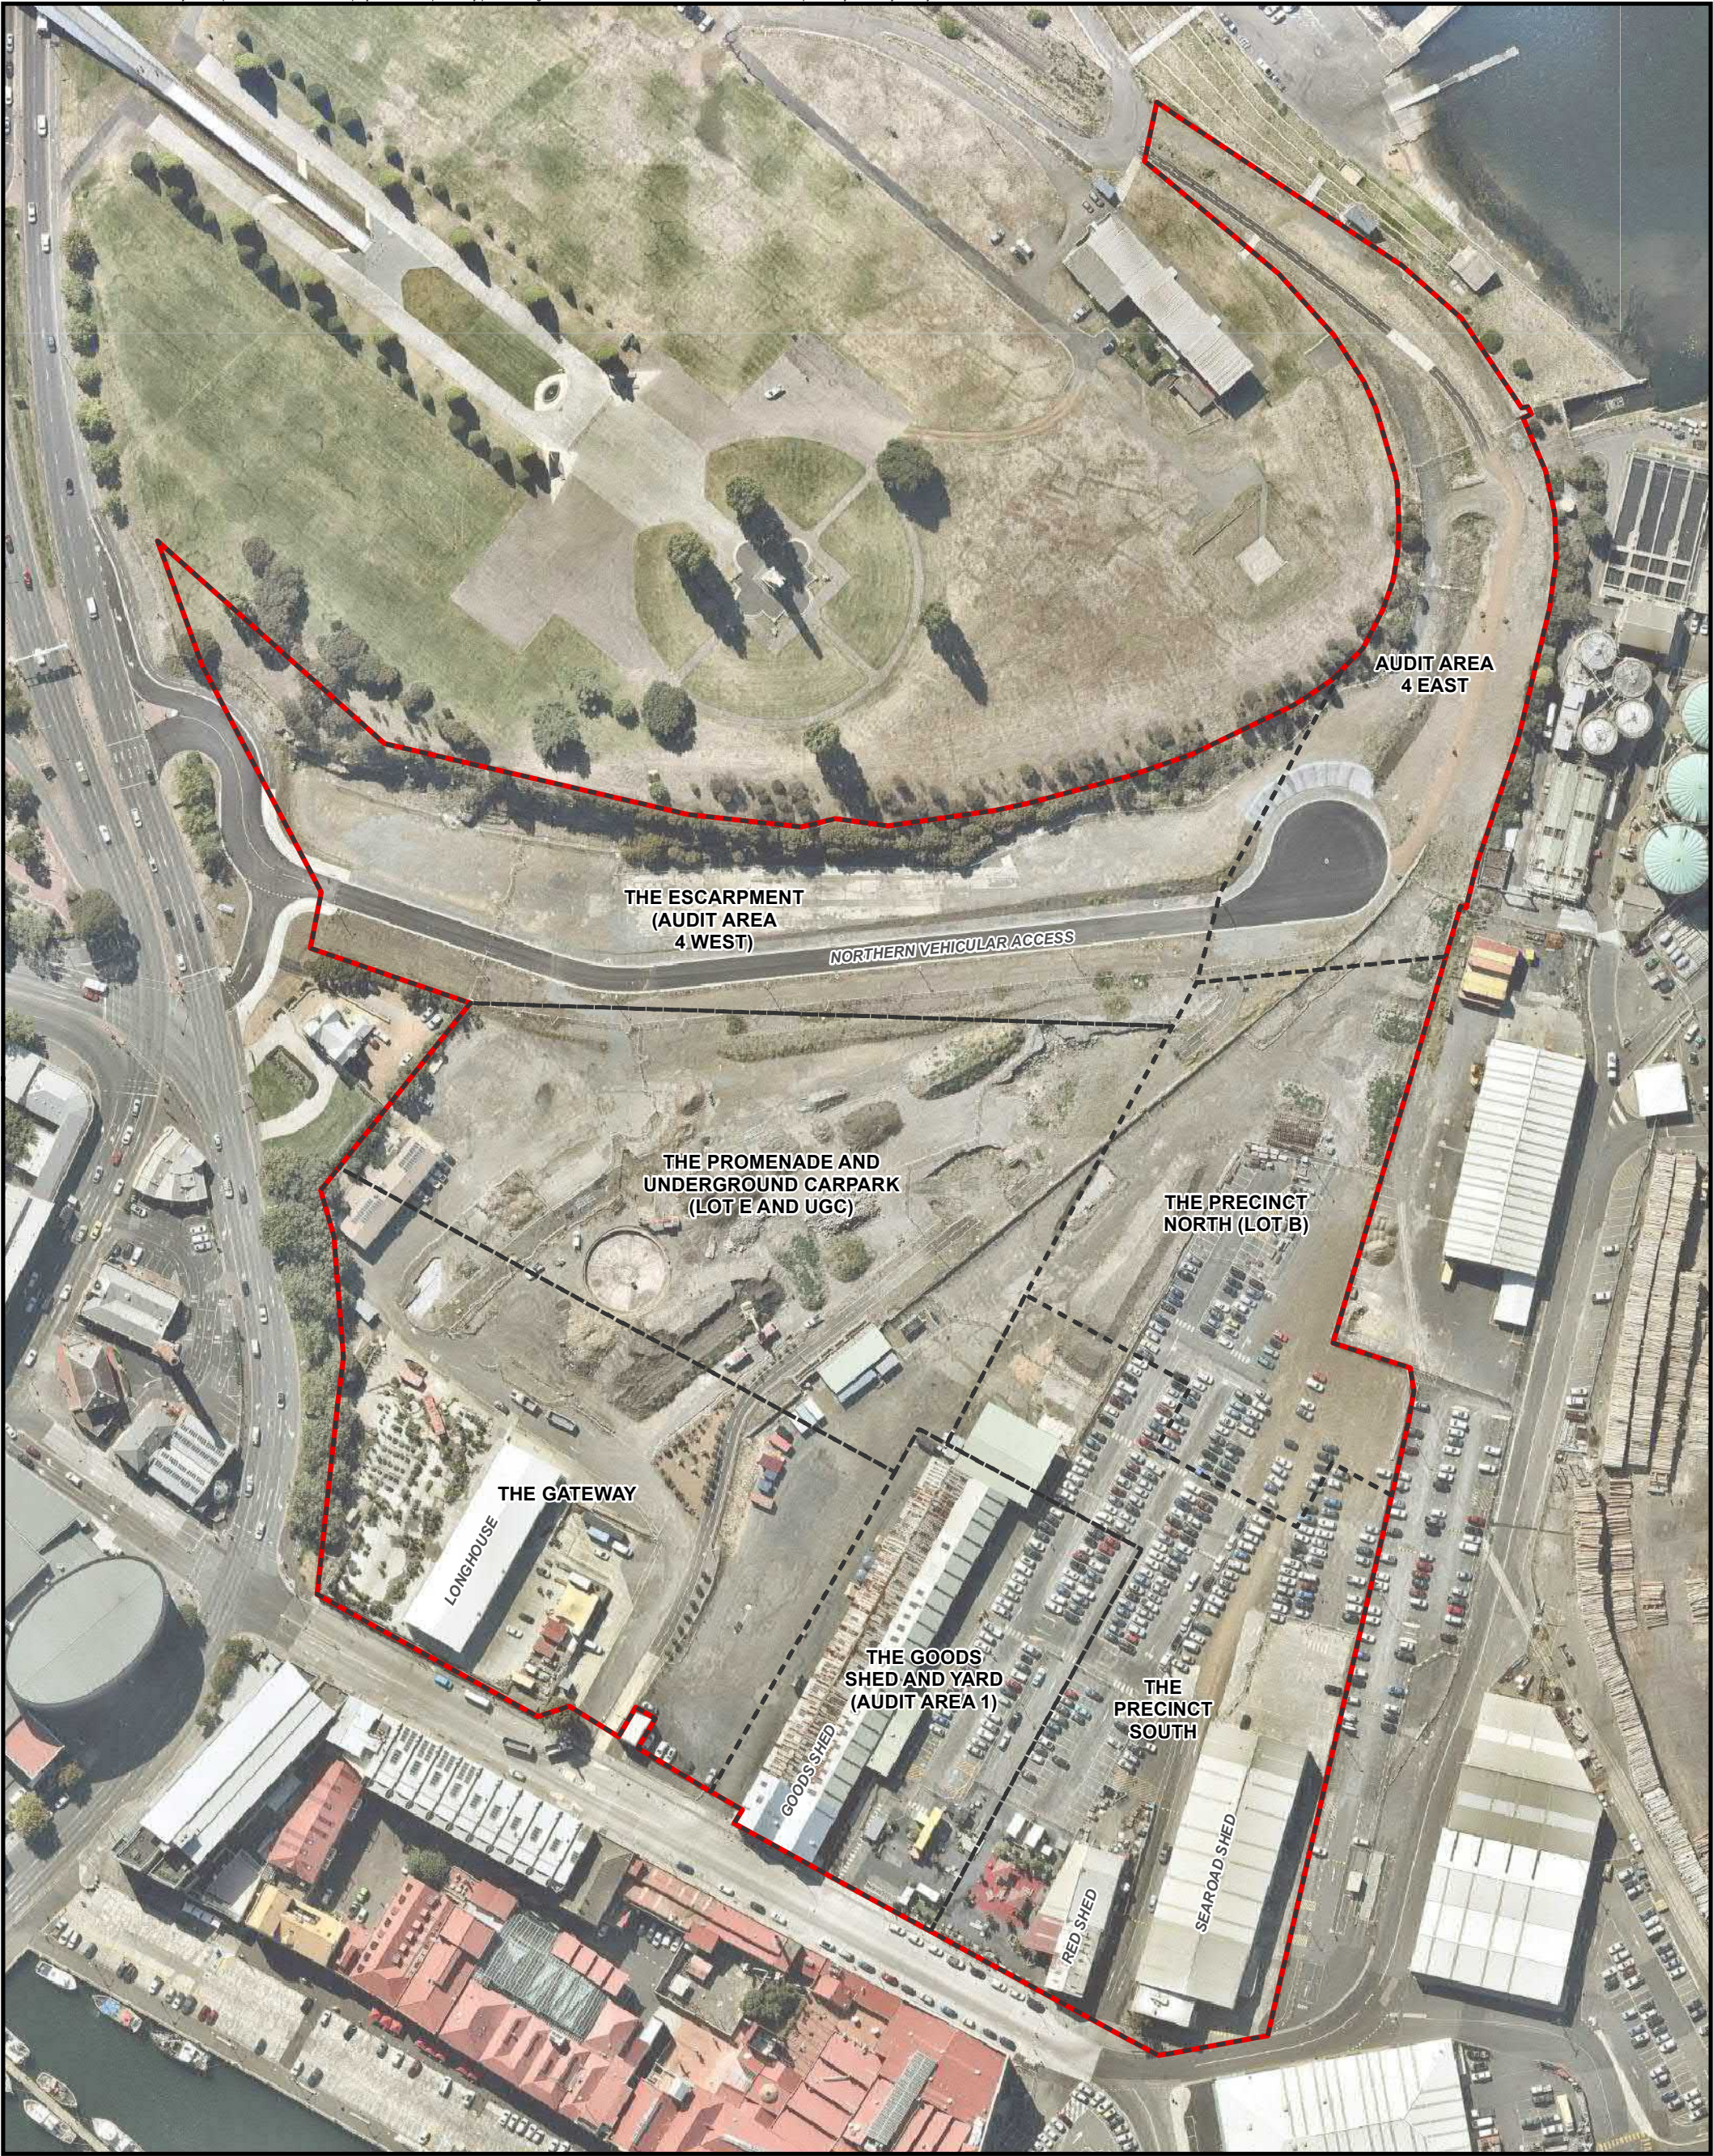
| <p>PROJECT ID 60321835<br/>CREATED BY PK<br/>LAST MODIFIED PK 11 Oct 2021</p> <p><b>AECOM</b><br/>www.aecom.com</p> <p>DATUM GDA 1994, PROJECTION MGA ZONE 55</p> <p>0 25 50 100<br/>metres<br/>1:1,675 (when printed at A3)</p> | <p><b>Legend</b></p> <p>Assessment Area</p> <p>Site Boundary</p> | <p><b>ASSESSMENT AREA BOUNDARY</b></p> <p>Macquarie Point Development Corporations</p> <p>Site Environment Management Plan</p> <p>Macquarie Point, Hobart, TAS</p> | <p>Figure<br/><b>F1</b></p> |

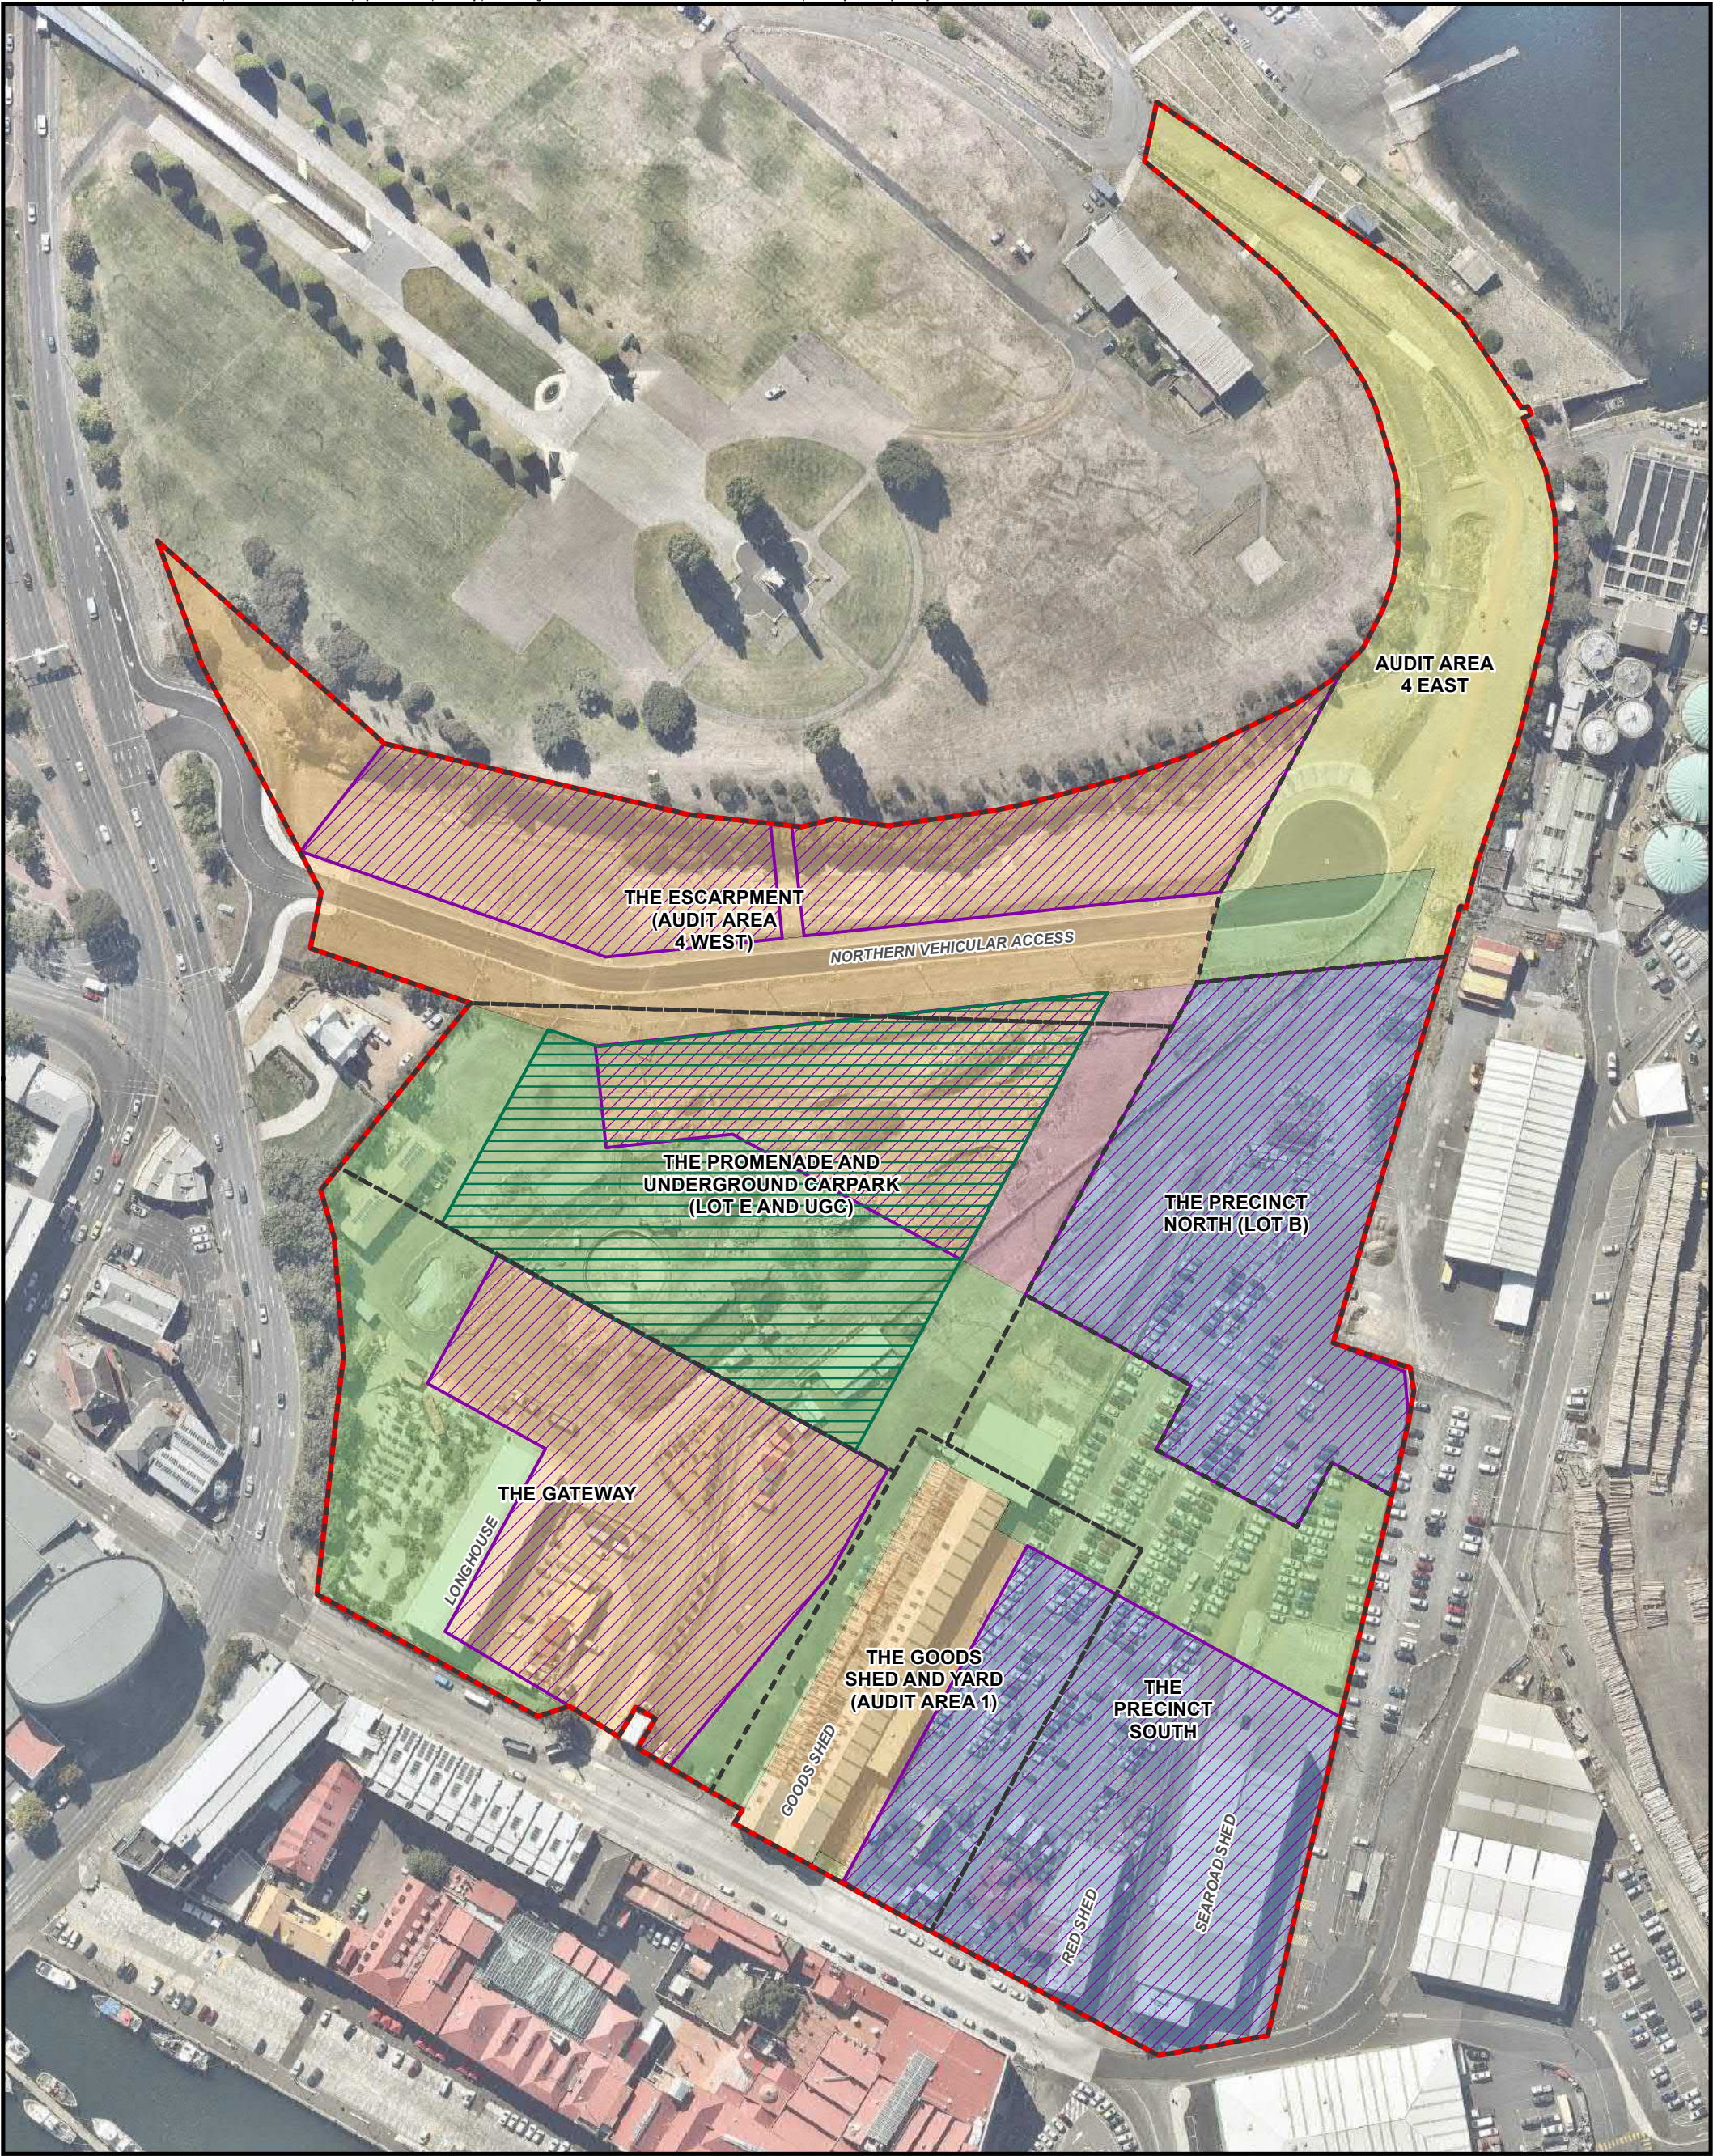
| <p>PROJECT ID 60321835<br/>CREATED BY PK<br/>LAST MODIFIED PK 11 Oct 2021</p> <p><b>AECOM</b><br/>www.aecom.com</p> <p>DATUM GDA 1994, PROJECTION MGA ZONE 55</p> <p>0 25 50 100<br/>metres<br/>1:1,675 (when printed at A3)</p> | <p><b>Legend</b></p> <p>Assessment Area<br/>Site Boundary<br/>Underground Carpark Footprint<br/>Building Parcels</p> <p><b>Land Use</b></p> <p>Art and Institutional Area<br/>Open Space Area<br/>Mixed Use Area<br/>Access Link<br/>Transport/Vehicle Areas</p> | <p><b>SITE LAYOUT</b></p> <p>Macquarie Point Development Corporations</p> <p>Site Environment Management Plan</p> <p>Macquarie Point, Hobart, TAS</p> <p>Figure<br/><b>F2</b></p> |

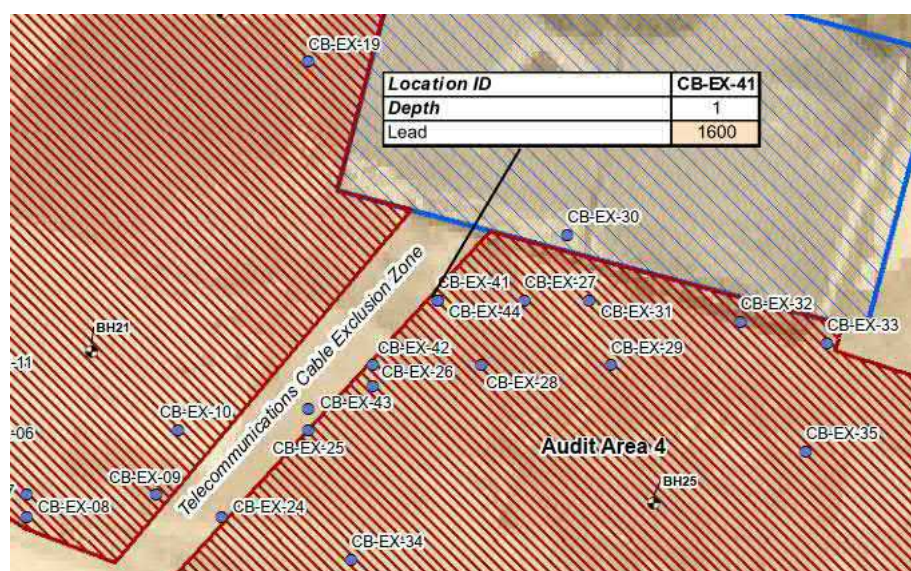
**Plate 1** Location of lead in soil detection in telecommunication cable exclusion zone

During remediation works in the Escarpment, a lead concentration of 1,600 mg/kg was reported in soil validation sample CB-EX-41, collected from the boundary of the 2 m buffer zone surrounding the major telecommunications cable in the former Concrete Batching Plant area of the Escarpment. The location of the lead detection is shown on **Plate 1** below.

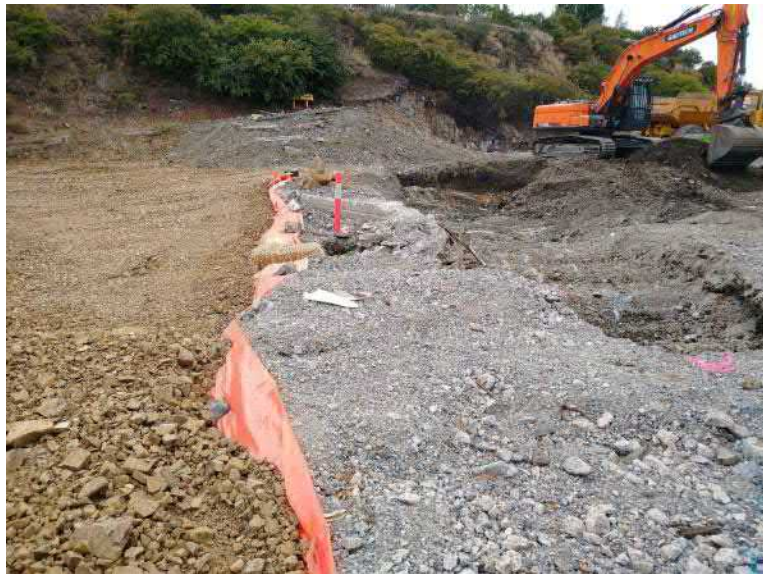
**Plate 2** Liner on the Western Boundary of the Telecommunications Cable

Due to the risk of damage to the cable from excavations in this area, the asset owner (Telstra) did not give approval for excavation of soil in the exclusion zone. The impact was assessed as localised and not typical of the material in the exclusion zone in the Remediation Validation report (AECOM, 2020b), and soil present within the exclusion zone has been isolated from clean fill using a 200 µm plastic liner (shown on **Plate 2** below).

Future works in this area should consider the potential for lead impacts to be present if this soil is to be disturbed.

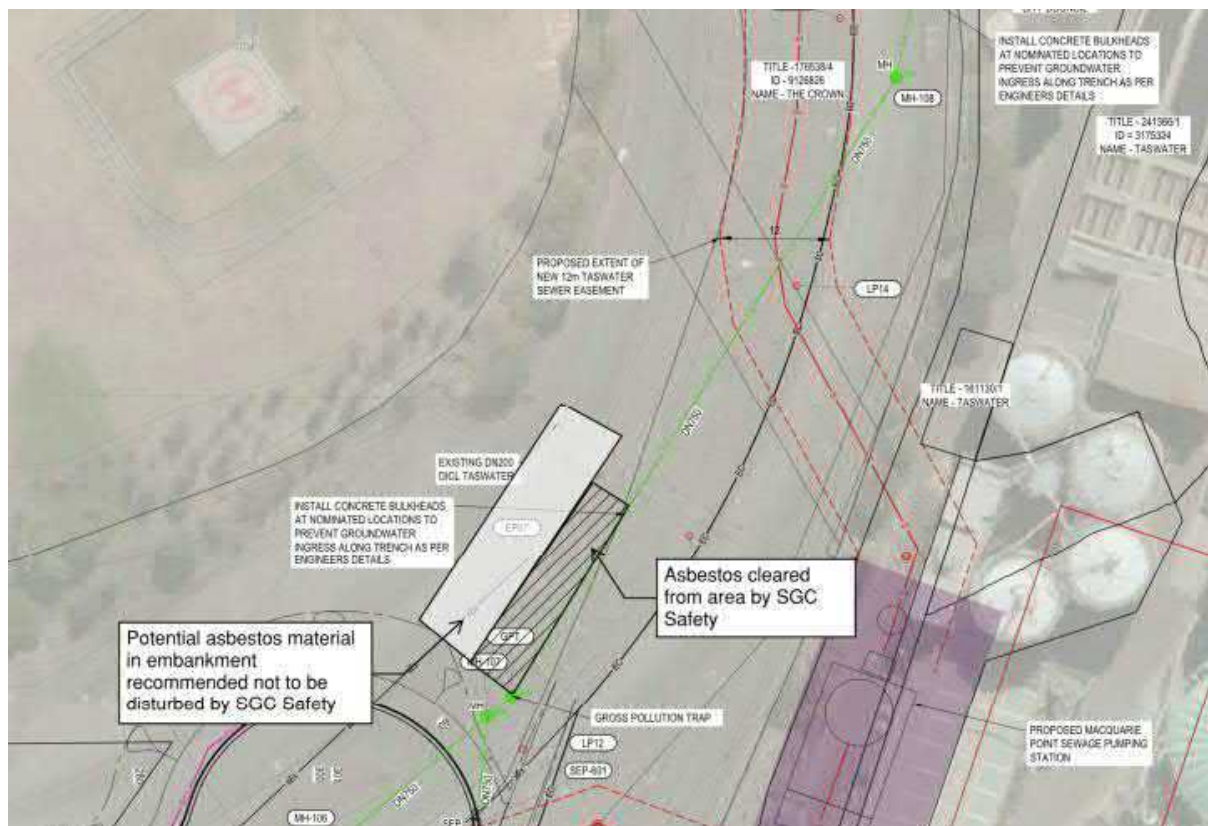
Plate 3 Audit Area 4 East - Area of ACM Encountered

All encountered ACM and surrounding soil were removed when encountered and the area was assessed by an occupational hygienist to be free of visual ACM. The hygienist indicated that the number of ACM fragments present appeared to increase in the northwest of the area cleared and may be present in the adjacent embankment in that direction.

The location where ACM was detected, and the potential area to the northwest, has been added to the Site Asbestos Register, and both areas are shown on **Plate 3** below.

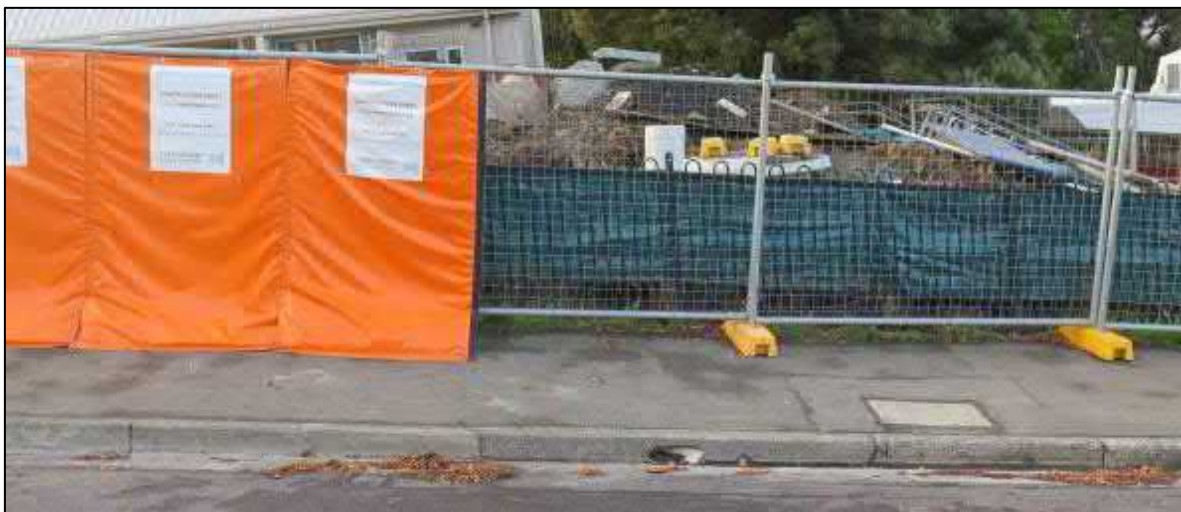
Figure 1 Typical sound absorbing barriers mounted on a temporary fence at a project in Hobart. These barriers are each 2m high and 1.3m wide and they can achieve 12-15 dB noise reduction when placed near a noise source such as a jackhammer. A heavy duty version of the barriers is also available that can achieve much better performance, especially regarding low frequency noise. There are other similar products on the market.

Placing sound absorbing barriers on the site boundary will not be very effective because the residences in the Glebe and the apartments on Evans Street have elevated line of sight to the Precinct. Sound absorbing barriers placed close to noise sources will be more effective than perimeter barriers and Contractors are expected to have a sufficient number of moveable sound absorbing barriers available on site to provide satisfactory mitigation of construction activity noise. As per the worked example in the previous section, some should be heavy duty barriers able to achieve better noise reduction performance than standard barriers, especially low frequency noise.

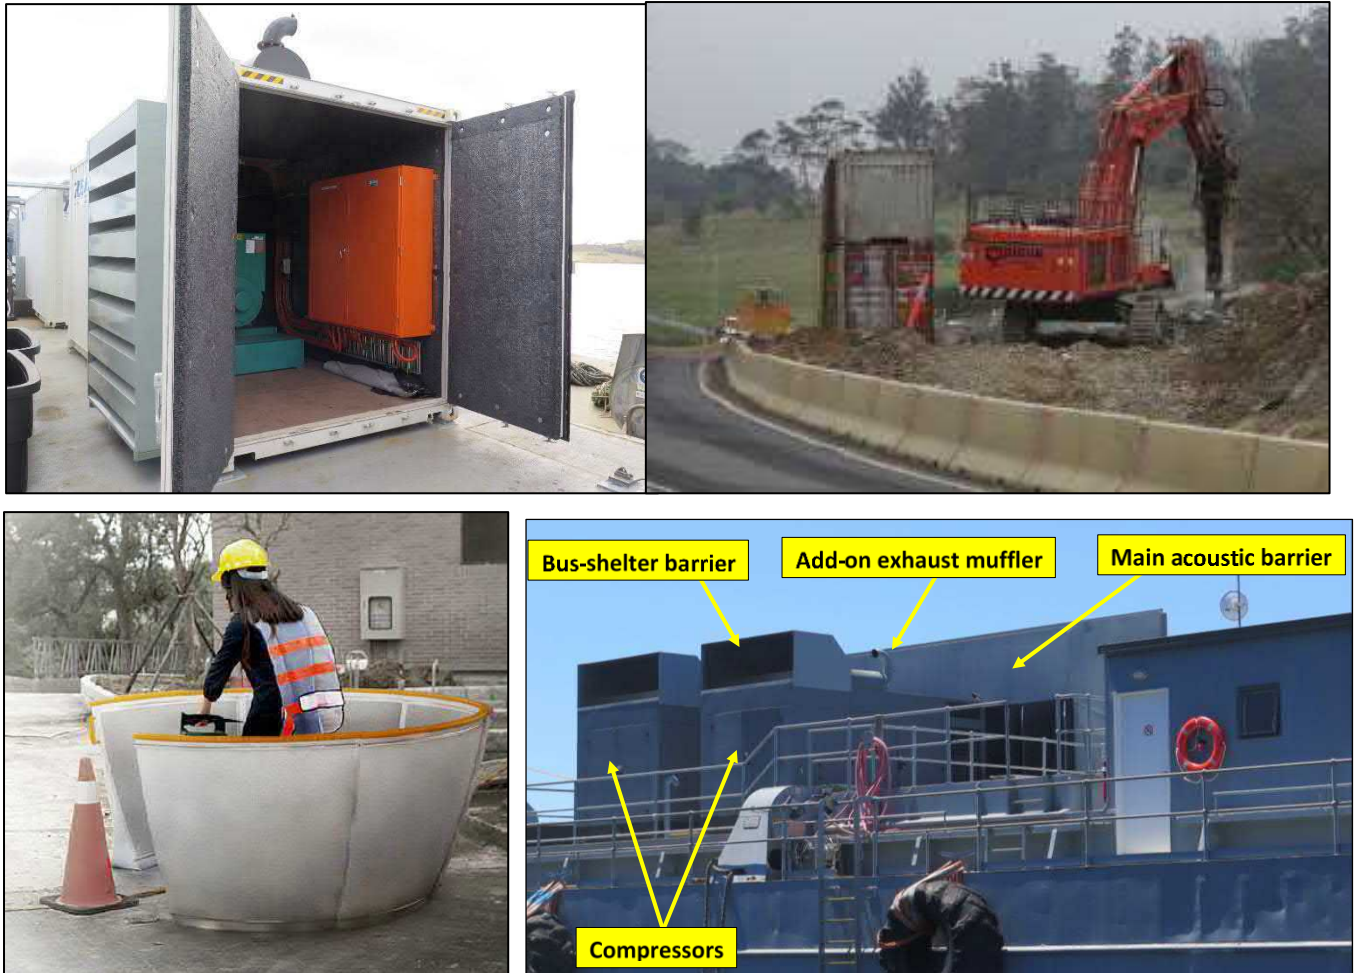
Figure 2 Top left. A 550 kVA generator inside a shipping container lined with acoustic material. Two high performance acoustic louvres provided ventilation, and on top is a custom-designed muffler.

Top right. An excavator with a rock breaker head operating behind shipping containers that reduced noise levels at a residence on the other side of the road.

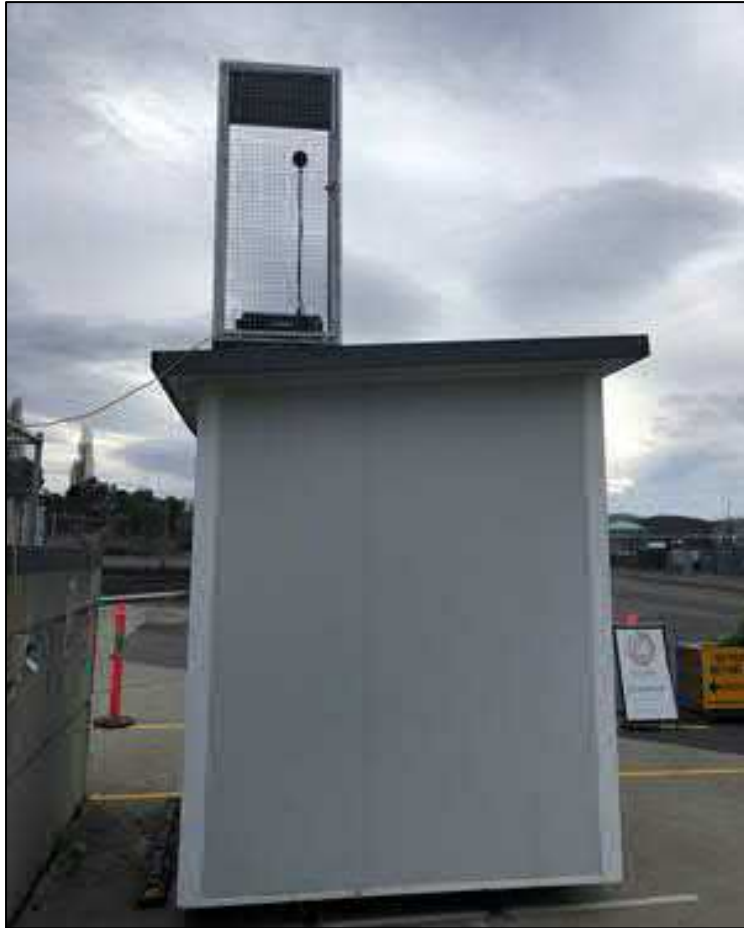
Figure 3. The Corporation's noise monitoring station in the south part of the Precinct near Evans Street.

The Corporation operates a real time noise monitor on site for continuous measurement of noise levels in the vicinity of Evans Street. However the Precinct is a large site and measurements of noise levels from a given activity should be made close enough to the noise source that its noise is at least 5 dB above the background noise. Noise levels in Evans Street and the Glebe can then be predicted using the distance adjustment equation given in the worked example.
