DCEMP - CONSTRUCTION HERITAGE MANAGEMENT PLAN (CHMP)

LOCAL HERITAGE PLACES
(BRIDGEWATER RAILWAY STATION, PARKVIEW, & FAIRFIELD)

BRIDGEWATER BRIDGE PROJECT NO: 2024

DOC NO: 2024-MCD-0000-PLA-PRJ-00063

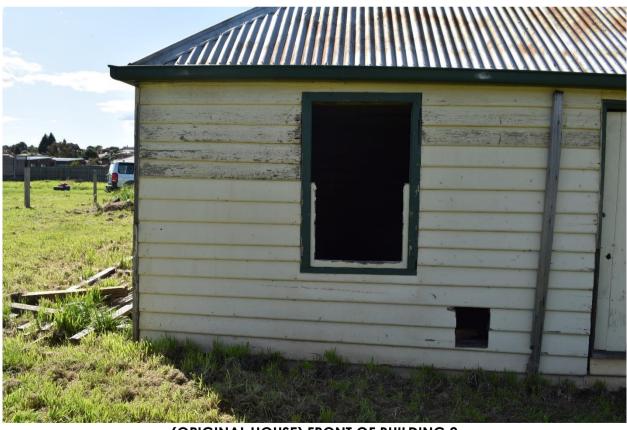
This dwelling is undergoing extensive renovations including restumping foundation wall, refurbishment timber replacement and repainting.

(BUILDING HAS BEEN RESTUMPED)

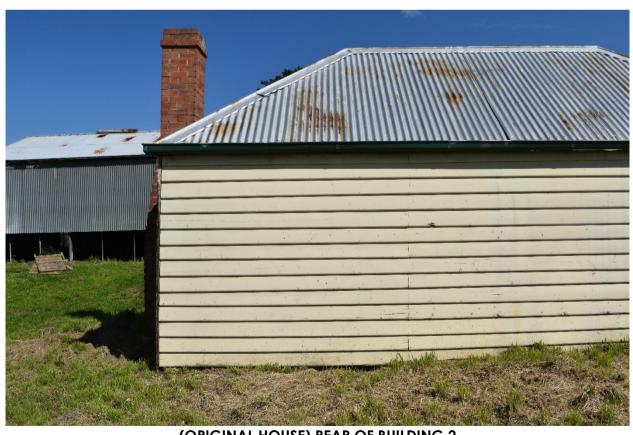
(ORIGINAL HOUSE) SIDE OF BUILDING 2- CRACKING OBSERVED ON CHIMNEY-10mm GAP APPROXIMATES

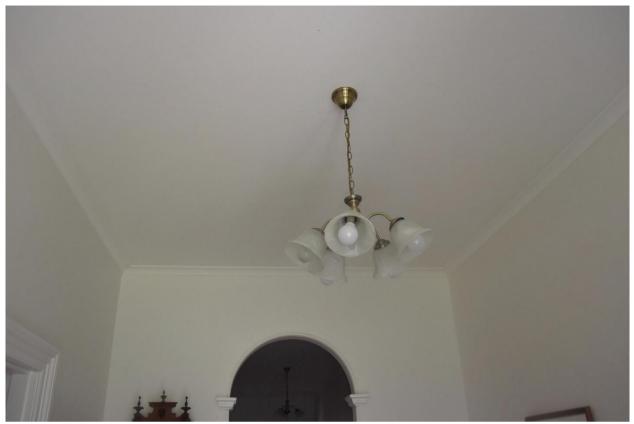
CRACKING IN HALLWAY WALL
